ERA24LA346

## INVESTIGATION PHOTOGRAPHS

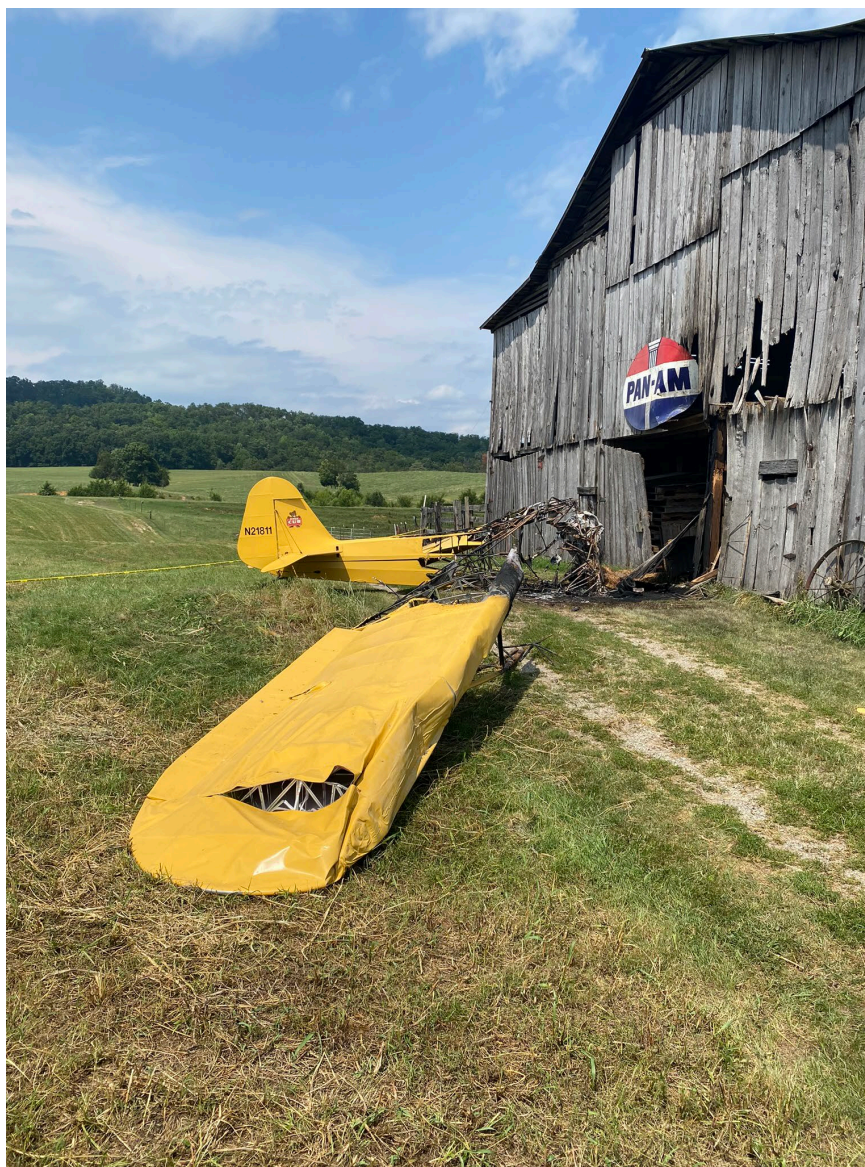
**Photograph 1 - Deformation noted to fuselage tubular structure (Courtesy of FAA)**

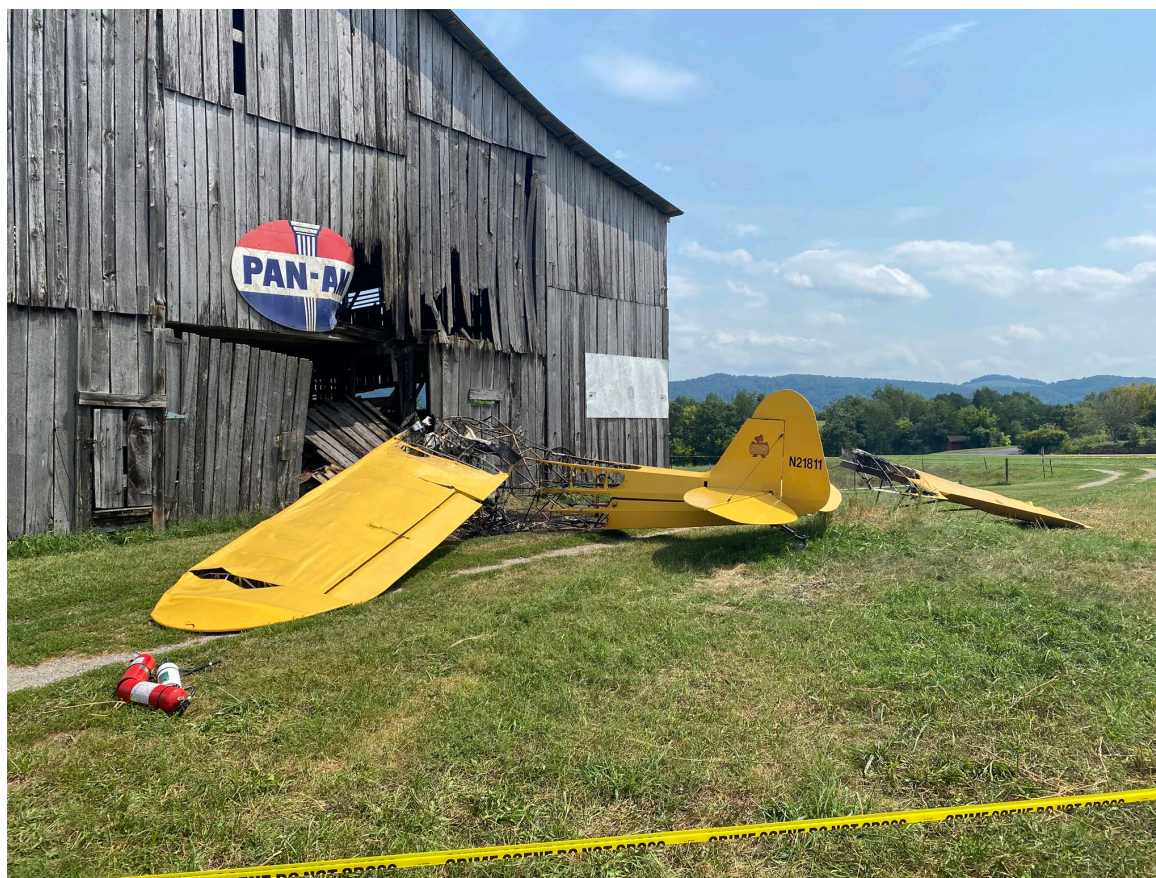
**Photograph 2 - Tubular structure deformation and thermal damage noted (Courtesy of FAA)**

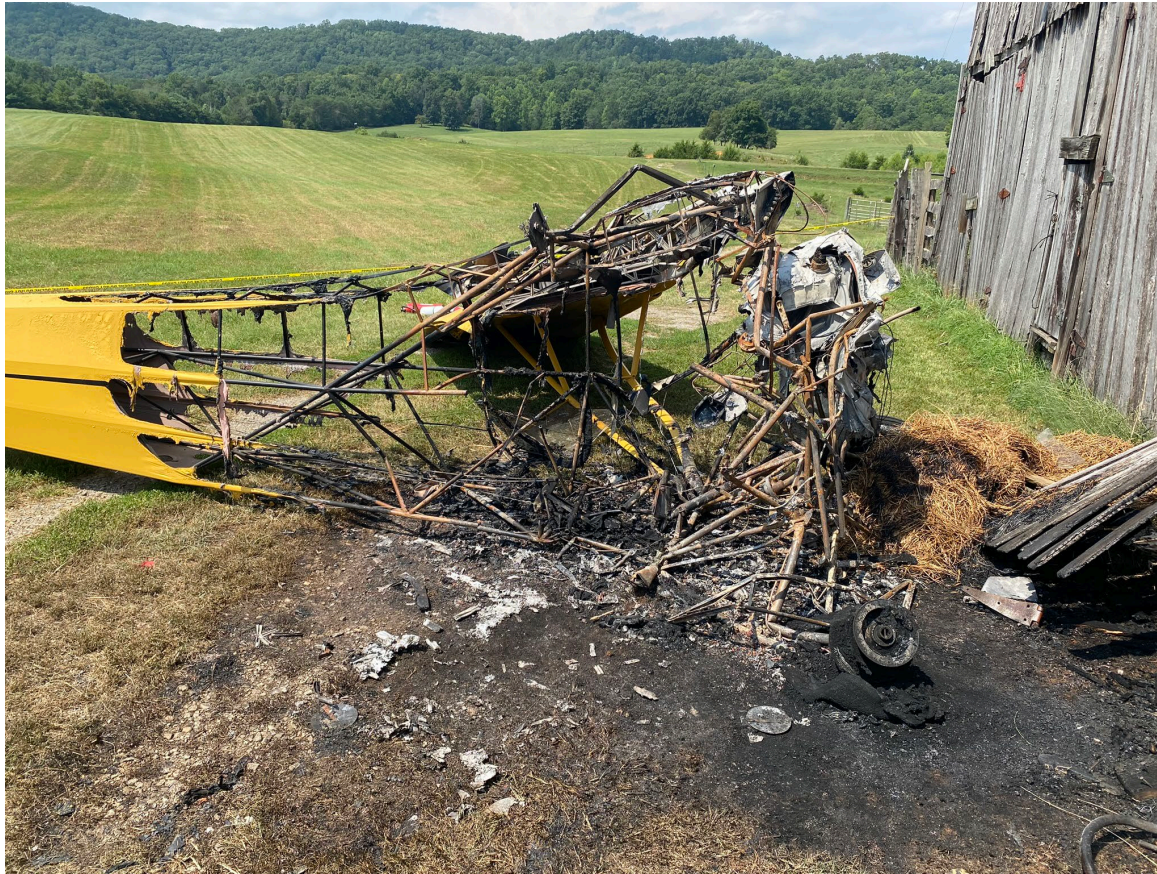
**Photograph 3 - Thermal damage noted to fuselage (Courtesy of FAA)**
