ERA24LA348

## INVESTIGATION PHOTOGRAPHS

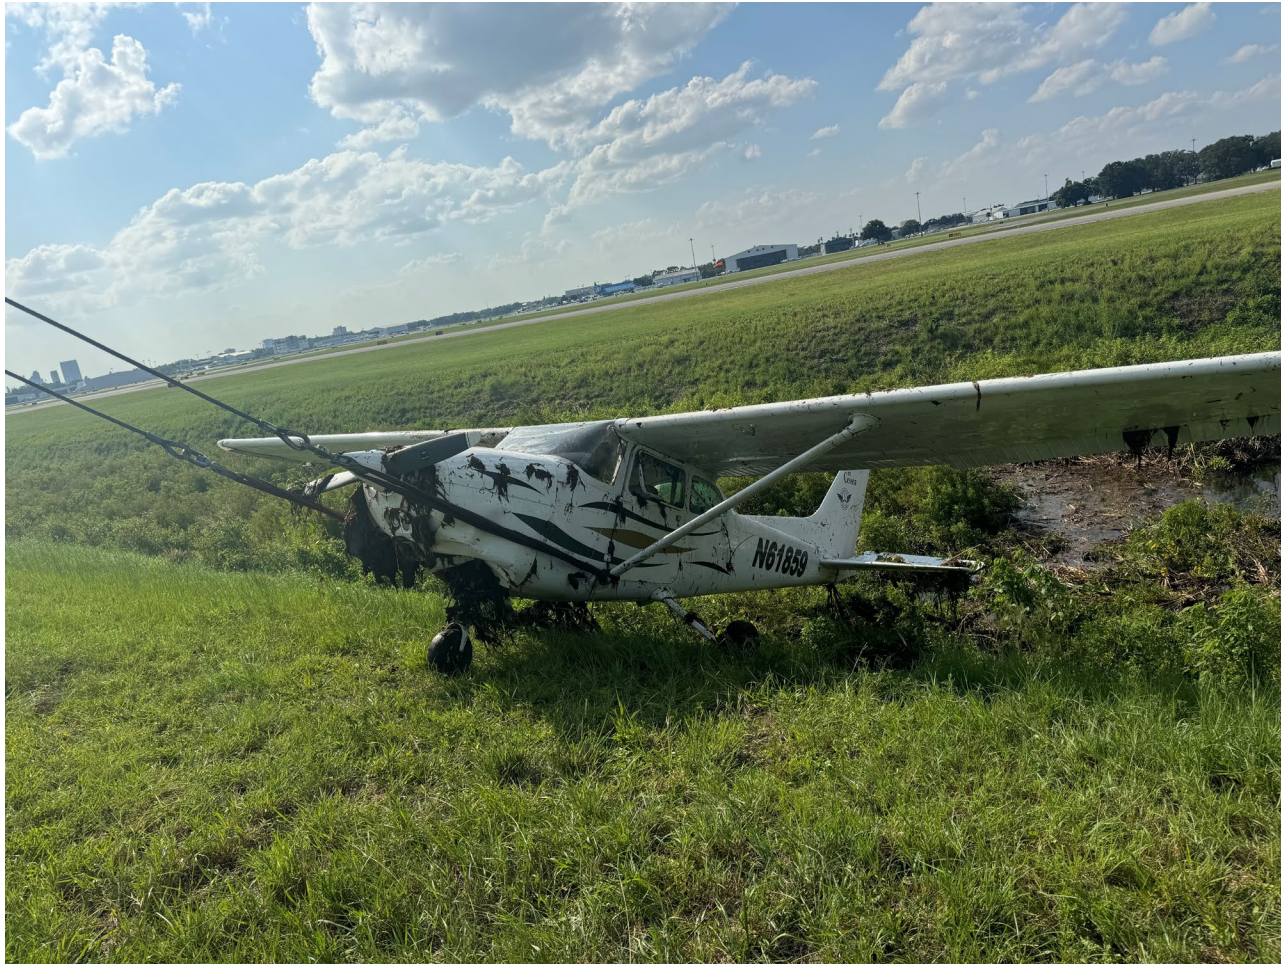
**Photograph 1 - Airplane as its being recovered. (Courtesy of FAA)**

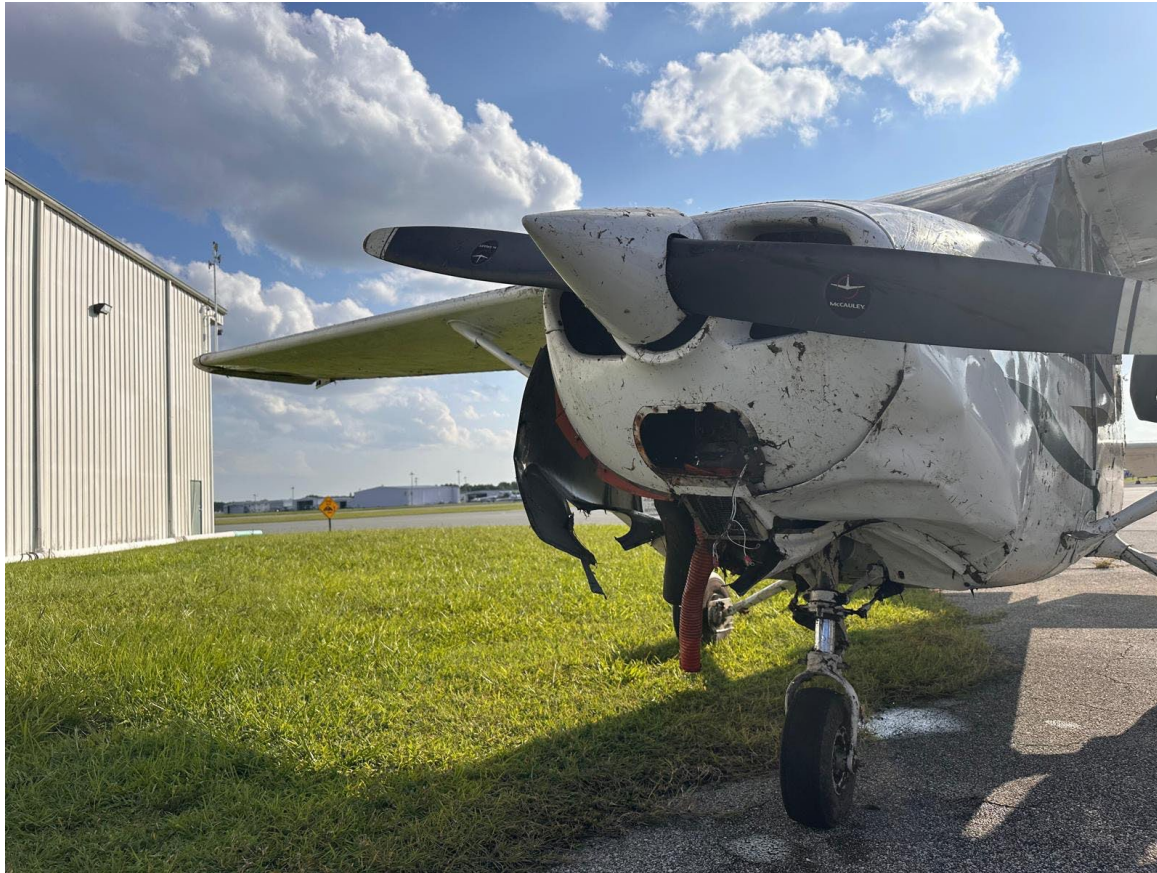
**Photograph 2 - Fuselage and engine compartment damage. (Courtesy of FAA)**

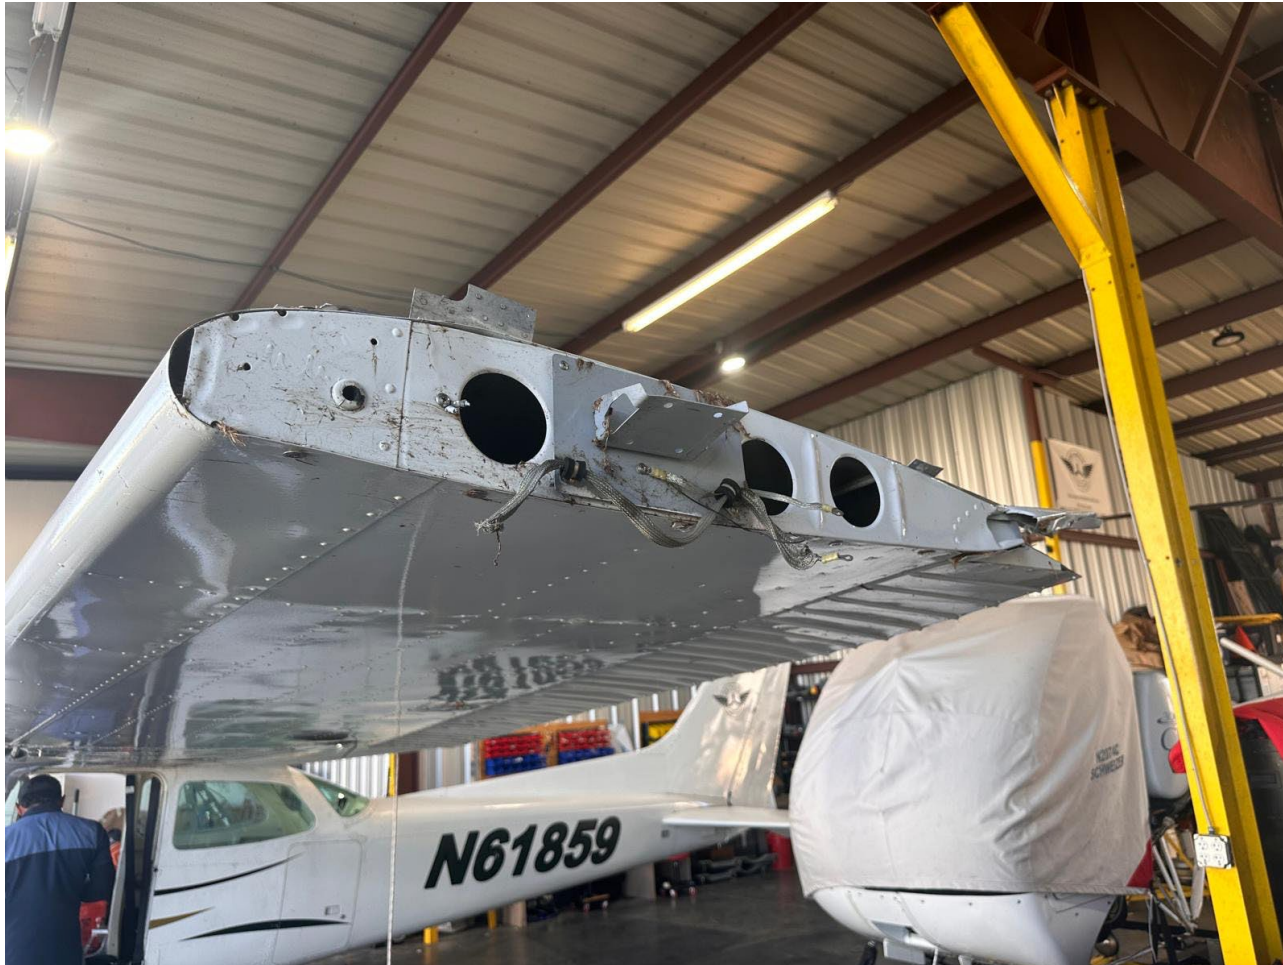
**Photograph 3 - Left wingtip damage. (Courtesy of FAA)**

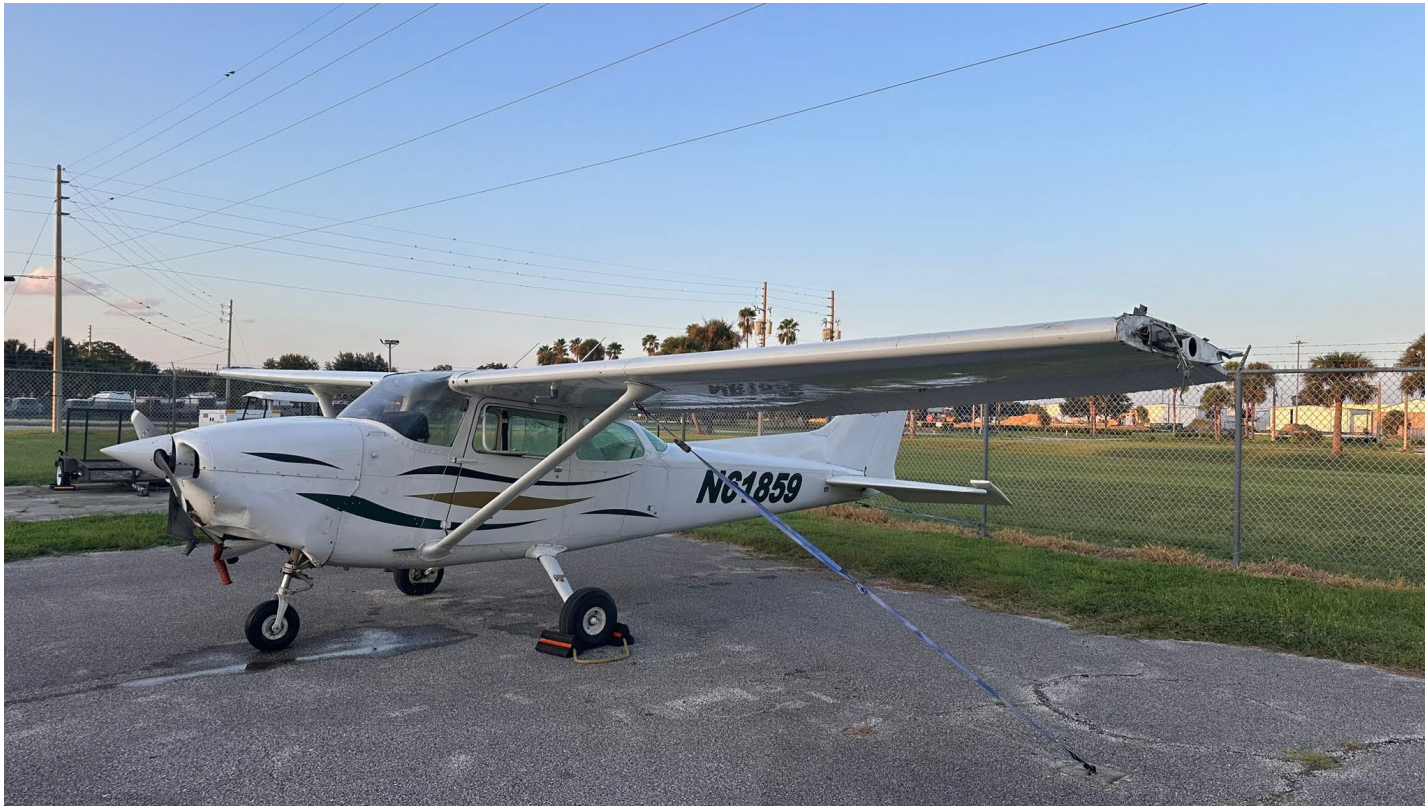
**Photograph 4 - Overall view of airplane after recovery. (Courtesy of FAA)**
