ERA24LA352

## INVESTIGATION PHOTOGRAPHS

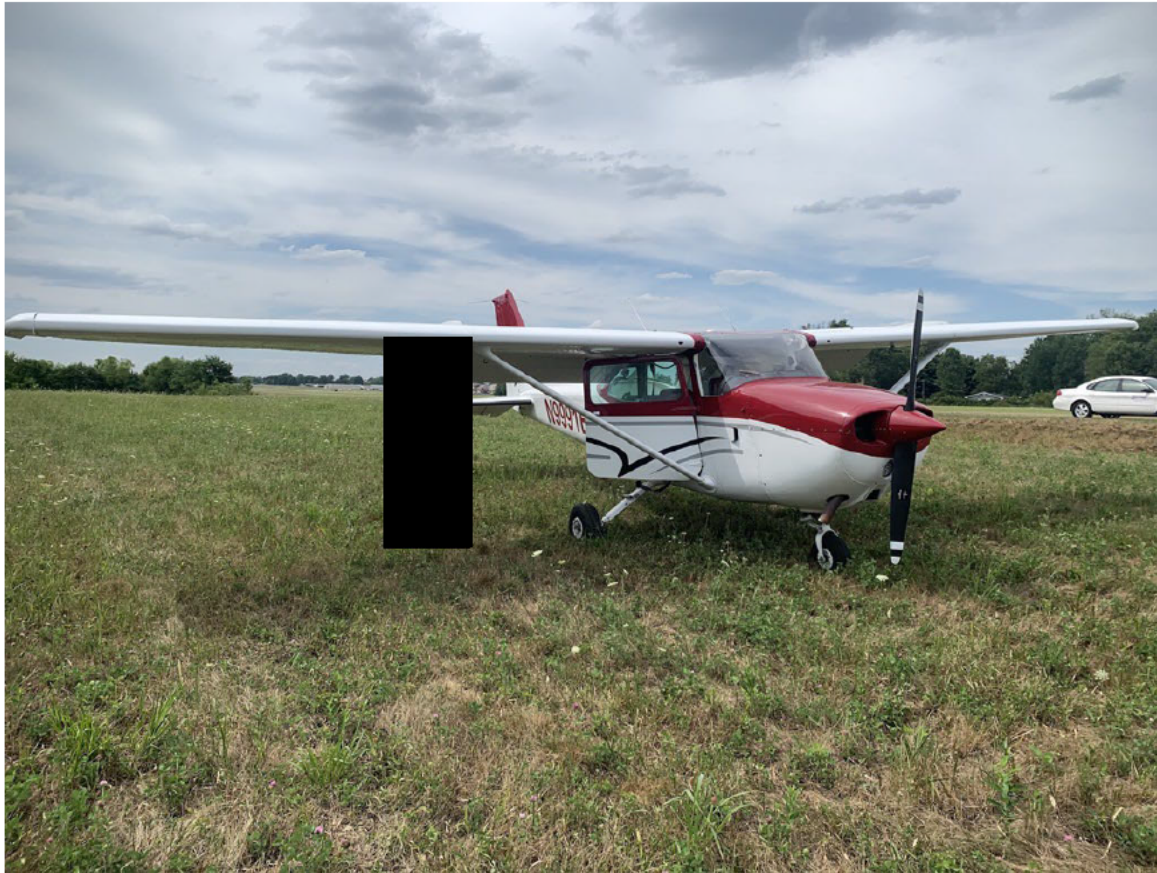
**Photograph 1 - Main Wreckage (Courtesy of Pilot)**

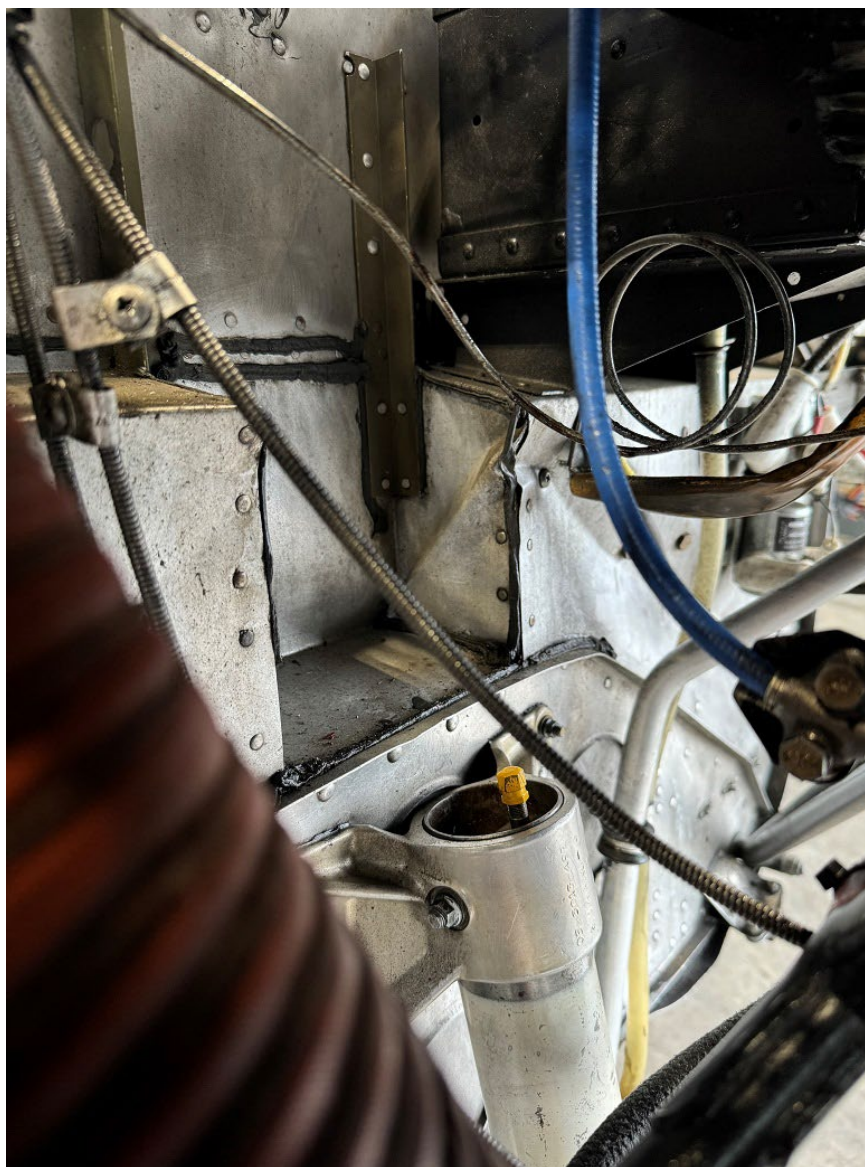
**Photograph 2 - Tunnel Structure Substantial Damage (Courtesy of FAA)**
