ERA24LA359

## INVESTIGATION PHOTOGRAPHS

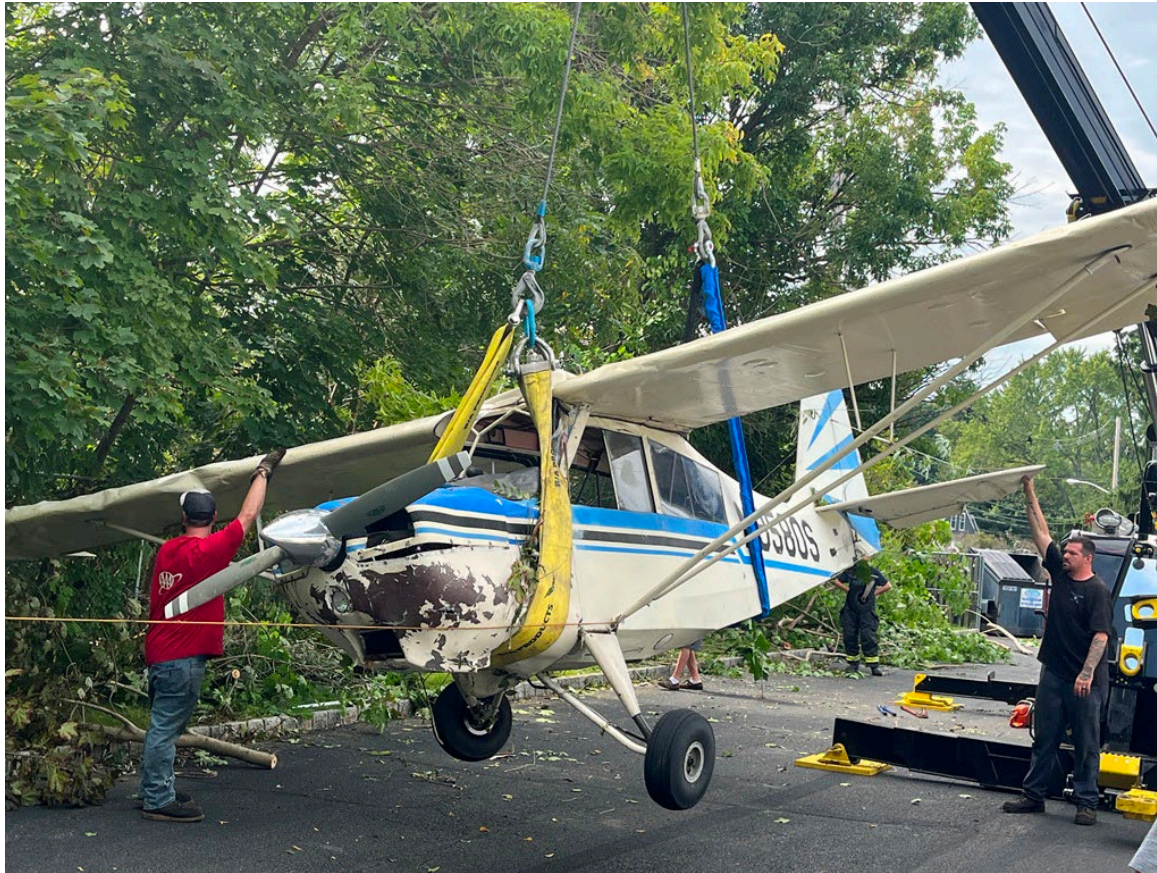
**Photograph 1 -Airplane being recovered from adjacent trees (Courtesy of FAA)**

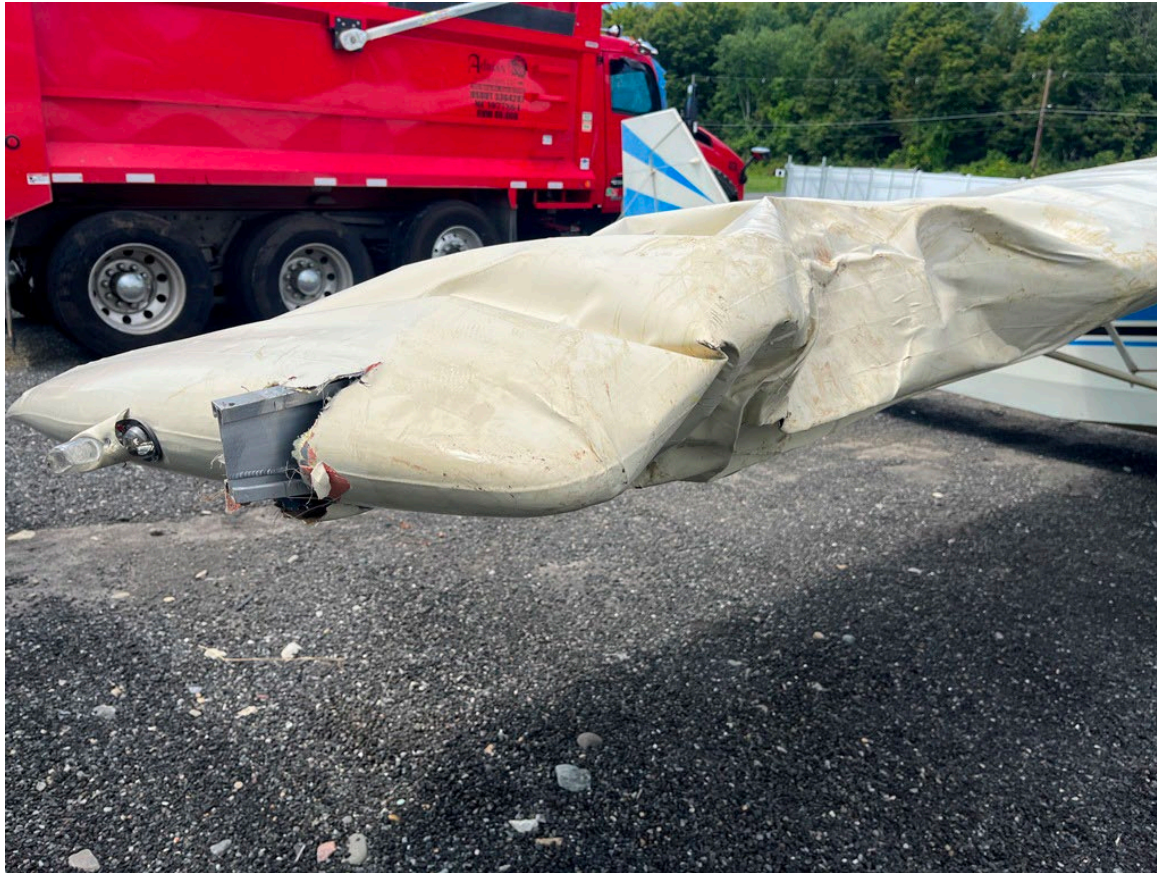
**Photograph 2 - Damage to right wing (Courtesy of FAA)**

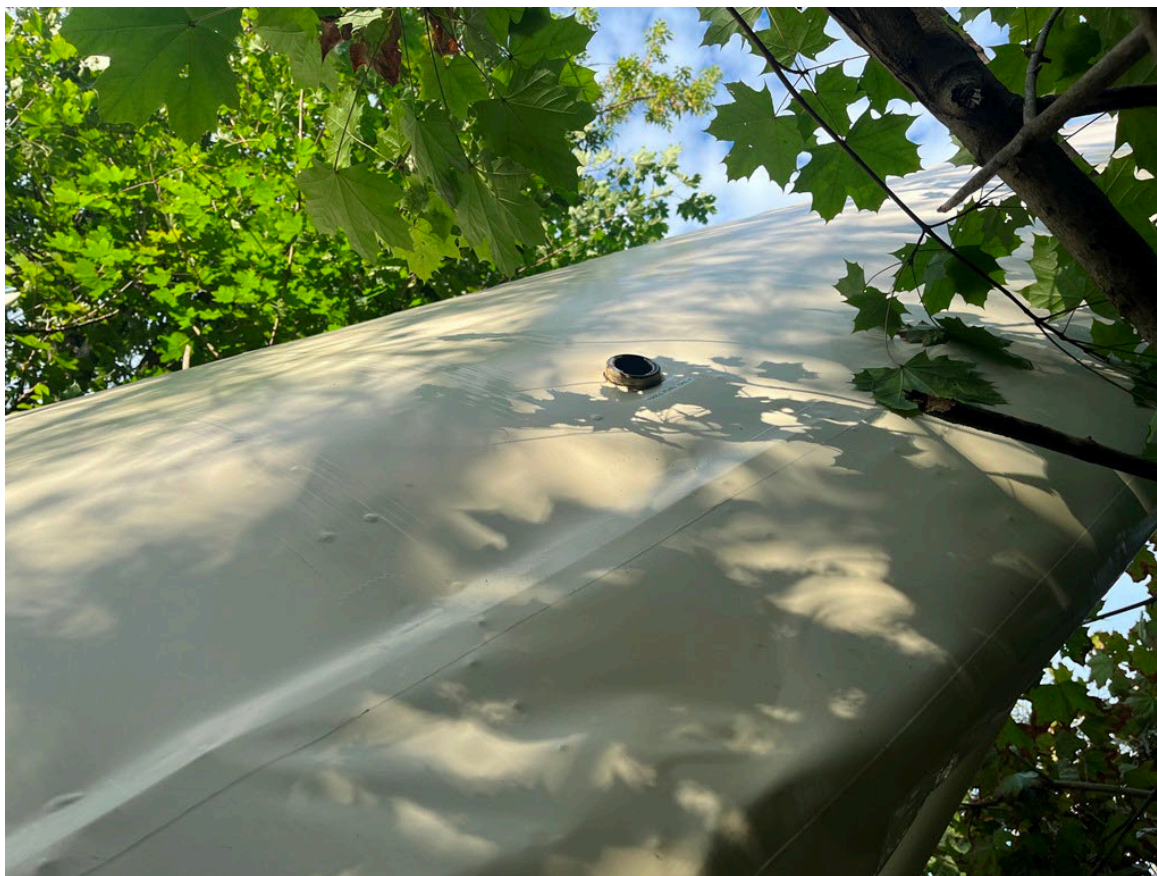
**Photograph 3 - Top of left wing - Fuel cap missing (Courtesy of FAA)**

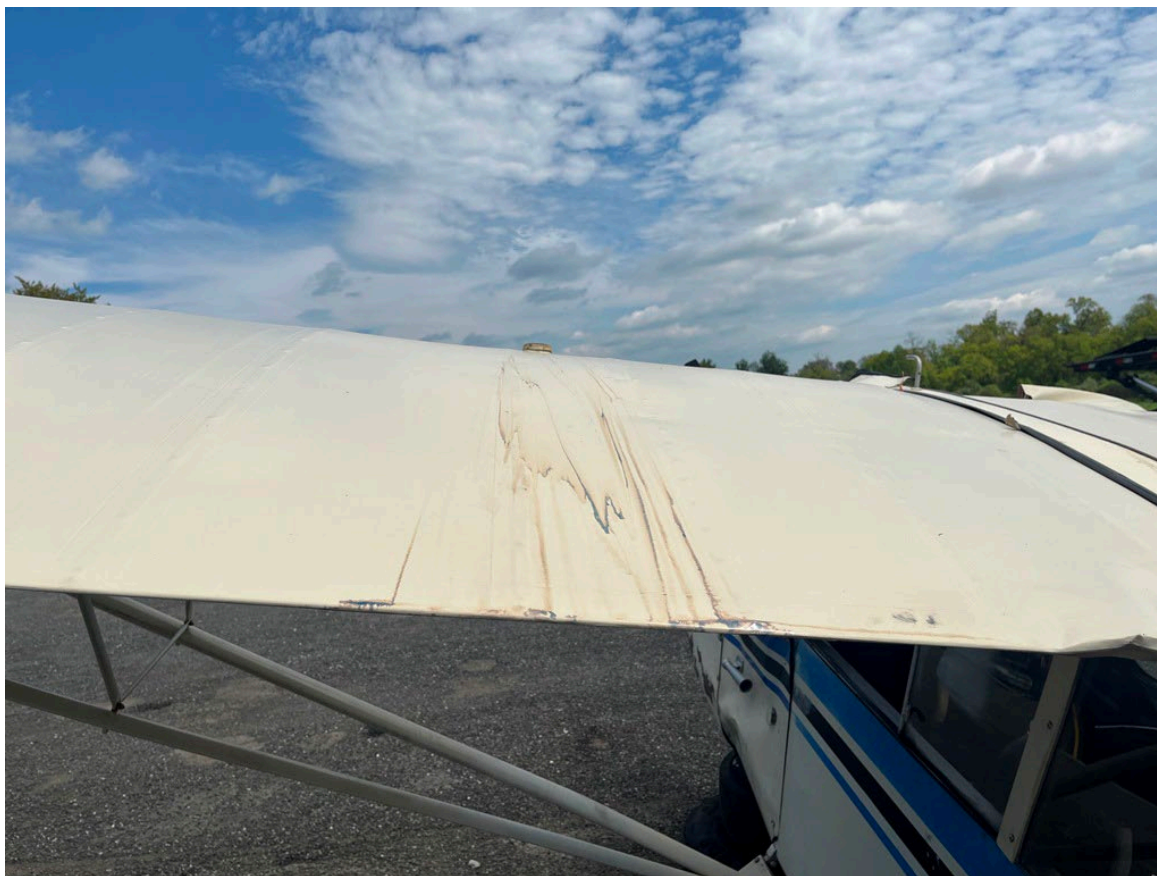
**Photograph 4 - Fuel streaking aft of fuel cap - Left wing (Courtesy of FAA)**

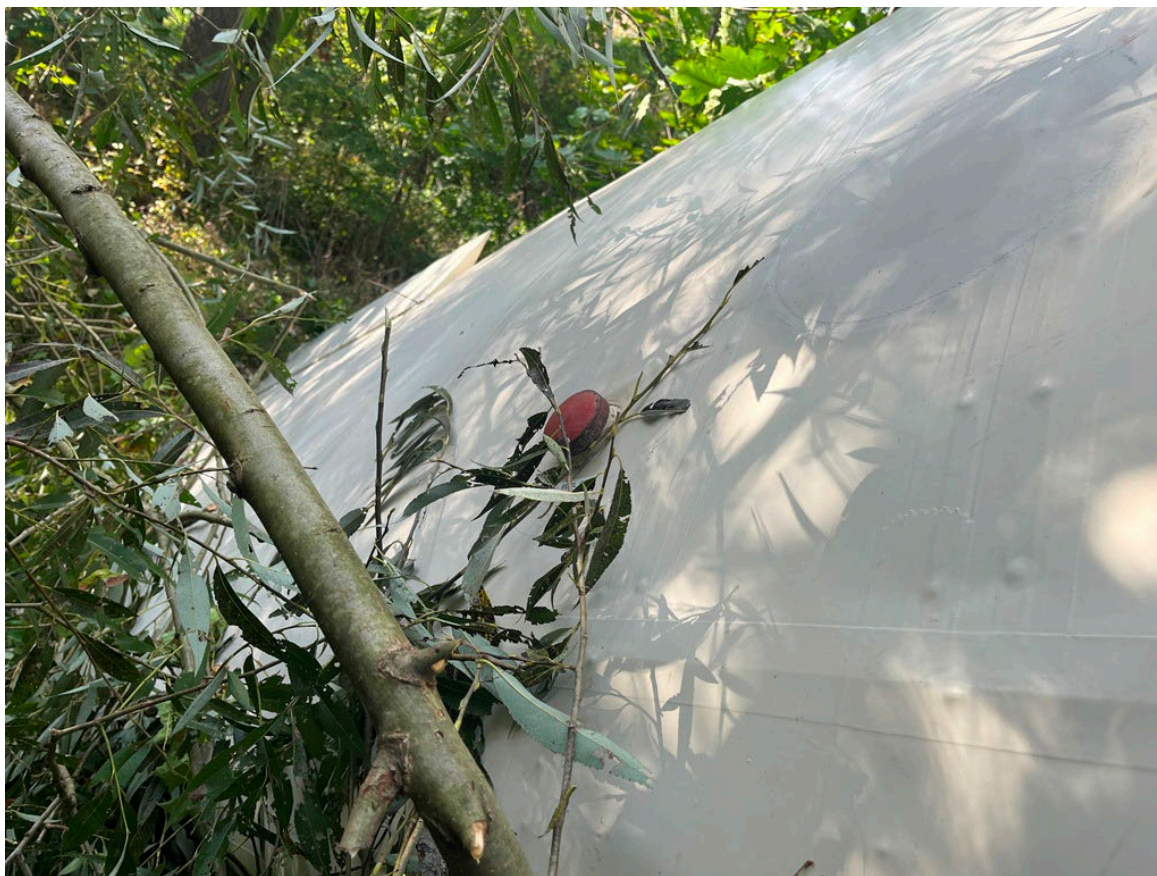
**Photograph 5 - Top of right wing - Fuel cap intact (Courtesy of FAA)**
