ERA24LA360

## INVESTIGATION PHOTOGRAPHS

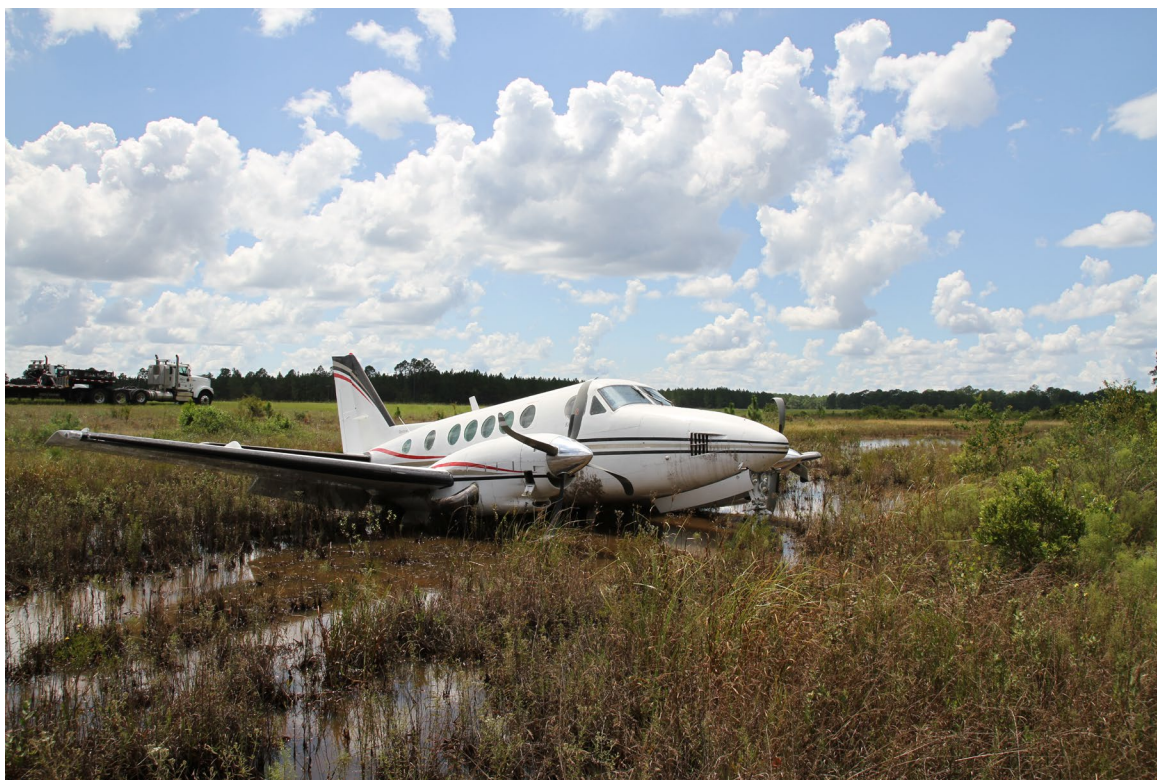
**Photograph 1 - View of the Airplane's Right Side (Courtesy of FAA)**

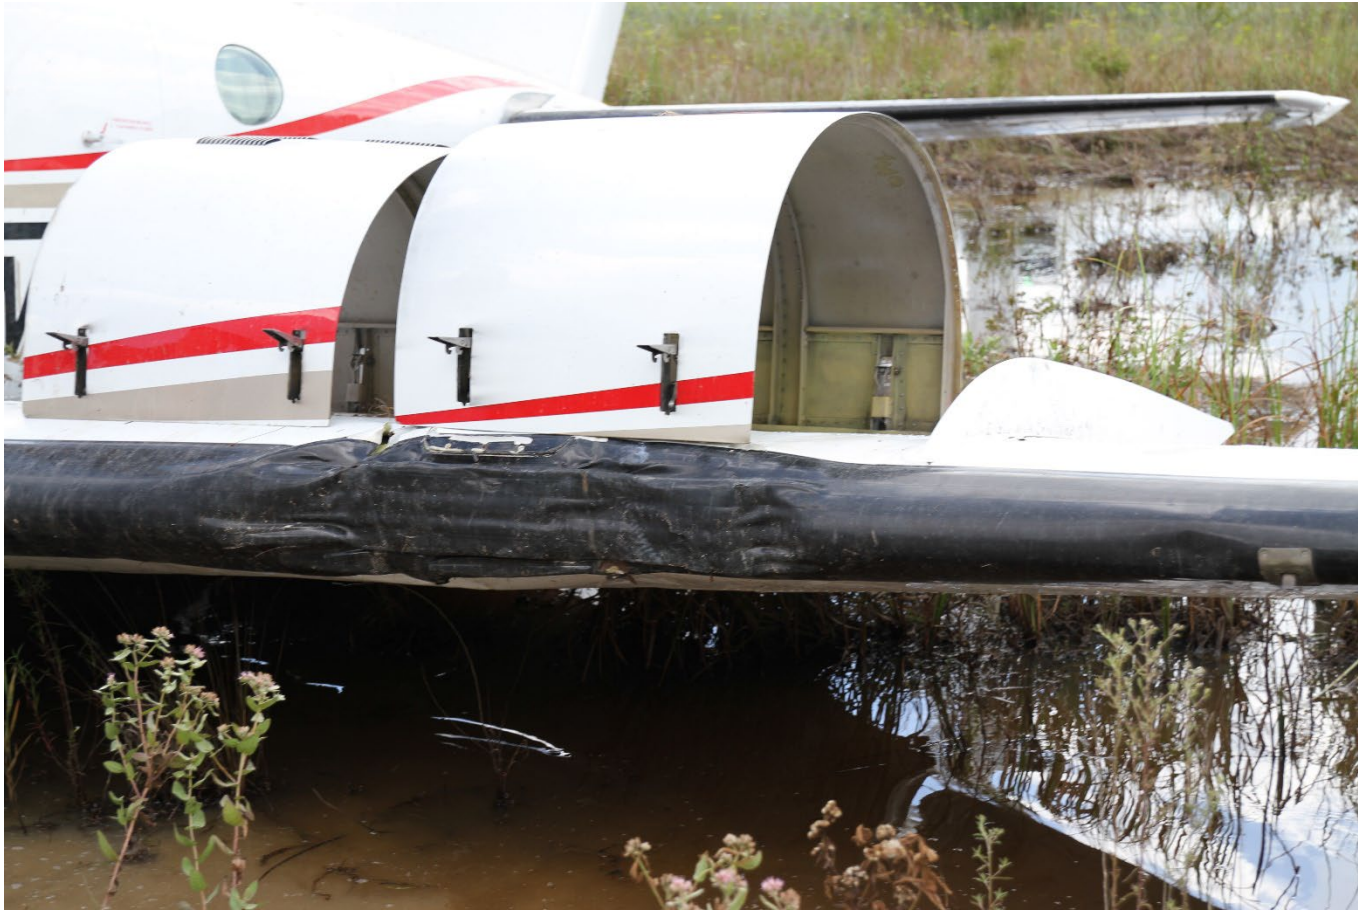
**Photograph 2 - View of Airplane's Left Wing Damage (Courtesy of FAA)**

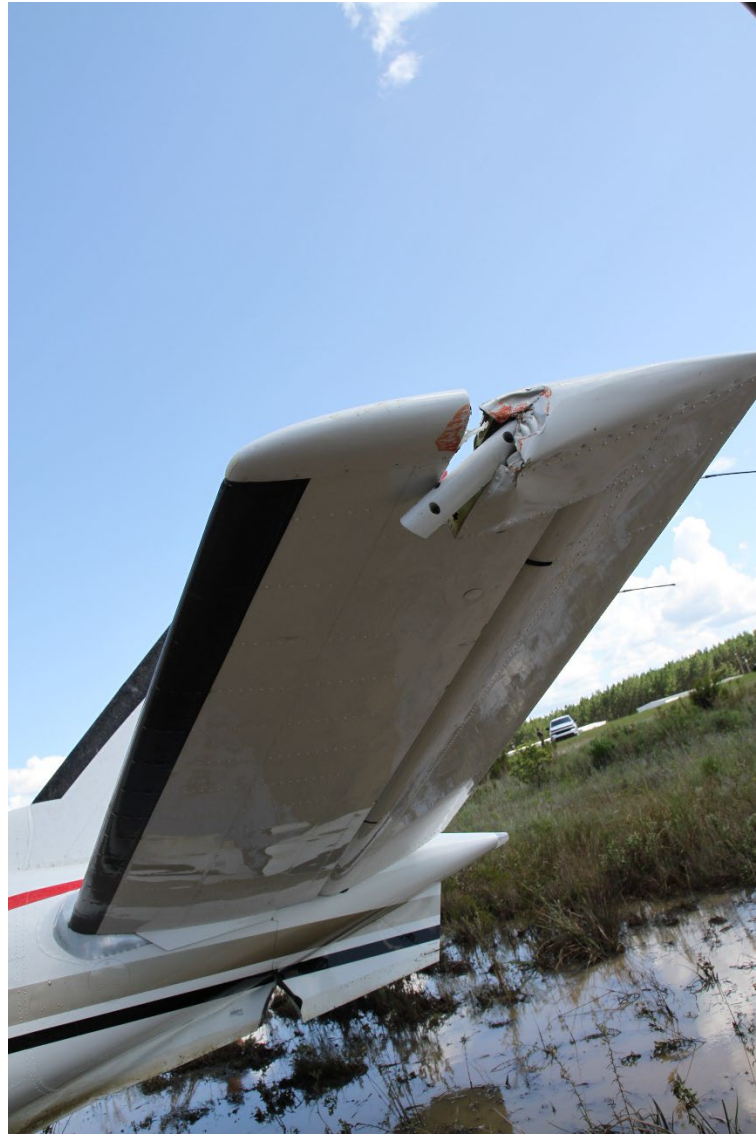
**Photograph 3 - Left Elevator Damage (Courtesy of FAA)**

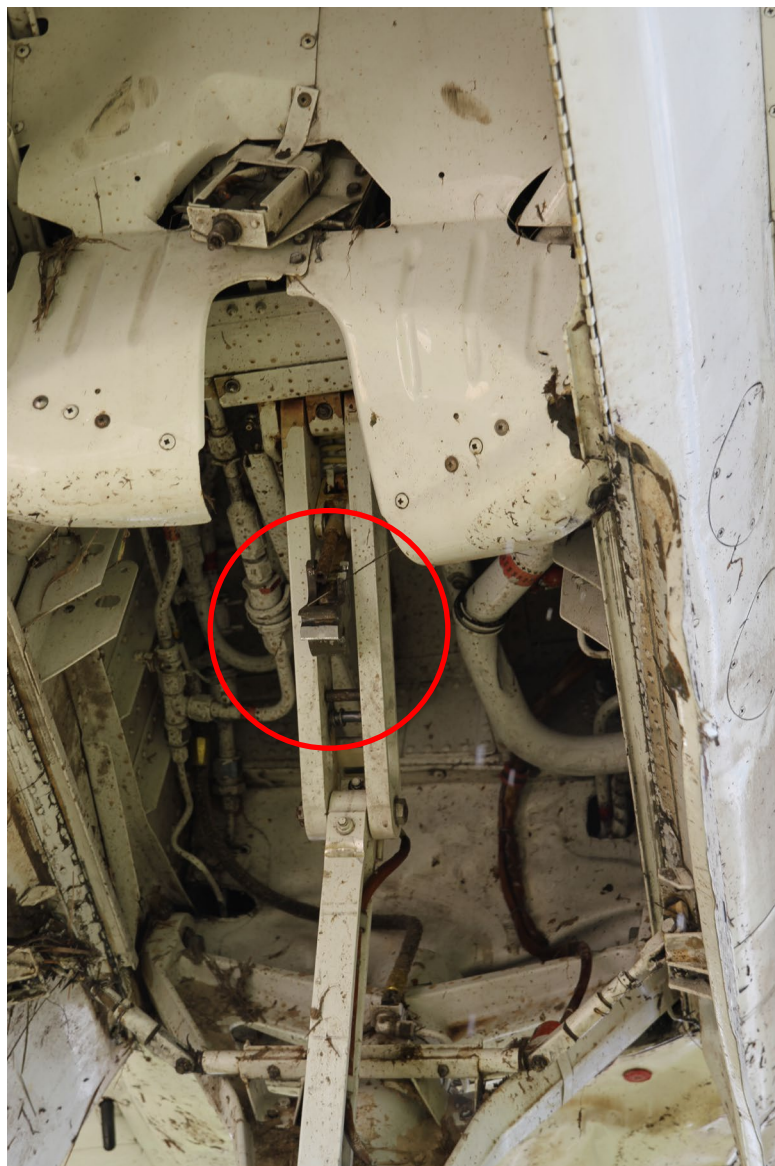
**Photograph 4 - Broken Left Main Actuator Clevis (Courtesy of FAA)**
