# National Transportation Safety Board

ERA24LA361

## EXAMINATION SUMMARY

Location: Lynchburg, VA  
Date: August 29, 2024  
Time: 1724 Local  
Airplane: N734SY, Cessna 172N, Serial Number 17269088

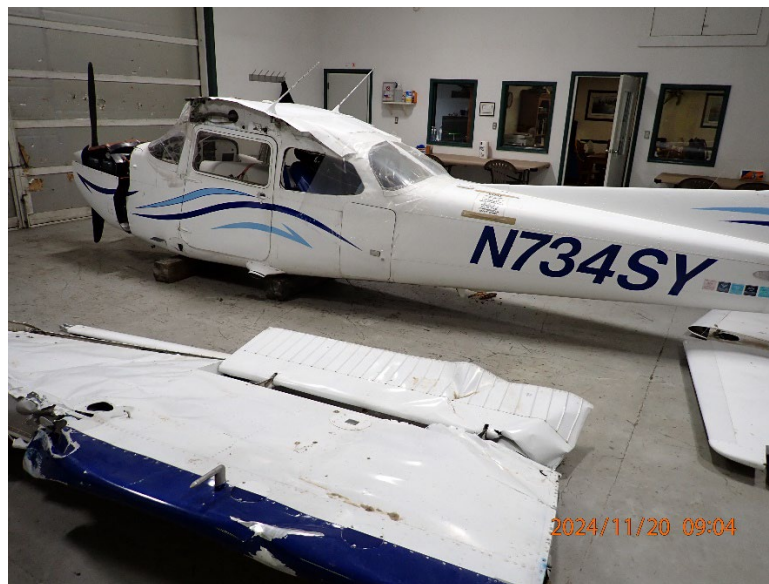
**Left Side of the Airplane**

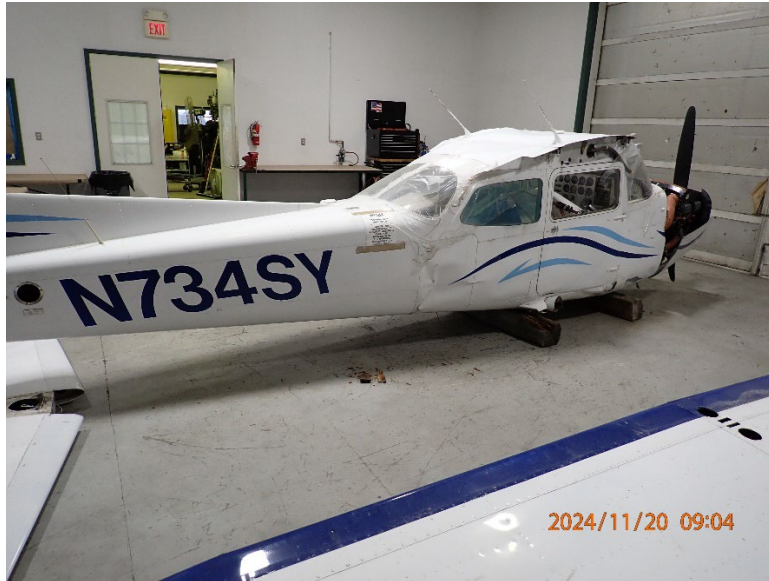
**Right Side of the Airplane**

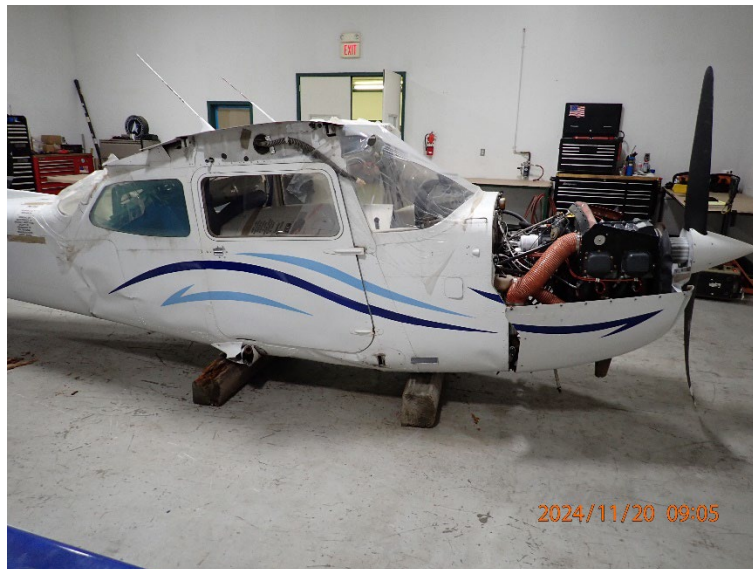
The fuselage was intact with buckling and wrinkling on the right side, aft of the passenger door and below the passenger door. The front seats had been removed and were stored in the back of the fuselage with the rear seats. The carpet had been removed prior to the examination. The front windscreen was broken in several places.

**Right Side Fuselage Wrinkling**

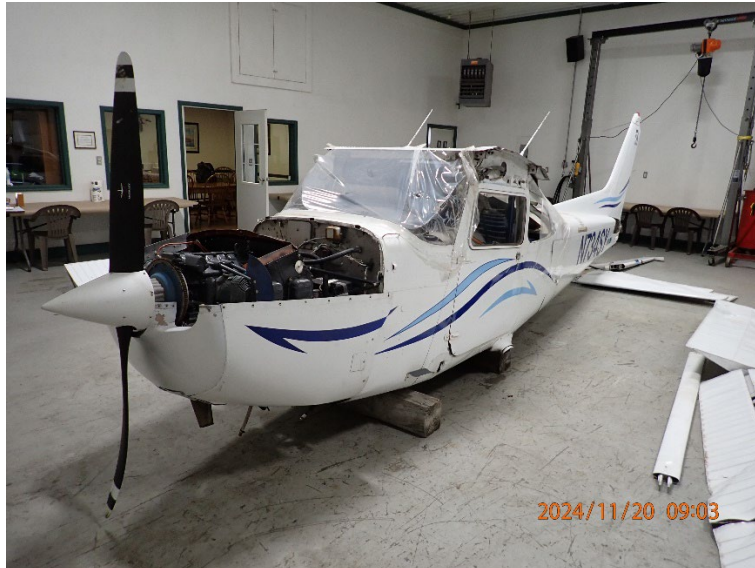
**Shattered Windscreen**

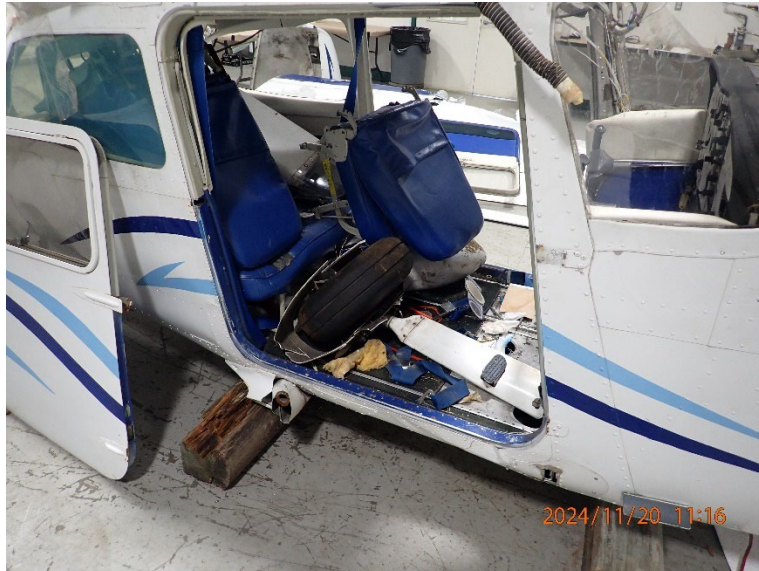
**Airplane Interior as Observed**

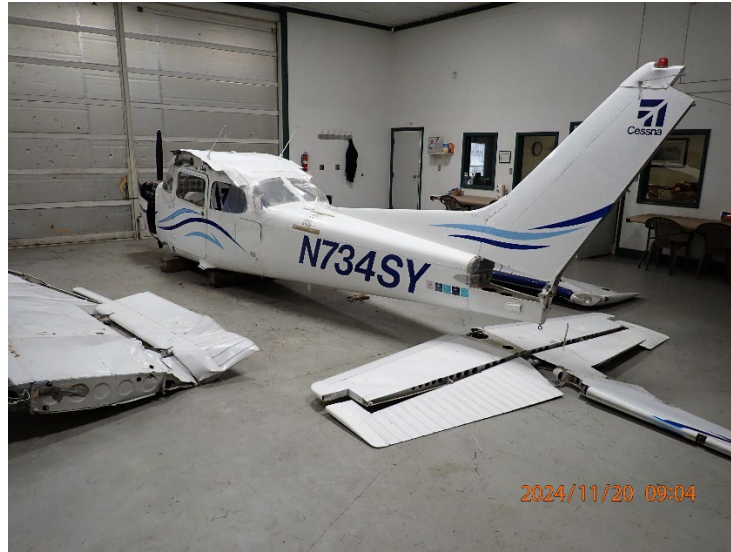
The empennage was mostly undamaged. The rudder and elevator were removed by recovery personnel for transport. The rudder and elevator were undamaged. Control cable continuity from the rudder and elevator were established to the cockpit.

**Empennage Structure**

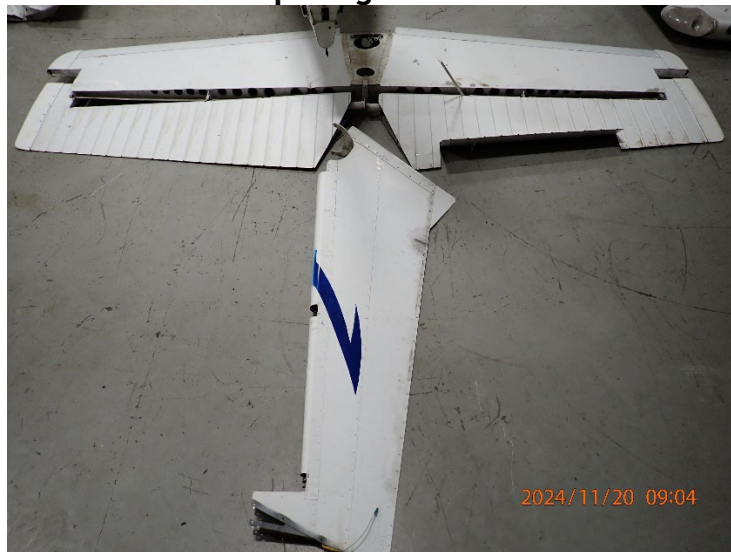
**Rudder and Elevator**

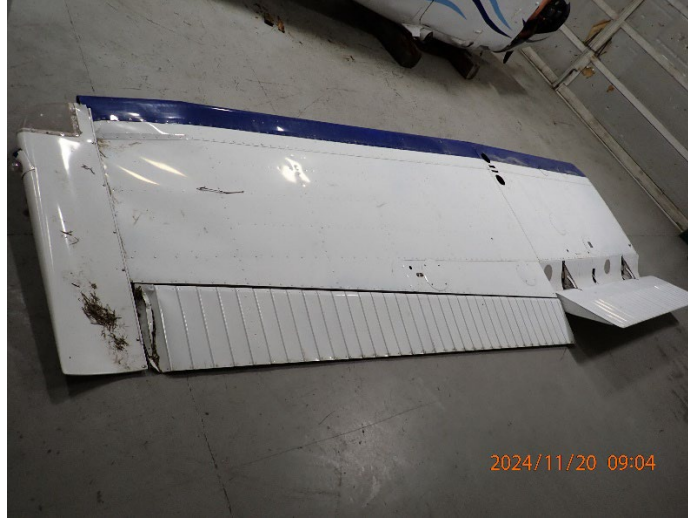
The right wing had impact damage to the outboard portion of the aileron, but the aileron moved freely. Skin buckling from impact forces was apparent on the wing on the outboard forward, bottom surface. According to the FAA, the right wing held fuel that the pilot was draining from the wing when he arrived on scene. The fuel lines and vents from the right wing to the fuselage were plugged by recovery personnel with wood to prevent fuel leakage during recovery.

**Right Wing**

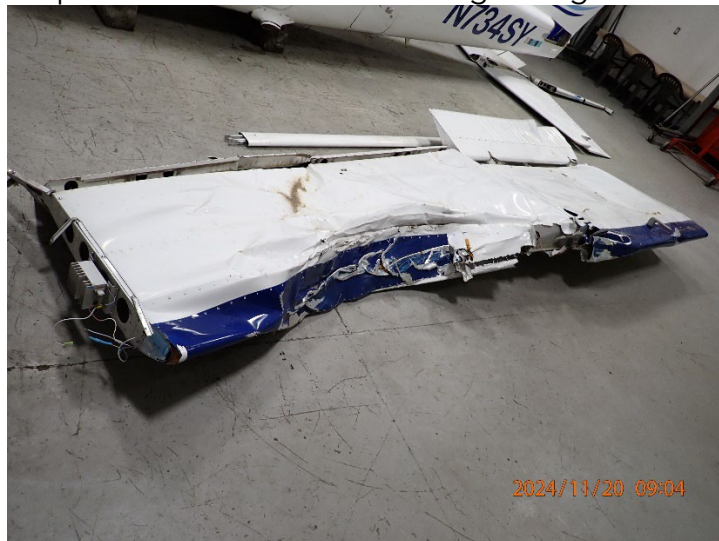
The left wing was substantially damaged from impact to the leading edge. The wing was wrinkled and bent in several locations. Crush damage to the leading edge was apparent over most of the wing. The left aileron was substantially damaged from the impact. The left flap was damaged. The left-wing fuel lines and vents were not plugged and were exposed to the elements during storage.

**Left Wing**

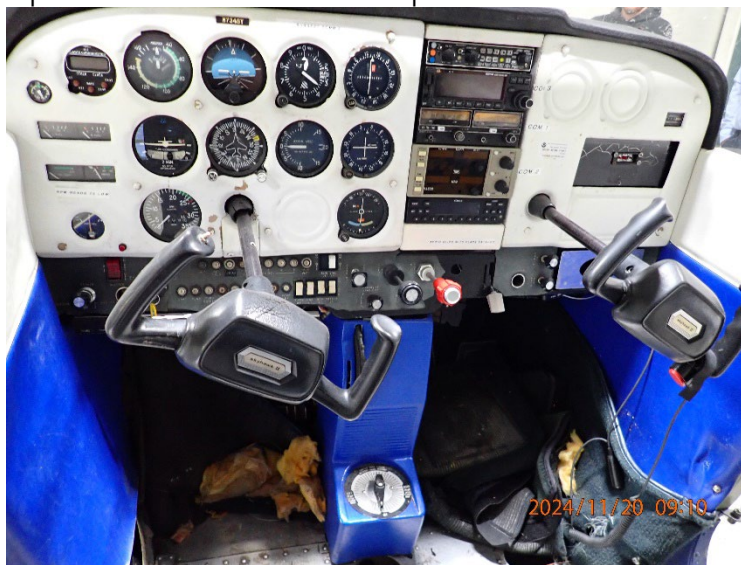
Cockpit

The cockpit was mostly undamaged. The airplane was equipped with two manual fuel level gauges that read "E". The engine tachometer read "0". The airspeed indicator read "0". The suction gauge was off the scale to the right. The altimeter reading was 350 with an altimeter setting of 30.15. The vertical speed indicator read "0". The navigational gauges appeared undamaged. The primer was in and locked. The master power switch was in the "off" position. The ignition was in the "off" position. There were no popped circuit breakers observed. The parking brake was in the off position. The pitot head, landing light, and navigation light switches were in the "off" position. The beacon light and strobe light were in the "on" position. The carburetor heat lever was in the off position. The throttle and mixture control levers were observed in an idle and idle-cutoff position, respectively. The flap lever was in the full down position. The fuel selector was in the "off" position. The communication equipment and Garmin GNC 300XL appeared undamaged. The Stratus transponder appeared undamaged. The cabin heat and cabin air control levers were in the "off" position. The tachometer hours reading was "0709.6". The Hobbs meter reading was "0954.7". The cockpit had a ACK ELT control panel.

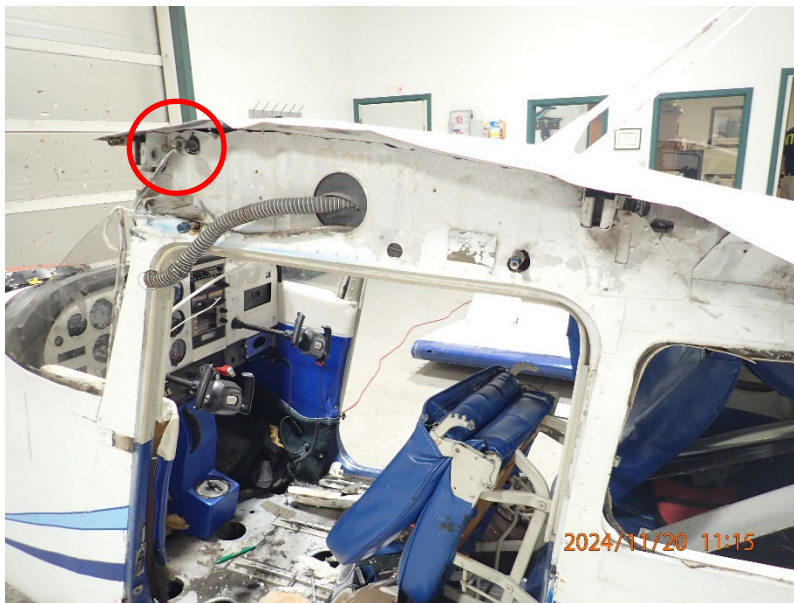
Both fuel tanks had been drained of fuel prior to the examination. It is unknown how much fuel was in each fuel tank. The fuel tank venting system appeared to be blocked by organic matter above the fuselage. The airplane was stored outside at the

recovery location and exposed to the environment; therefore, the blockages are likely from insects.

**Plugged Left Wing Vent**

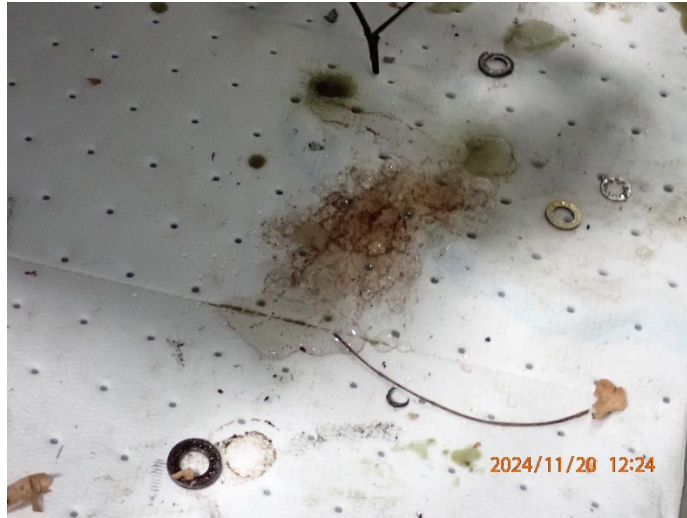
**Remaining Liquid and Debris from Fuel Strainer**

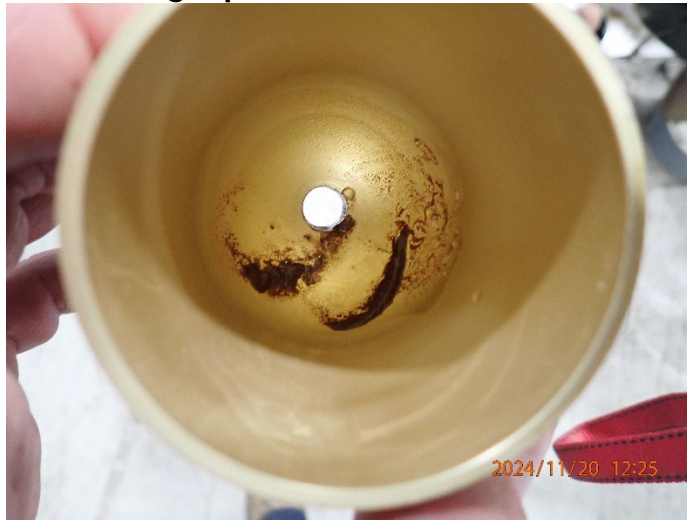
**Fuel Strainer Bowl with Debris**

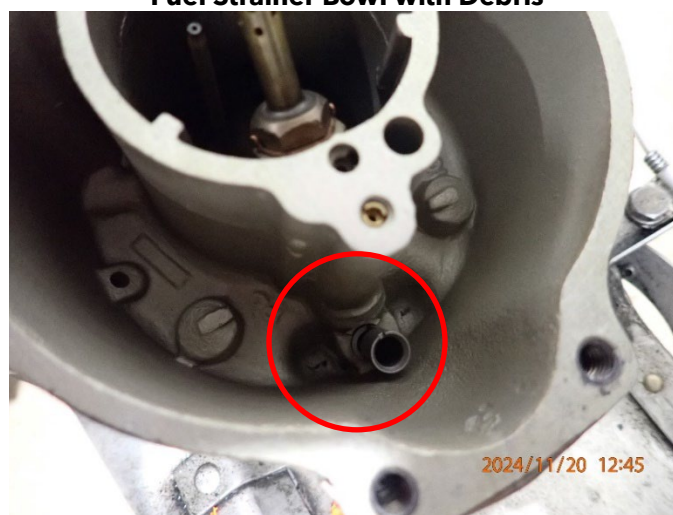
**Debris in the Carburetor Bowl**

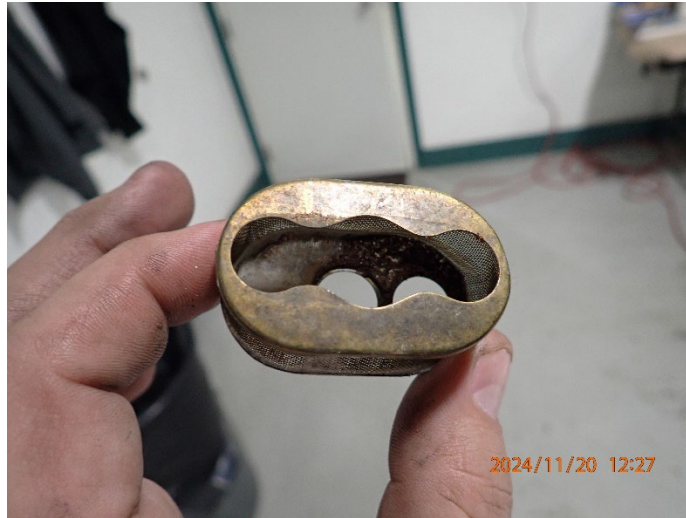
**Debris in the Fuel Filter**

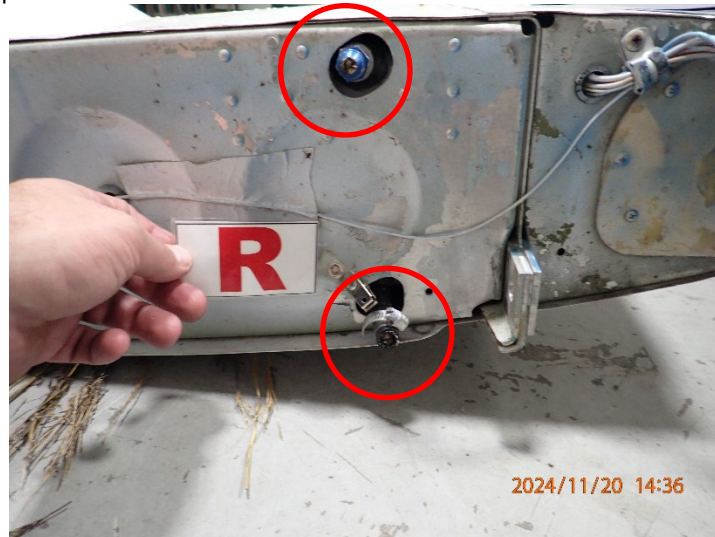
The right-wing vent and fuel lines were plugged by recovery personnel with tree sticks to prevent fuel leakage during the recovery operations. The left-wing vent and fuel lines were not capped during storage. Both wing tanks were examined with a lighted borescope and no debris was noted.

**Plugged Fuel Lines from Recovery Personnel**

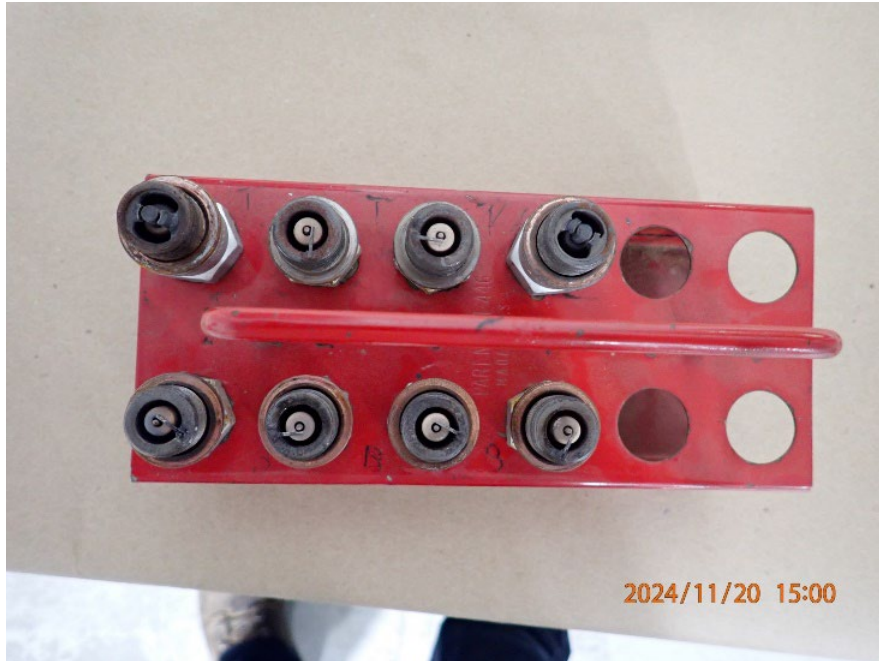
All spark plugs remained installed in their respective cylinder heads and were undamaged. The top spark plugs were a combination of massive electrodes and fine wire electrodes. The bottom spark plugs were all fine wire electrodes. The spark plugs displayed coloration consistent with normal engine operation and had normal wear when compared to the Champion Aviation AV-27 check-a-plug chart. The engine was equipped with a dual magneto with an impulse coupling. The impulse coupling produced spark at all leads when actuated. The timing of the dual magneto was checked and found at 25°.

**Spark Plugs as Removed**

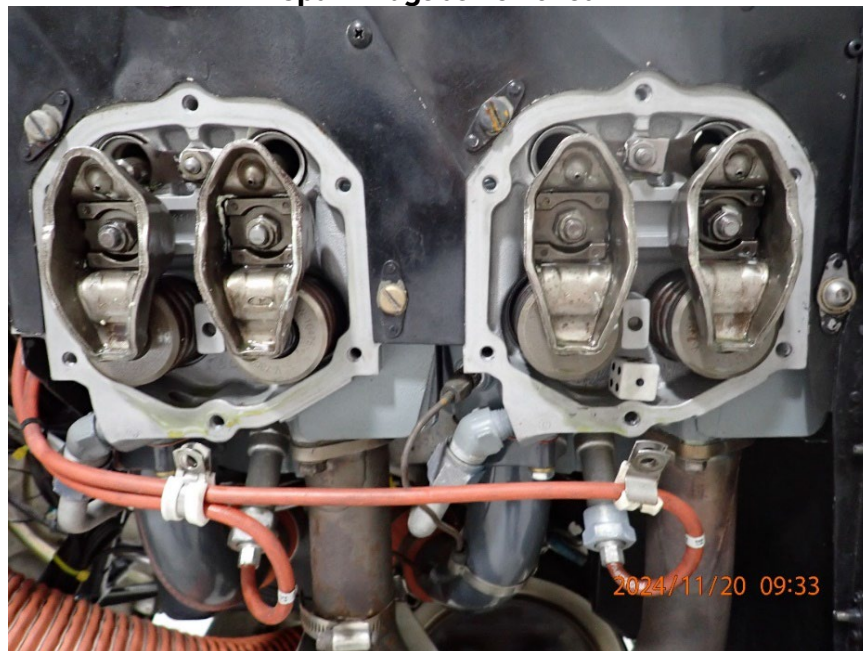
**Cylinders 1 (right) and 3 (left) with the Induction Pipes, Exhaust Pipes, and Lower Leads Attached**

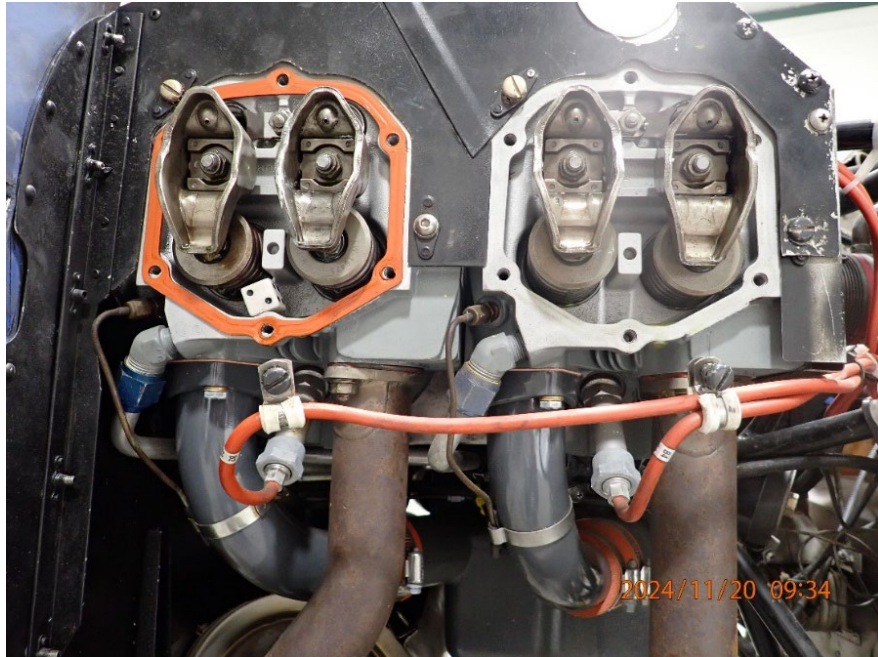
**Cylinders 2 (left) and 4 (right) with the Induction Pipes, Exhaust Pipes, and Lower Leads Attached**

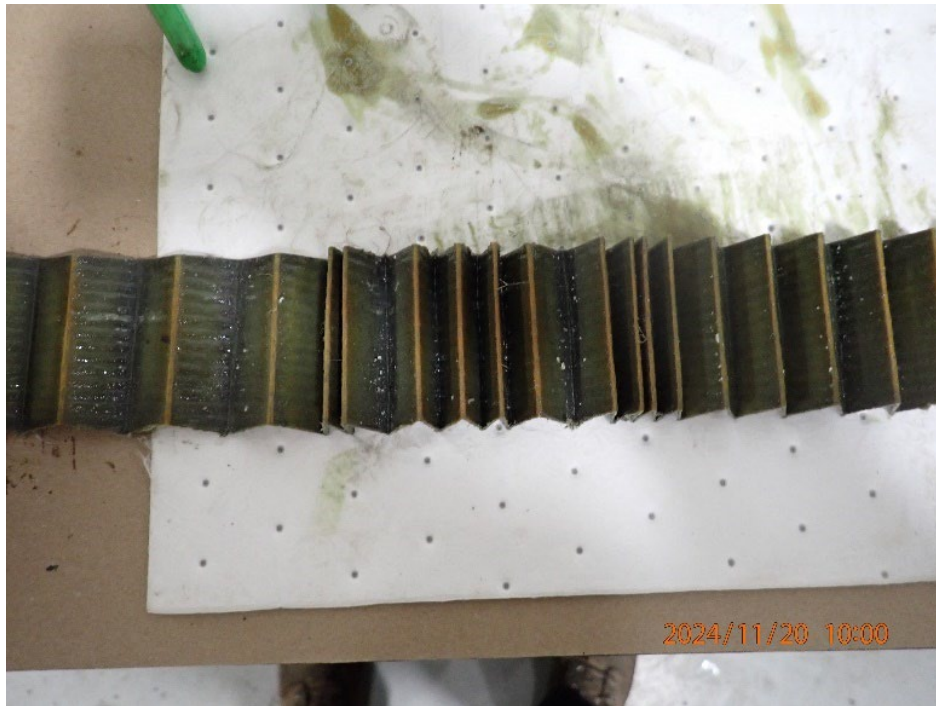
The oil filter remained secured to the accessory housing and was removed for further examination. The filter contained a large quantity of viscous oil, similar to engine assembly oil. A small quantity of ferrous and non-ferrous metal material was observed and was a likely result of the engine break-in period from the recent engine overhaul. The oil suction screen was not present within the oil sump. The oil pump was removed for examination with no discrepancies noted. With the oil pump, oil filter housing, and oil pressure relief valve removed, the oil passages were checked for blockages with safety wire, but no blockages were observed. The oil pressure relief valve was clean with no nicks or indents on the ball or the seat. The oil cooler bypass valve was removed and a uniform witness mark from seating was observed. The engine oil sump contained 5 quarts of clean engine oil when measured on the oil level gauge.

**Oil Filter Element with Visible Assembly Lubrication**

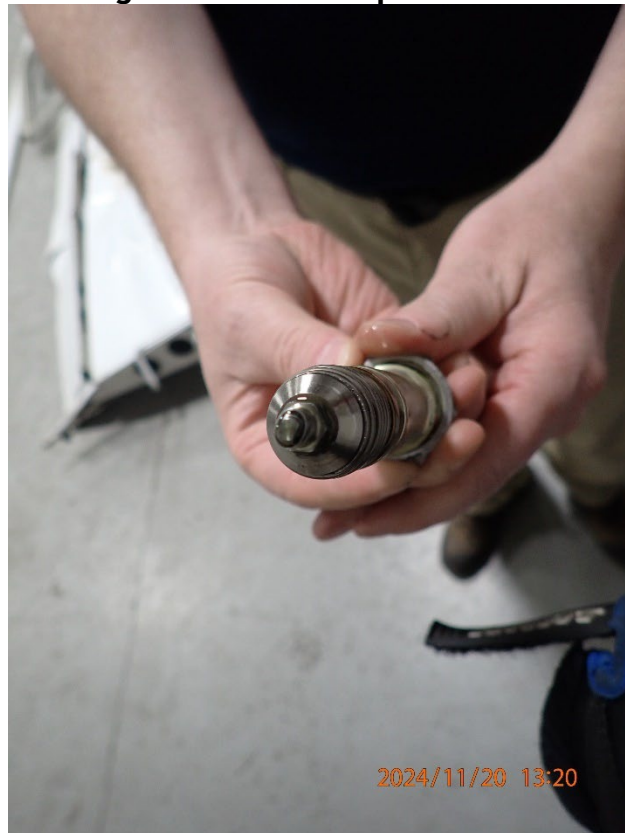
**Oil Cooler Bypass Valve with Uniform Contact Marking**

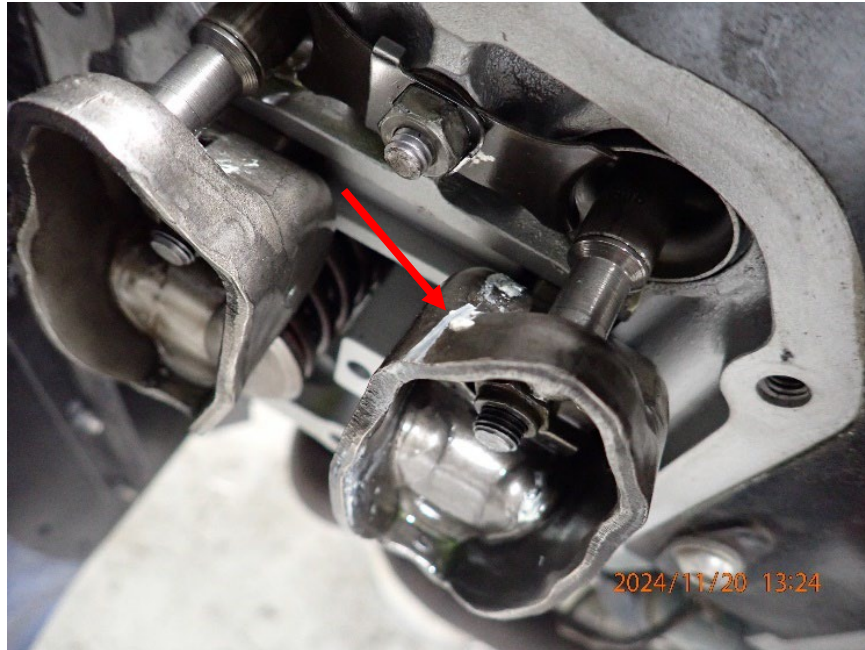
**Visible Assembly Lubrication Oil Present on Rocker Arms**
