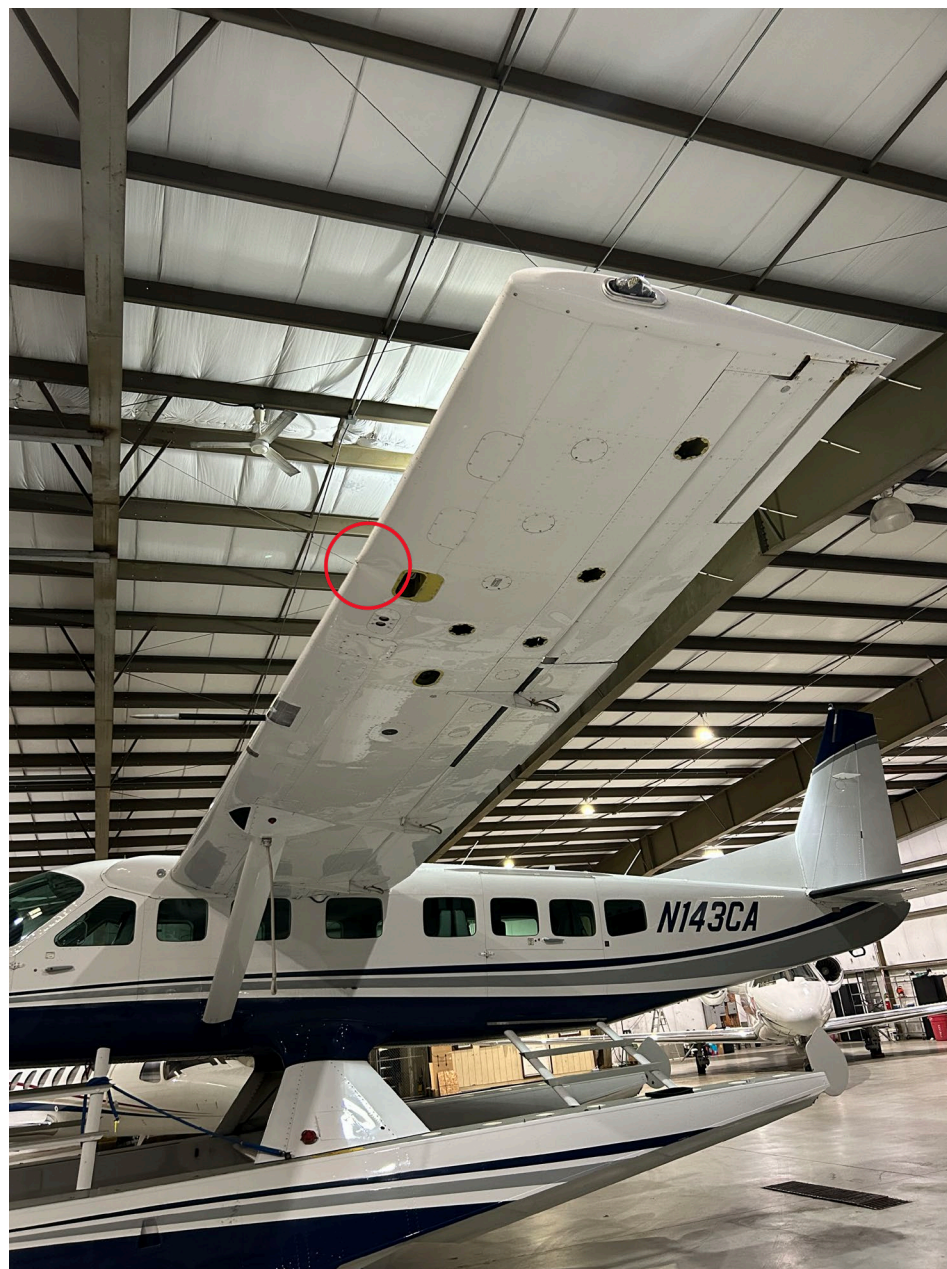
**Photo 1 – View of Left Wing Underside (FAA)**

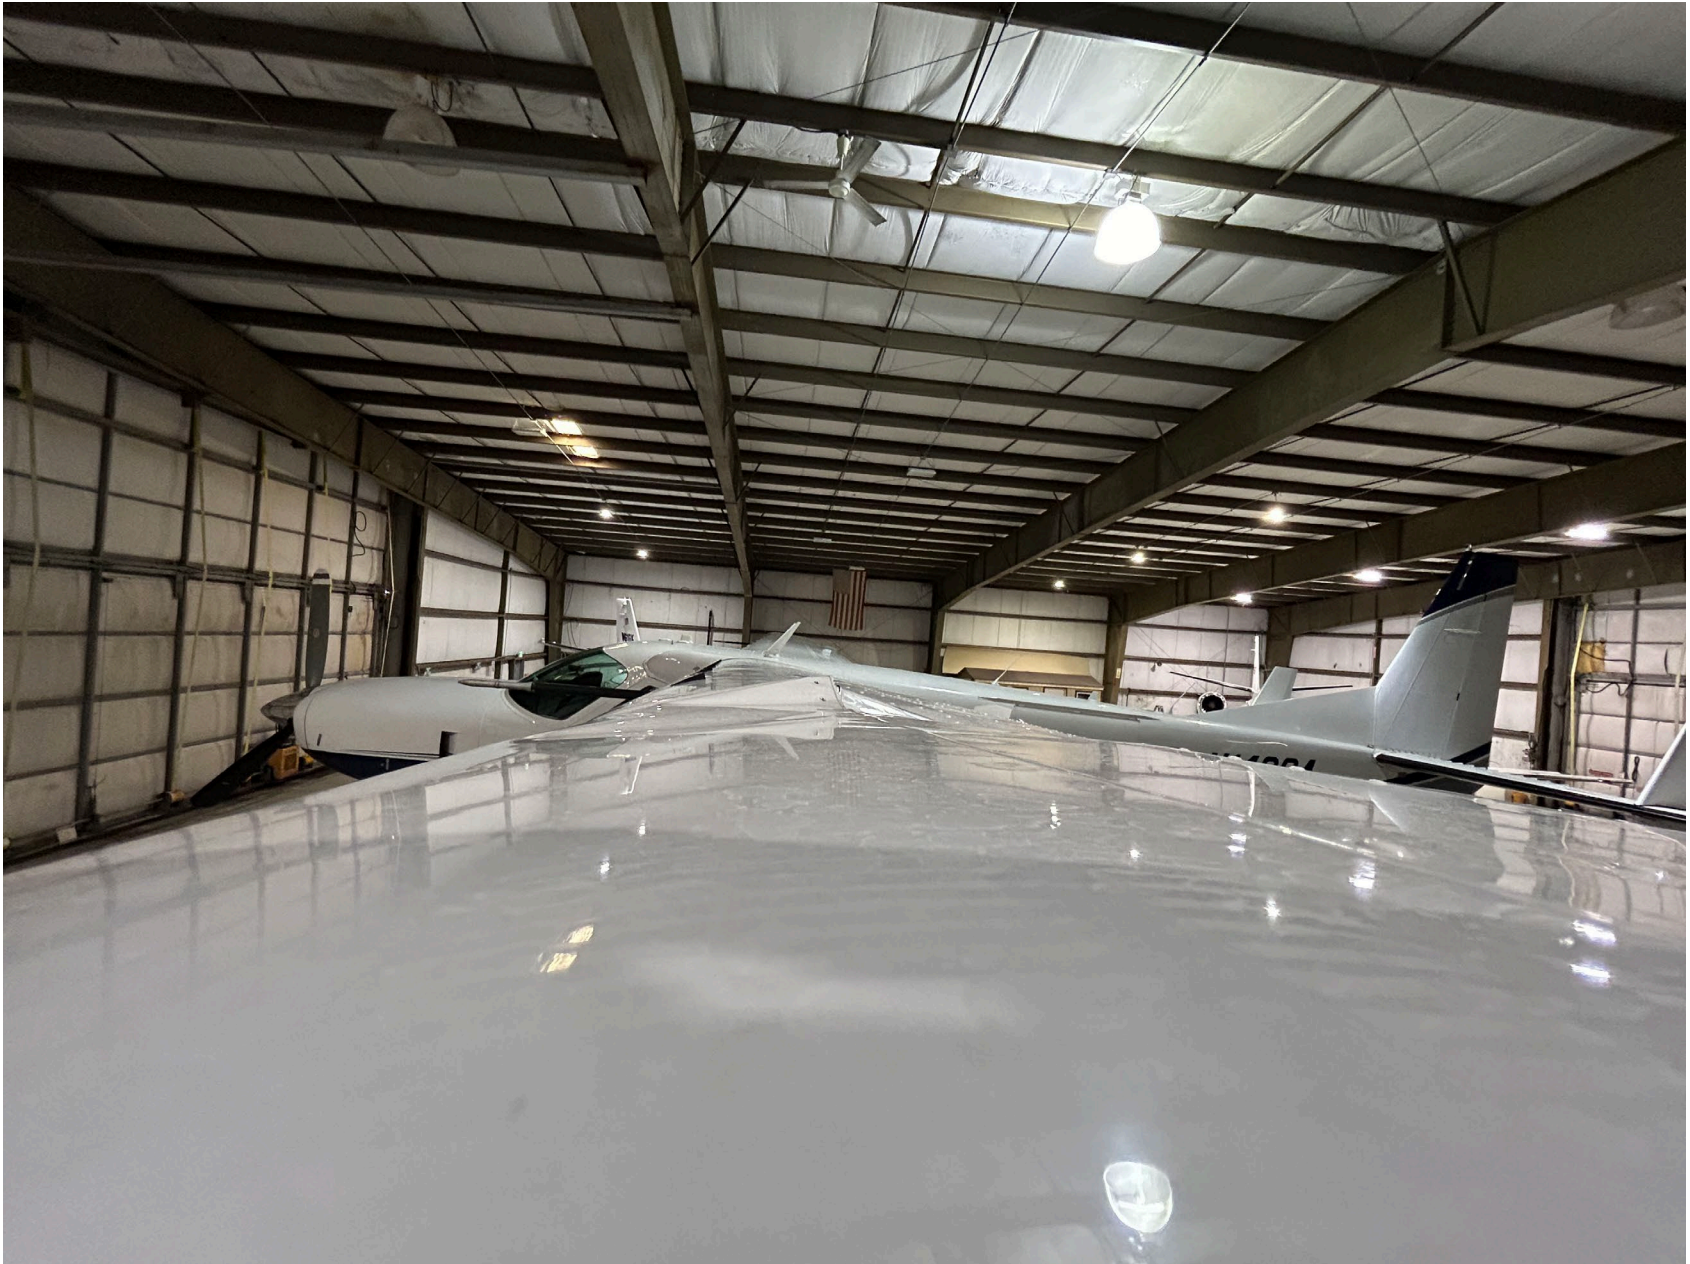
**Photo 2 – Top View of Left Wing Facing Inboard (FAA)**

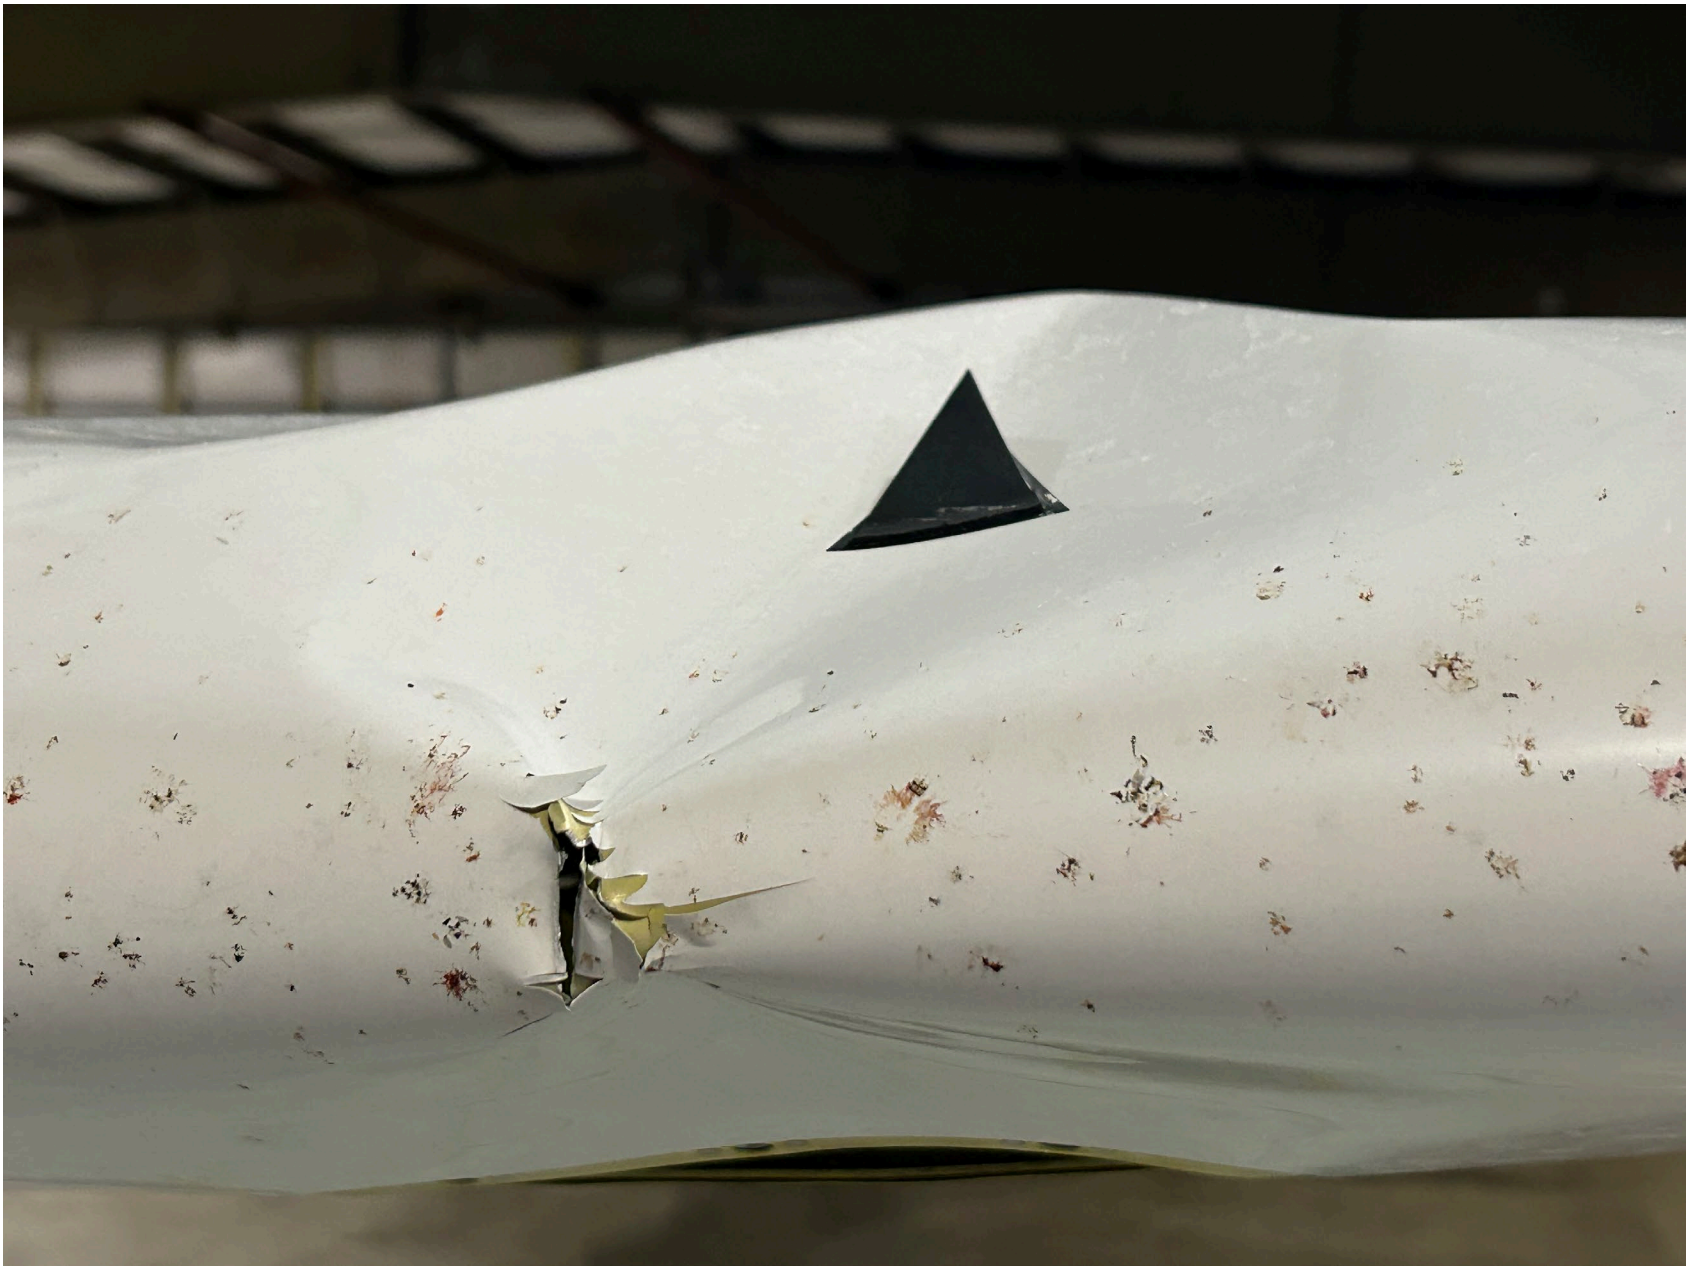
**Photo 3 – View of Left Wing Leading Edge Damage (FAA)**

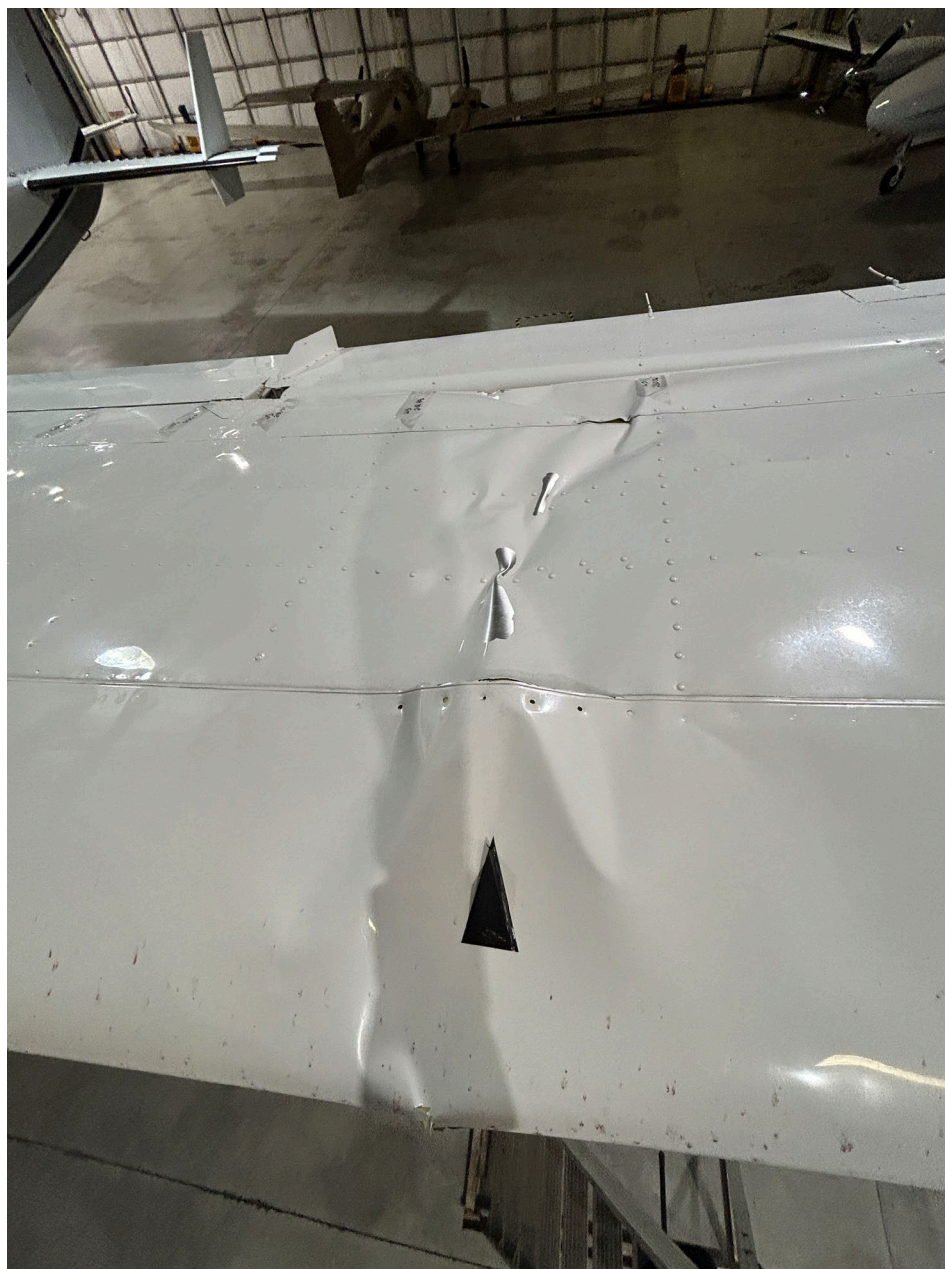
**Photo 4 – Upper Left Wing View Facing Towards Trailing Edge (FAA)**

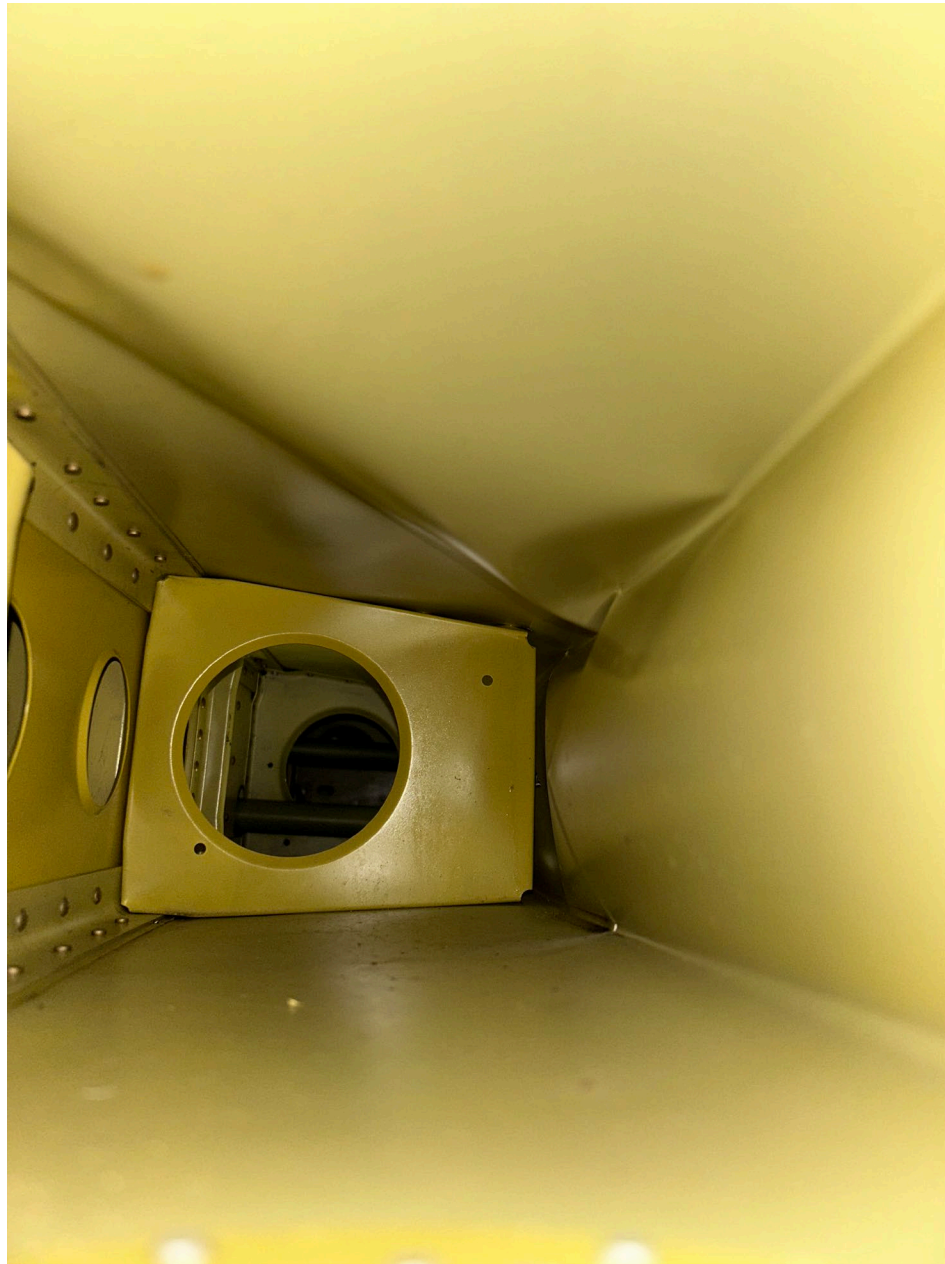
**Photo 5 – Interior View of Left Wing Structure Forward of Aileron (FAA)**
