Joshua Young  
Air Safety Investigator  
AS-ERA

**Date:** 6/5/2025

**Subject:** ERA25LA375, Woodward Bellows Report

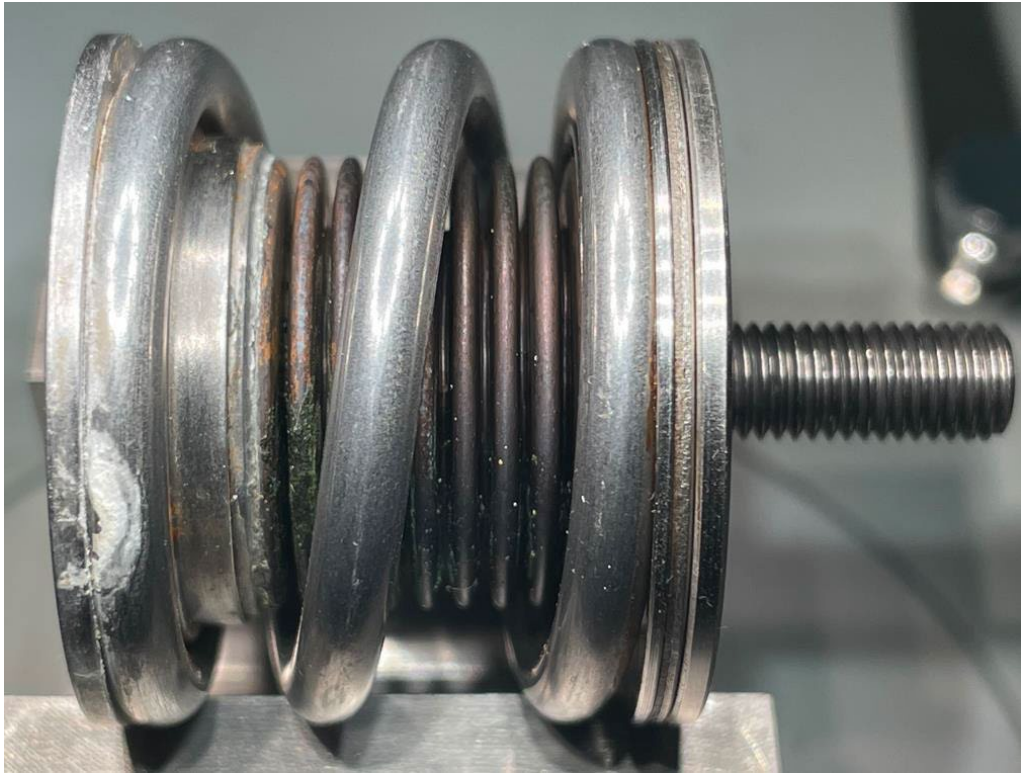
An as-received test was then performed. Following the as-received testing the FCU was disassembled to perform a visual inspection on the internal components. There was no evidence of contamination in the tach valve or fuel valve system. The bellows exhibited evidence of corrosion, with orange and green colors present on the exterior. A white foreign material was observed on the coil spring of the bellows. See figures below. No other anomalies were observed during disassembly of the FCU.

*Figure 1: View of the bellows assembly. (Courtesy of Woodward)*

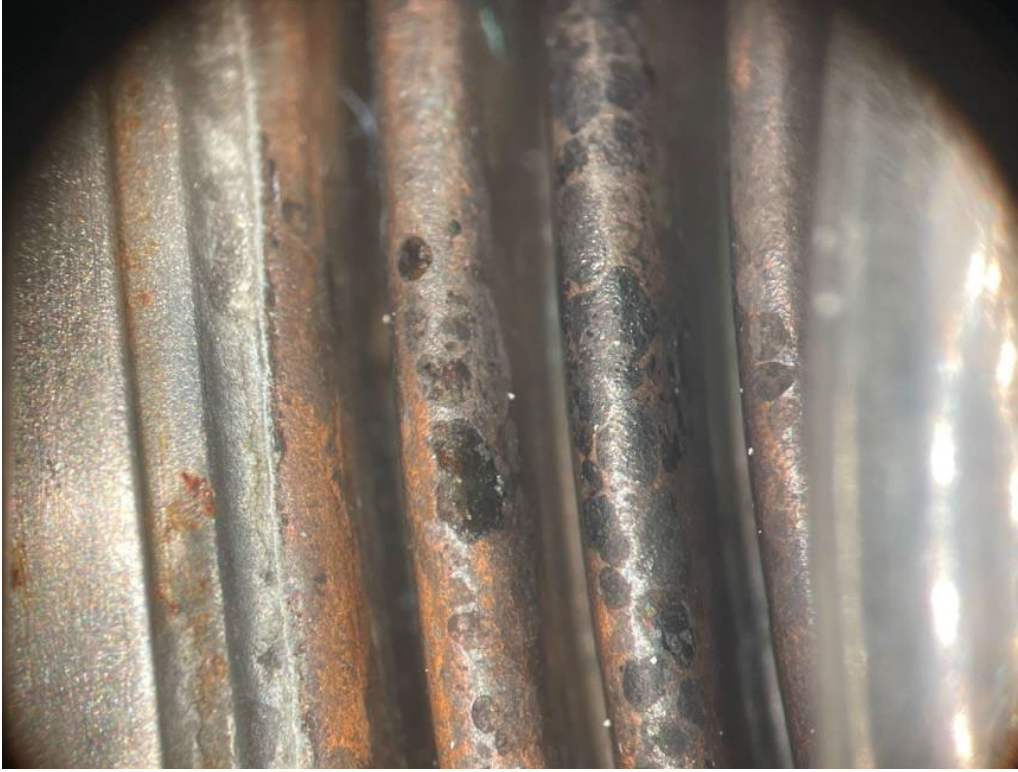
*Figure 2: View of corrosion on the bellows assembly. (Courtesy of Woodward)*

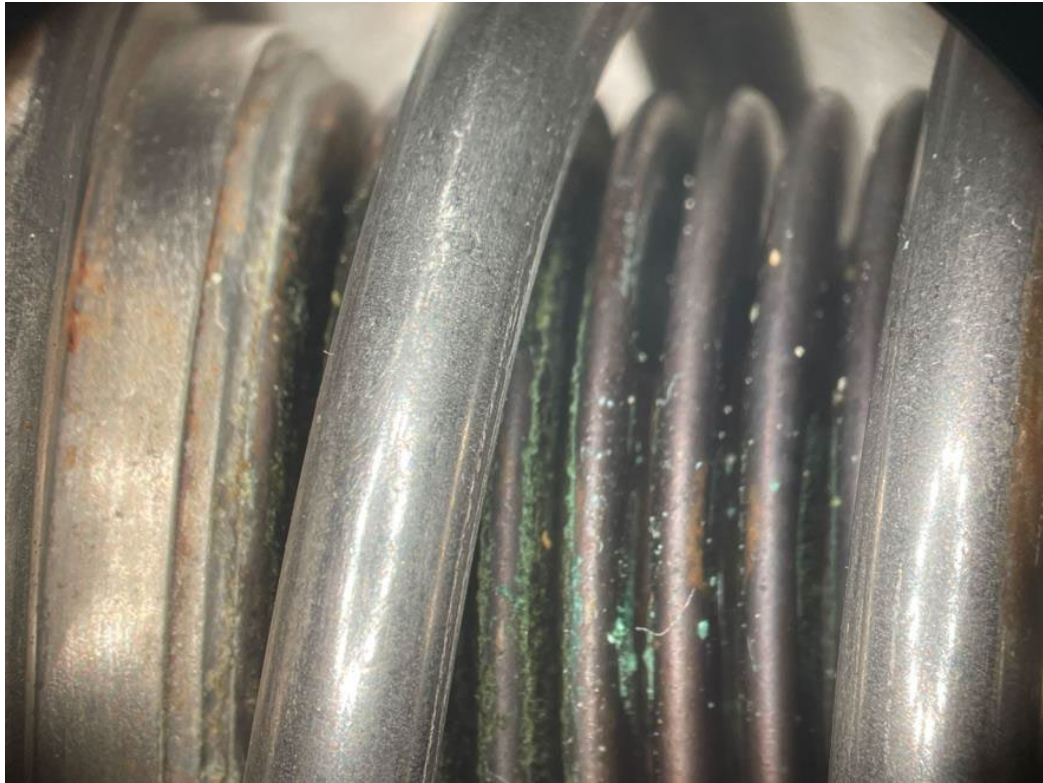
*Figure 3: View of corrosion on the bellows assembly. (Courtesy of Woodward)*

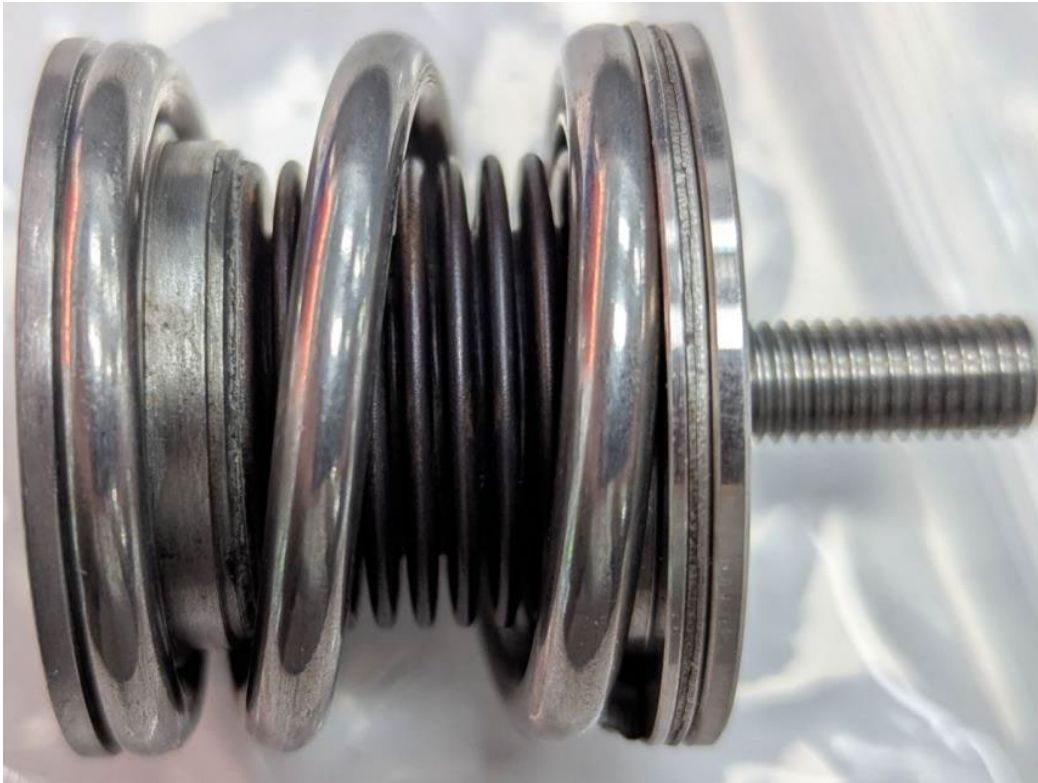
Another 24 hour leak check was performed again after pressure washing the bellows to remove any corrosion precipitate that may have sealed any small voids in the bellows. The length increased from 1.01284 to 1.01346 inches for this test.

*Figure 4: View of the cleaned bellows. (Courtesy of Woodward)*

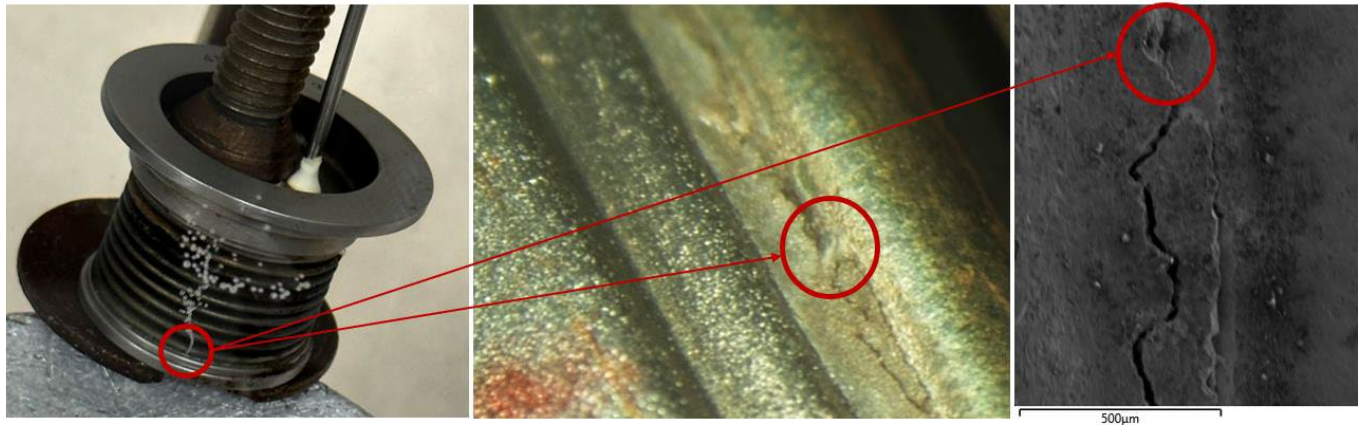
The bellows was then evaluated by the Woodward materials lab to determine location of the leakage. The bellows was internally pressurized and submerged in fluid. Leakage was observed at the solder joint between the bellows and end cap. Three images from this analysis are shown below. The left image shows the bellows leaking during the pressure test. The middle image is a magnified image to pinpoint the location, a bubble can be seen escaping the bellows. The right most image is a SEM inspection of the defect. The materials analysis concluded a silver deficiency at interface of the solder joint, which is consistent with oxidation due to corrosion of the bellows.

*Figure 5: Images of the bellows and crack found. (Courtesy of Woodward)*

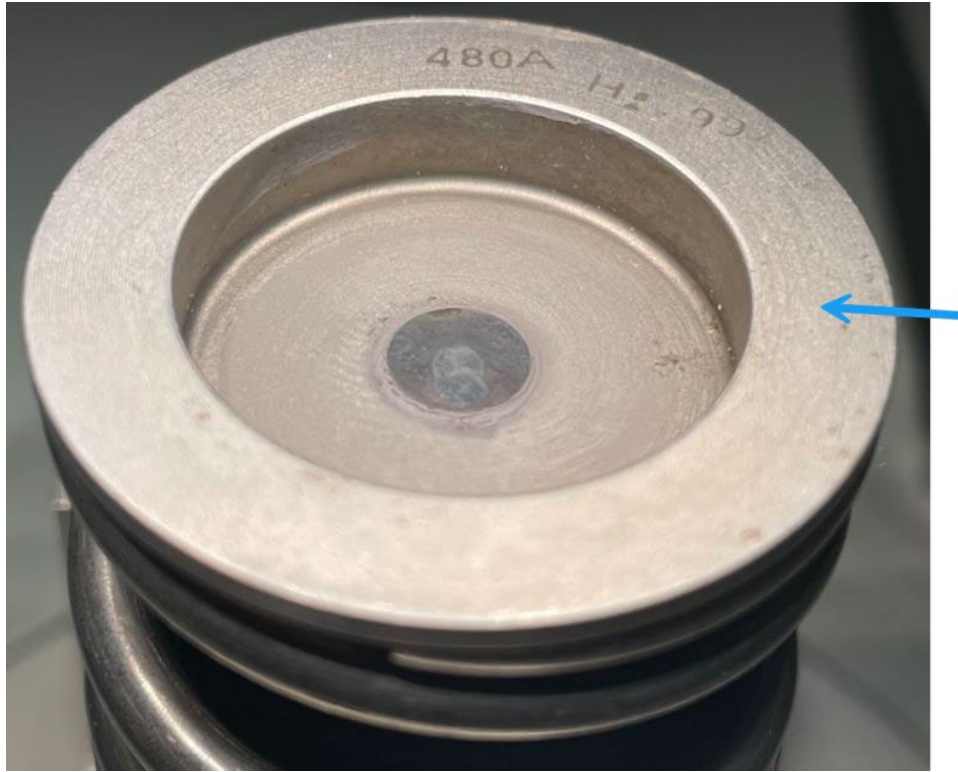
Woodward service bulletin 83212-73-023 was issued October 13, 2014 which includes instructions to measure the bellows length ("L" dimension marked on the part) for various models. For this bellows part number 5215-084 the SB states that bellows manufactured prior to January 1993 are not marked with an "L" and should therefore be replaced. It also states this should be accomplished any time the unit is returned for service. This particular bellows is not marked with an "L" and therefore should have been replaced at last repair/overhaul. The image below shows the bellows surface where the "L" would be marked if manufactured after January 1993.

*Figure 6: View of the bellows end without a "L" marking. (Courtesy of Woodward)*
