# National Transportation Safety Board

ERA24LA375

## **ENGINE EXAMINATION**

Location: Hickory Valley, TN  
Date: September 10, 2024  
Time: 0843 CDT  
1343 UTC  
Airplane: N802JF; AT-802

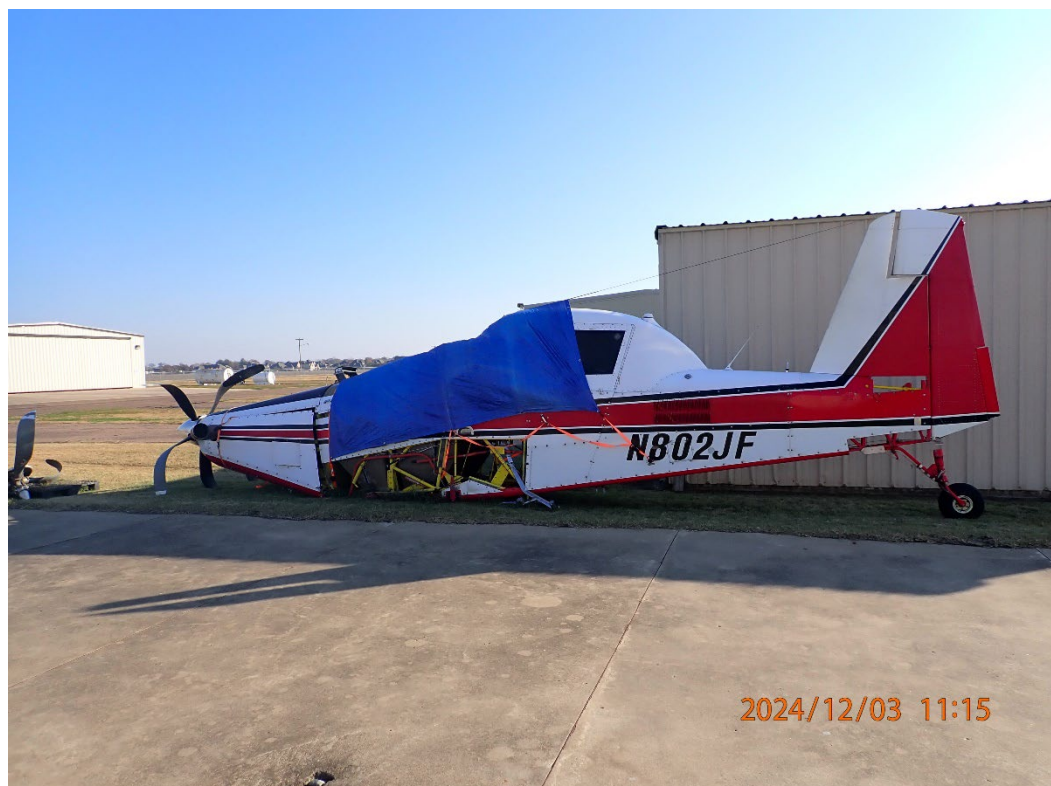
Upon arrival the airplane was sitting on the ground outside a hangar with both wings, the horizontal stabilizer/elevator, and both main landing gear removed. The side and top cowling was removed to facilitate the examination. Both wing fuel tank finger strainers were removed and were unobstructed with minimal debris noted. The firewall fuel strainer was removed and examined with no obstructions noted. There was fuel in the line to and from the fuel strainer that was consistent with Jet-A aviation fuel. The fuel strainer was filled with liquid consistent with Jet-A aviation fuel. The engine driven fuel pump inlet filter was removed and examined with no obstructions noted. The fuel control unit fuel filter was removed and examined with no obstructions noted. The filter bowl was full of liquid consistent with Jet-A aviation fuel.

**Photo 1: The airplane as first viewed.**

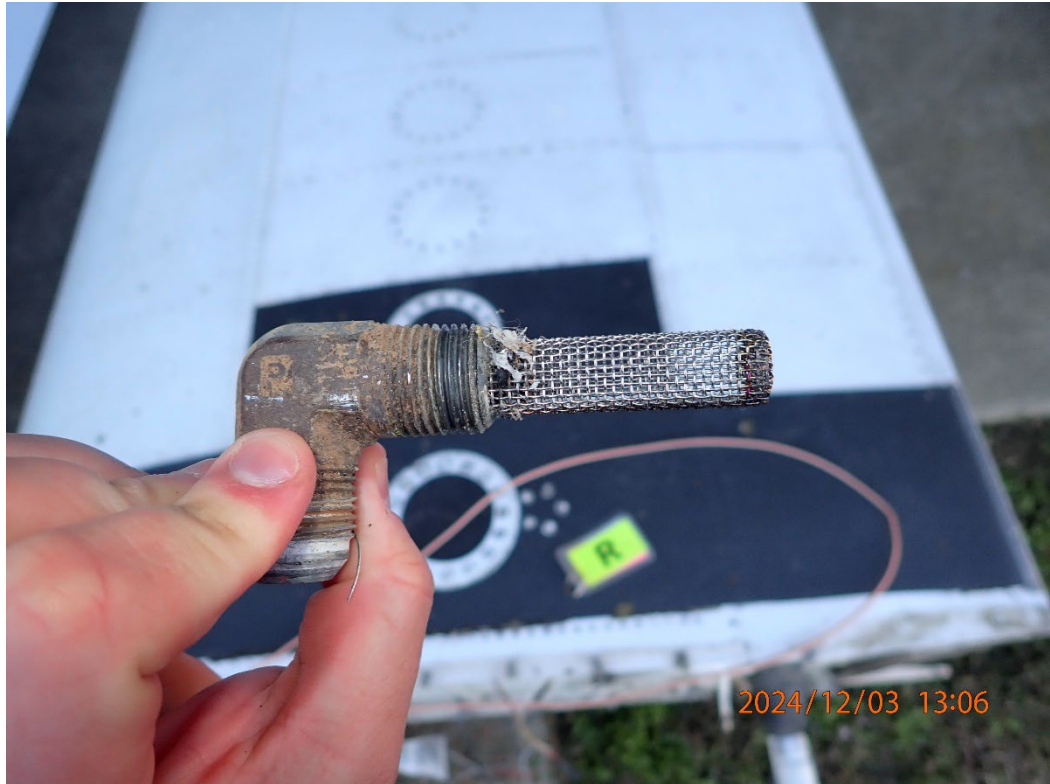
**Photo 2: View of the right wing fuel tank finger strainer.**

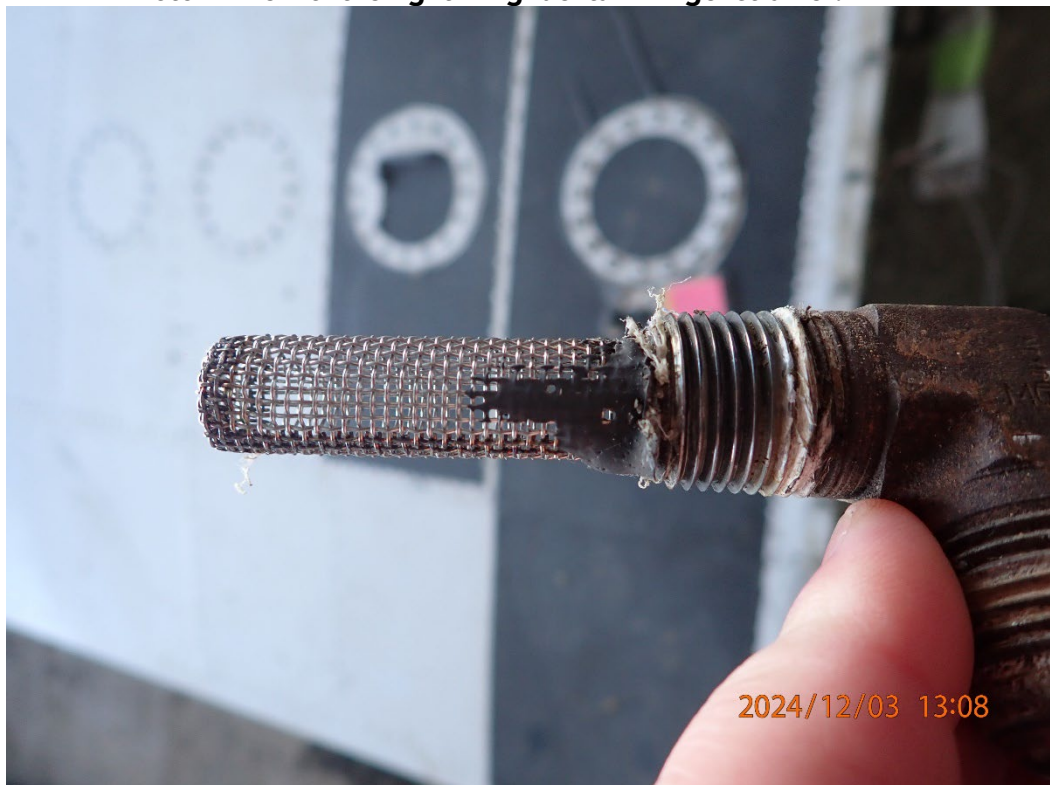
**Photo 3: View of the left wing fuel tank finger strainer.**

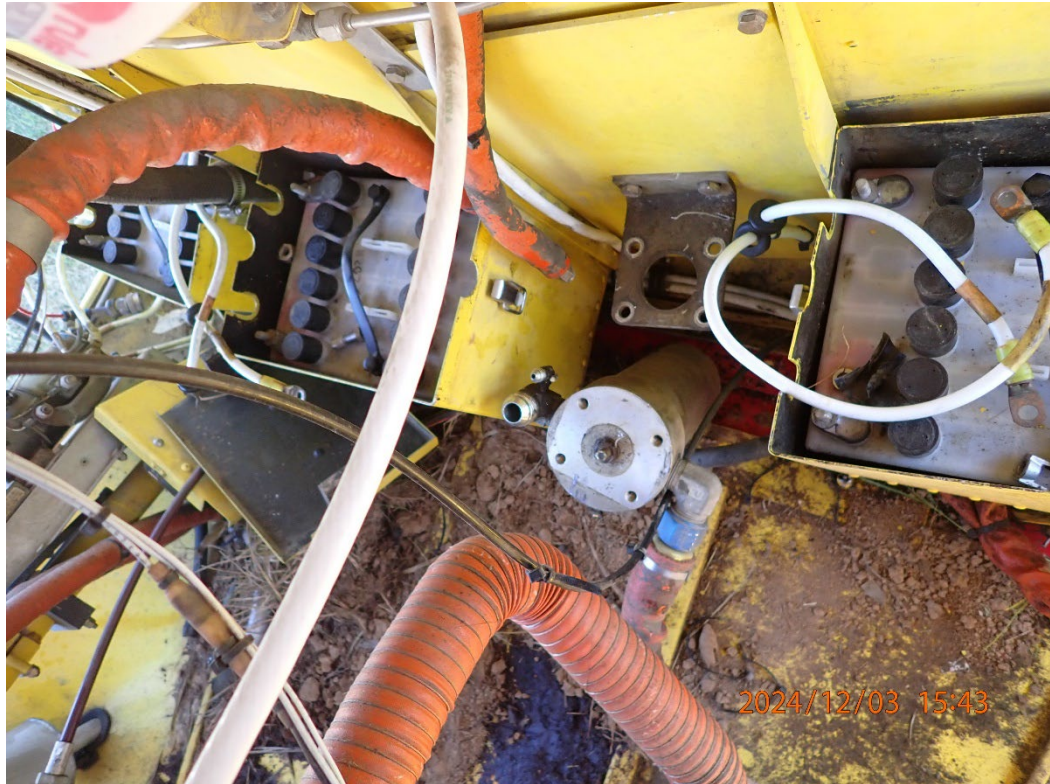
**Photo 4: View of the fuel strainer after being removed from the mounting bracket.**

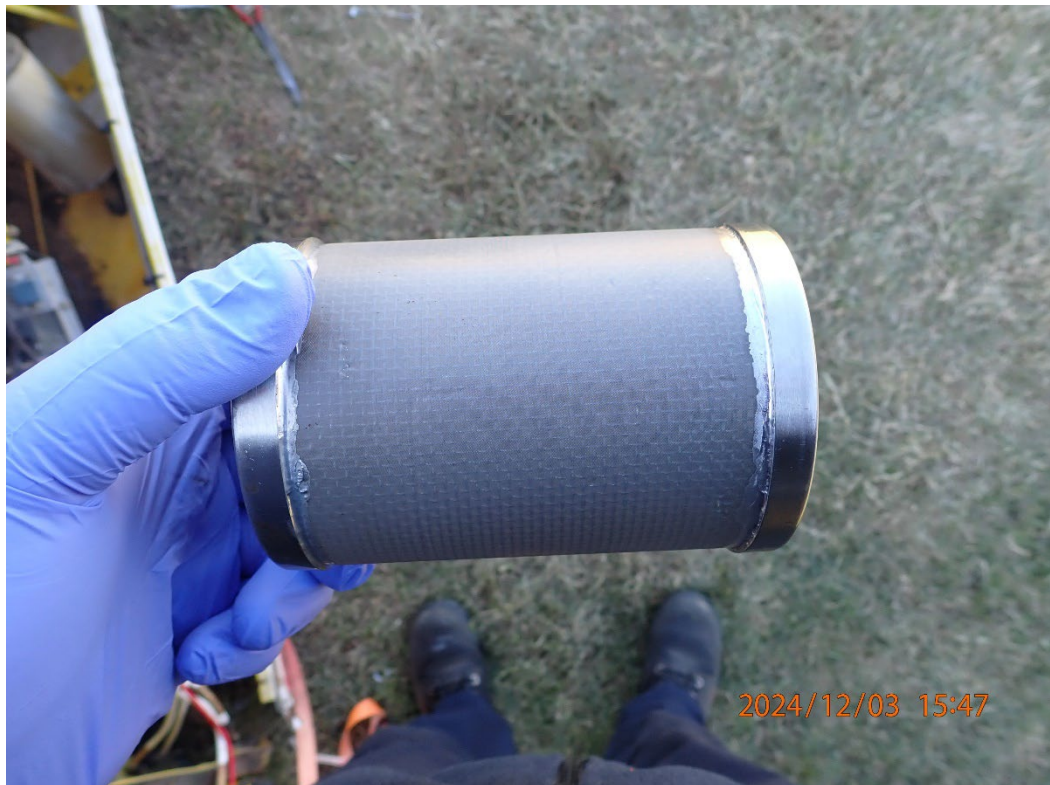
**Photo 5: View of the unobstructed fuel strainer screen.**

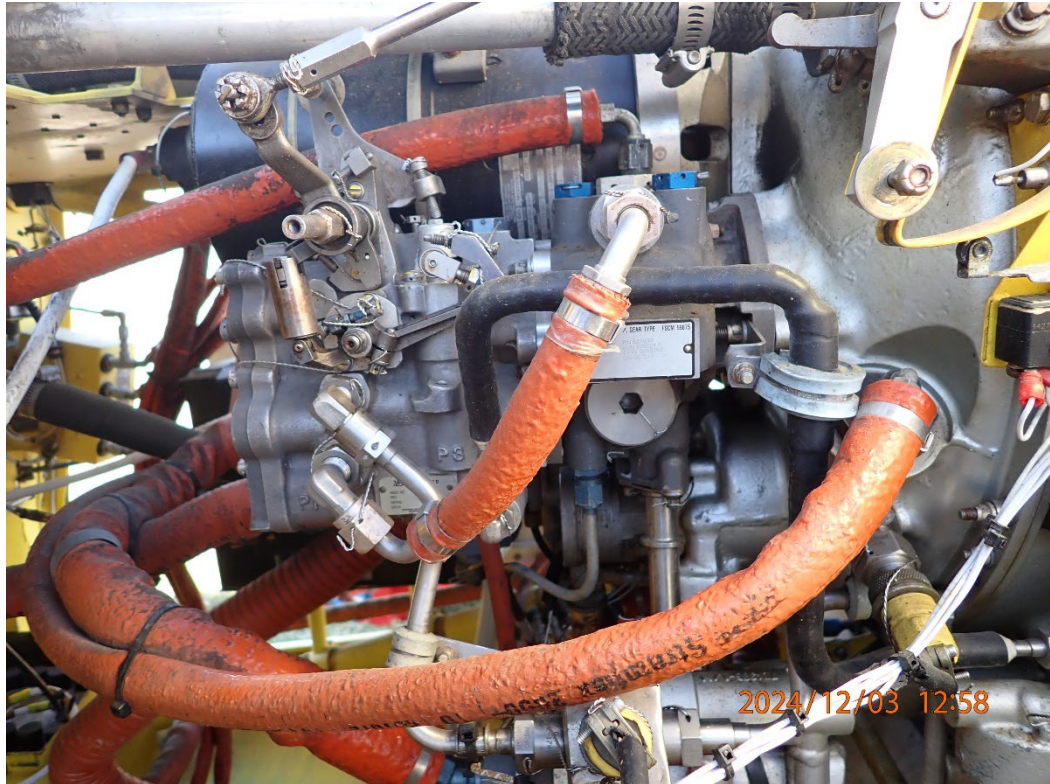
All connections to the fuel control unit were tight and could not be moved by hand. The P3 line remained connected and was tight. The P3 air filter was removed and examined with no obstructions noted.

The engine driven fuel pump and fuel control unit were removed and retained for further examination.

**Photo 6: View of the fuel control unit (FCU) and engine driven fuel pump.**

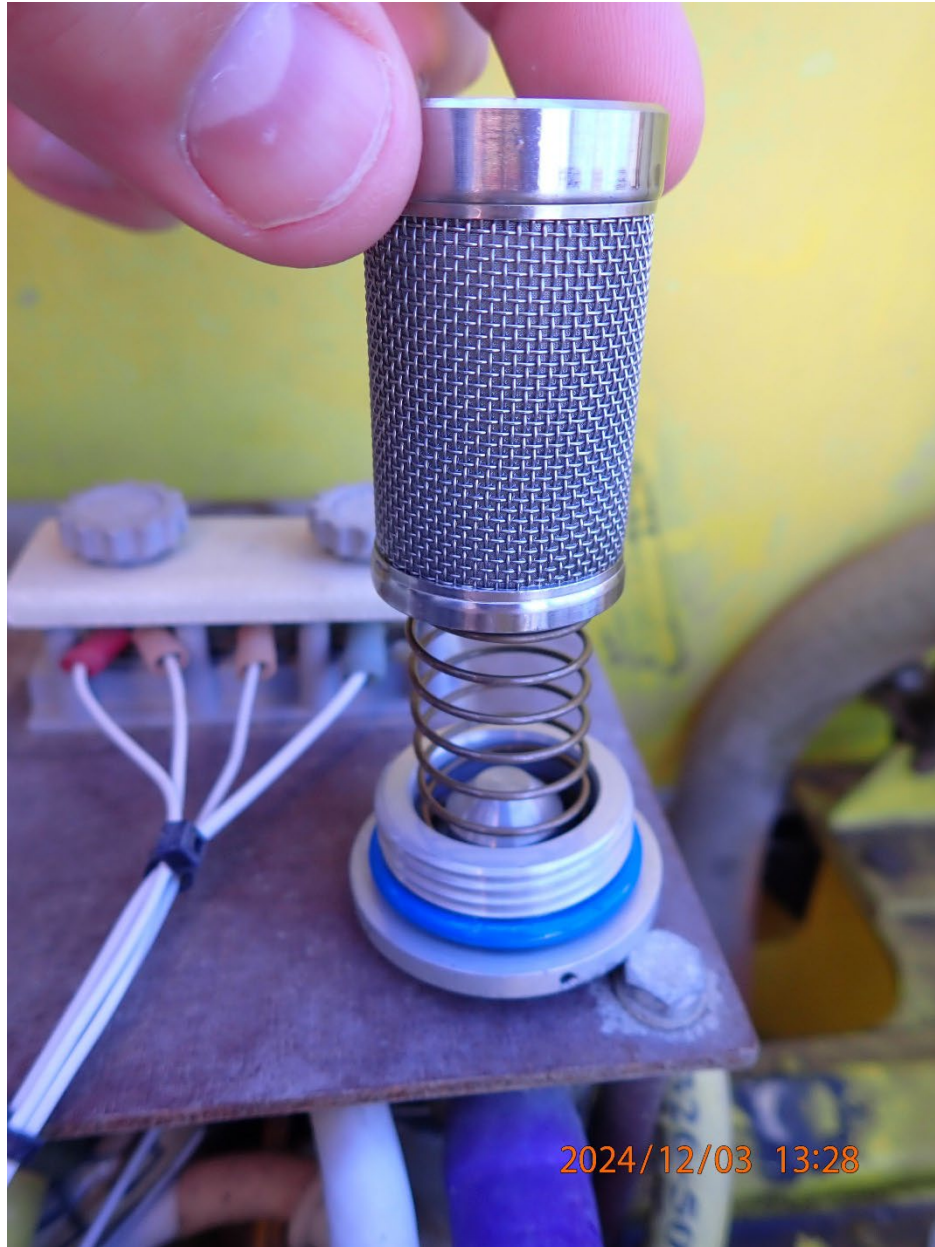
**Photo 7: View of the engine driven fuel pump inlet screen.**

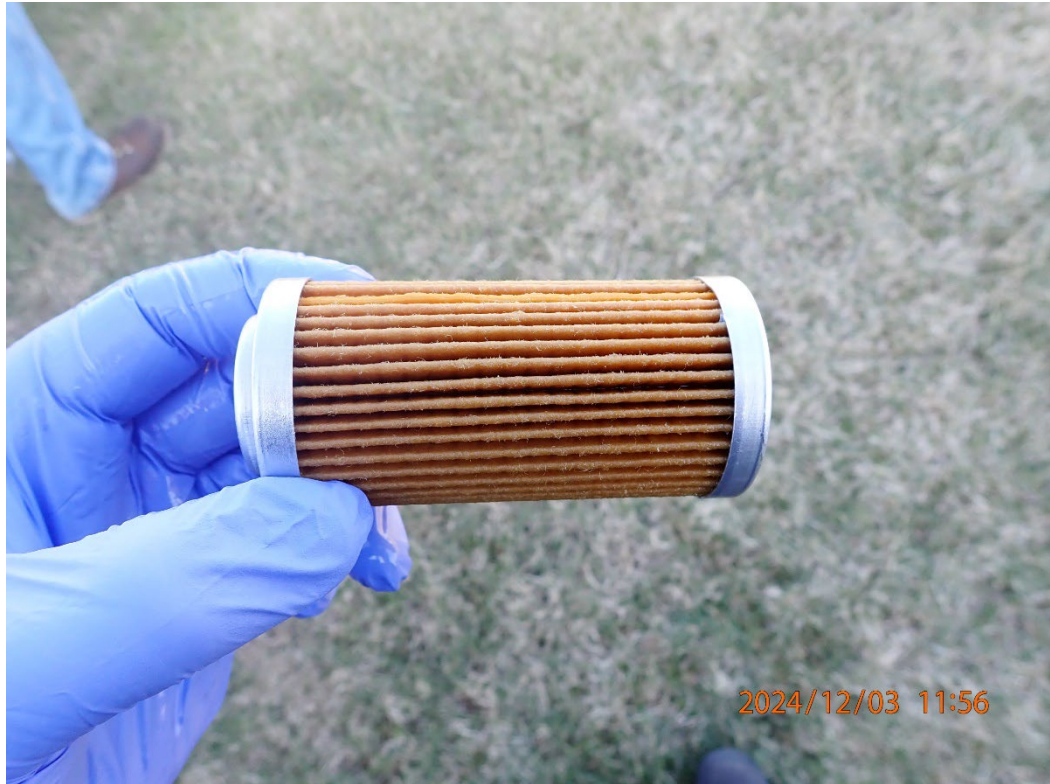
**Photo 8: View of the fuel control unit fuel filter.**

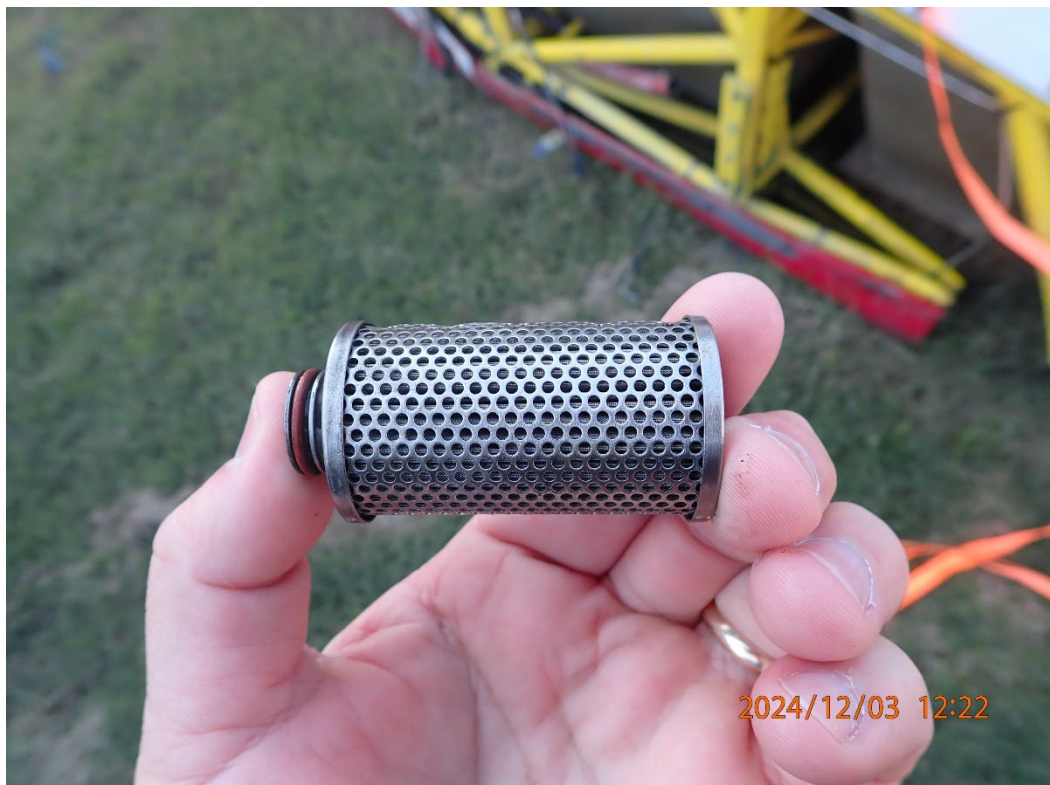
**Photo 9: View of the P3 air filter.**

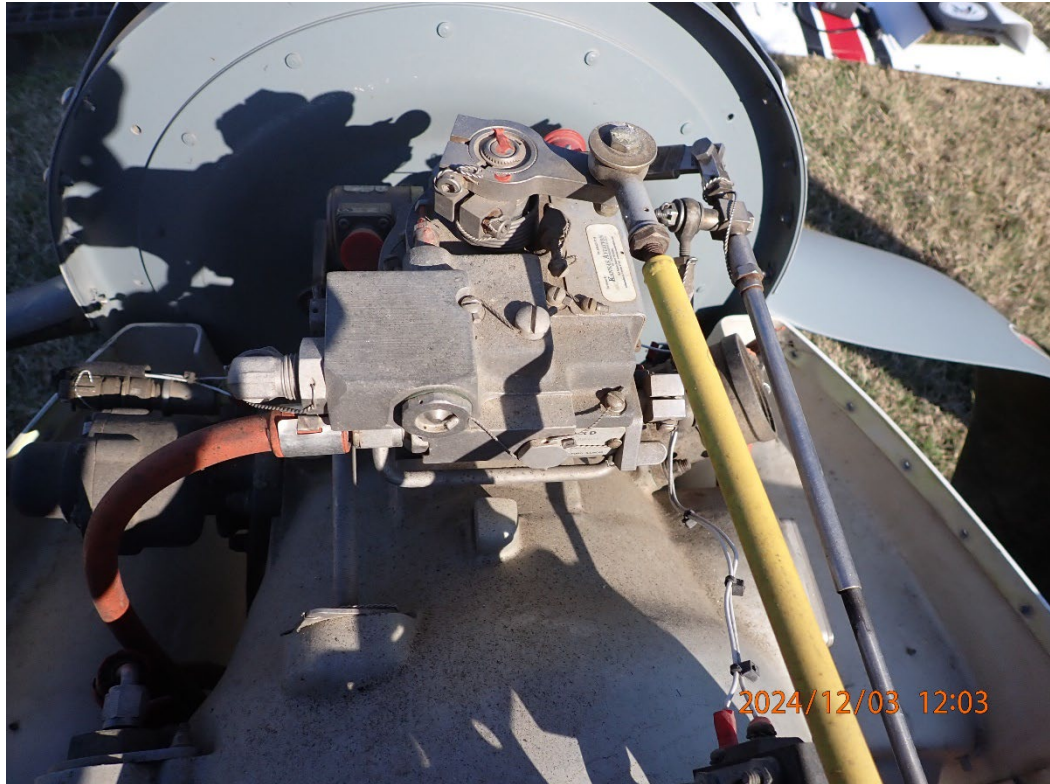
The PY line from the propeller governor to the fuel control unit was connected and tight on both ends. The propeller governor NF linkage remained connected and was undamaged.

**Photo 10: View of the propeller governor.**

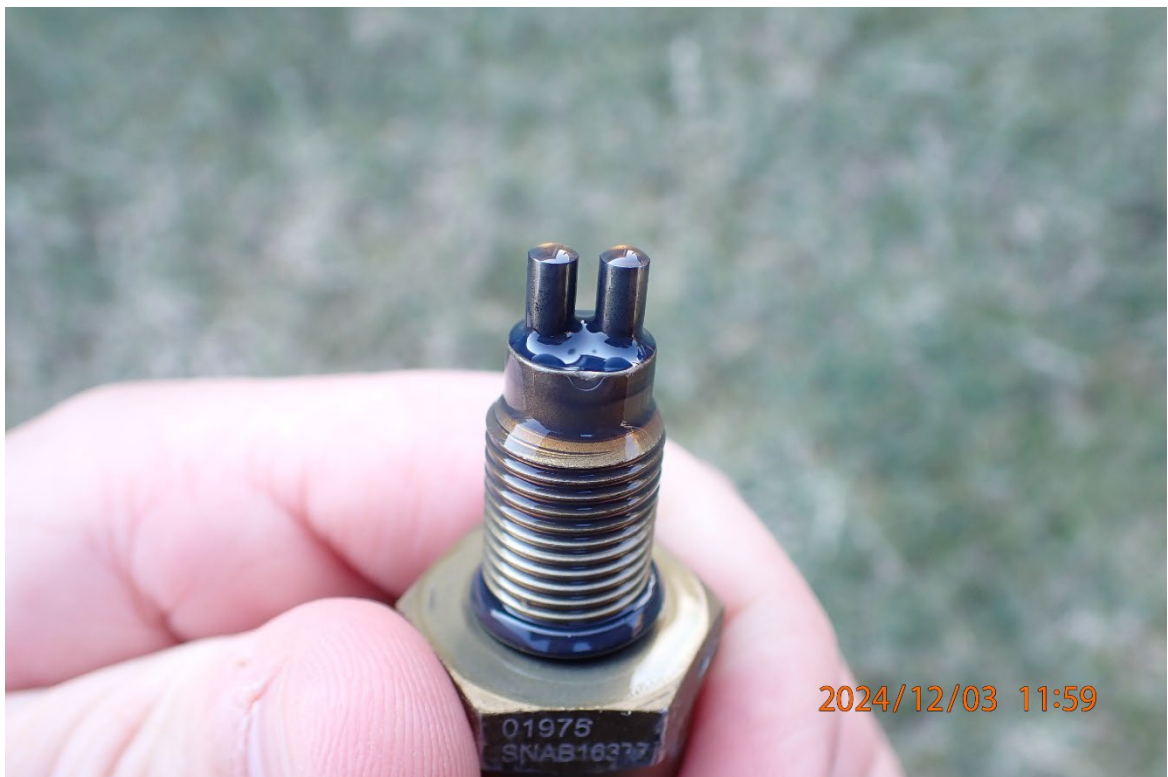
The engine's chip detector was removed and examined with no chips observed on the detector. The engine oil filter was removed and examined with no debris or obstructions noted.

**Photo 11: View of the chip detector.**

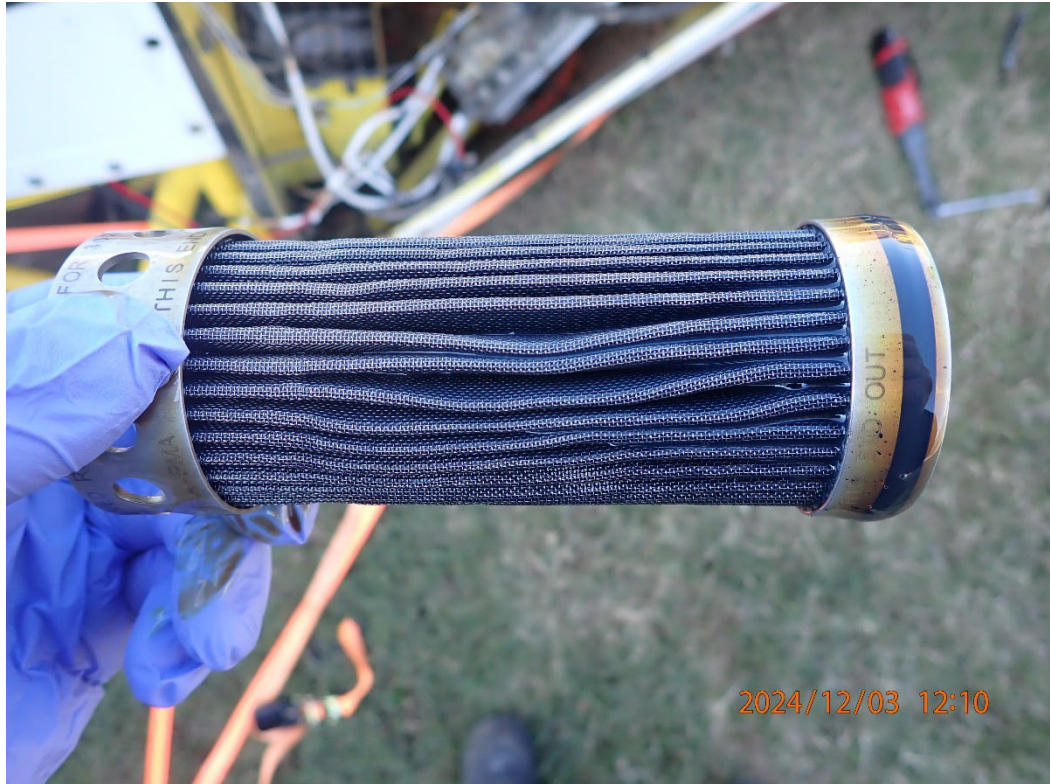
**Photo 12: View of the oil filter.**

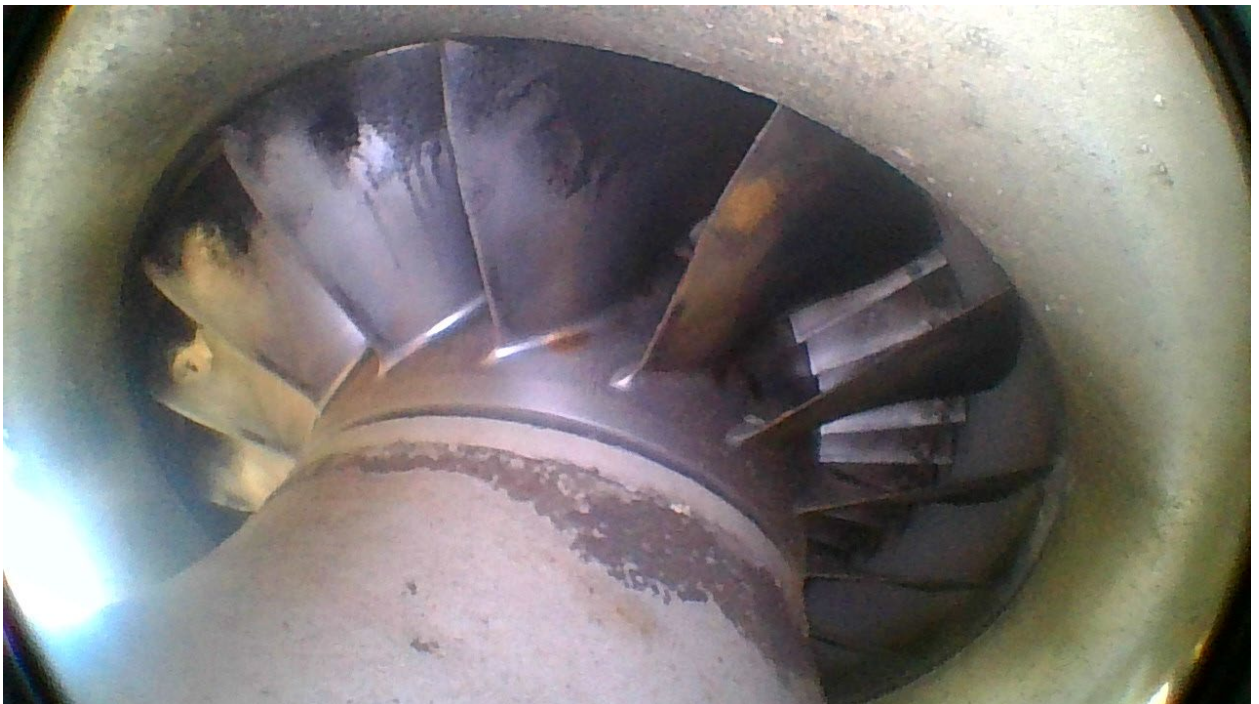
The compressor and turbine blades were observed using a lighted borescope. All blades were observed intact with no chips or missing blades. Multiple fuel nozzles were removed and examined with no debris or obstructions noted.

**Photo 13: View of the compressor blades.**

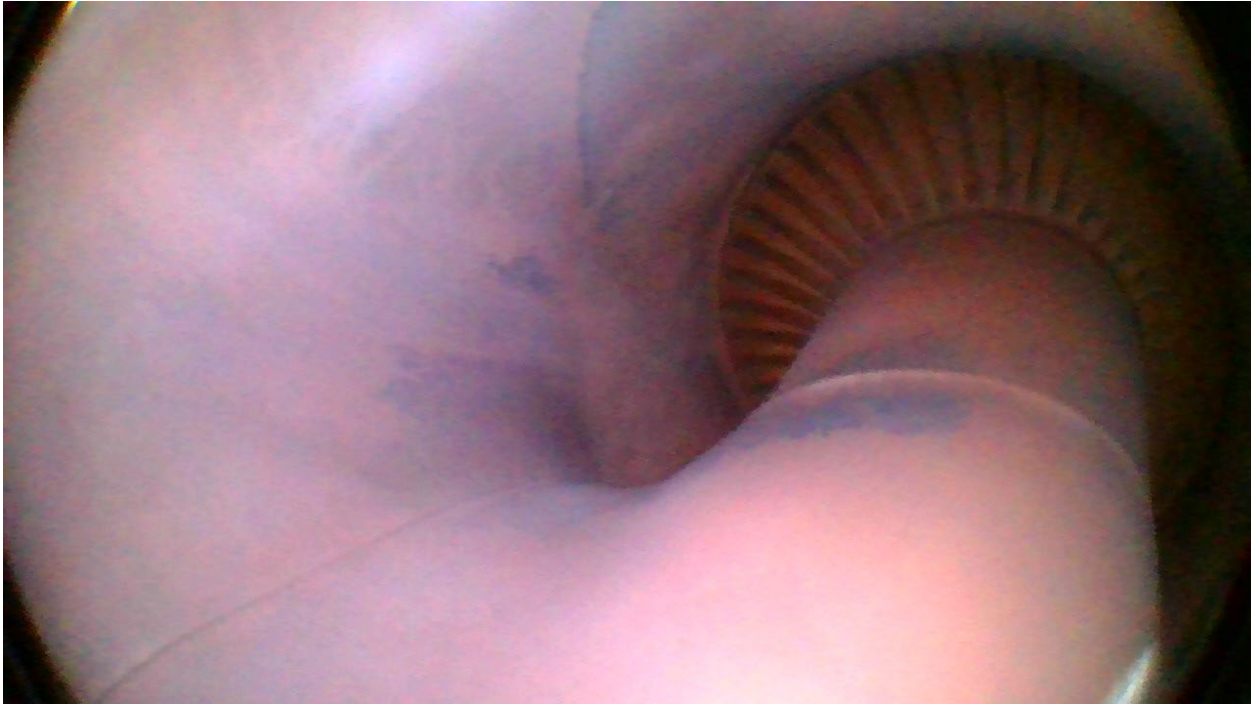
**Photo 14: View of the turbine blades.**
