Joshua Young  
Air Safety Investigator  
AS-ERA

**Date:** 7/14/2025

**Subject:** ERA24LA375, Fuel Control Unit and Fuel Pump Inspection

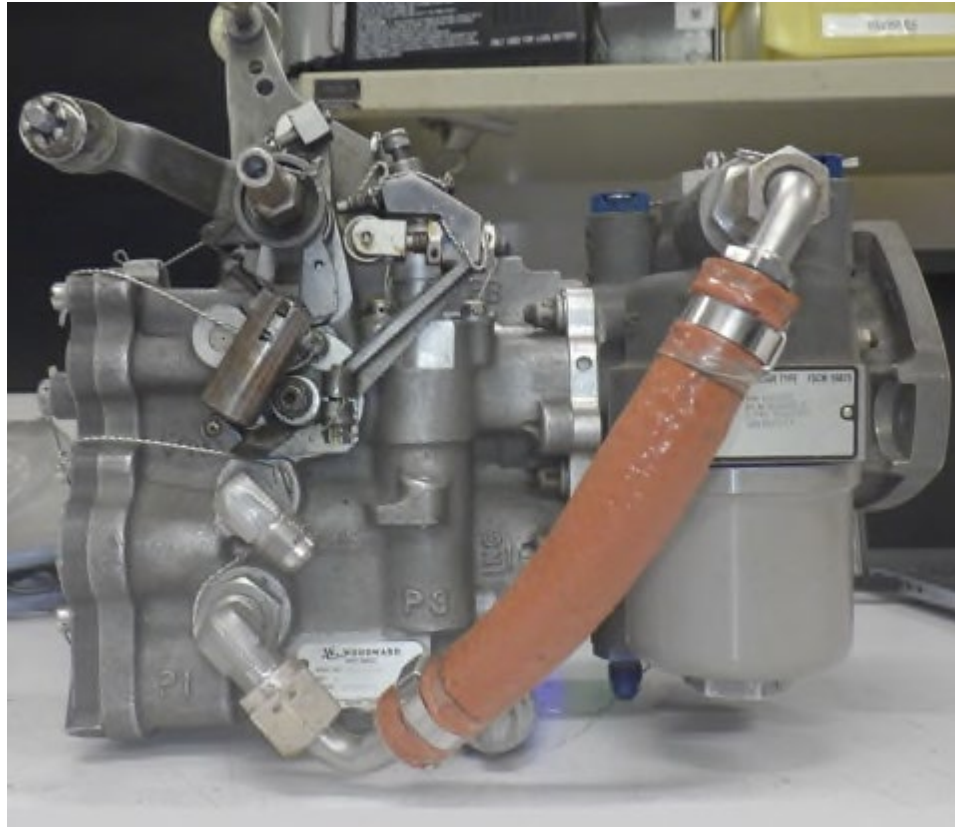
The FCU and fuel pump were attached together. The fuel supply line from the fuel pump to the FCU showed that there was no lockwire between the FCU inlet fitting and the fuel line "B" nut. The fuel line was disconnected from the FCU end, and the fuel pump was separated from the FCU. The FCU drive shaft splines showed the presence of a brownish deposit similar to grease along with wear on the portion of the drive shaft engaging in the fuel pump spline. Reviewing the engine maintenance manual (EMM) 3032842 section 73-20-00 removal / installation paragraph, there is no recommendation to use grease while installing the FCU on the fuel pump. The drive shaft was rotating normally with the fingers. The mounting plate showed presence of particles in the bellows nut cavity. There were two colors of anti-tamper paint, white on top of red on the mounting plate retaining bolts and the bellows nut. The underneath red anti-tamper paint was undamaged. The external surface was relatively clean, however blackish deposits in the vicinity of the power lever and the shutdown valve were present. The condition lever was bent at the airframe connecting point and the condition lever minimum adjustment stop was bent as well. Brownish / reddish coloration was present on some portions of the condition lever. The condition lever was rotating on its full range without restriction. The power lever was also rotating normally. The reverse thrust yield shield showed a varnish like deposit. The P3 drain orifice was clean, and the special orifice looked clean. The fuel inlet filter was generally clean. A small section showed a brownish color. The lockwire on the deadband adjustment screw, the idle and the high idle adjustment roller were bigger compared to the other ones. The idle and high idle are permissible field adjustments,

not the deadband. The seals and antitamper paint were at the right location. There was a VSE service label present on the cover.

*Figure 1: FCU and fuel pump, as-received, attached together. (Courtesy of P&WC)*

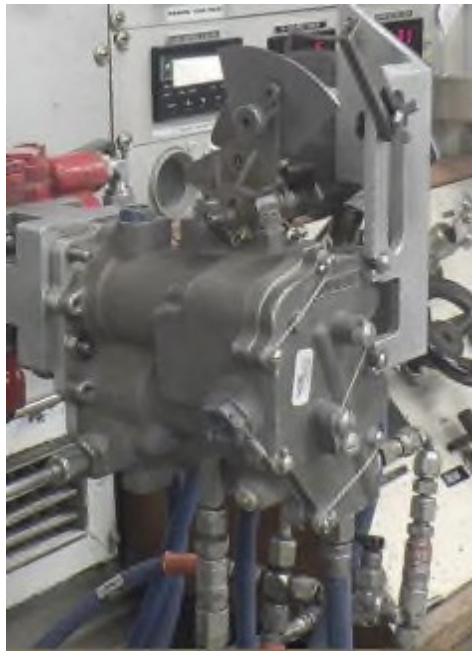
The unit was installed on the test rig in preparation for the test as received in accordance with the Woodward CMM 73-20-07 Rev. 5. Prior testing the unit, the FCU setting were adjusted to get the fuel flow output at mid-range. The FCU was ran for roughly 5 minutes. Throughout this period the fuel flow output did not change. The following are the deviations to the CMM requirements observed as received.

The low idle test point (T.P.) was 164 RPM above the CMM maximum limit. With the RPM adjusted to the nominal setting, the fuel flow output was 13 pounds per hour (PPH) above the CMM set point. This is a permissible field adjustment. The high idle T.P. was 407 RPM above the CMM maximum limit. With the RPM adjusted to the nominal setting, the fuel flow output was 69 PPH above the CMM set point. This is a permissible field adjustment. During this test, it was observed that the minimum stop bolt head was

bent. The shutdown lever T.P. showed that in the open settings, the fuel flow output was 9 PPH below the CMM minimum limit. It was noticed that the shutdown valve cap was fretting against a lockwire when pressed down in the shutdown position. No remarkable wear was present on the cap and lockwire. The maximum reverse T.P. was 213 RPM below the CMM minimum limit. With the RPM adjusted to the nominal setting, the fuel flow output was 42 PPH below the CMM set point. This is a permissible field adjustment. The maximum forward T.P. was 18 RPM below the CMM minimum limit. With the RPM adjusted to the nominal setting, the fuel flow output was 51 PPH below the CMM set point. The dead band adjustment was 14.5 degrees above the CMM maximum limit. The CDP (P3) schedule testing showed that the lower portion of the schedule was below the CMM minimum requirements. T.P. 6.1 was 21 PPH below the CMM minimum limit. T.P. 6.2 was 23 PPH below the CMM minimum limit. T.P. 6.3 was 14 PPH below the CMM minimum limit. T.P. 6.4 and 6.5 were within the CMM limits, however on the low side of the tolerance band. The CDP (P3)-Py schedule T.P. 7.1 was 2 PPH below the CMM minimum limit. The T.P. 7.2 was 17 PPH below the CMM minimum limit. The start and acceleration schedule showed that most of the fuel flow output was below the CMM minimum limit for P3 values below 100 psia which was as the CDP (P3) schedule testing. T.P. 9.2 with the power lever (P/L) set to high idle and the condition lever (C/L) set to maximum, the fuel flow output was 6 PPH below the CMM minimum limit. With the P/L set to maximum and the C/L to idle, the fuel flow output was 2PPH below the CMM minimum limit. T.P. 9.3, with the P/L set to high idle and the C/L set to maximum, the fuel flow output was 12 PPH below the CMM minimum limit. With the P/L set to idle and the C/L set to idle, the fuel flow output was 2 PPH below the CMM minimum limit. With the P/L set to maximum and the C/L set to idle, the fuel flow output was 7 PPH below the CMM minimum limit. T.P. 9.4, with the P/L set to high idle and the C/L set to maximum, the fuel flow output was 20 PPH below the CMM minimum limit. With the P/L set to idle and the C/L set to idle, the fuel flow output was 6 PPH below the CMM minimum limit. With the P/L set to maximum and the C/L set to idle, the fuel flow output was 13 PPH below the CMM minimum limit. T.P. 9.5, with the P/L set to high idle and the C/L set to maximum, the fuel flow output was 17 PPH below the CMM minimum limit. With the P/L set to idle and the C/L set to idle, the fuel flow output was 12 PPH below the CMM minimum limit. With the P/L set to maximum and the C/L set to idle, the fuel flow output was 14 PPH below the CMM minimum limit. T.P. 9.6, with the P/L set to high idle and the C/L set to maximum, the fuel flow output was 14 PPH below the CMM minimum limit. With the P/L set to idle and the C/L set to idle, the fuel flow output was 13 PPH below the CMM minimum limit. With the P/L set to maximum and the C/L set to idle, the fuel flow output was 14 PPH below the CMM minimum limit. T.P. 9.7, with the P/L set to maximum and the C/L set to idle, the fuel flow output was 18 PPH below the CMM minimum limit. T.P. 9.8, with the P/L set to maximum and the C/L set to idle, the fuel flow output was 20 PPH below the CMM minimum limit. T.P. 9.9, with the P/L set to maximum and the C/L set to idle, the fuel flow output was 20

PPH below the CMM minimum limit. T.P. 9.10, with the P/L set to maximum and the C/L set to idle, the fuel flow output was 13 PPH below the CMM minimum limit. T.P. 9.11, with the P/L set to maximum and the C/L set to idle, the fuel flow output was 12 PPH below the CMM minimum limit. T.P. 9.12, with the P/L set to maximum and the C/L set to idle, the fuel flow output was 7 PPH below the CMM minimum limit. The maximum flow test T.P. 10.1 was 23 PPH above the CMM maximum limit.

*Figure 2: FCU installed on the test stand. (Courtesy of P&WC)*

Following the test as received, the deadband was adjusted to the CMM maximum limit. The low idle, high idle, maximum reverse and maximum forward T.P. were re-checked and found within the CMM limit.

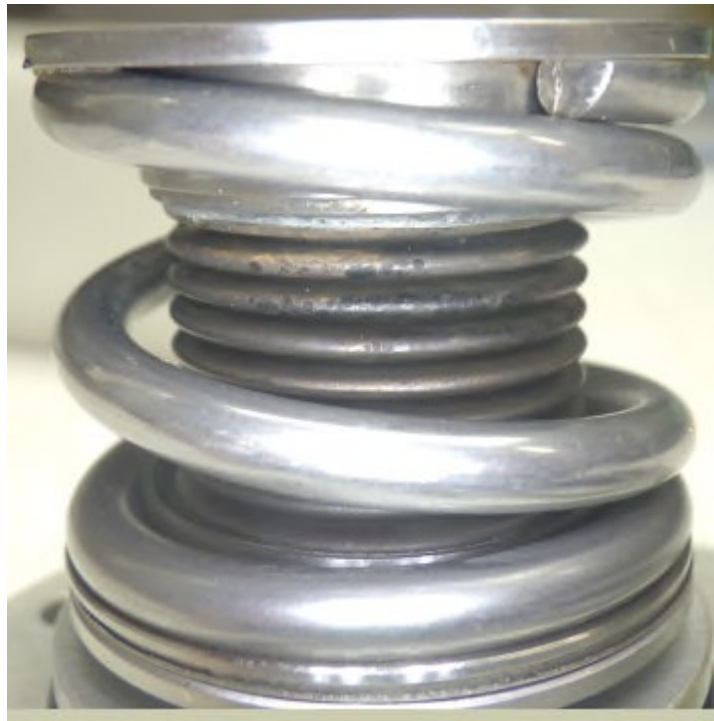
To understand why the P3 schedule and the start and acceleration schedule were showing fuel flow lower than the CMM minimum limit for P3 pressures below 100 psia, the FCU was partially disassembled. The mounting plate was removed giving access to the bellows. The bellows showed signs of external surface contamination of a brownish color and whiteish deposit.

*Figure 3: Bellows with contamination. (Courtesy of P&WC)*

Testing did not replicate the reported engine issue. However, disassembly of the FCU revealed a corroded bellows. The FCU manufacturer investigation revealed a leaking bellows because of a silver deficiency at the interface of the solder joint, which is consistent with oxidation due to corrosion.

During the event, this condition would have allowed the bellows to expand, subsequently moving the FCU fuel valve to the minimum fuel flow output as observed in the engine data recorded at the time of the event, preventing further power modulation.

The bellows housing cavity also showed presence of brownish and whiteish contaminants. The bellows was removed from the mounting plate to measure the length. There was no dimension "L" recorded on the bellows end plate. As per the Woodward Service bulletin 83212-73-023 released in 2014, as per paragraph 3 C (1), bellows assembly manufactured prior to December 1999 and bellows assembly manufactured prior to January 1993 are not marked with an "L" dimension. Due to the

age of these unmarked parts in addition to the lack of a length reference, these bellows assemblies shall be replaced. For reference, the bellows was measured to 1.0121

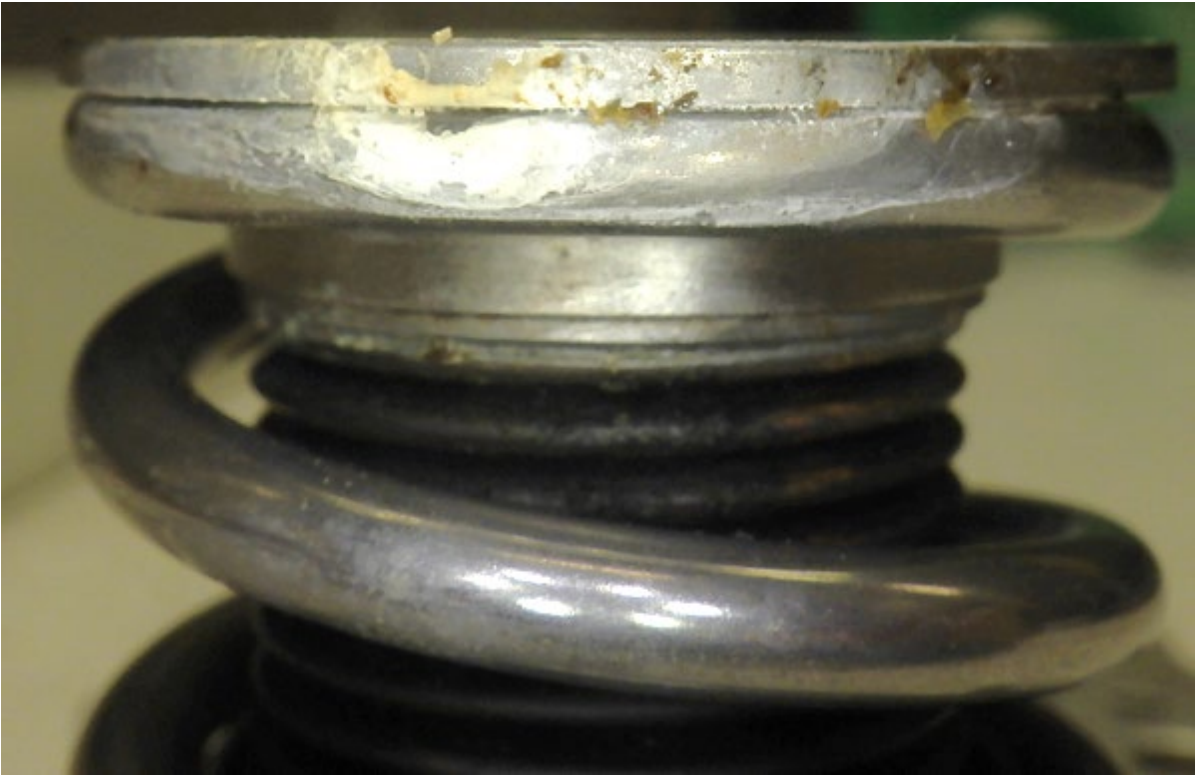
*Figure 4: Bellows contamination. (Courtesy of P&WC)*

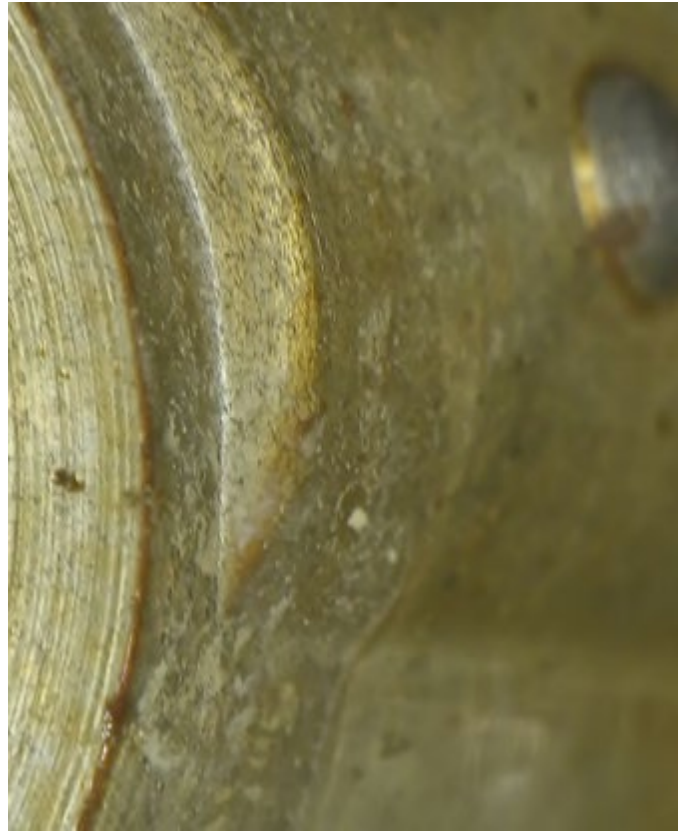
*Figure 5: Bellows housing cavity contamination. (Courtesy of P&WC)*
