Ralph E. Hicks  
Senior Air Safety Investigator  
AS-ERA

**Subject:** ERA24LA377, Materials Laboratory Findings

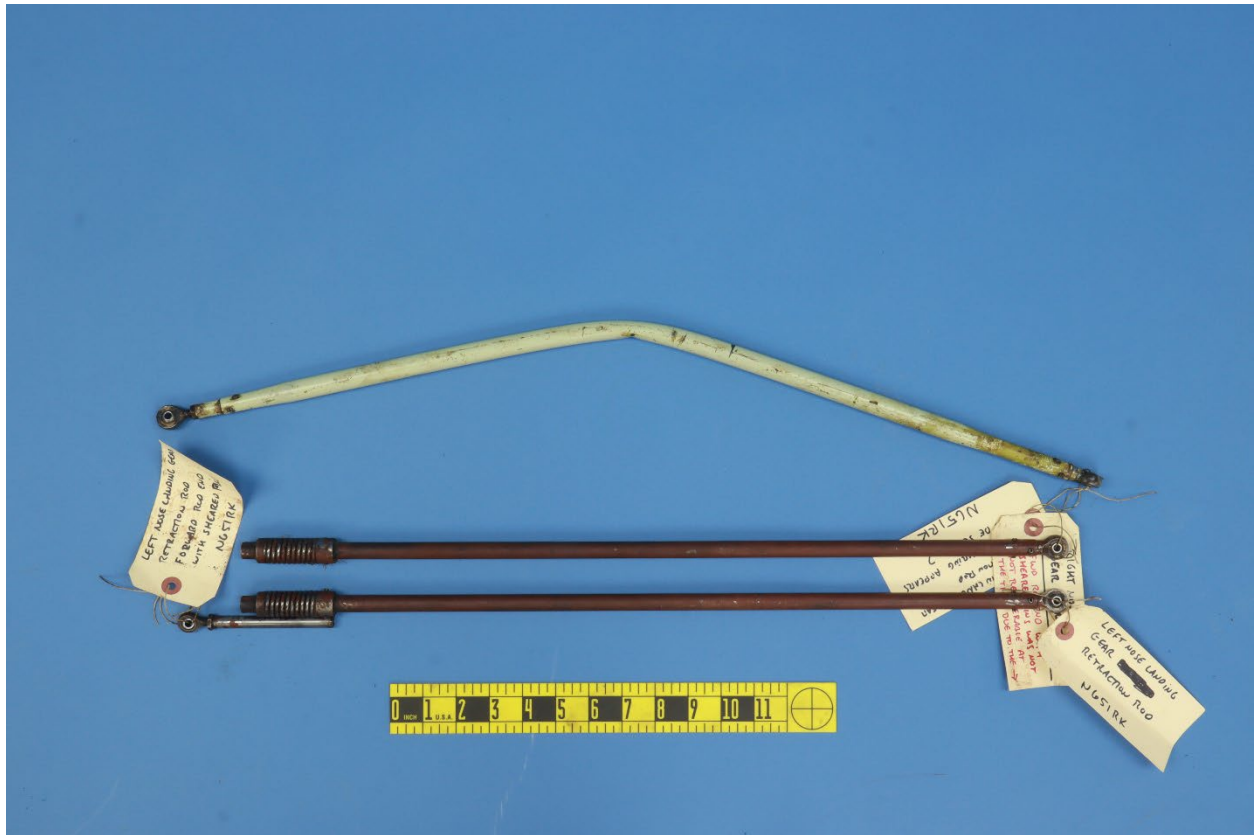
The seized bearing is at the forward end of the right MLG retraction rod. In one of the attached images you can see this rod. It is painted light green. This rod is plastically buckled in the middle. The two rod ends are at 90-degree rotations to one-another. The seized bearing is at the right end of the rod as it is laid out in the image. The buckle in the rod and the seizure of the bearing are consistent with a compressive overload failure of this rod.

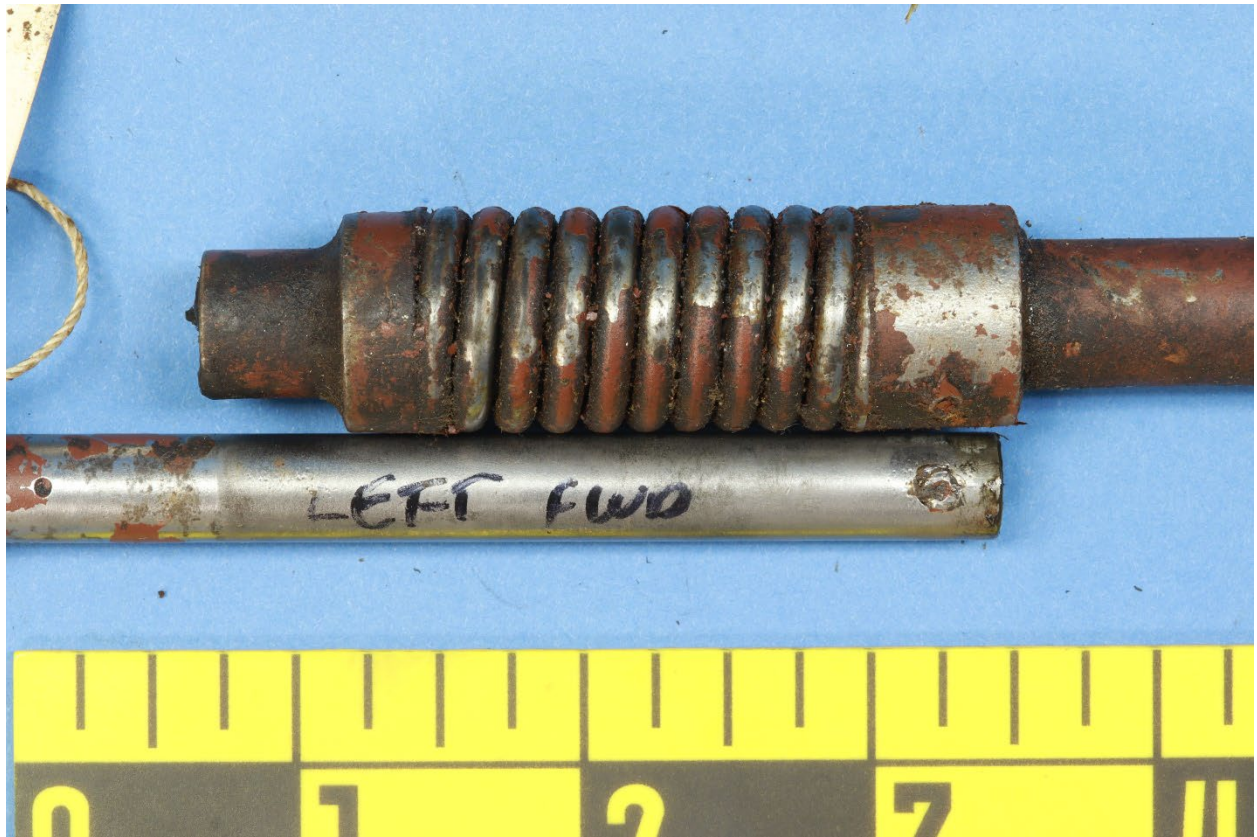
The left and right NLG retraction rods show a different separation pattern. These rods are capped by a spherical bearing at one end and a long solid rod end at the other. The rod ends are inserted into the ends of their respective rods and are held in place by shear pins. A spherical bearing caps each rod end. The rod ends had pulled out of their respective rods. The left rod end was submitted with the rods while the right rod end was not. Pieces of shear pin were observed still inside the NLG rods and a piece of pin was inside the pin hole of the left rod end. The fracture surfaces on the rod end were smeared from pulling out of the rod. The right rod end was not submitted. The fracture surfaces of the pin fragments lodged within the rods were not examined. The spherical bearings on the NLG rods all rotated freely.
