ERA24LA377

## INVESTIGATION PHOTOGRAPHS

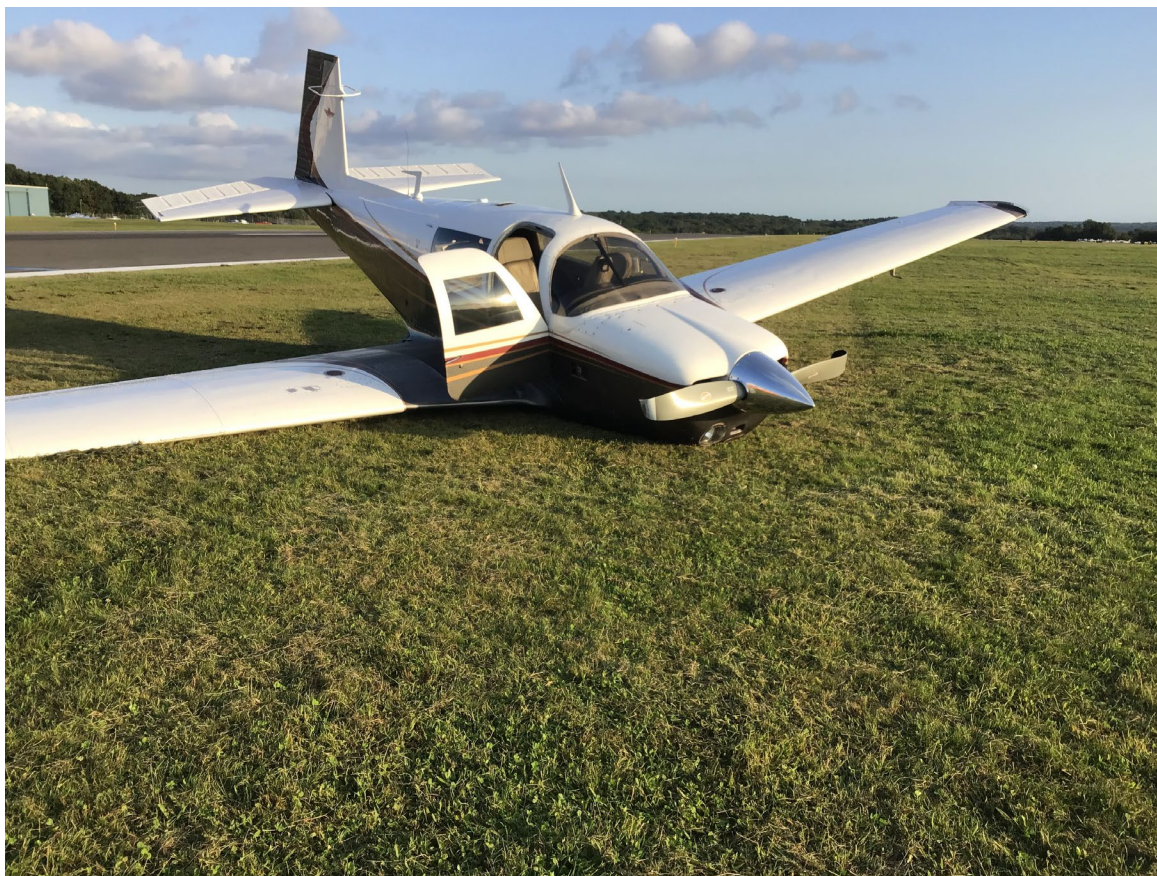
**Photograph 1 - Main Wreckage (FAA Photo)**

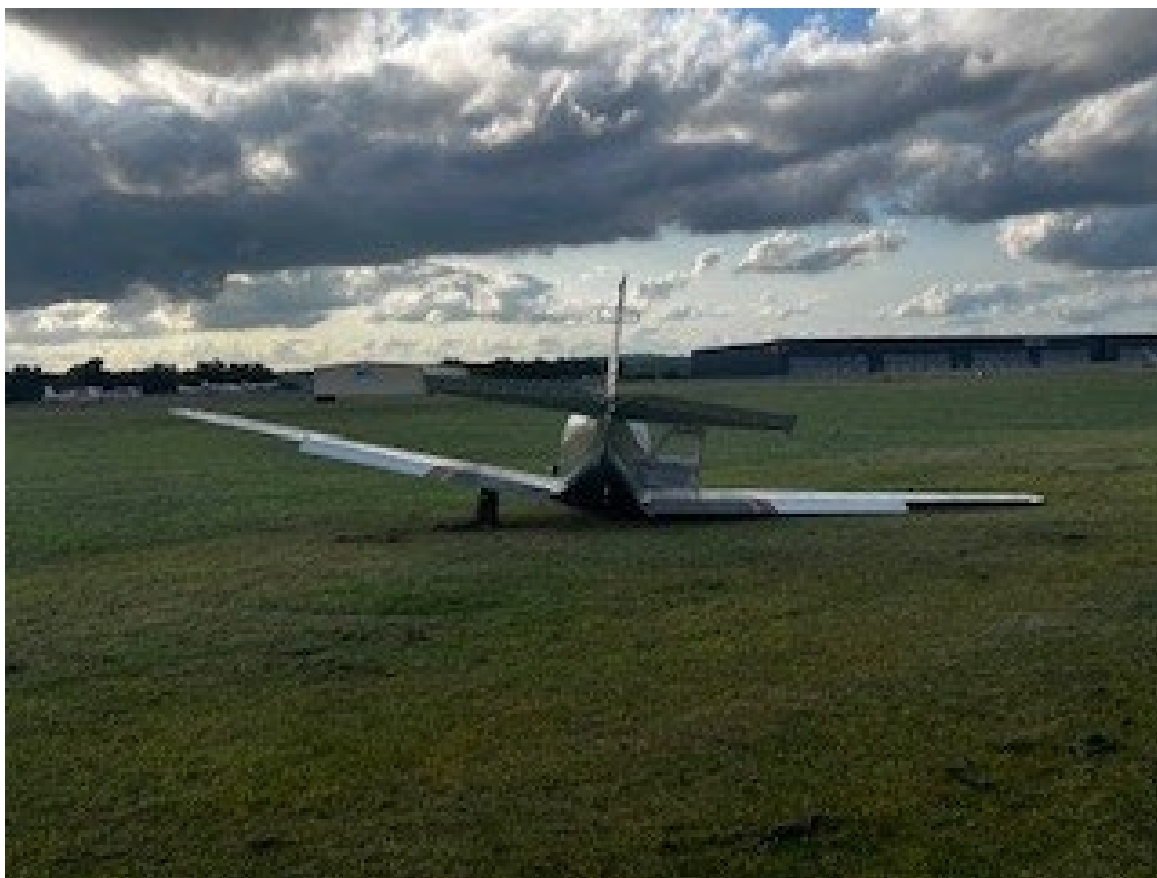
**Photograph 2 - Main Wreckage (FAA Photo)**

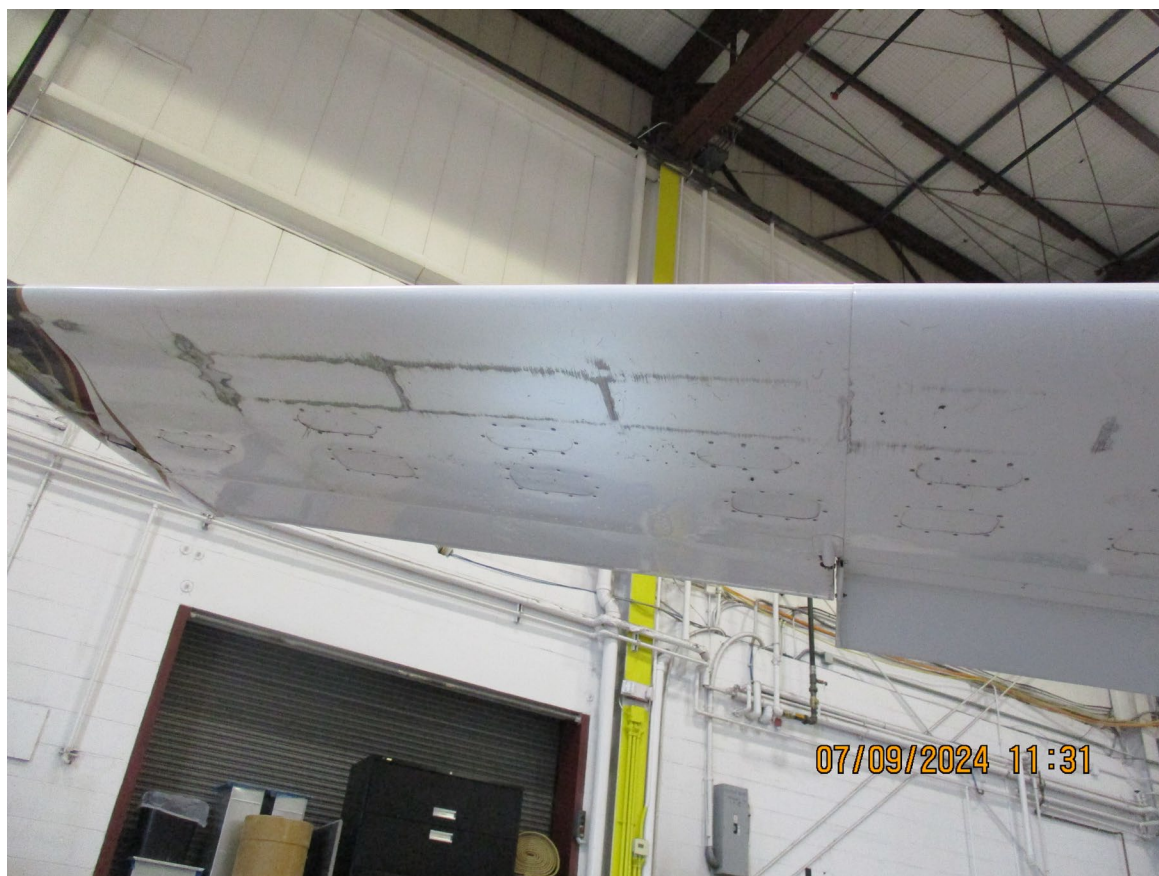
**Photograph 3 - Right Wing Damage (FAA Photo)**

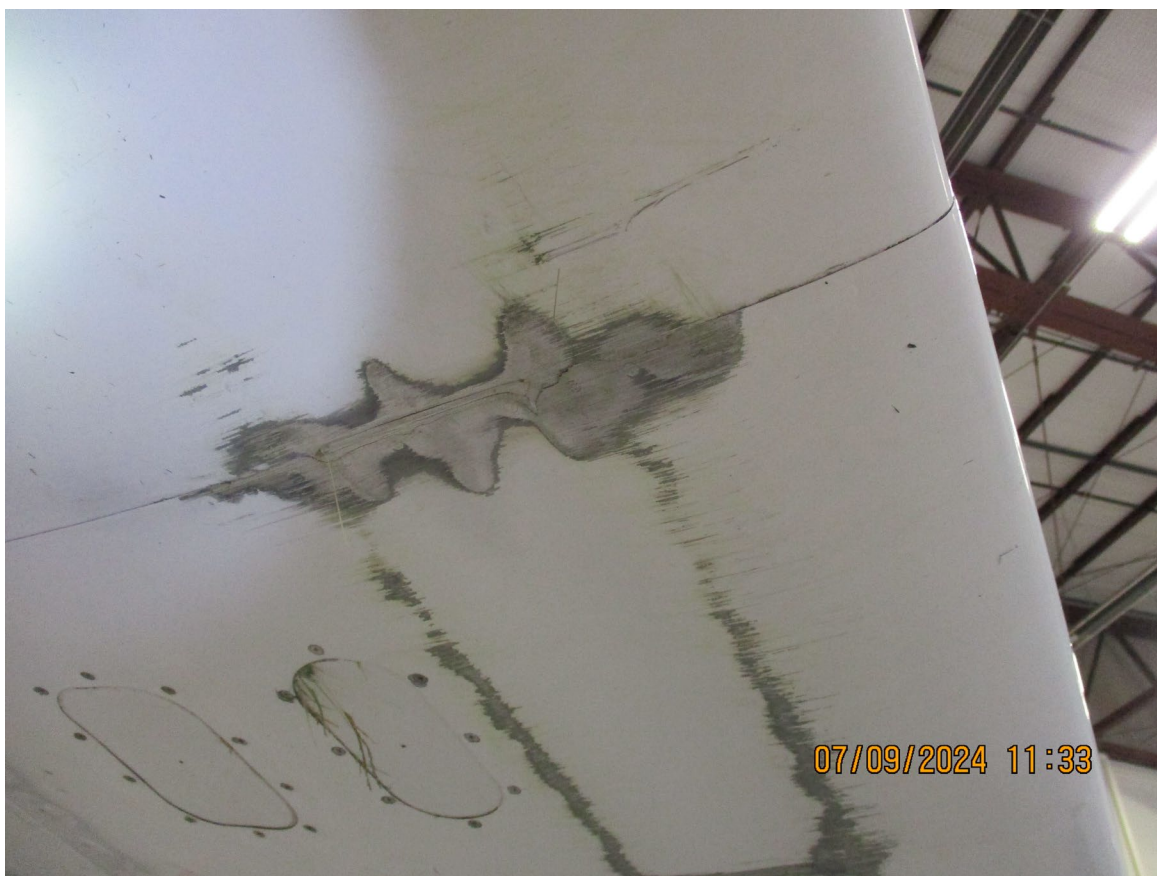
**Photograph 4 - Right Wing Damage (FAA Photo)**

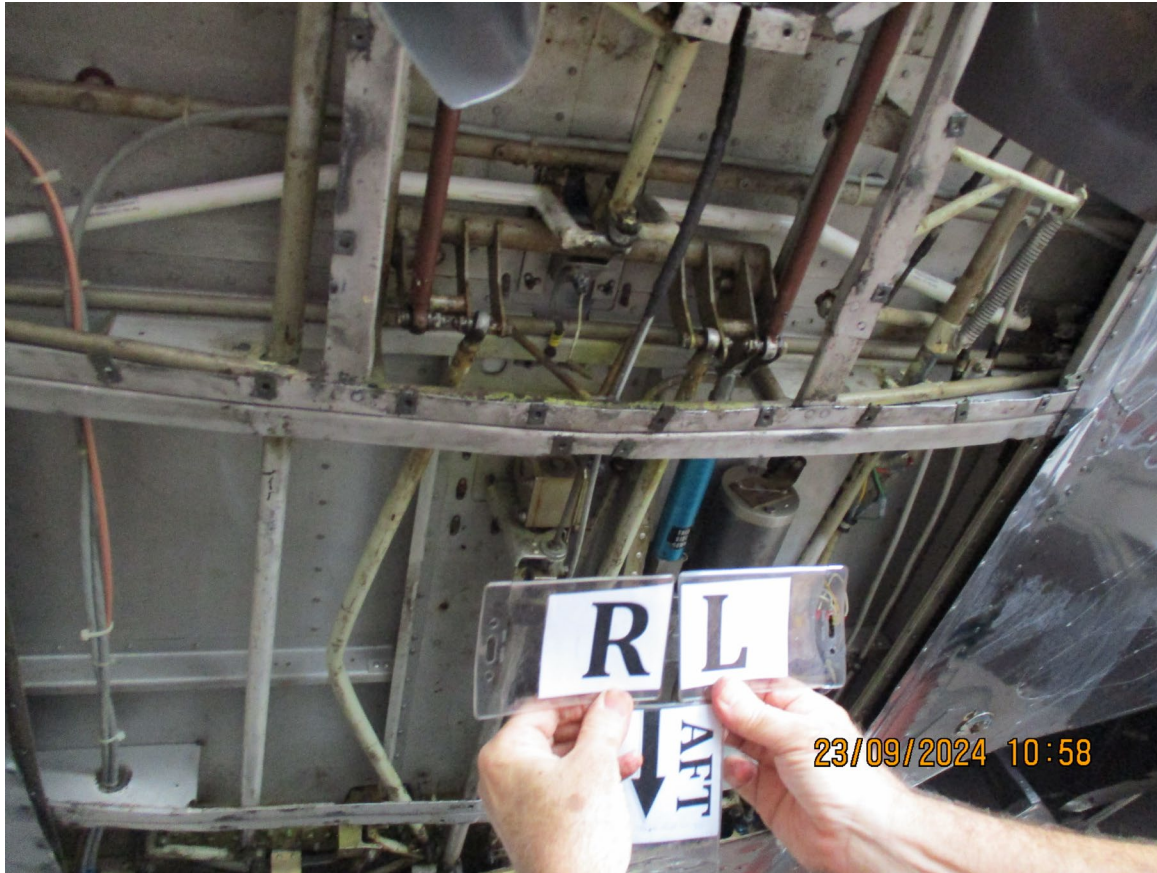
**Photograph 5 - Bent Right Main Landing Gear Extension Rod (FAA Photo)**

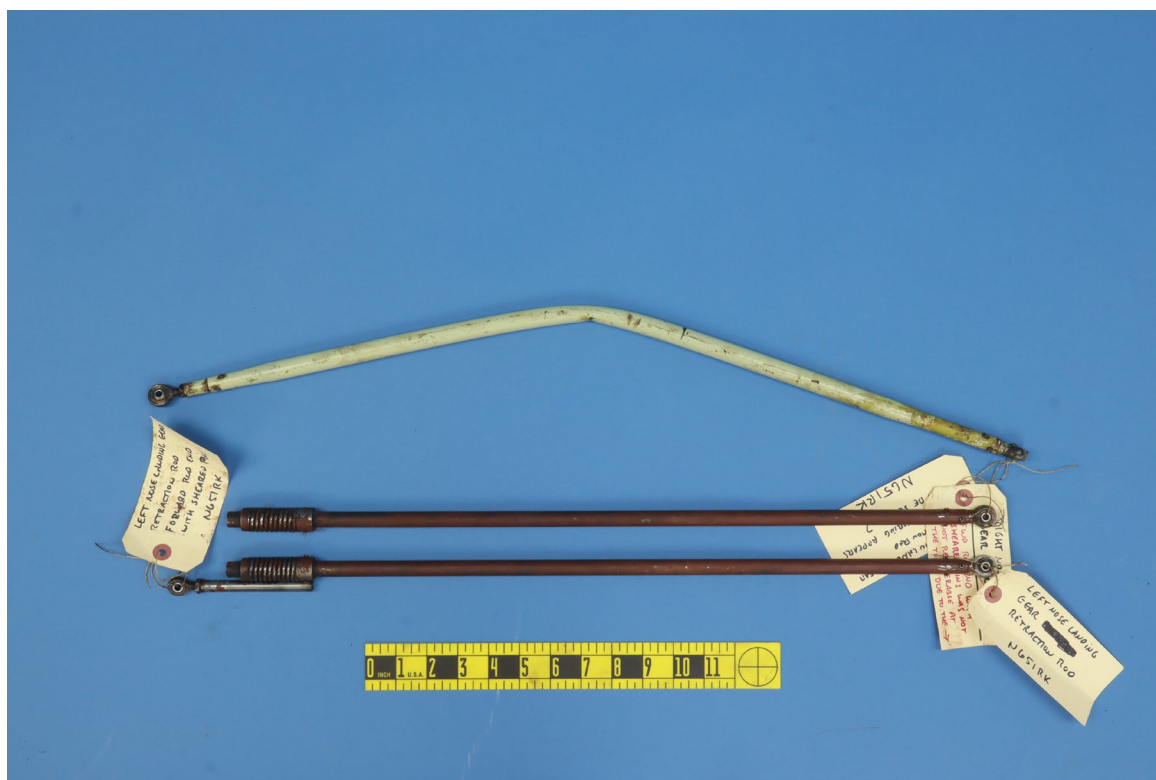
**Photograph 6 - Bent Right Main Landing Gear Extension Rod and Nose Gear Extension Rods (NTSB Photo)**
