ERA24LA383

## INVESTIGATION PHOTOGRAPHS

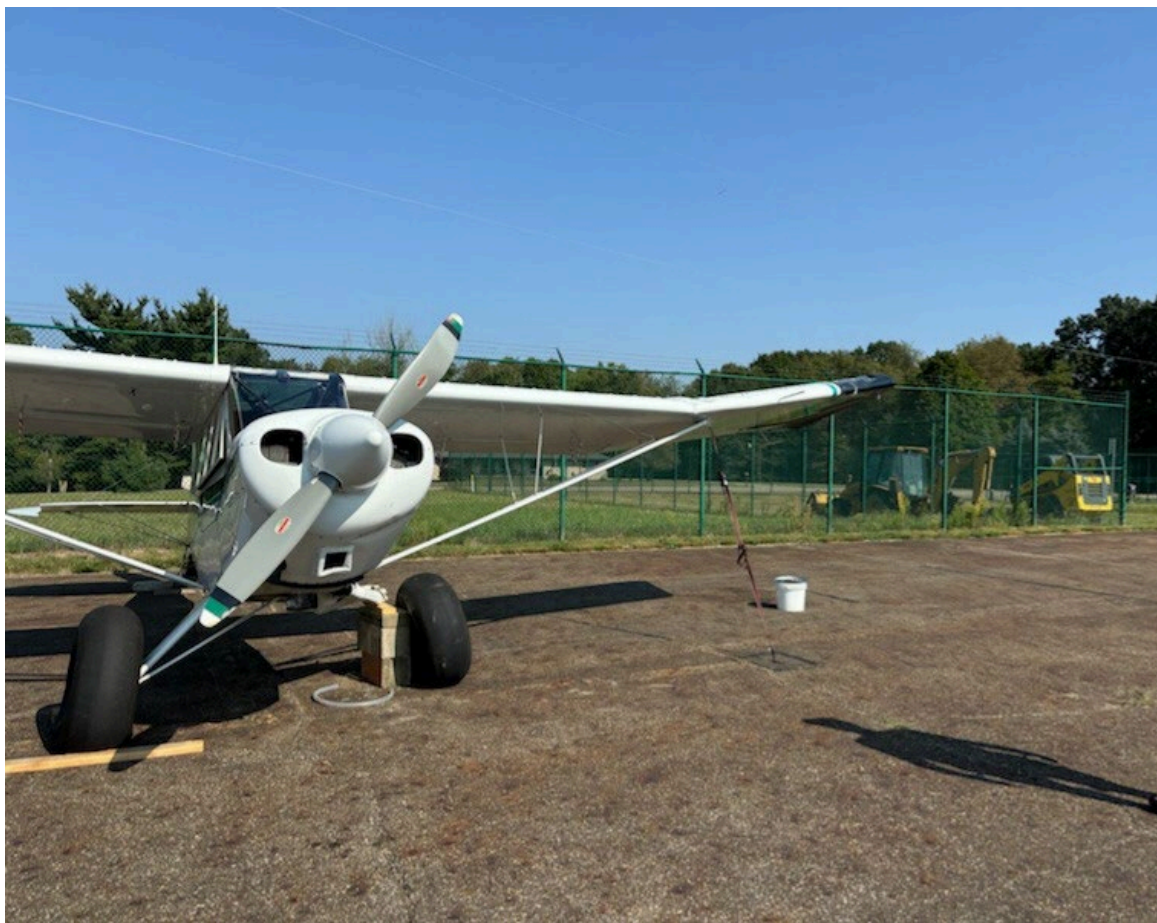
**Photograph 1 - View of blue and white airplane with left wing bent upwards.  
(Courtesy of FAA)**

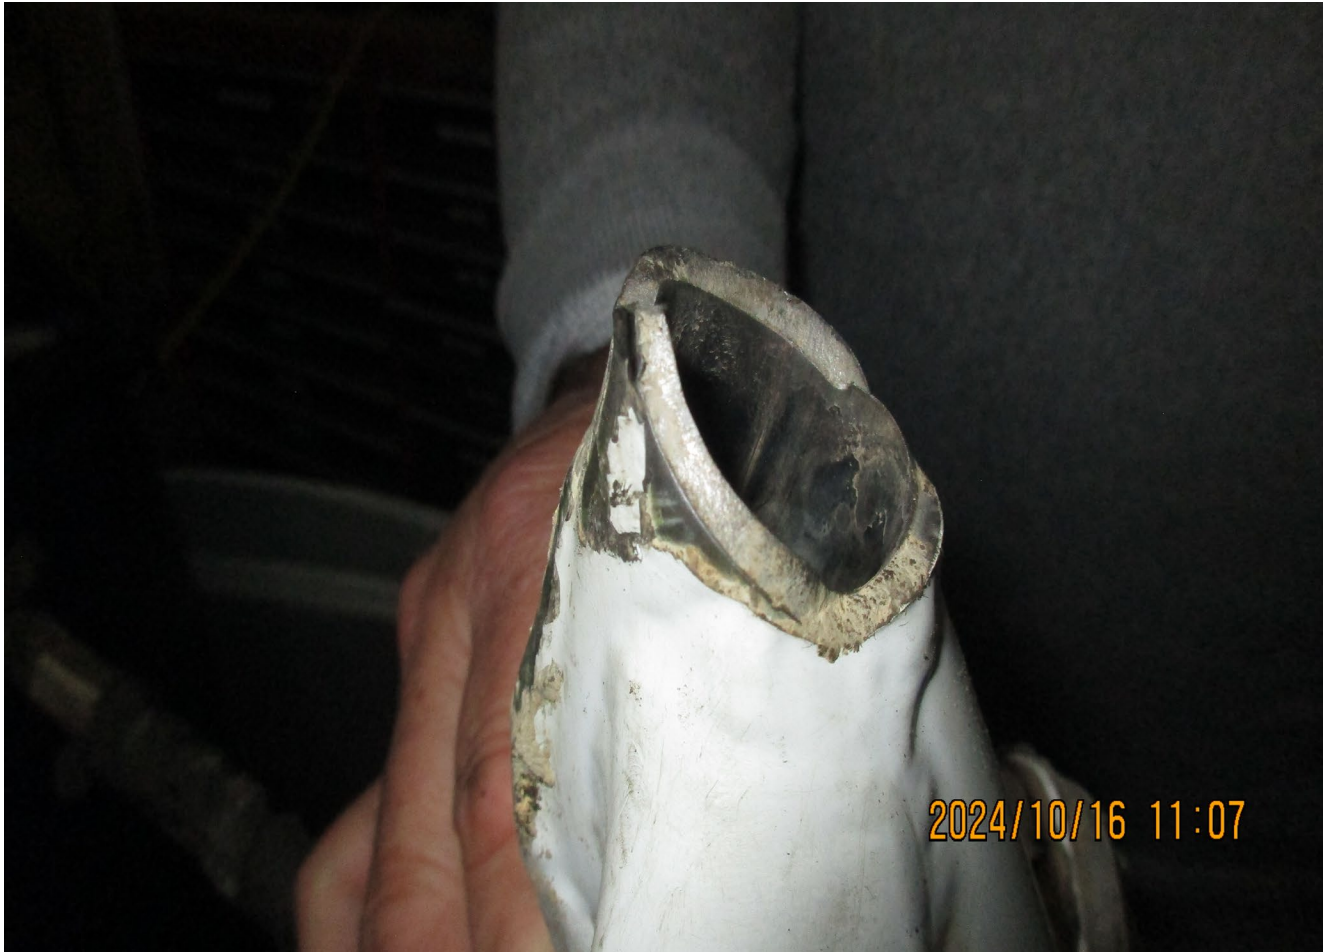
**Photograph 2 - View of broken left landing gear strut  
(Courtesy of FAA)**

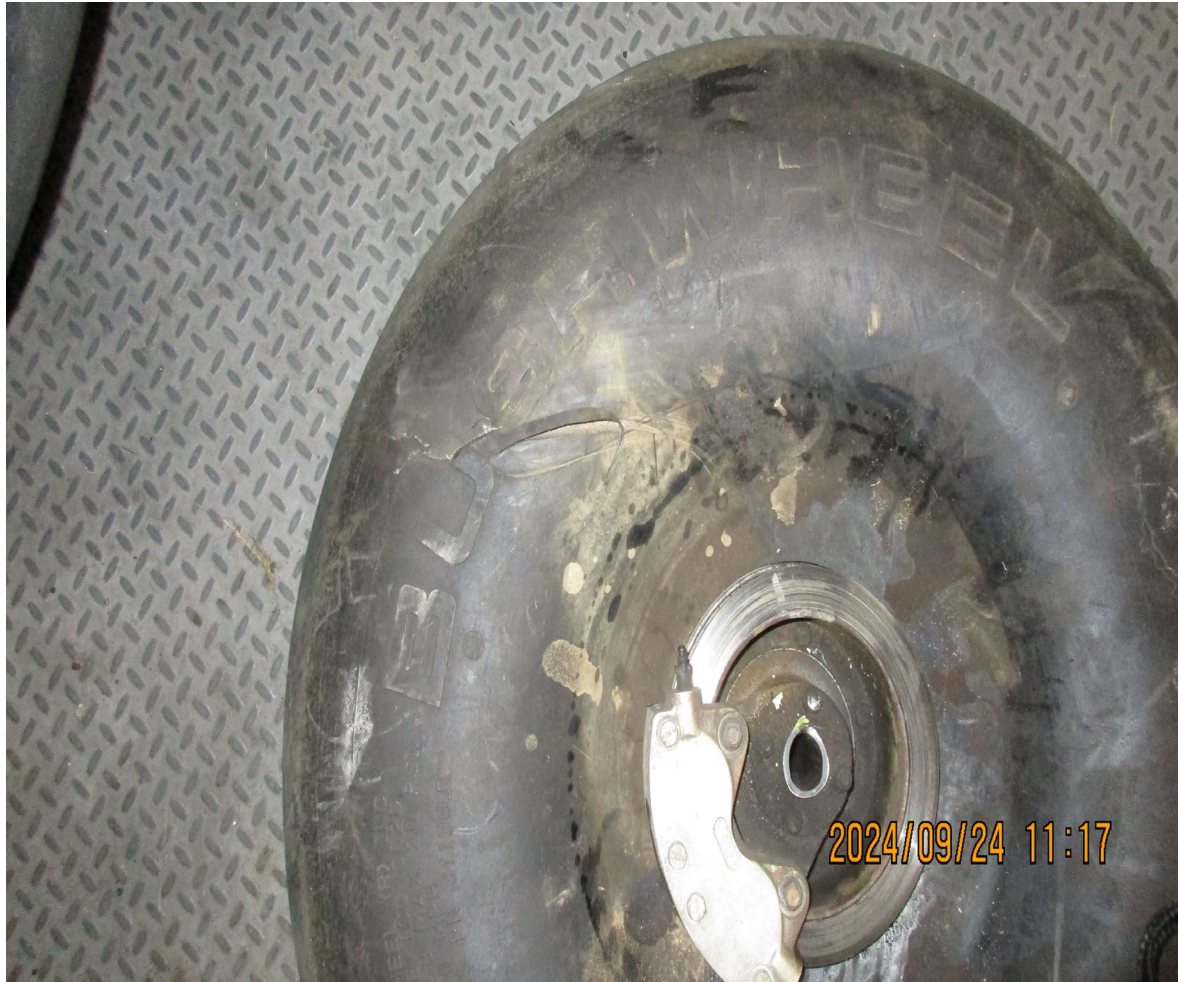
**Photograph 3 - View of broken landing gear wheel assembly  
(Courtesy of FAA)**
