ERA24LA383

## **ADDITIONAL INVESTIGATION PHOTOGRAPHS**

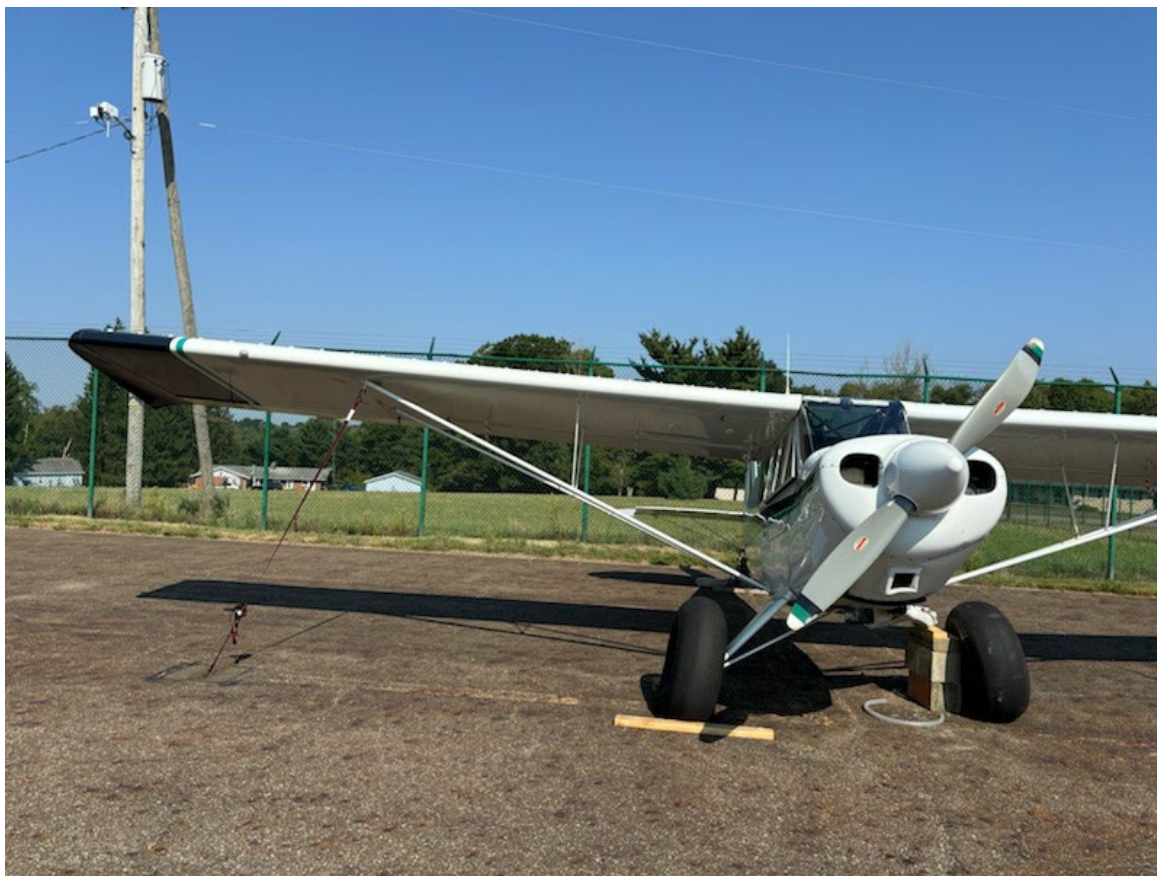
**Photograph 1 - View of blue and white airplane with left wing bent upwards.  
(Courtesy of FAA)**

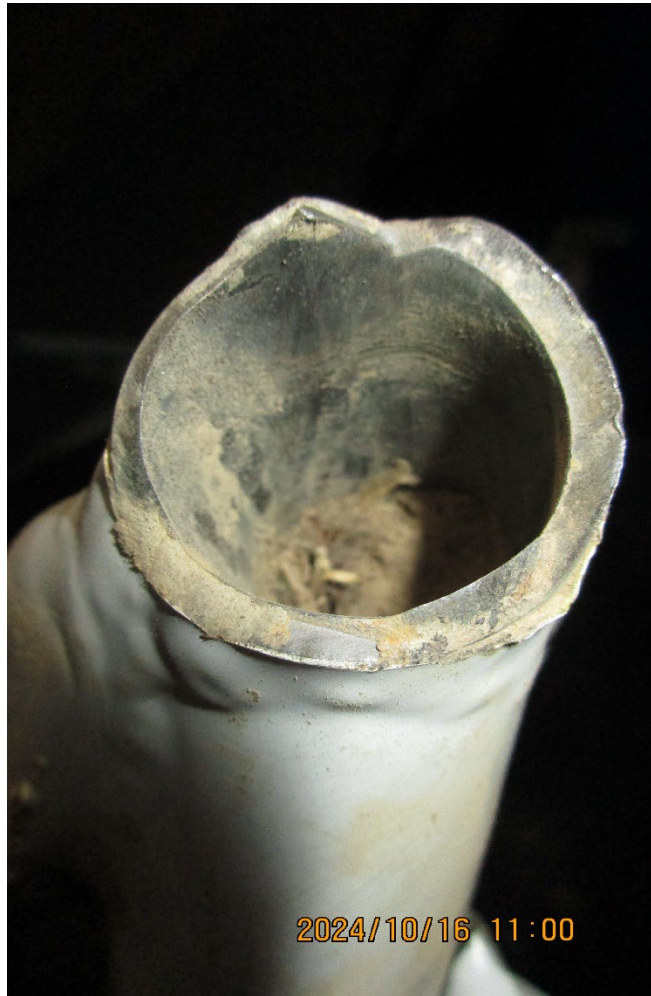
**Photograph 3 - Close up of left landing gear strut fracture.  
(Courtesy of FAA)**

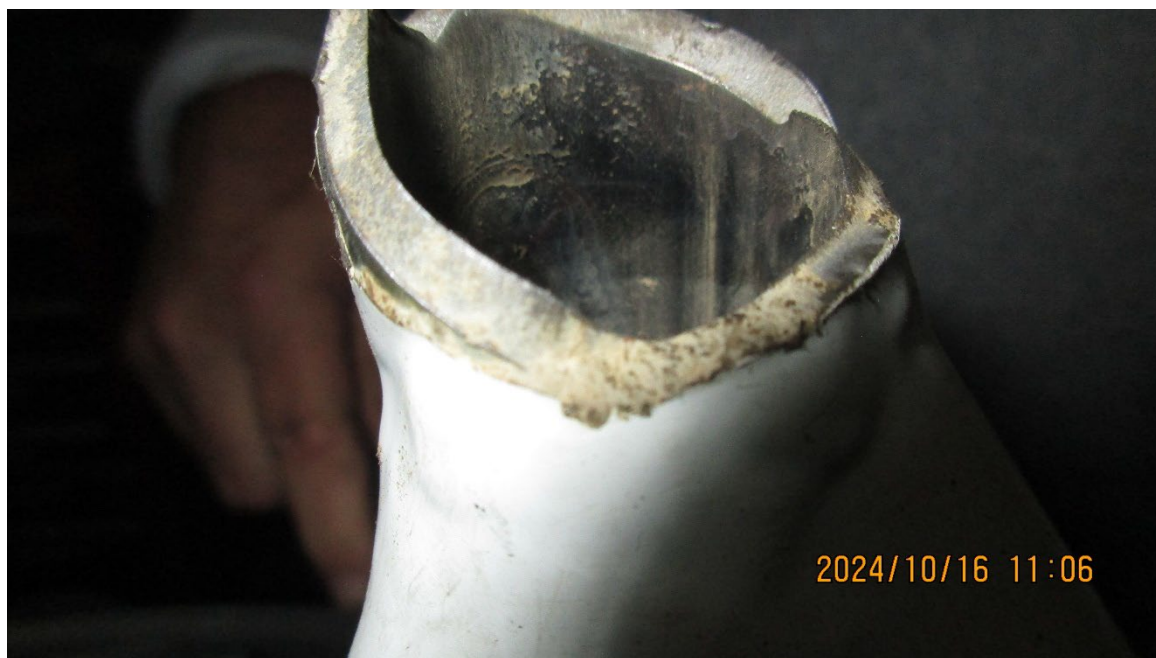
**Photograph 4 - Close up of left landing gear strut assembly (side view) fracture.  
(Courtesy of FAA)**

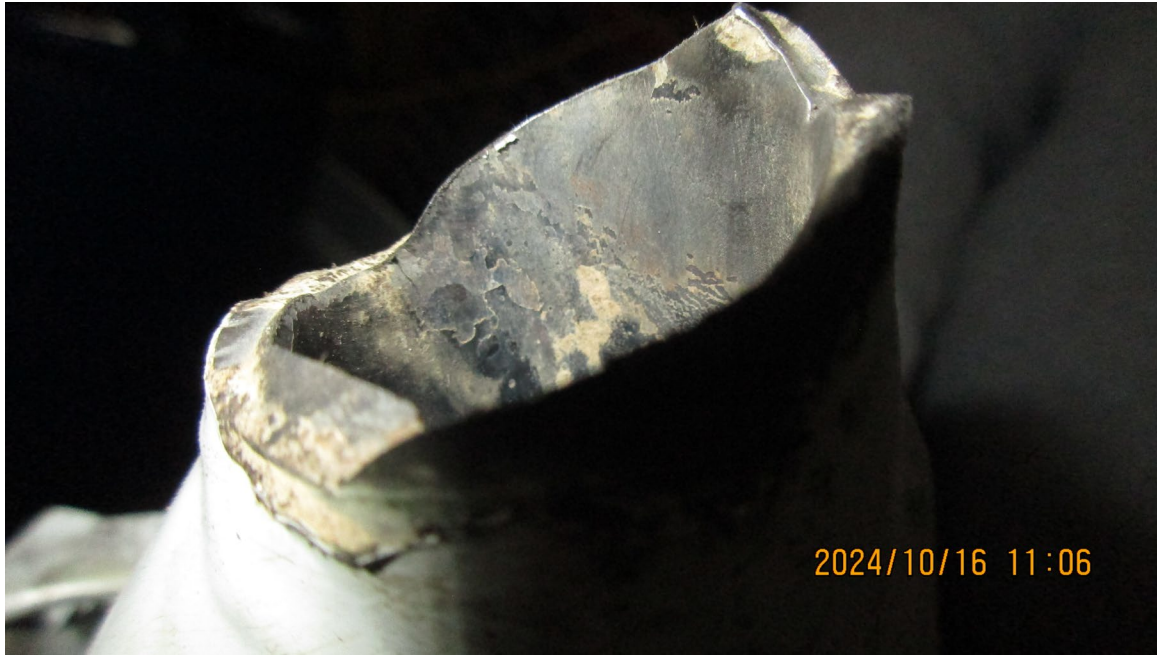
**Photograph 5 - Close up of left landing gear strut assembly fracture edges.  
(Courtesy of FAA)**

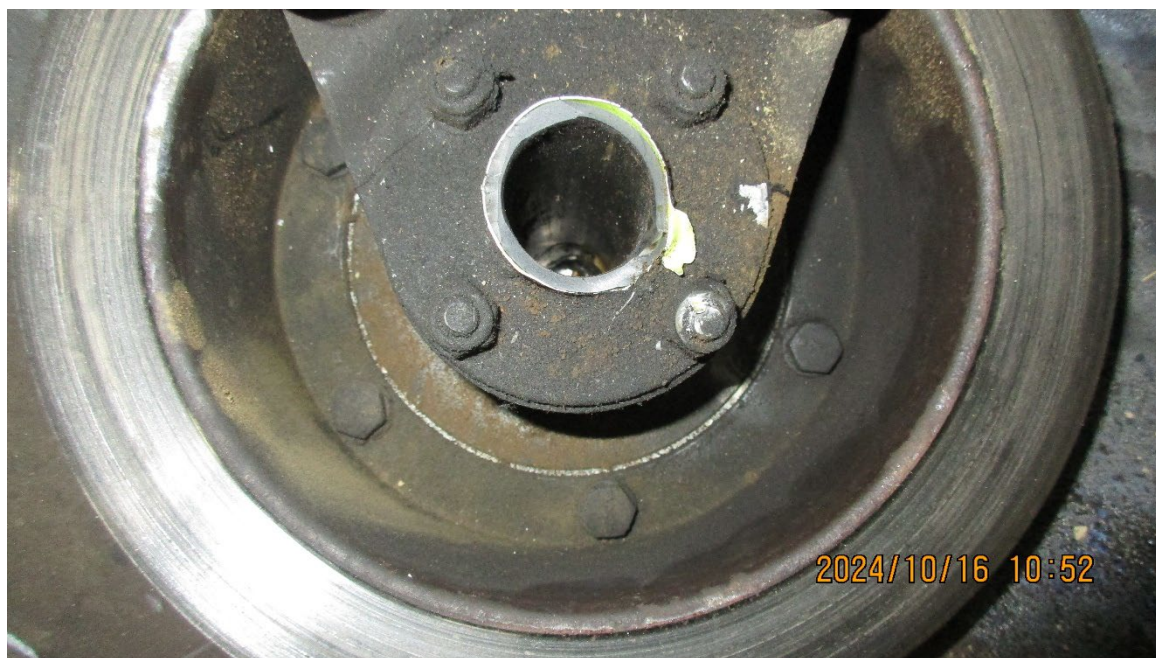
**Photograph 6 - Close up of fractured wheel assembly.  
(Courtesy of FAA)**
