ERA24LA388

## INVESTIGATION PHOTOGRAPHS

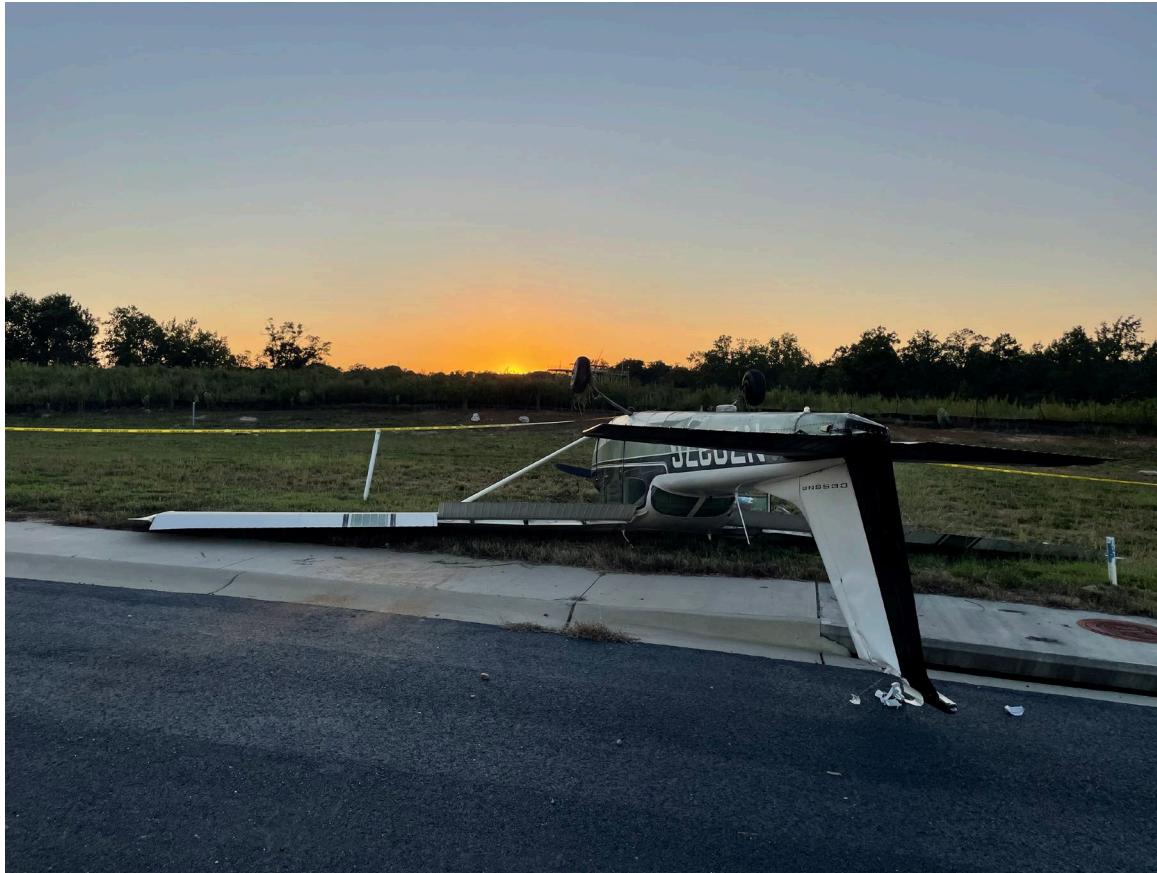
**Photograph 1 - Deformation noted to rudder and vertical stabilizer (Courtesy of FAA)**

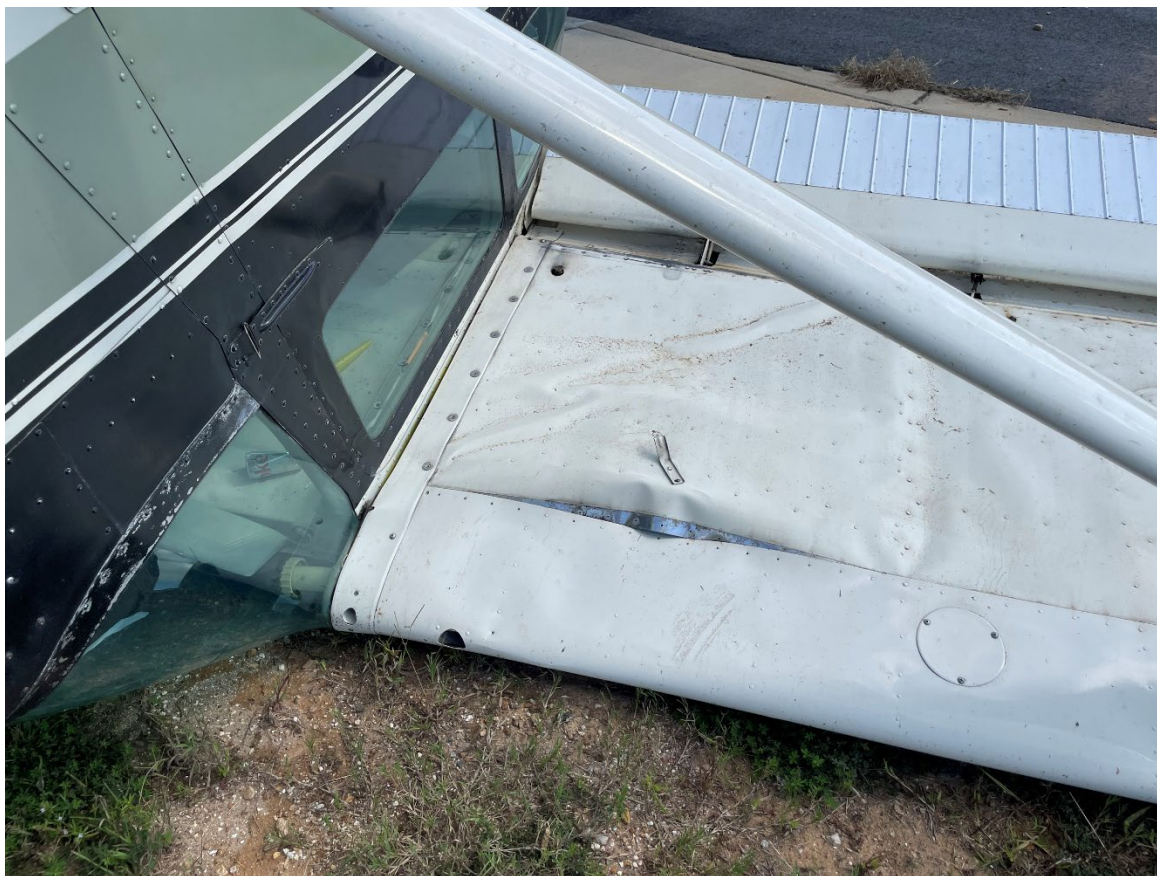
**Photograph 2 - Deformation and skin separation noted to right wing (Courtesy of FAA)**

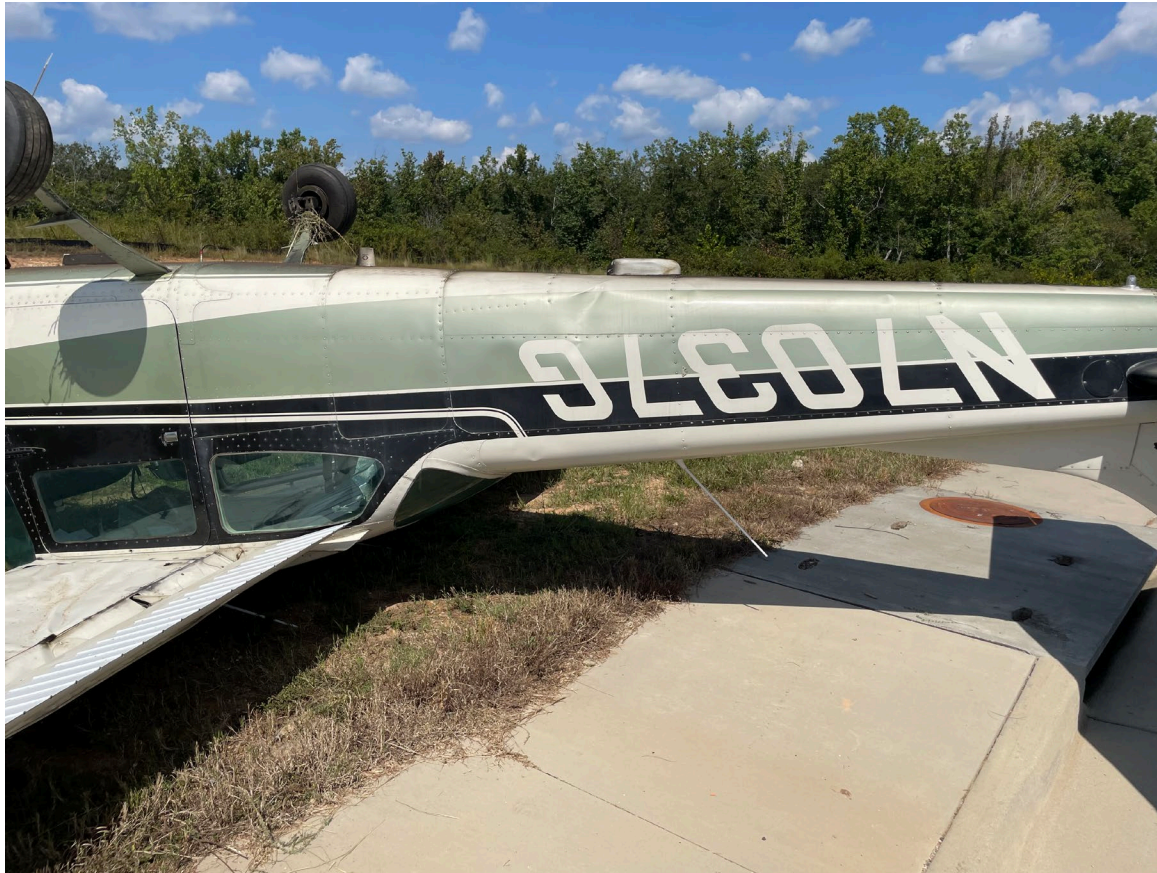
**Photograph 3 - Buckling noted to fuselage (Courtesy of FAA)**
