# National Transportation Safety Board

ERA24LA388

## **EXAMINATION SUMMARY**

Location: Spartanburg, South Carolina  
Date: September 20, 2024  
Time: 1543 EDT  
2043 UTC  
Airplane: Cessna 172K, N7037G, S/N: 17258737  
Tach: 751.67, Hobbs: 2104.9

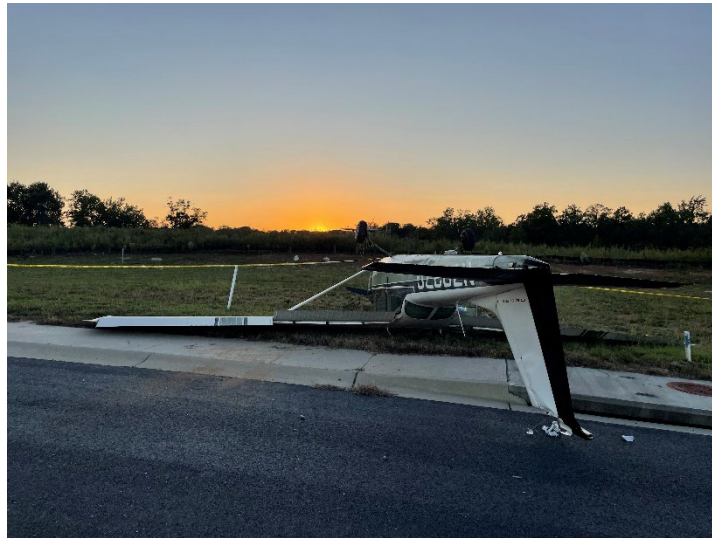
Photograph of accident site (provided by FAA)

The airplane came to rest inverted in a field about 0.3 miles northeast of runway 5 of the Spartanburg Downtown memorial Airport / Simpson Field (SPA), Spartanburg, South Carolina.

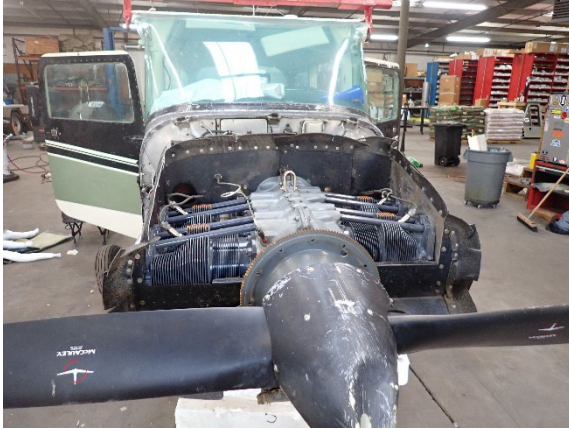
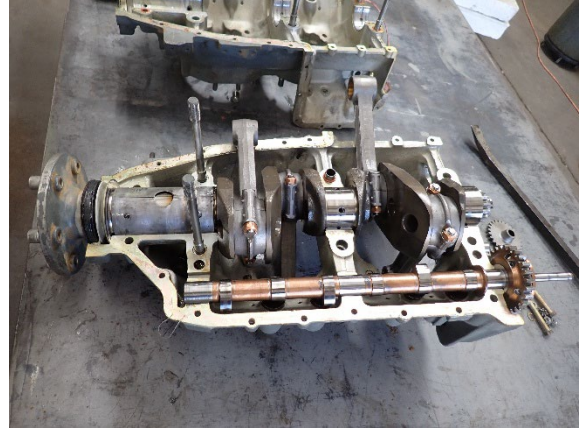
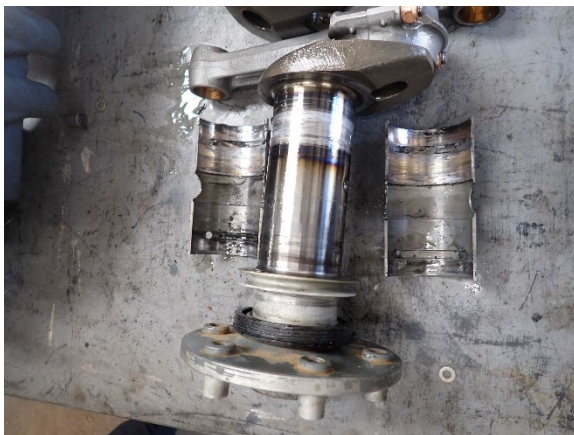
Photograph of front main bearing and crankshaft.

The front main bearing was discolored and exhibited rotational abrasion at its rear oil passage (bearing surface area) and corresponding crankshaft surface. No anomalies were noted to the front main bearing's front oil passage (bearing surface area) or corresponding crankshaft surface.

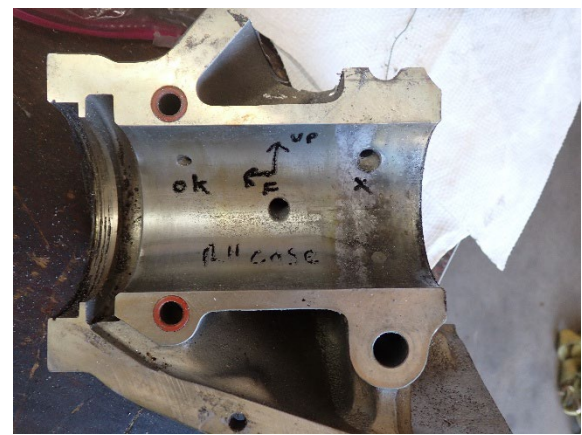
Photograph of sectioned crankcase and noted obstructed passage.

Oil passage continuity checks with low-pressure air revealed an obstruction between the oil header and front main bearing's rear oil passage. The right crankcase half was sectioned at the front main bearing area for identification of the obstruction. Further examination revealed the oil passage was obstructed with an unknown gritty material. Additionally, an oil passage was obstructed to the No. 4 cylinder intake cam follower bore with a similar debris noted to that of the front main bearing passage. Abrasion was noted to the No. 4 cylinder intake cam follower body. All other oil passages were clear of obstruction, and the remaining seven cam follower bodies were free of abrasion.

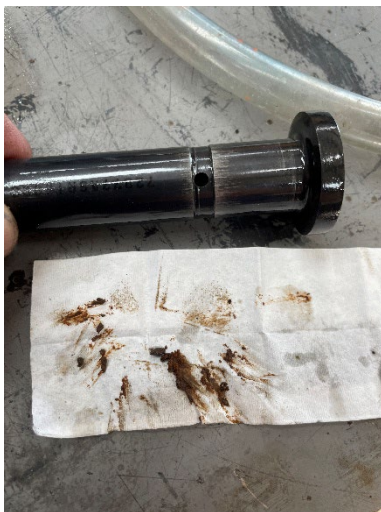
Photograph of the No. 4 cylinder intake cam follower and oil passage debris.

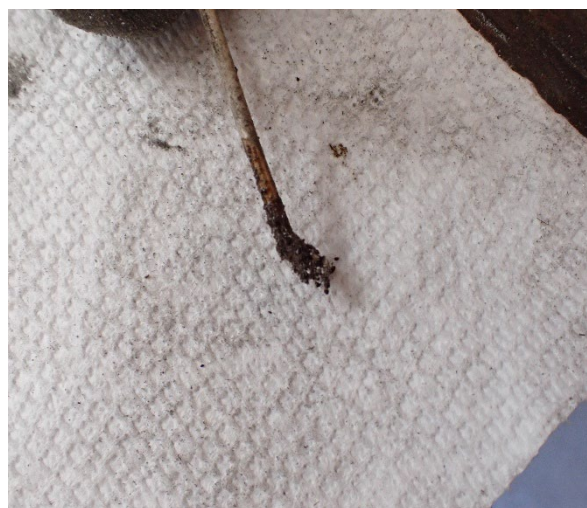
Photograph of debris recovered from the rear oil passage of the crankcase's front main bearing area.

The debris was sent to the NTSB laboratory for further examination.
