ERA24LA389

## INVESTIGATION PHOTOGRAPHS

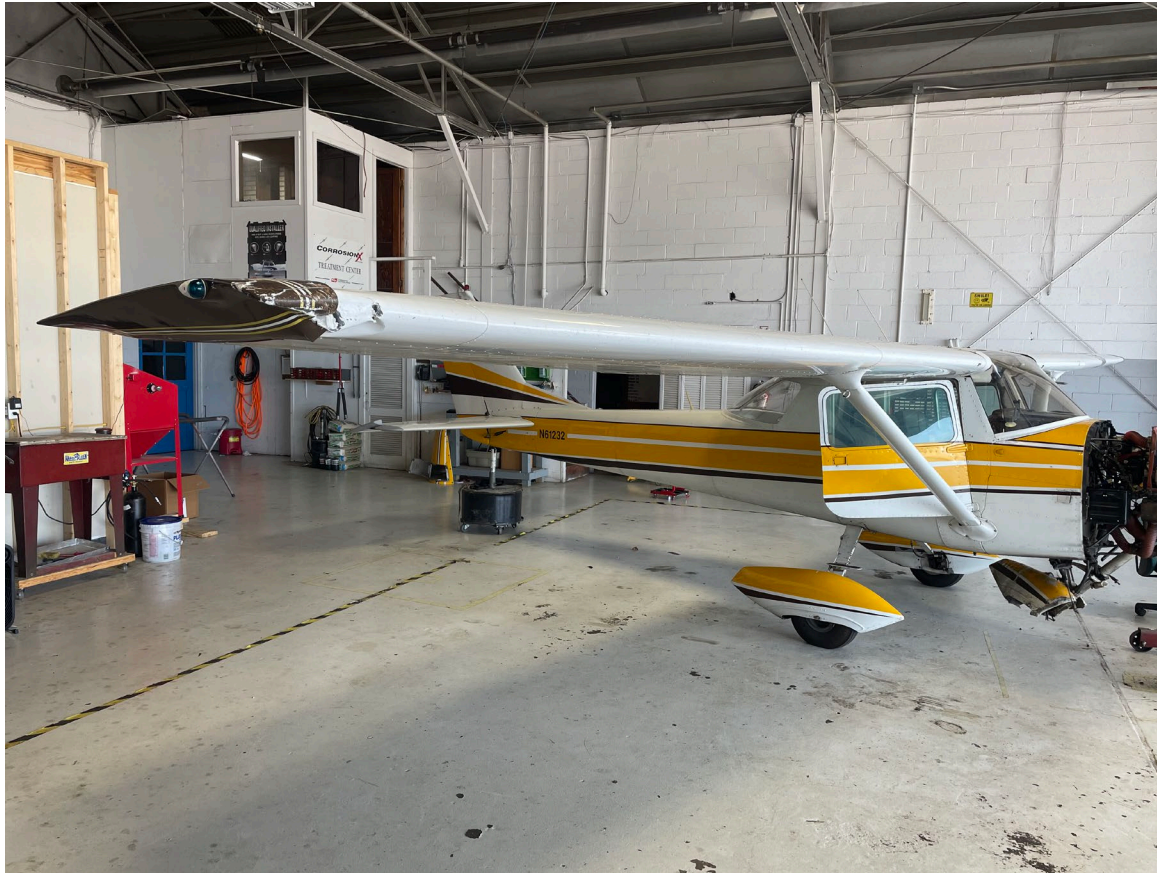
**Photograph 1 - Right wing and nose wheel damage (Courtesy of FAA)**

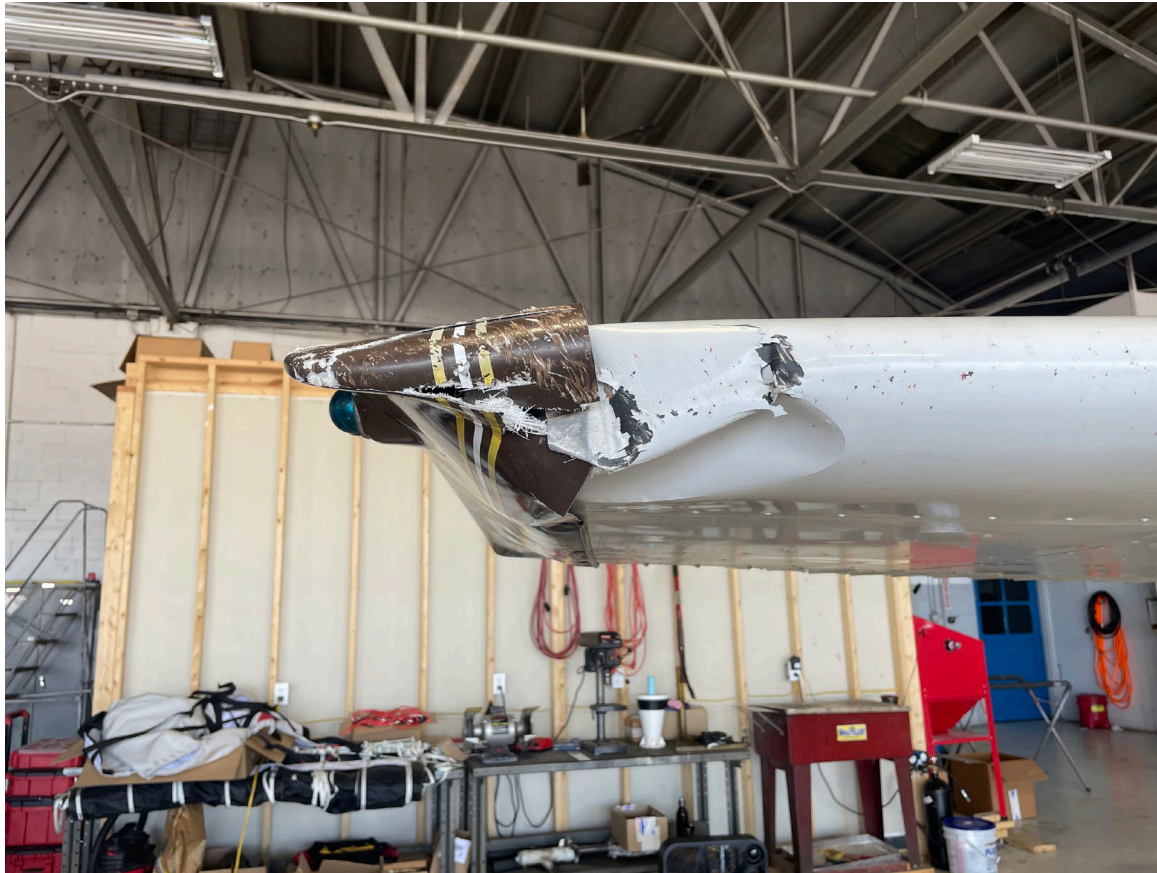
**Photograph 2 - Right wing impact damage (Courtesy of FAA)**

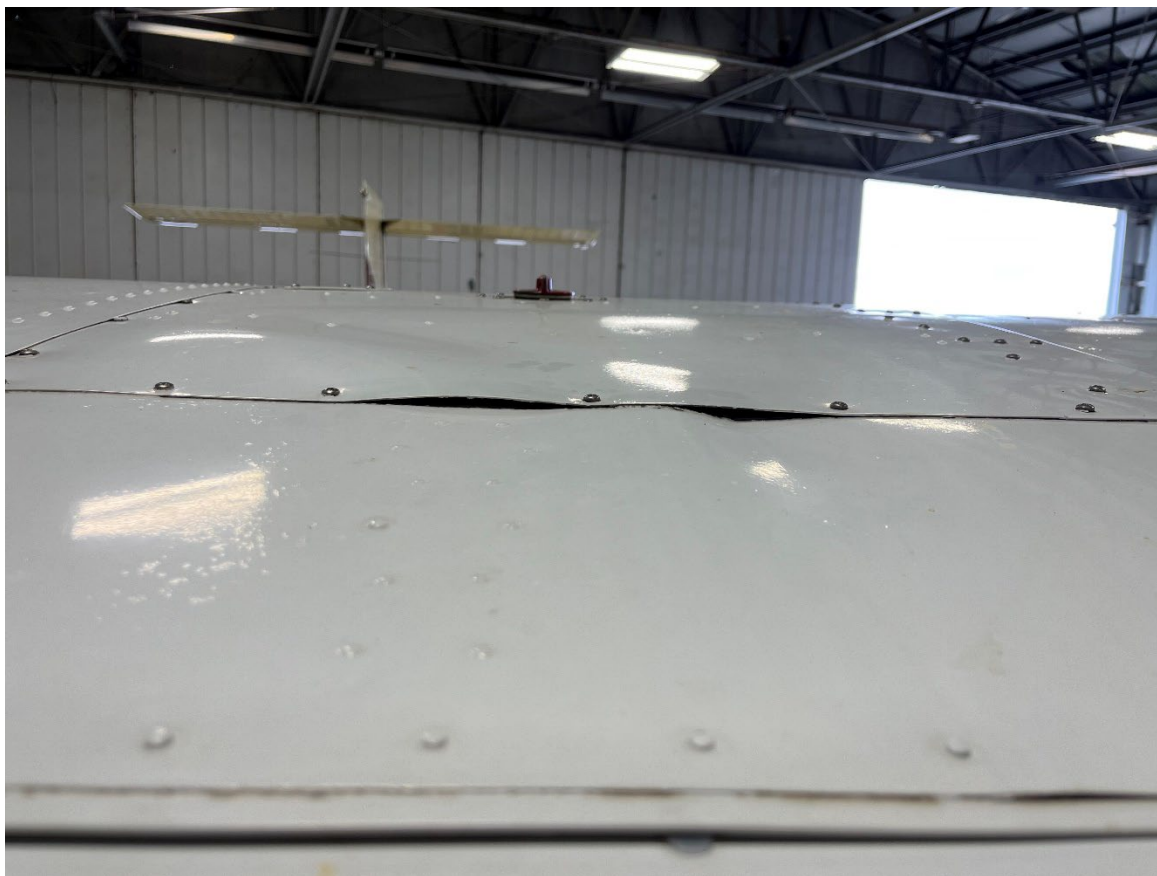
**Photograph 3 - Right wing impact damage buckling(Courtesy of FAA)**

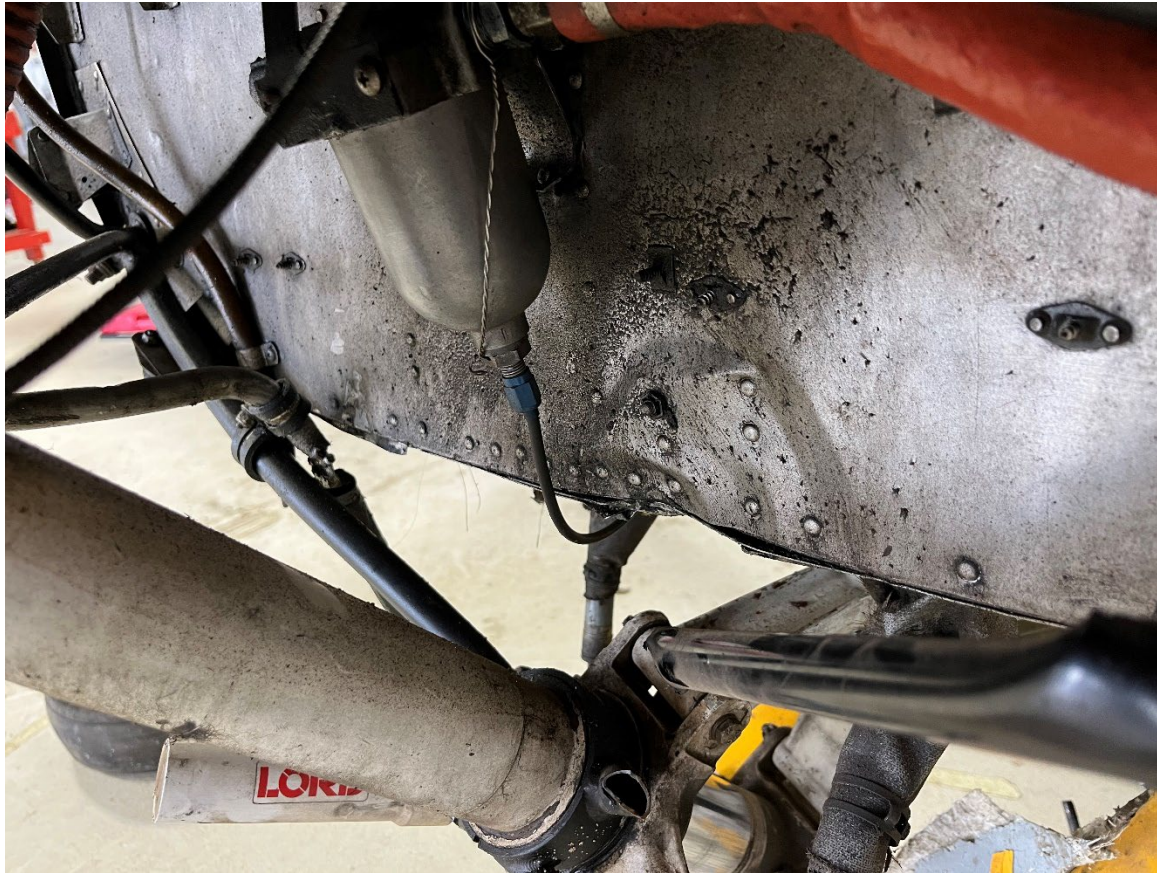
**Photograph 3 - Lower fuselage impact damage (Courtesy of FAA)**
