ERA24LA390

## INVESTIGATION PHOTOGRAPHS

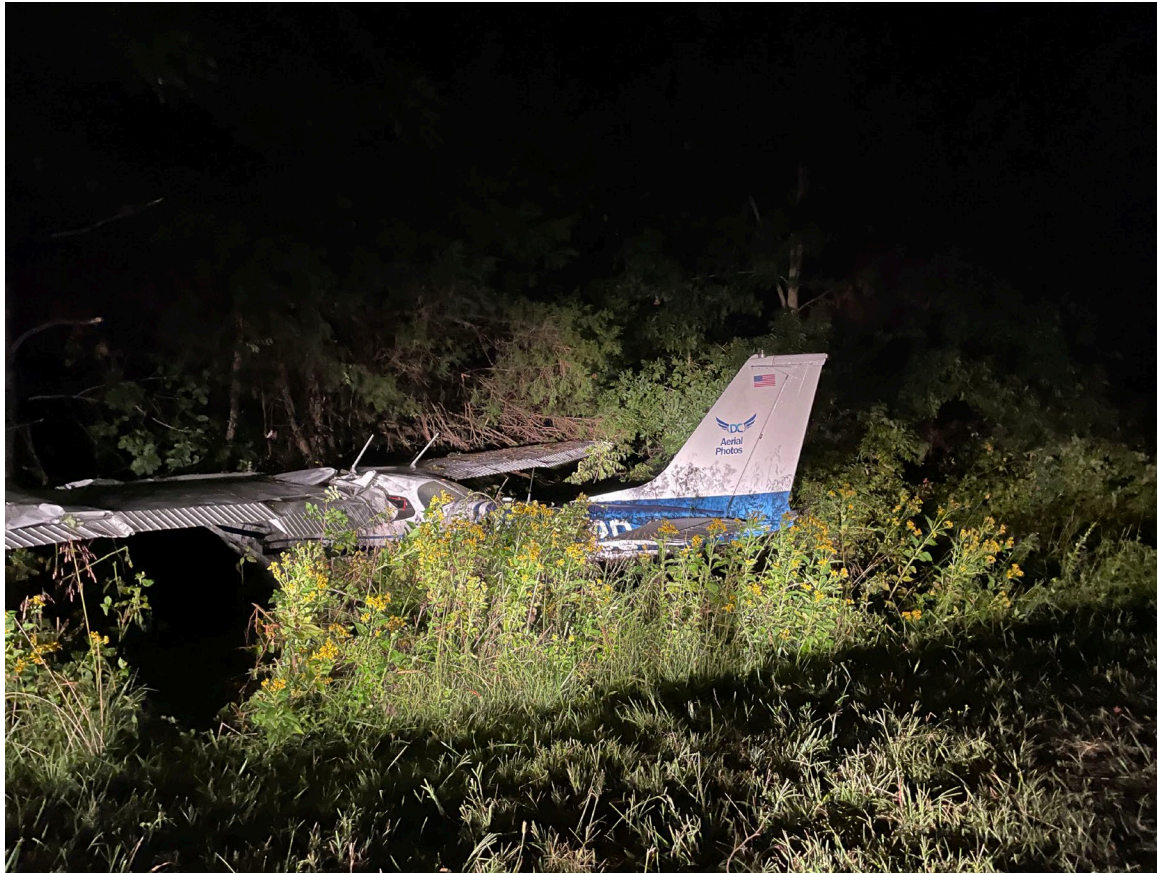
Photograph 1 –View of airplane in wooded area showing damaged left wing. (Courtesy of FAA)

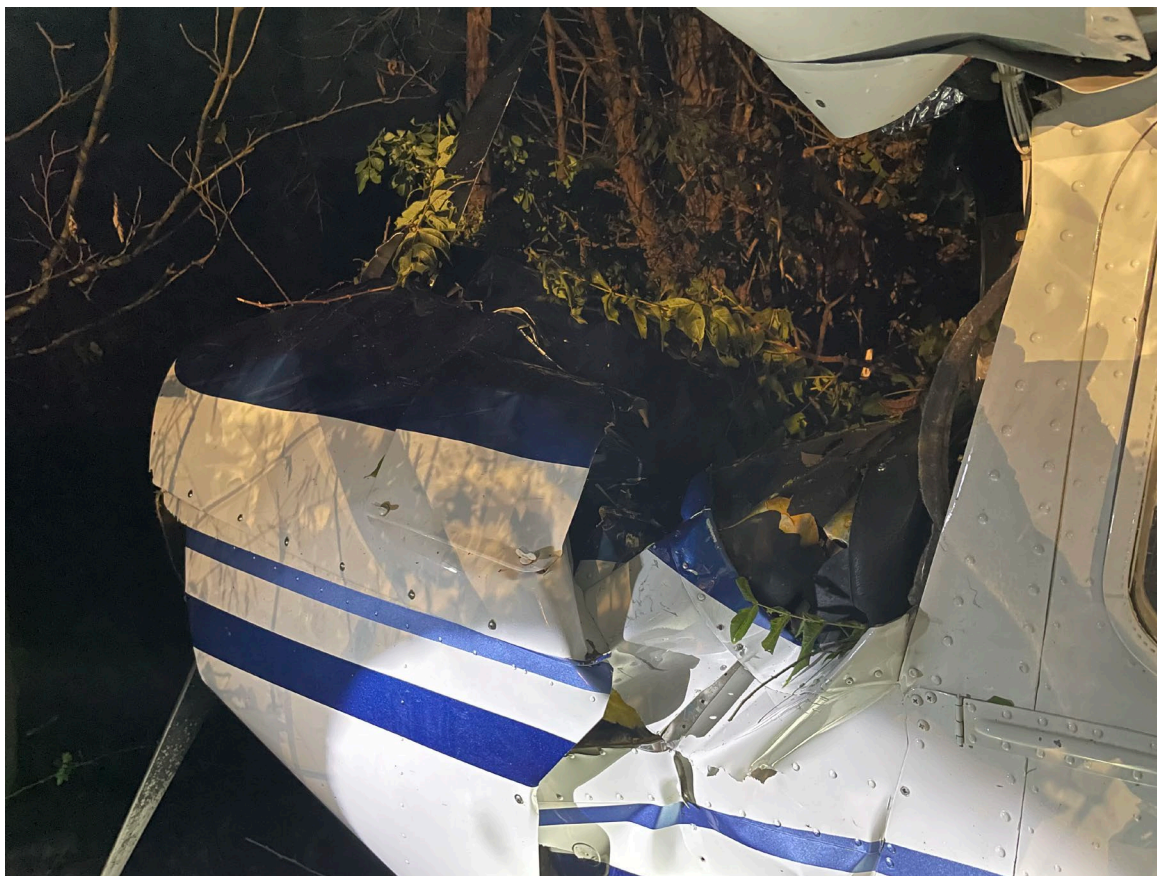
Photograph 2 – View of crushed engine cowling and fuselage (Courtesy of FAA)

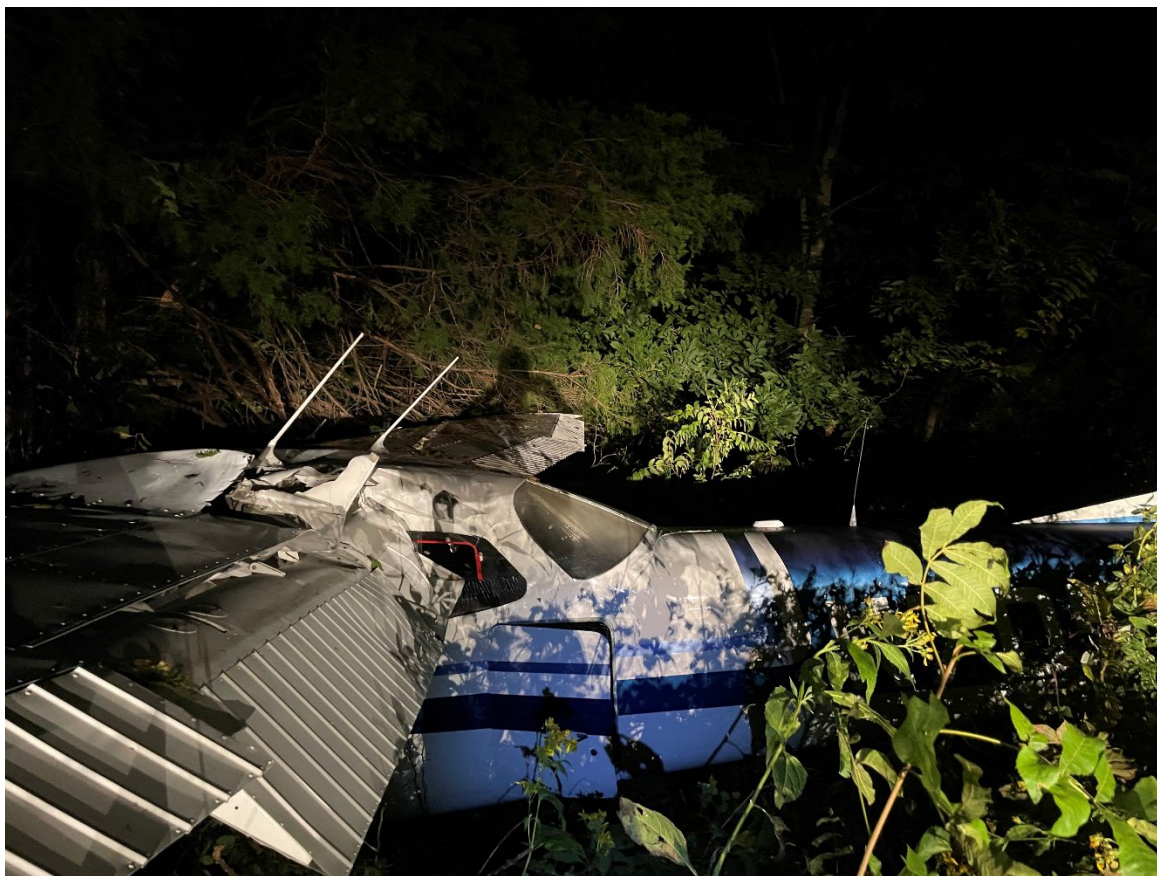
Photograph 3 –View of buckled left wing root and upper fuselage damage. (Courtesy of FAA)
