ERA24LA392

## INVESTIGATION PHOTOGRAPHS

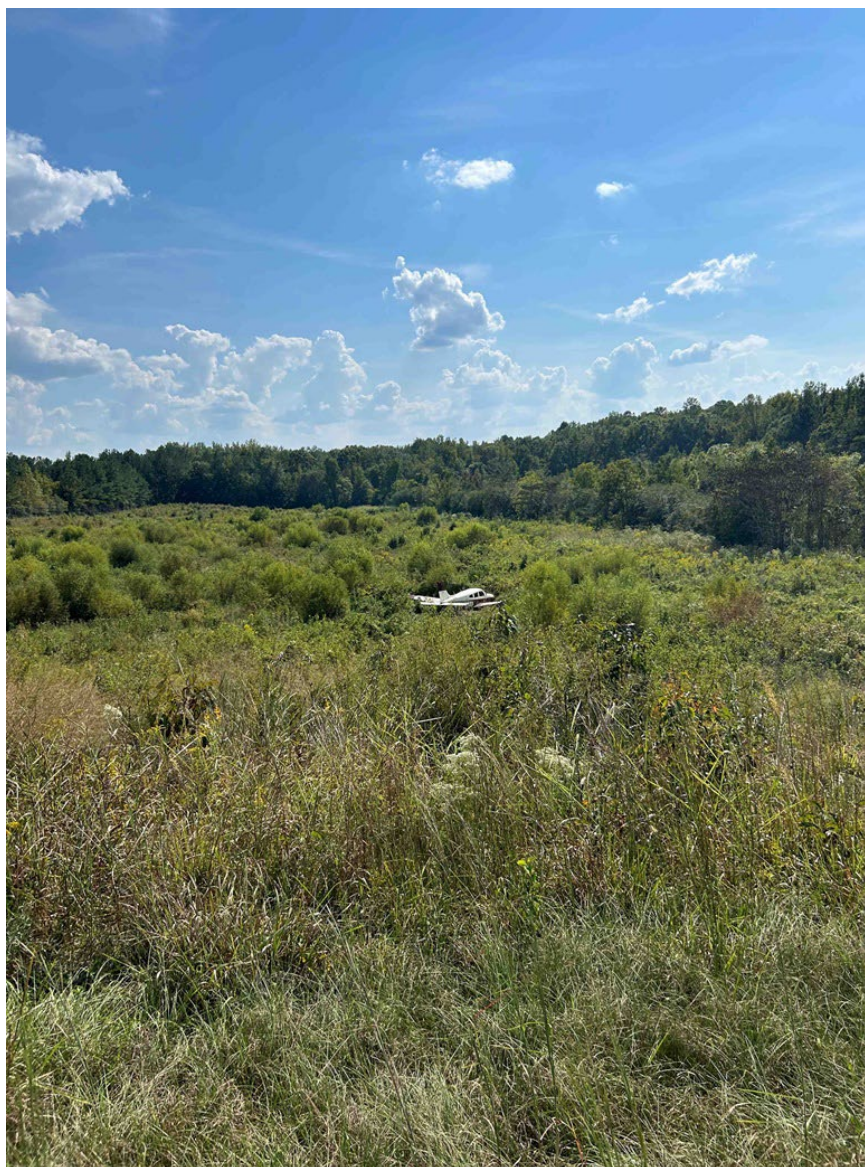
**Photograph 1 - Main Wreckage From End of Runway (Courtesy of FAA)**

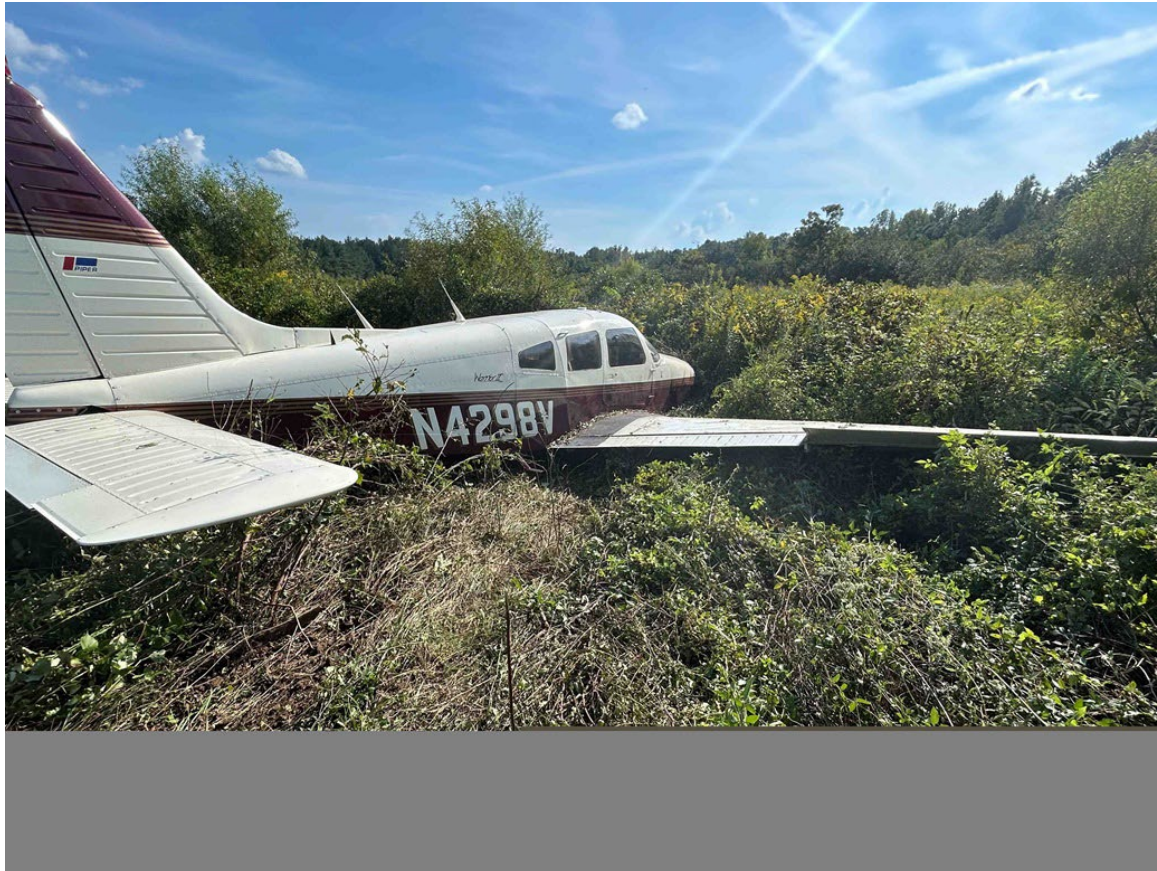
**Photograph 2 - Right Side Main Wreckage (Courtesy of FAA)**

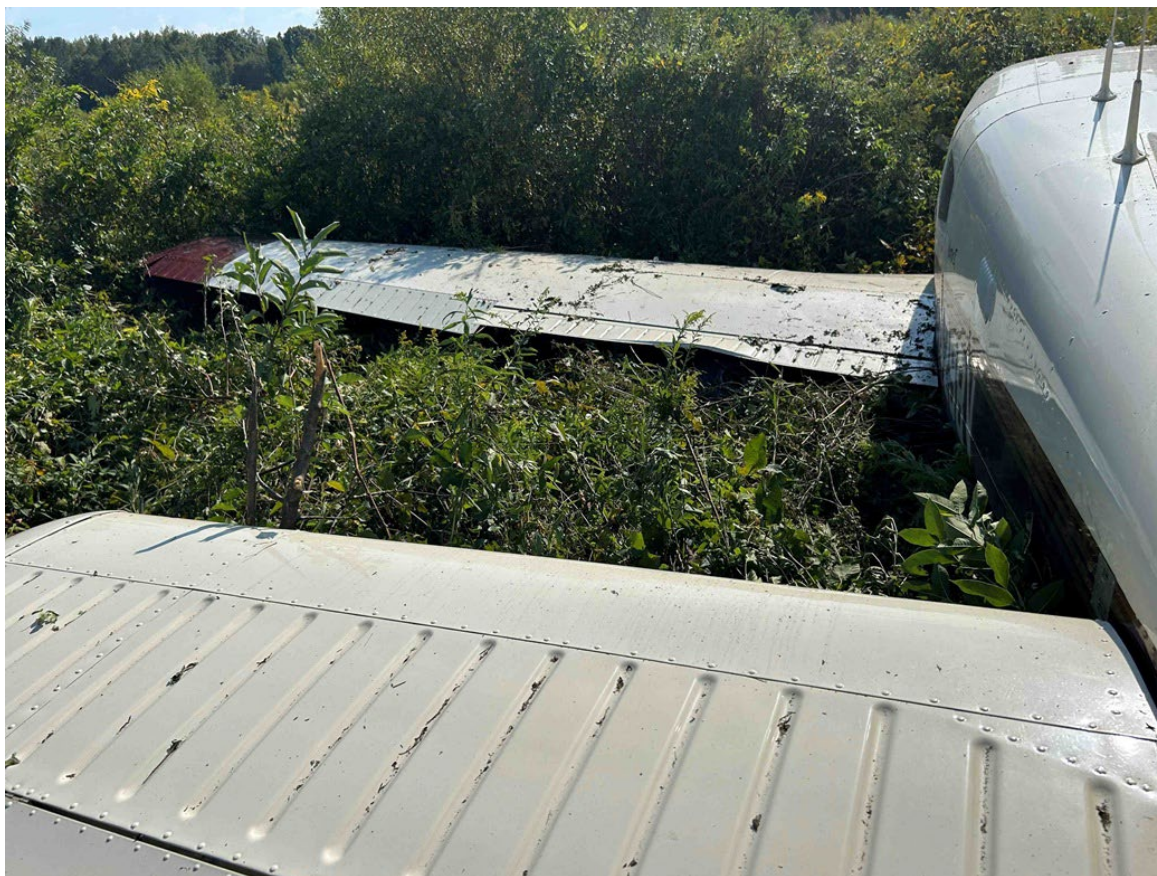
**Photograph 3 - Left Wing Damage (Courtesy of FAA)**

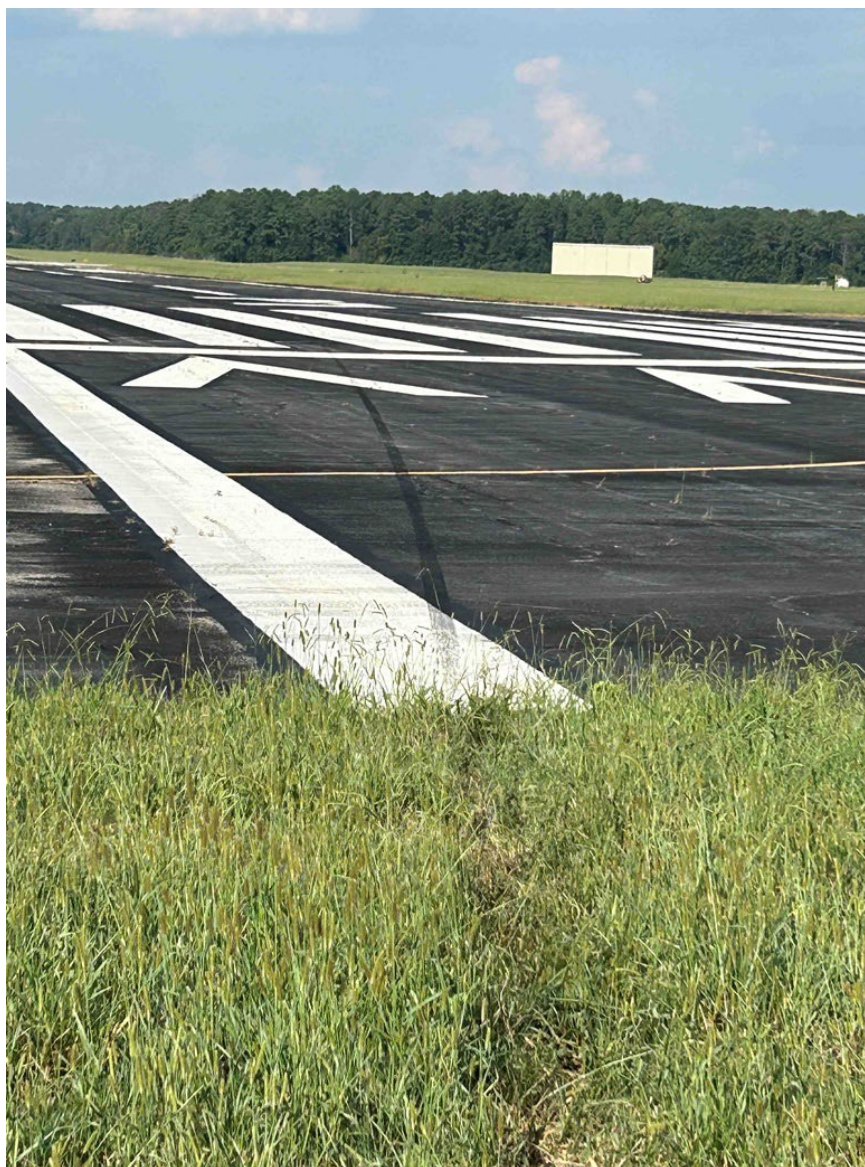
**Photograph 4 - Runway Skid Marks (Courtesy of FAA)**

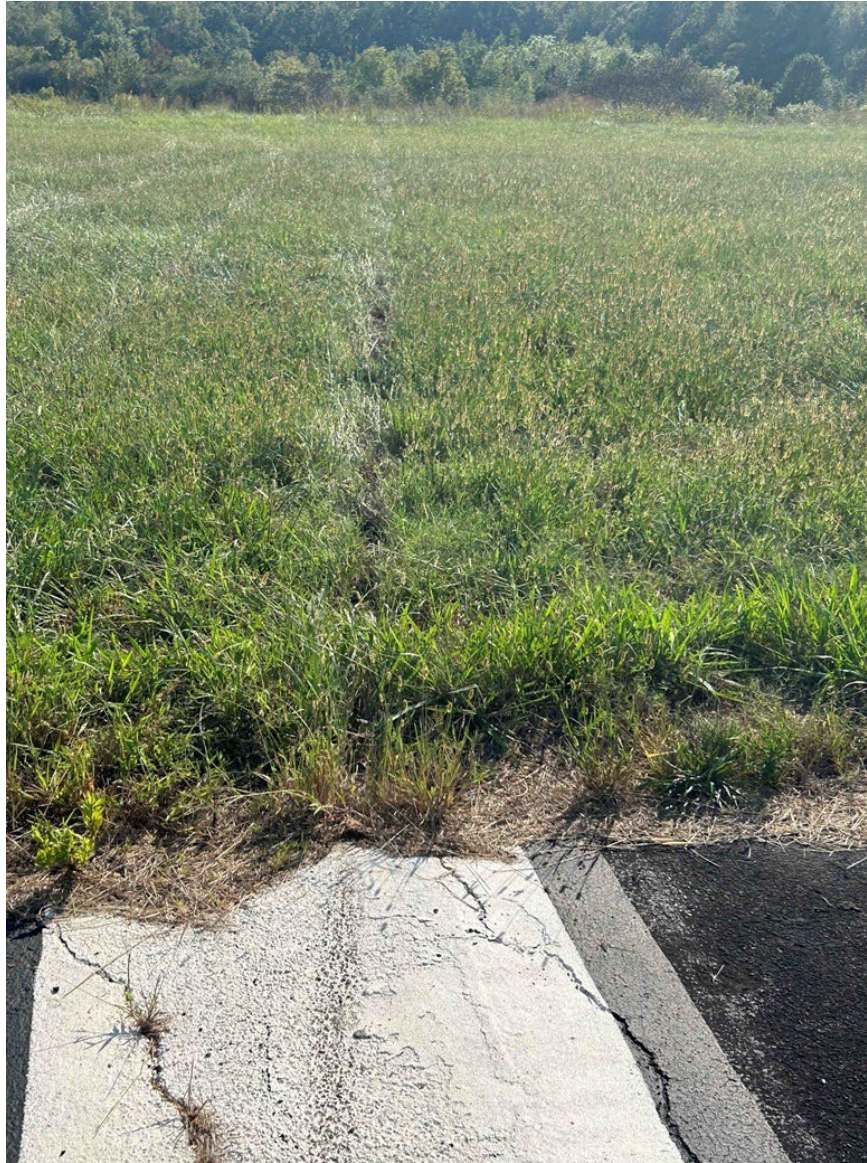
**Photograph 5 - Tire Tracks to Main Wreckage (Courtesy of FAA)**
