ERA24LA399

## INVESTIGATION PHOTOGRAPHS

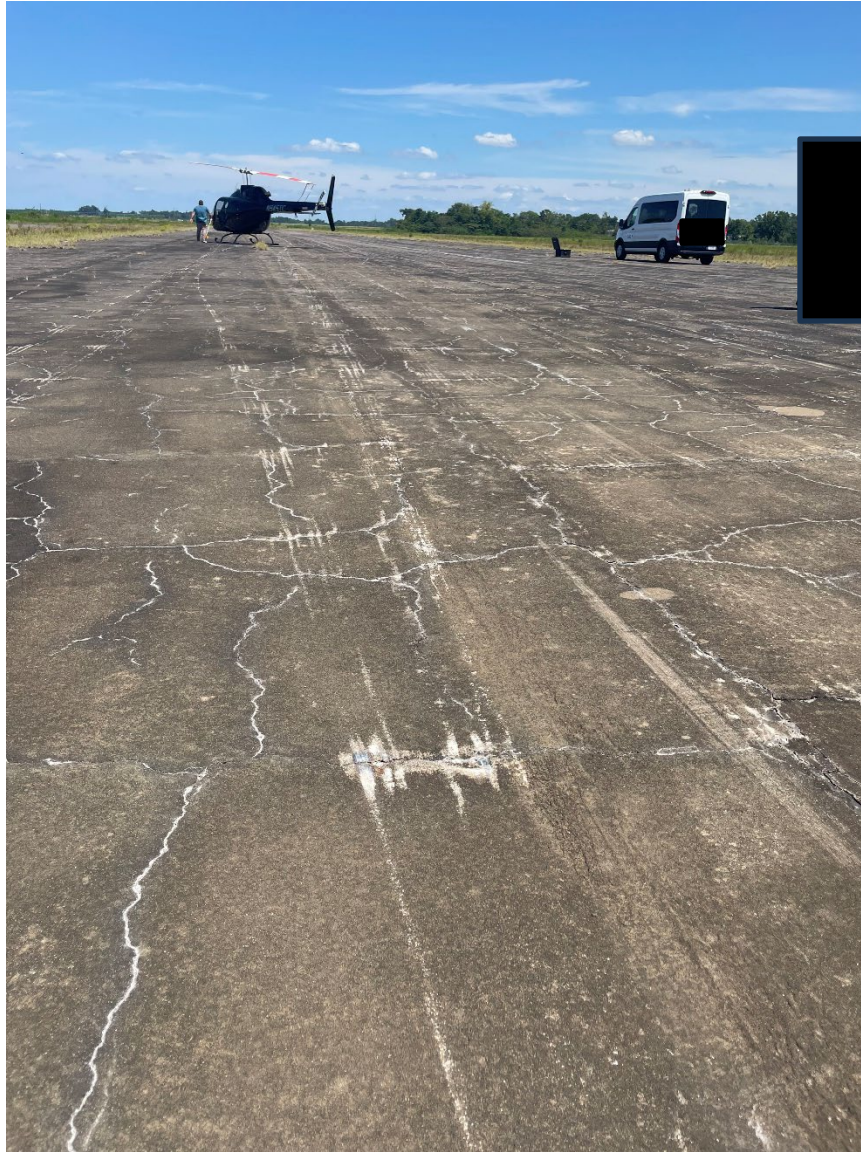
**Photograph 1 - Helicopter at accident site (Source: Operator)**

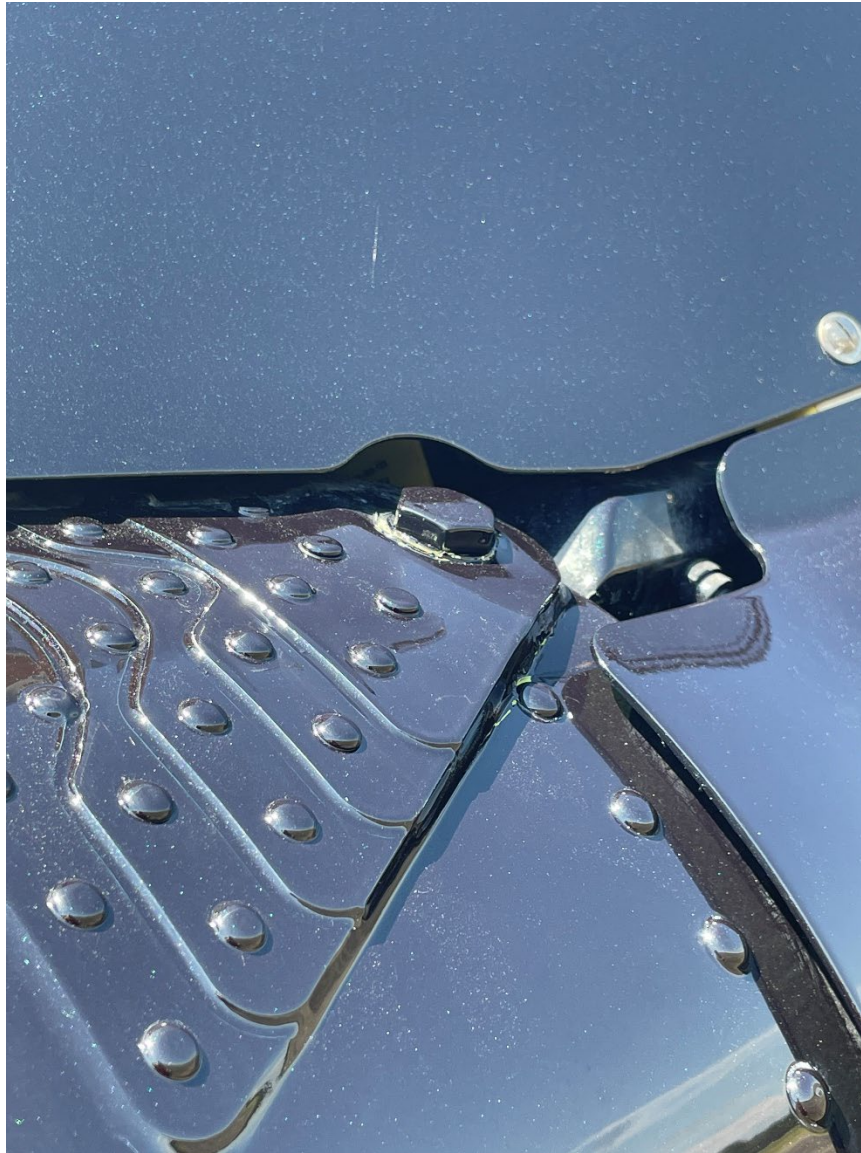
**Photograph 2 - Damage to tail cone assembly (Source: Operator)**

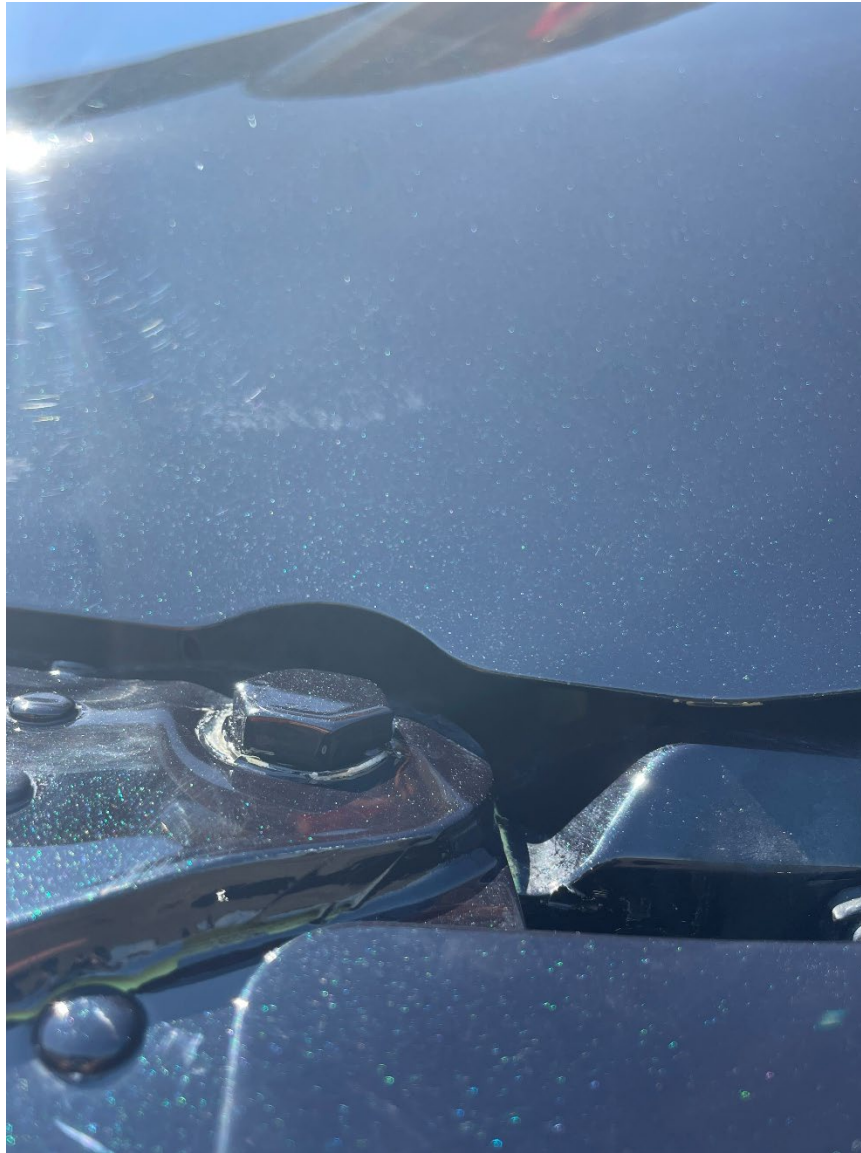
**Photograph 3 - Damage to tail cone assembly (Source: Operator)**
