## Exemplar Truss

505 S/N 65573 N945TC

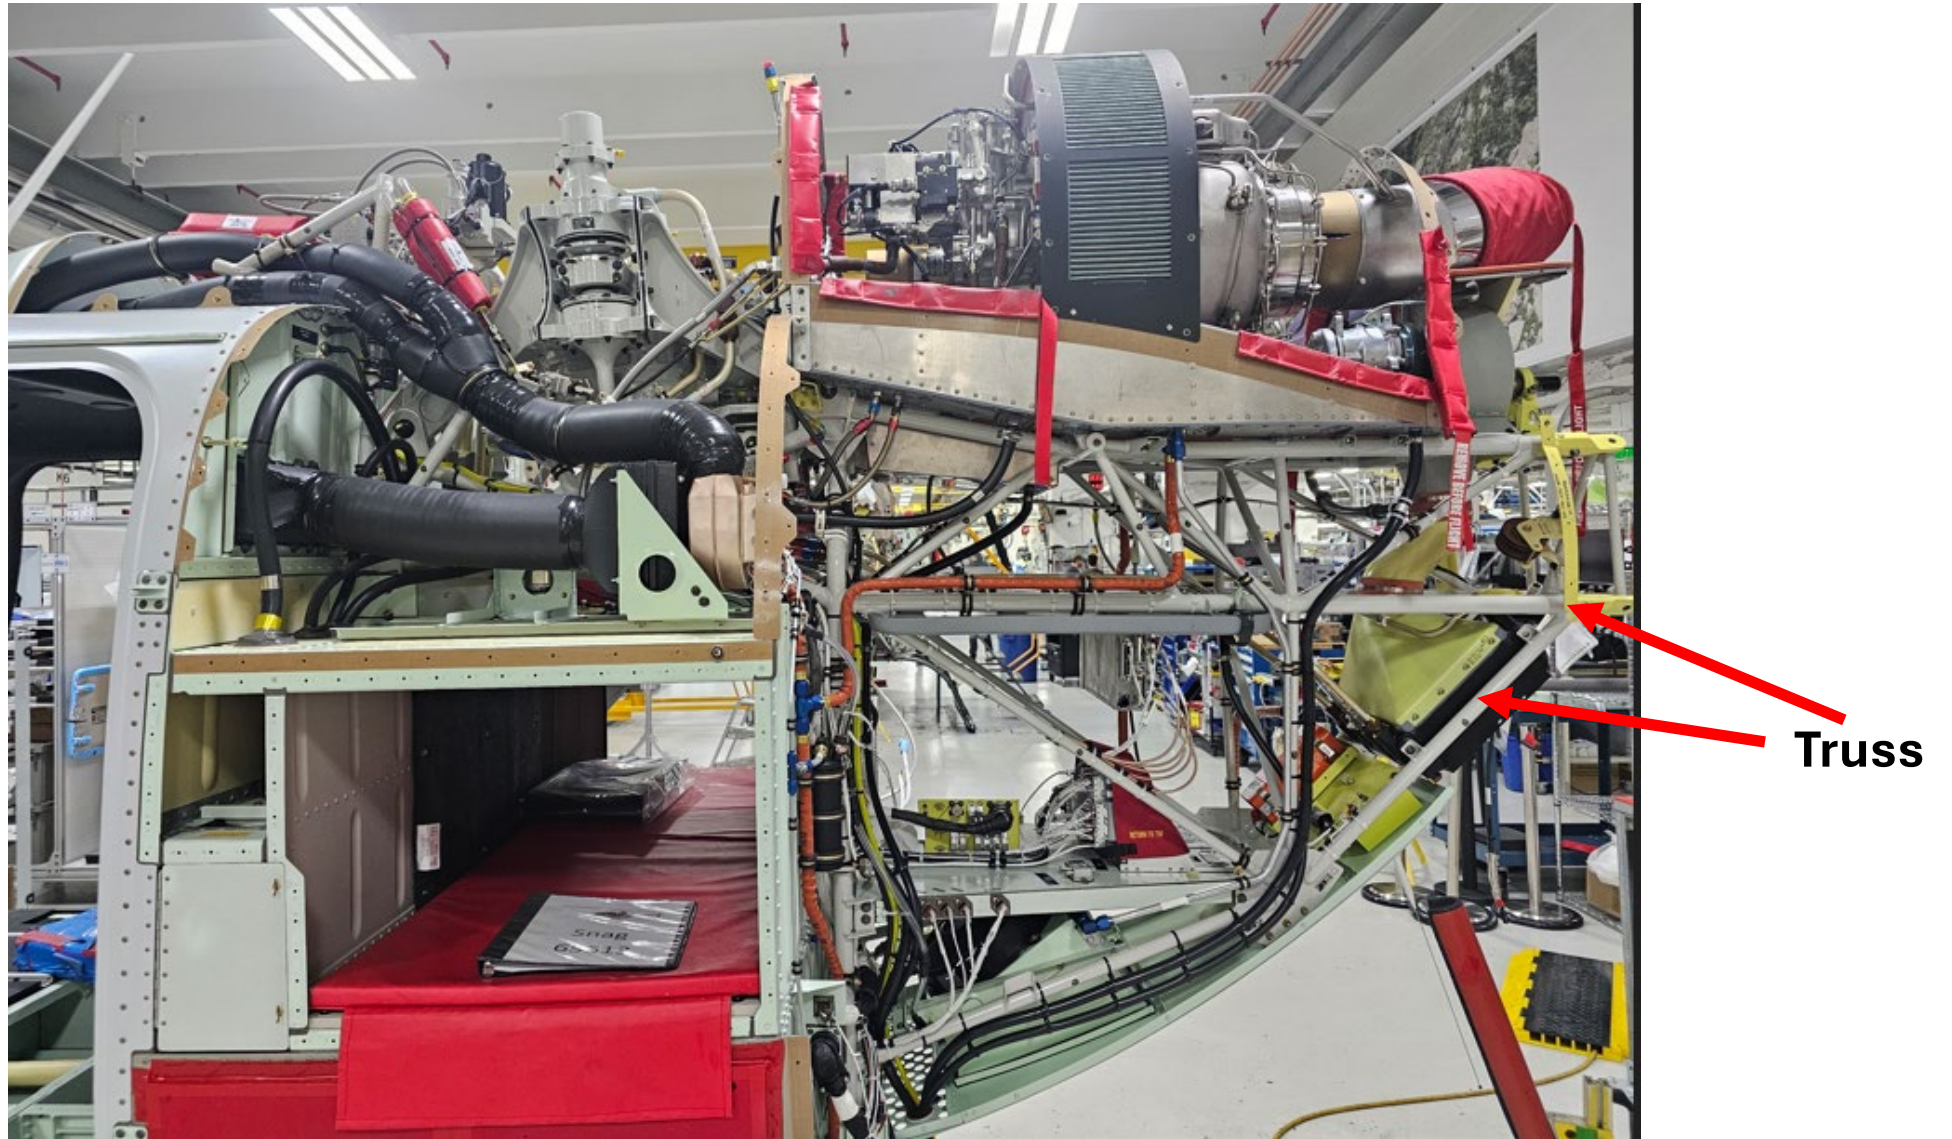
Side view showing the truss on an aircraft on the assembly line

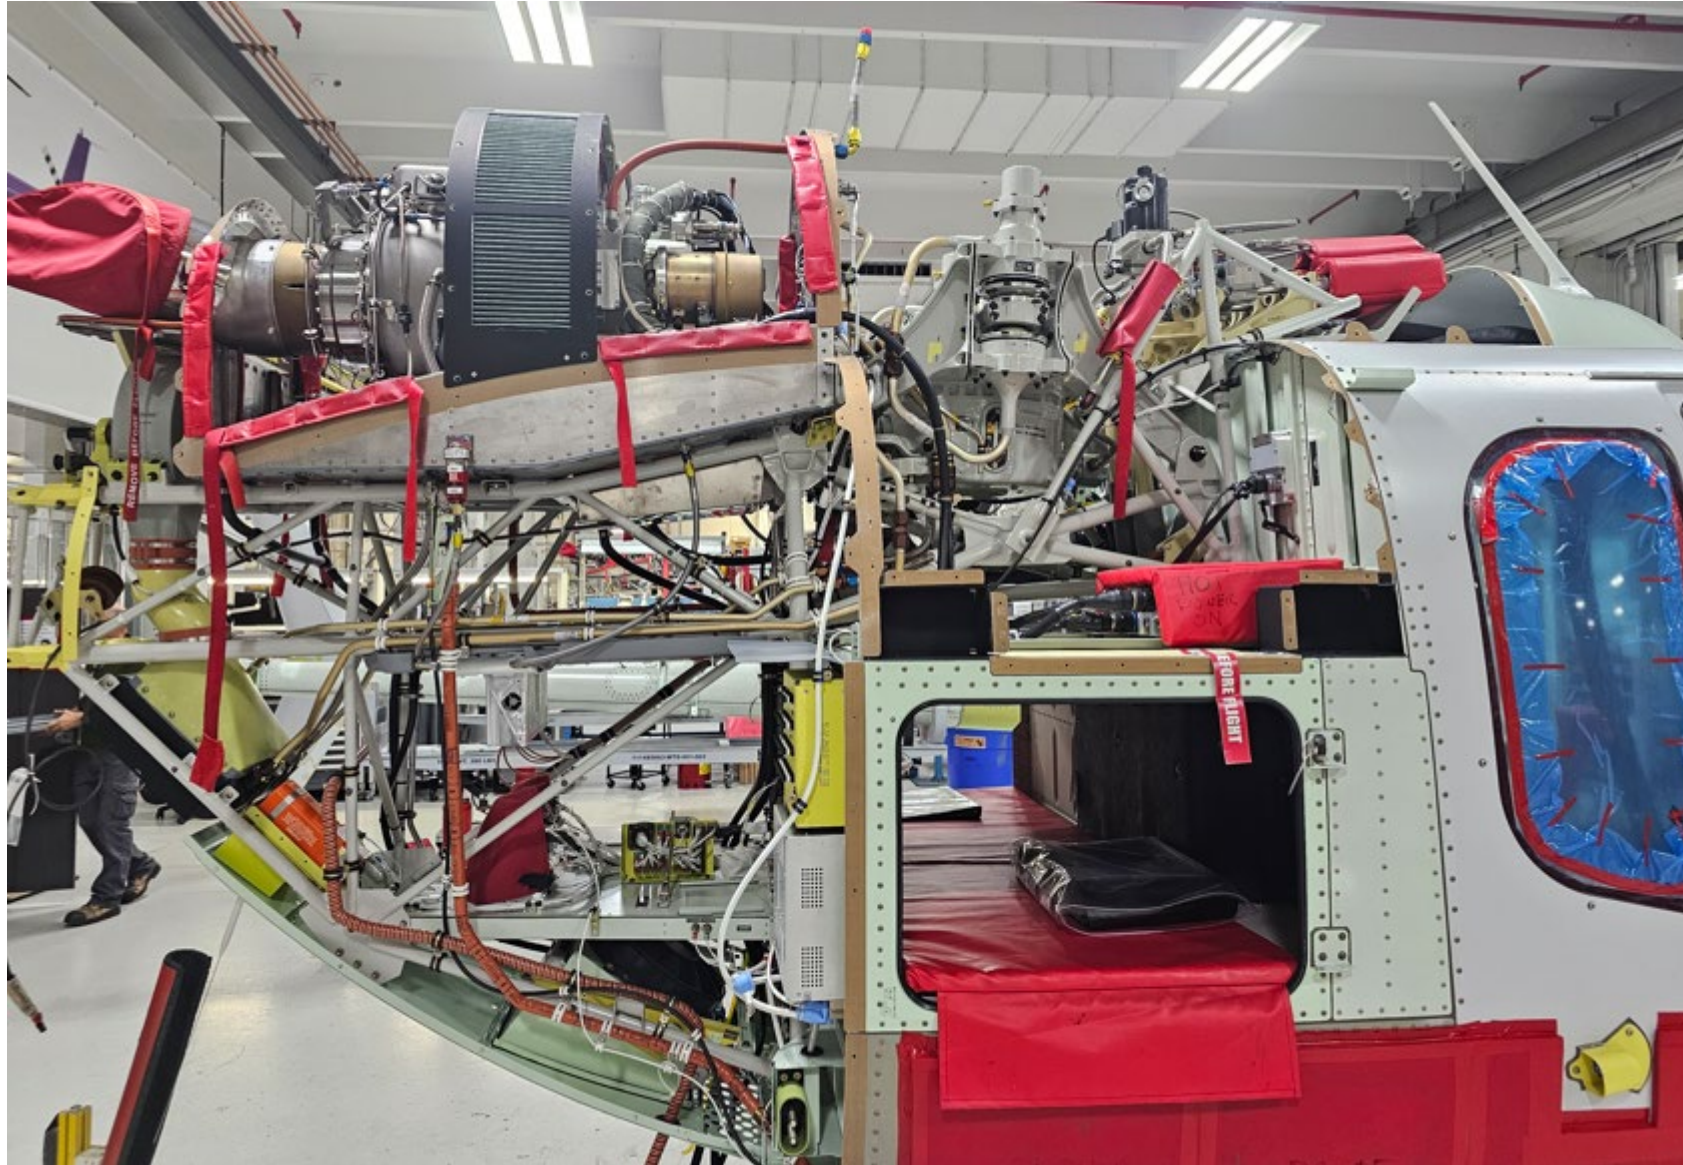
Side view pictures showing the truss on an aircraft on the assembly line

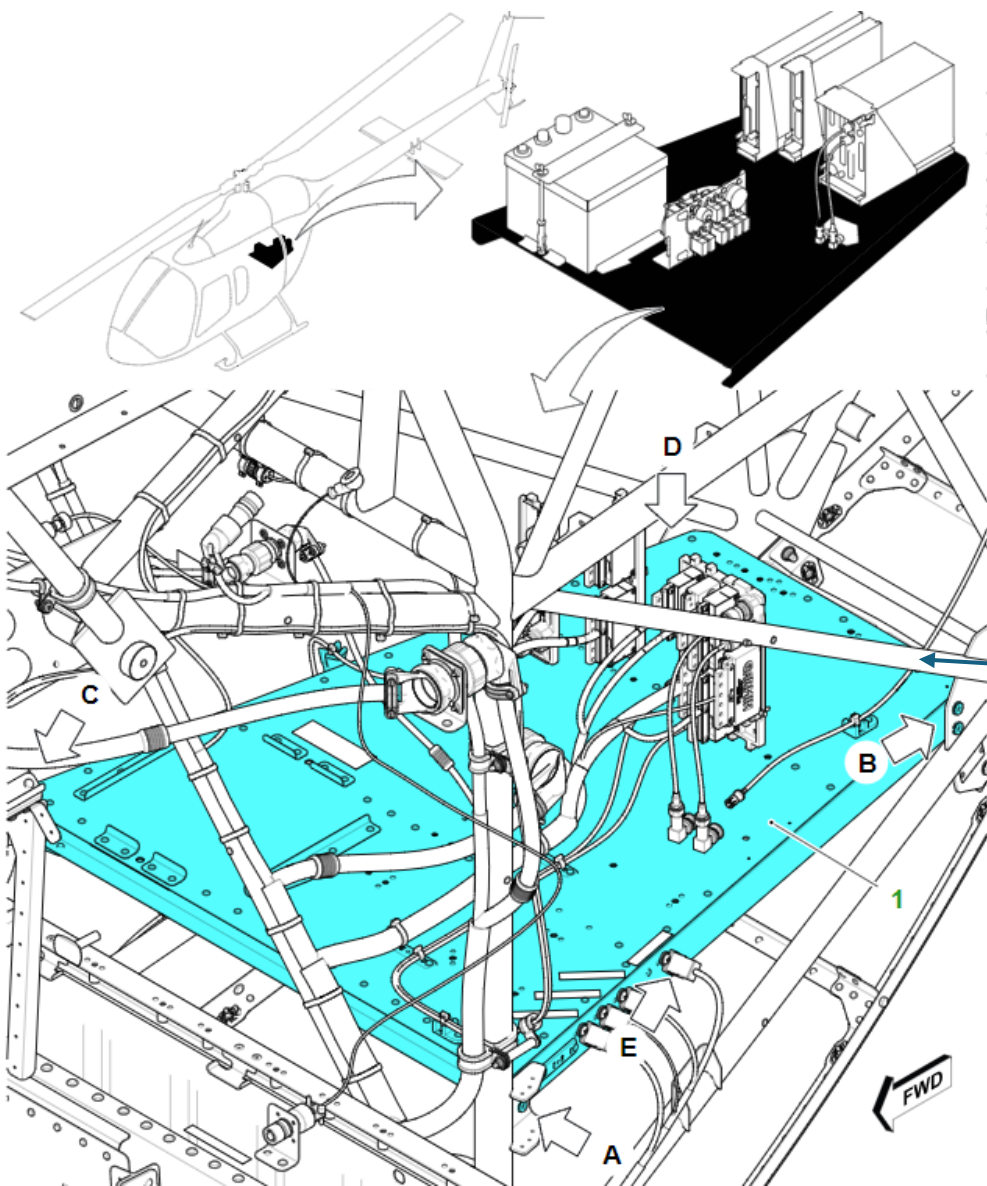
P/N SLS-030-056-015 Mechanical Truss Assembly  
S/N MJ560621

Tailboom (tailcone) is being replaced due to the deformation of the doublers at the attachment point to the truss assembly, which is not repairable

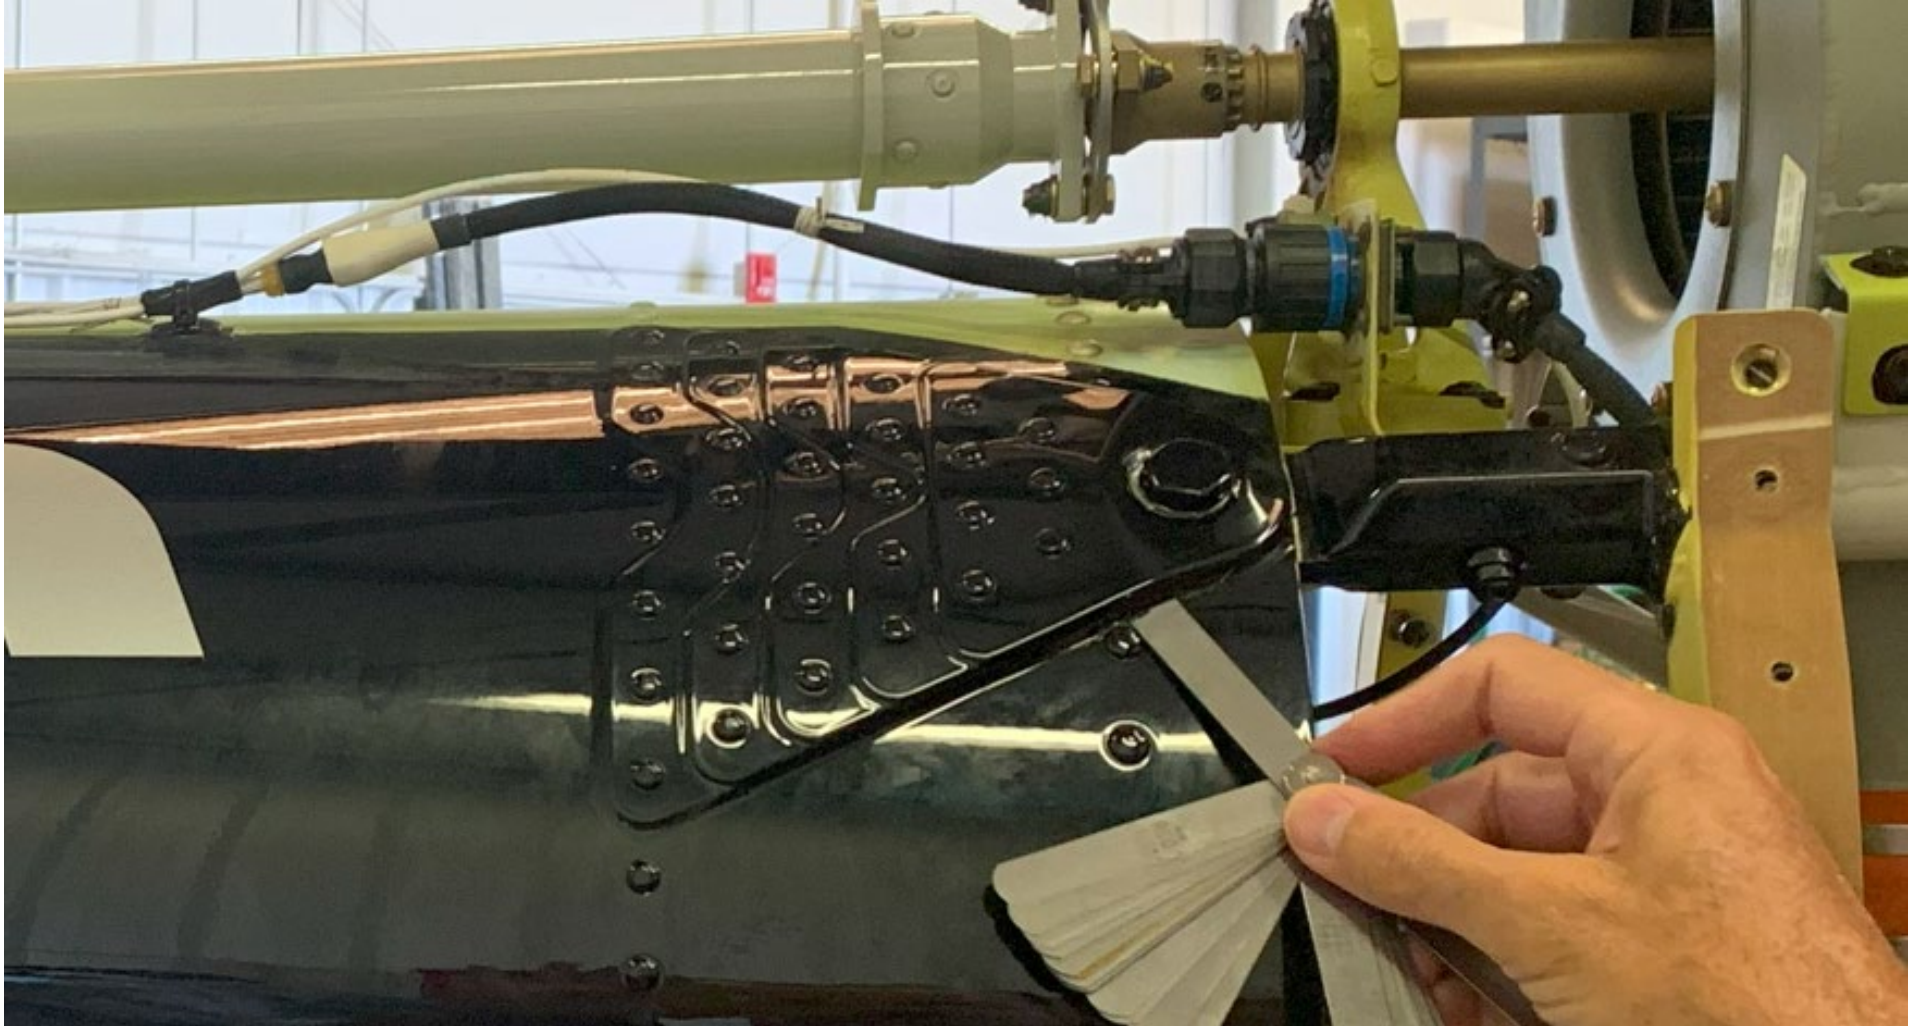
Deformation of the doublers at the attachment point to the truss assembly

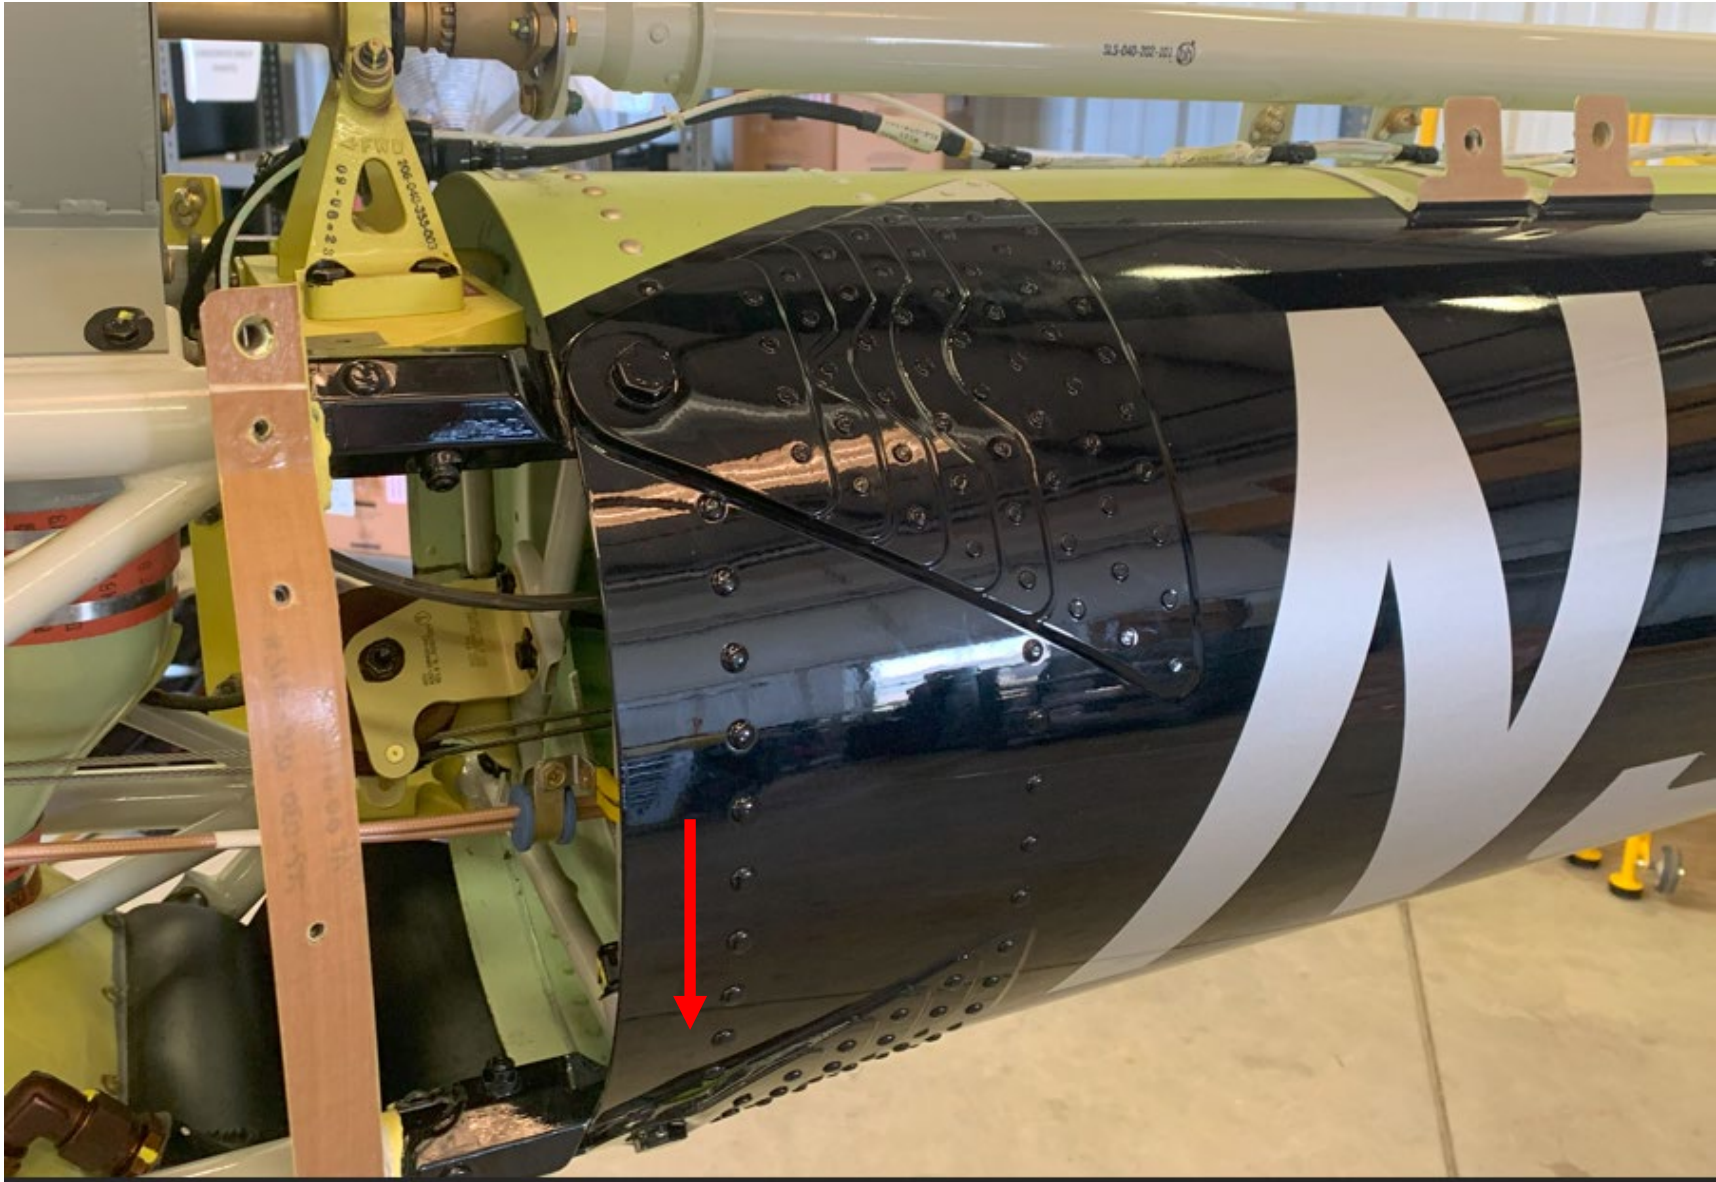
505 S/N 65573 N945TC

## Deformation of the doublers at the attachment point to the truss assembly
