# National Transportation Safety Board

ERA25FA020

## **WRECKAGE EXAMINATION**

Location: Cross City, FL  
Date: October 20, 2024  
Time: 1600 EDT  
2000 UTC  
Airplane: N510G; Lancair 360

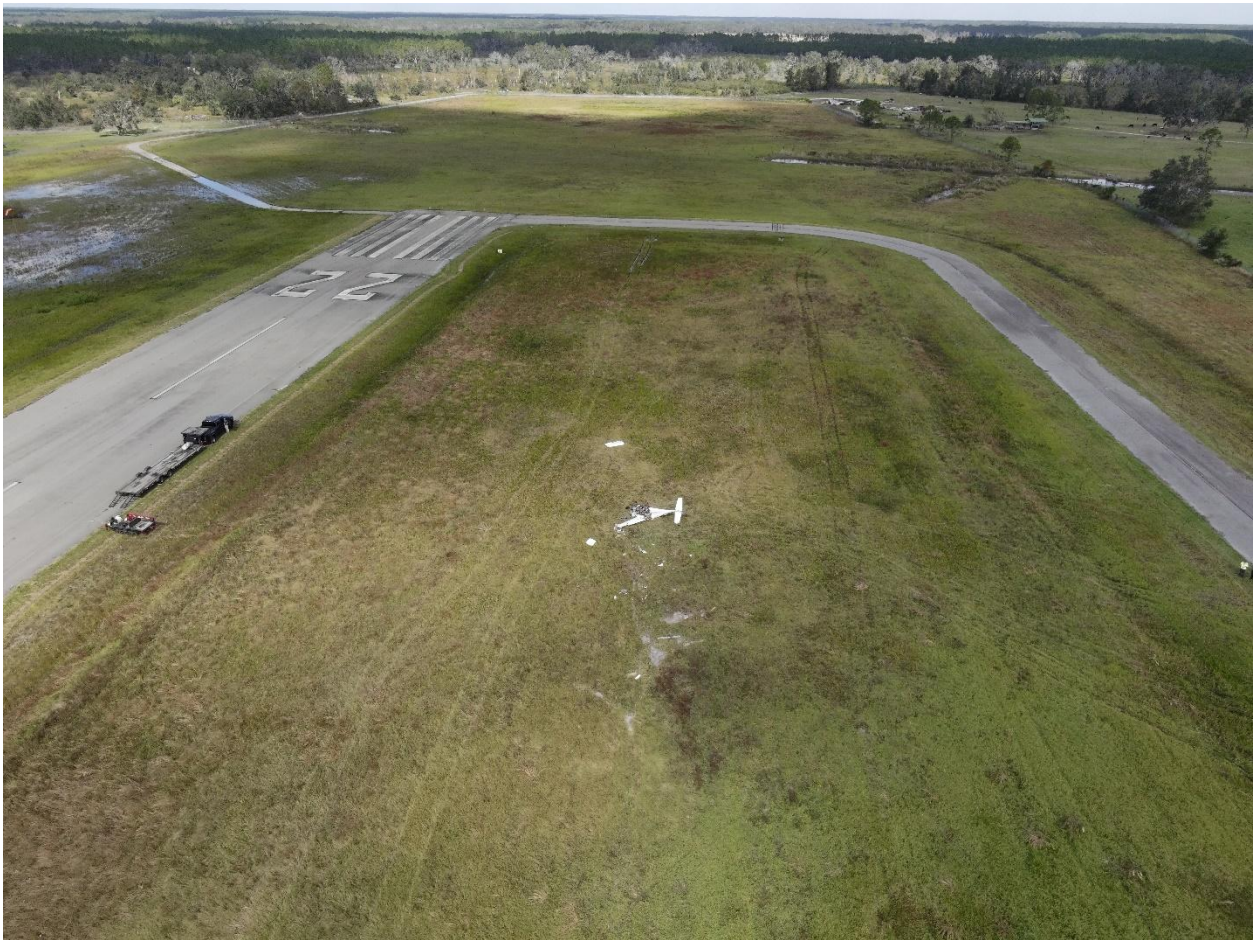
The airplane came to rest on the airport about 4,500 ft from the runway 4 threshold, about 210 ft right of the runway 4 centerline, and in between runway 04 and taxiway B. The main wreckage was oriented on a magnetic heading of 340. The debris path was about 160 ft in length and was oriented on a magnetic heading of 048. All major components were discovered in the debris path. The initial ground impact scar was about 100 ft from the main wreckage site and green lens glass was observed in the scar. Two pieces of right wing skin including the pitot tube were

**Photo 1: Overhead view of the accident site.**

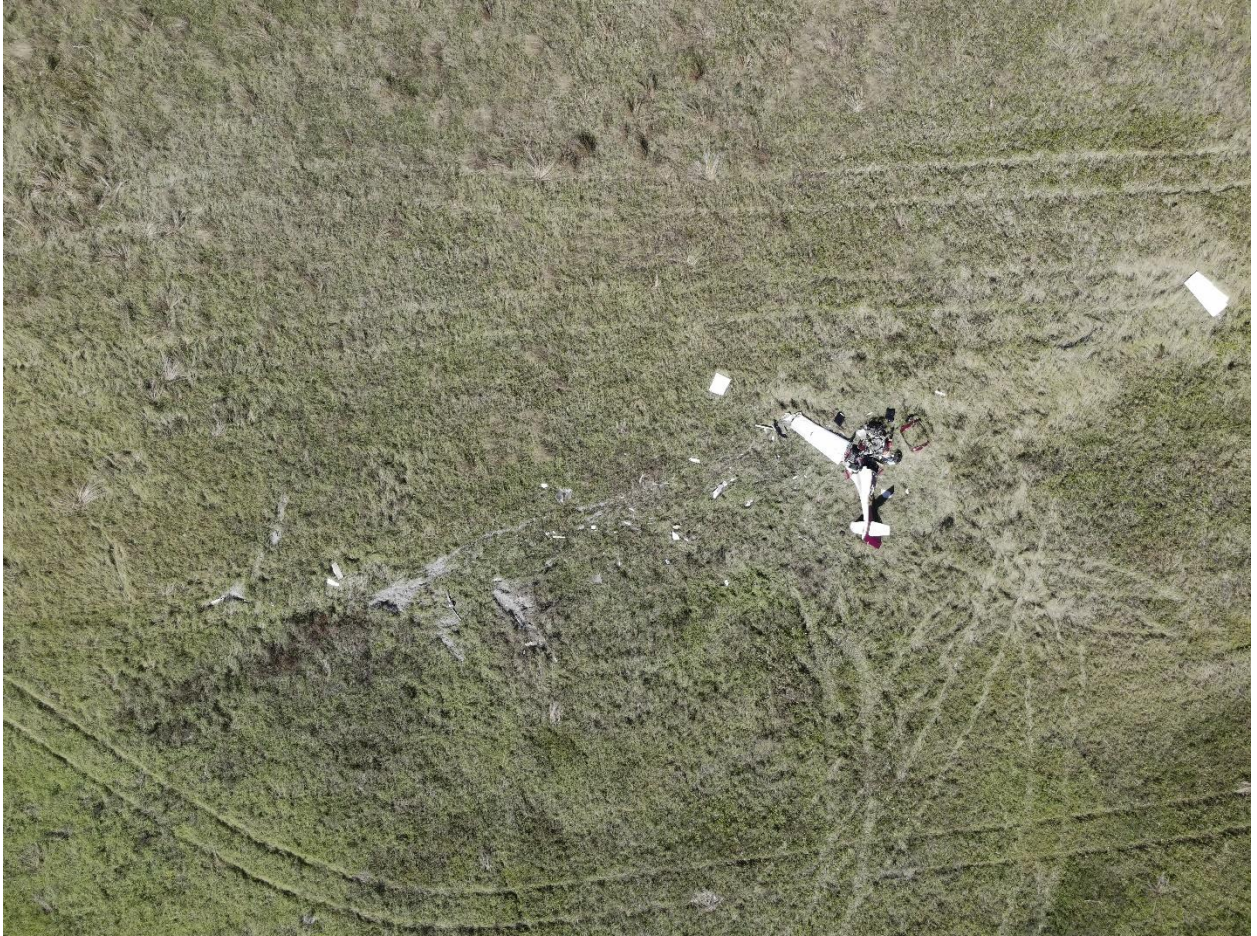
found about 15 ft from the initial impact scar along the debris path. A large crater was observed about 25 ft from the main impact scar along the debris path. The propeller was observed about 8 ft past the large crater. An impact scar which contained pieces of a wingtip was observed about 45 ft past the initial impact scar along the debris path. The main wreckage came to rest about 100 ft from the initial impact scar. The outboard section of the right wing was observed about 60 ft past the main wreckage and was the last piece of debris observed.

**Photo 2: Overhead view of the accident site.**

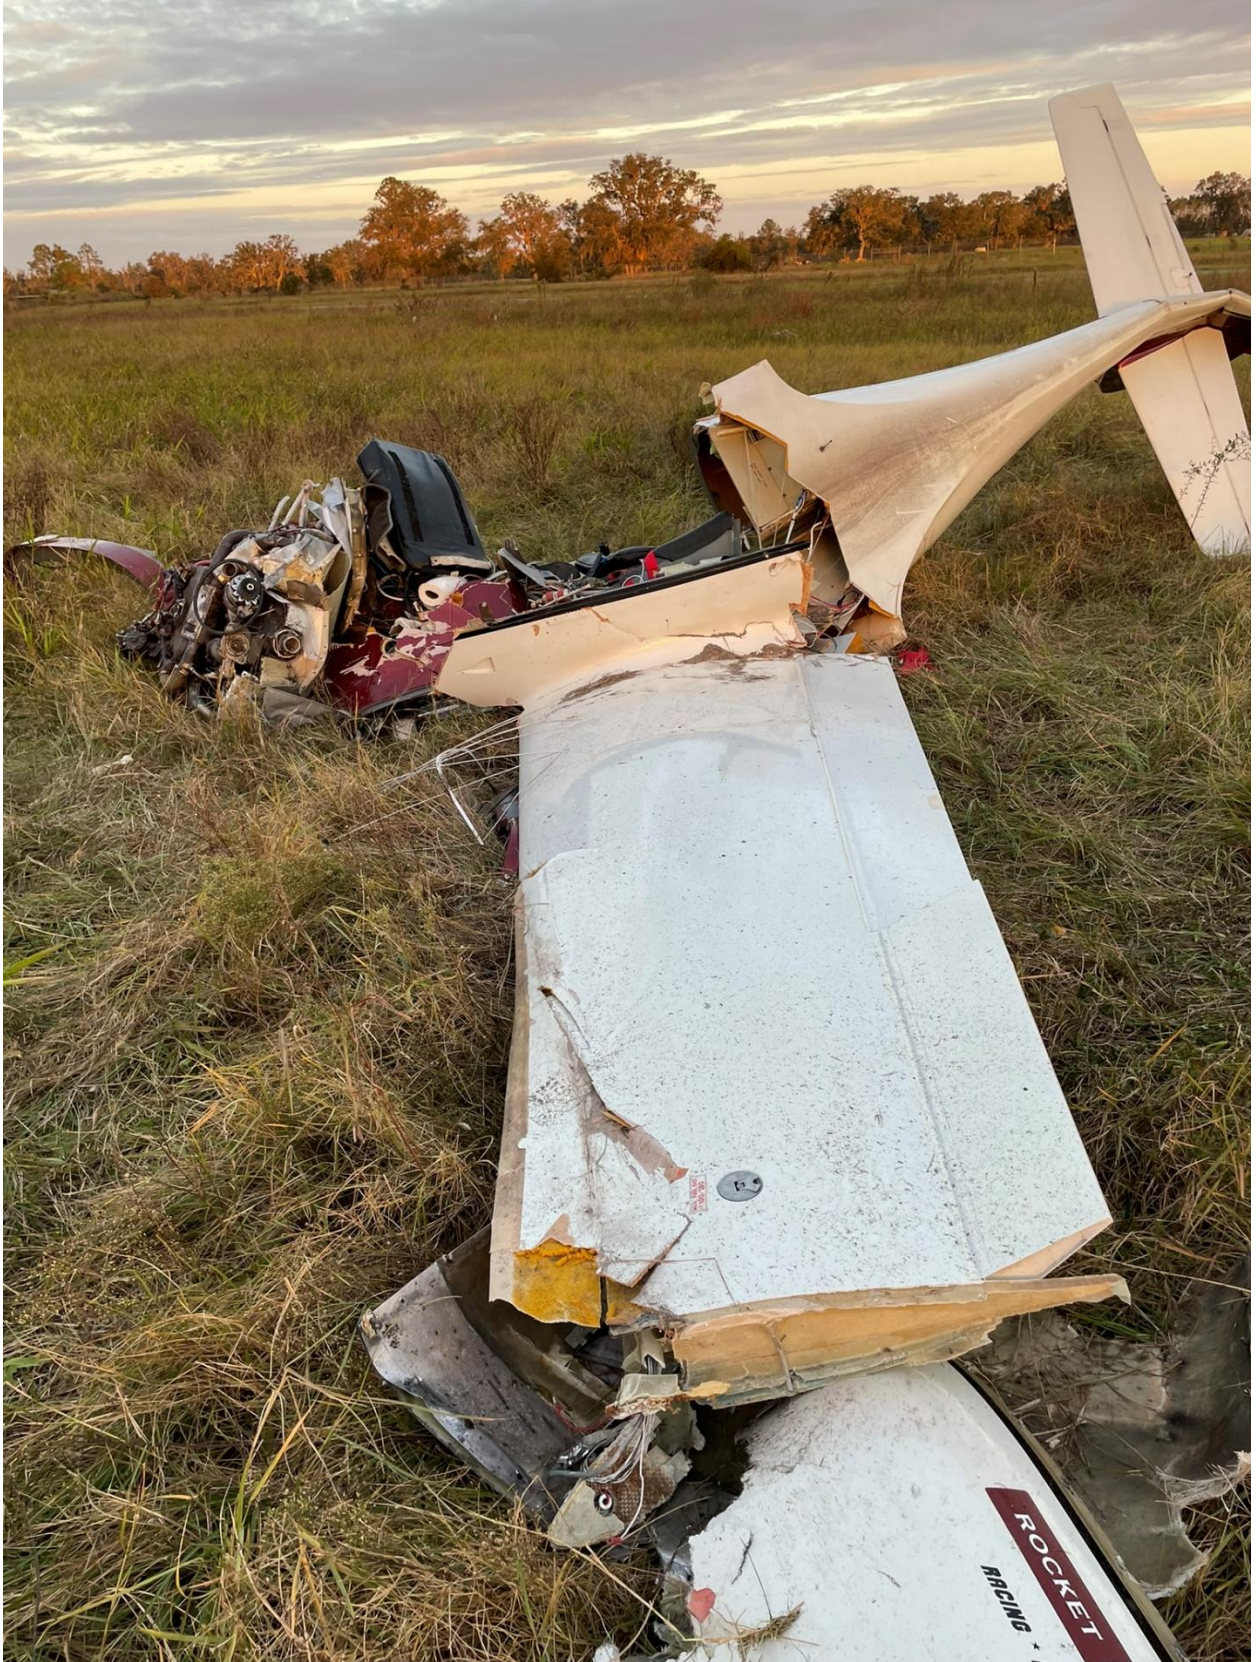
The fuselage exhibited extreme impact damage and twisting. The canopy was impact separated. The floor was partially impact separated just forward of the main wing spar and remained attached via control cables and wires. The aft fuselage was twisted right and remained attached via wires and cables.

**Photo 3: View of the fuselage.**

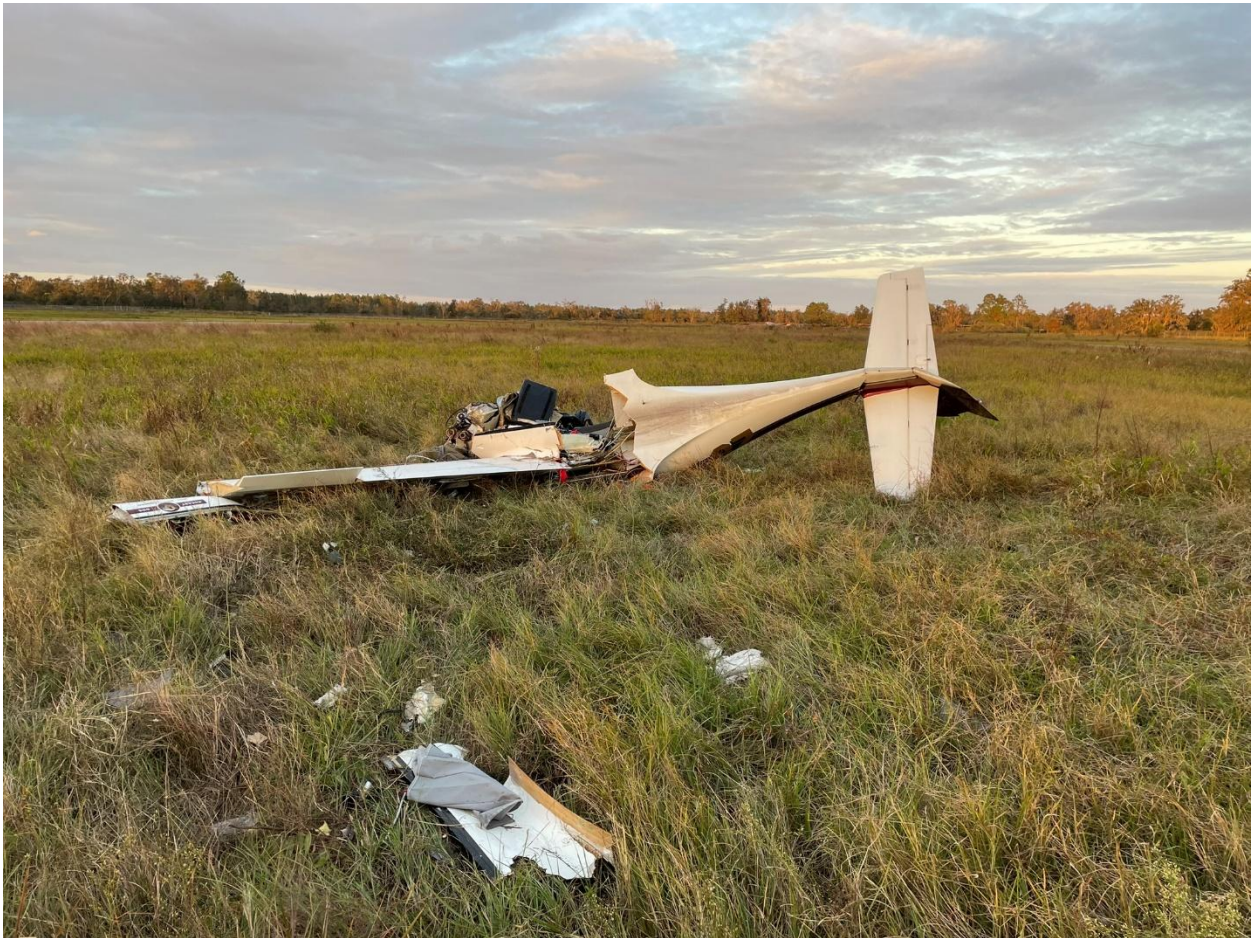
The empennage remained attached to the fuselage, was twisted to the right, and exhibited a crack in the composite structure just forward of the horizontal stabilizer. The horizontal stabilizer and elevator were undamaged. The elevator and elevator trim tabs remained attached at all attachment points and the elevator was continuous from the control surface to the flight control stick through an impact fracture. The vertical stabilizer and rudder were undamaged. The rudder remained attached at all attachment points and was continuous from the flight control surface to the flight controls in the cockpit through a cut made by first responders to extract the pilot.

**Photo 4: View of the empennage in situ at the accident site.**

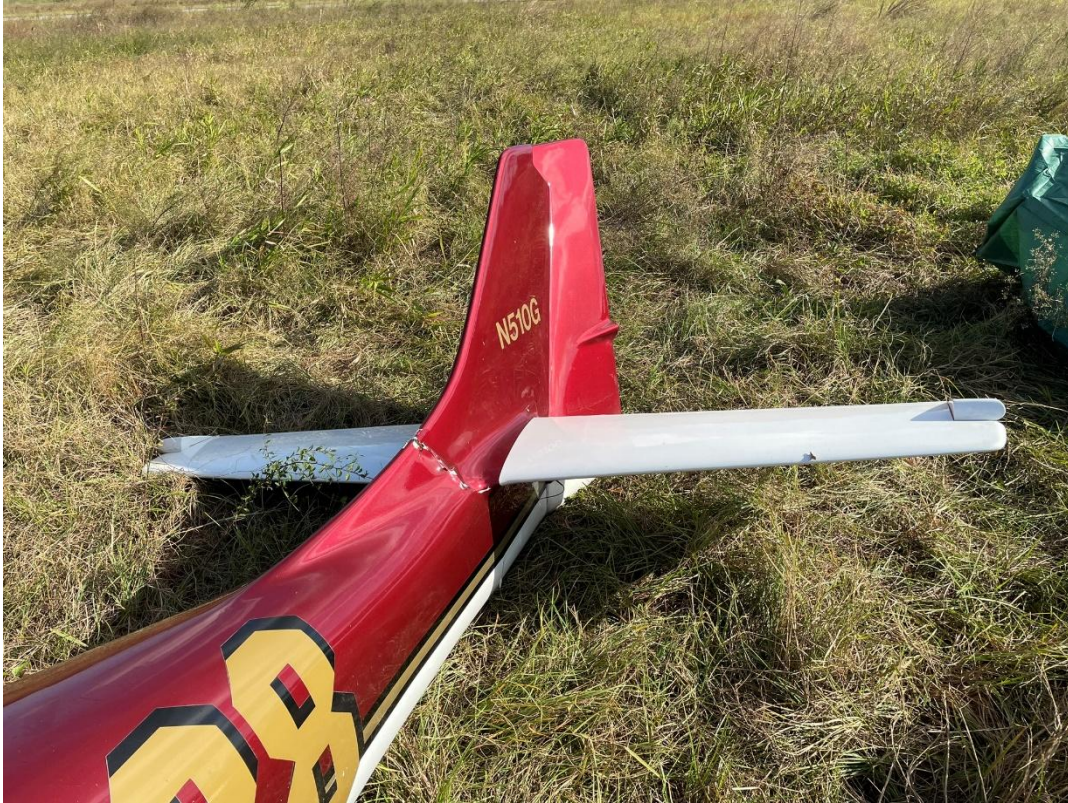
**Photo 5: View of the empennage.**

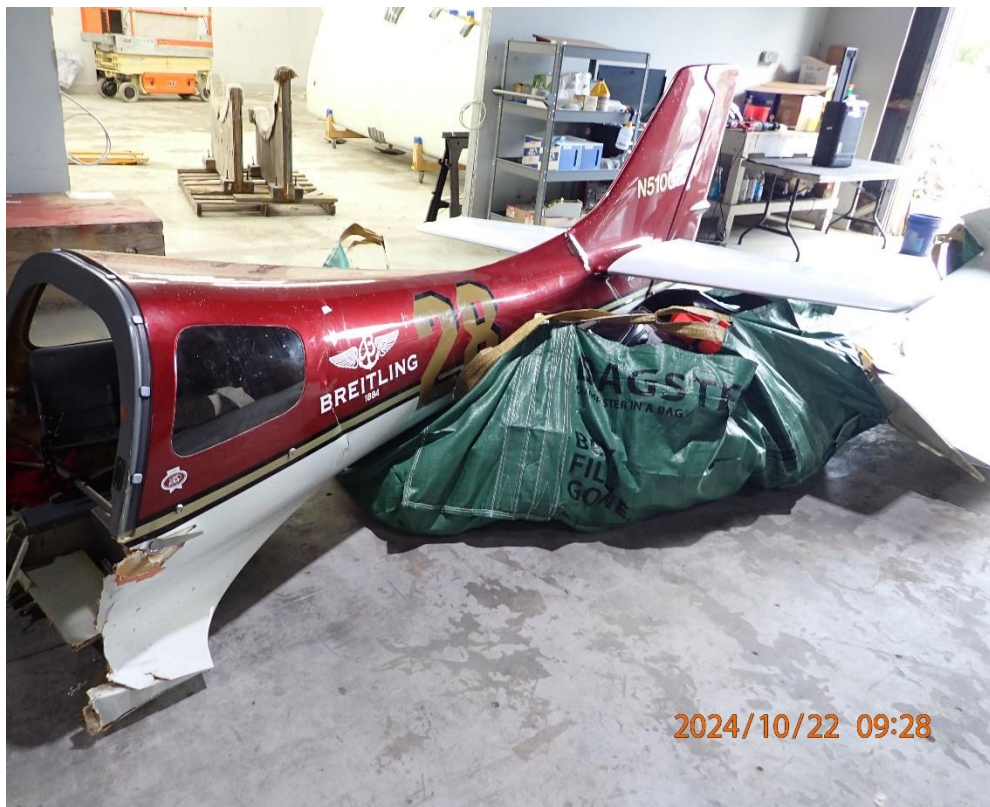
**Photo 6: View of the empennage at the recovery facility.**

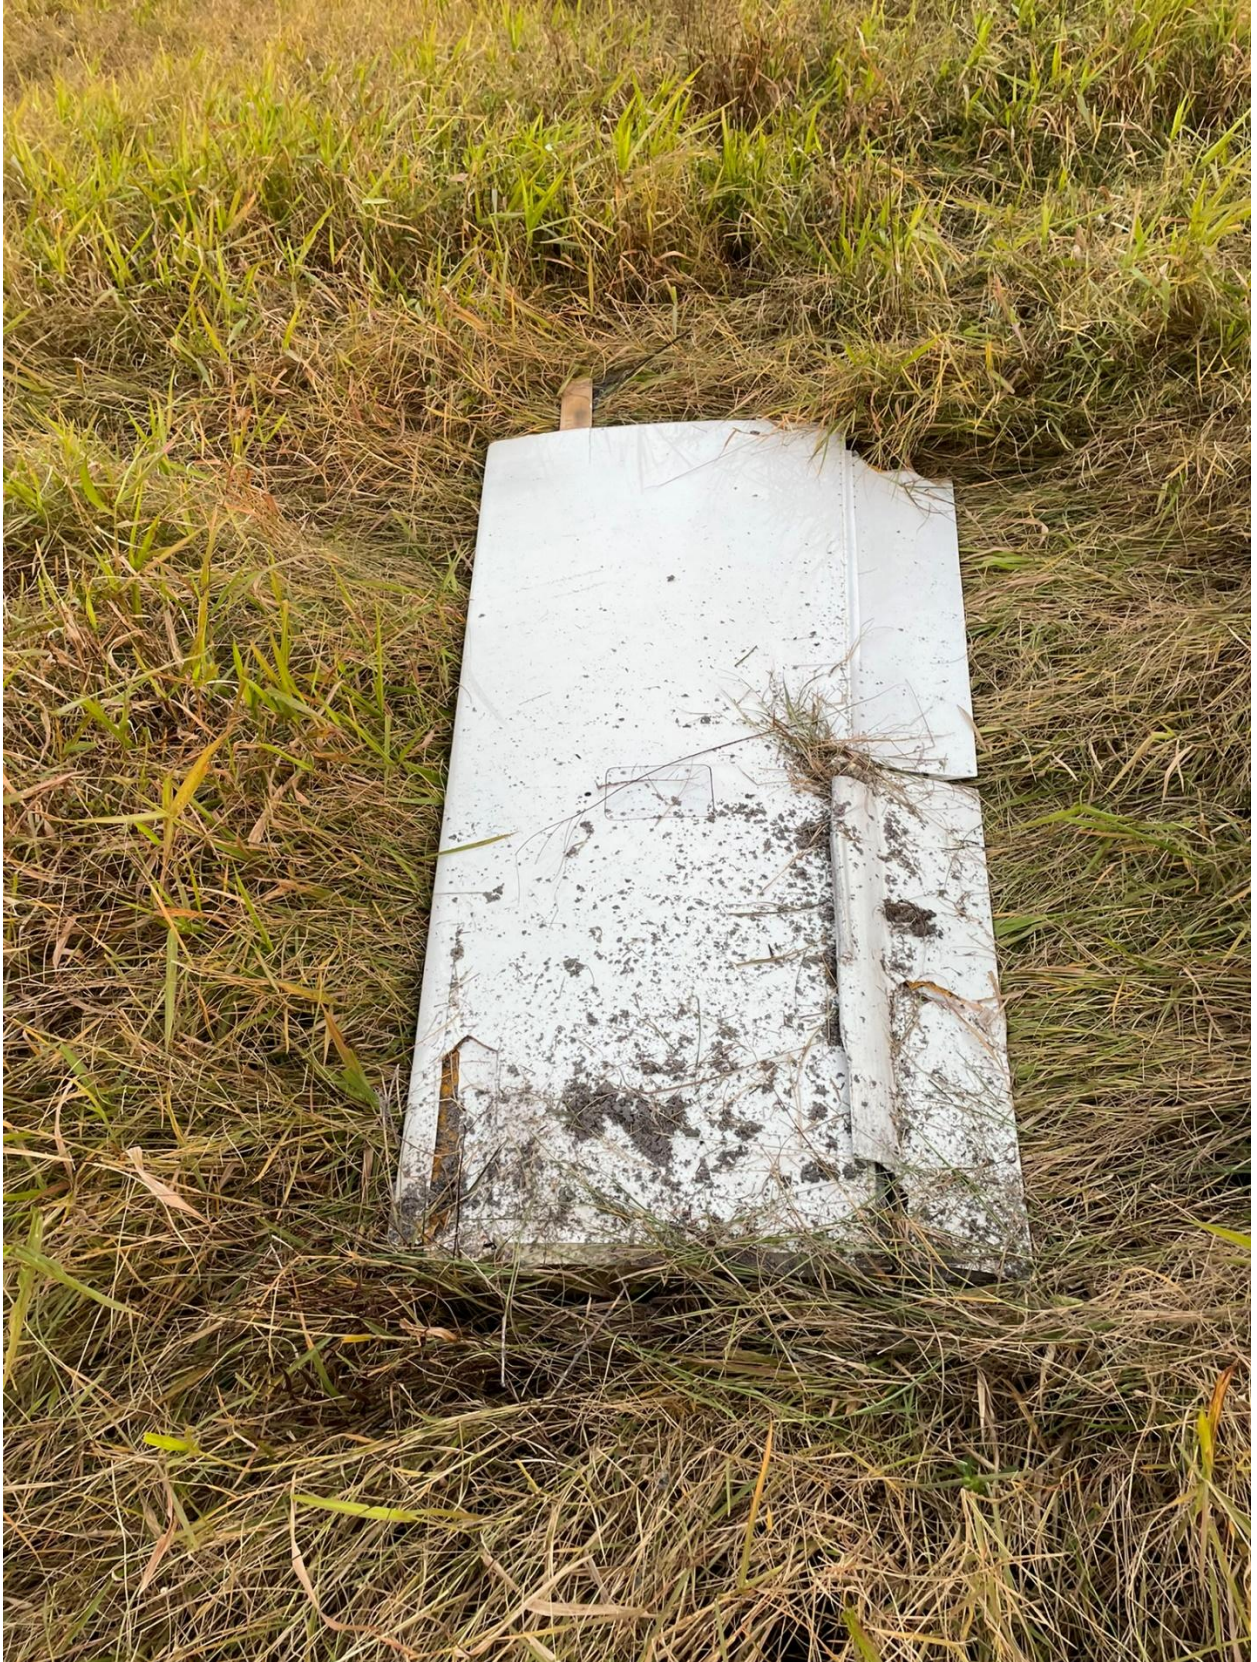
The right wing was impact separated from the fuselage and in multiple pieces. The outboard section of the wing containing the aileron and about 1/2 of the flap was in one piece. The wing tip was destroyed with lens glass from the right wing tip and a wing navigation light assembly were found in the initial impact scar. The lower right wing skin containing the pitot tube was found near the large impact crater. A portion of the wing spar between the fuselage spar box and outboard section of the wing spar was found in the debris path. The aileron remained attached to the wing. The aileron flight control surface was impact separated from the aileron control horn and the torque tube was impact separated. A small portion of the aileron control tube remained attached to the flight control stick in the cockpit and was impact separated at the wing root. The right flap control tube was impact separated just outside of the fuselage.

**Photo 7: Outboard portion of the right wing in situ at the accident site.**

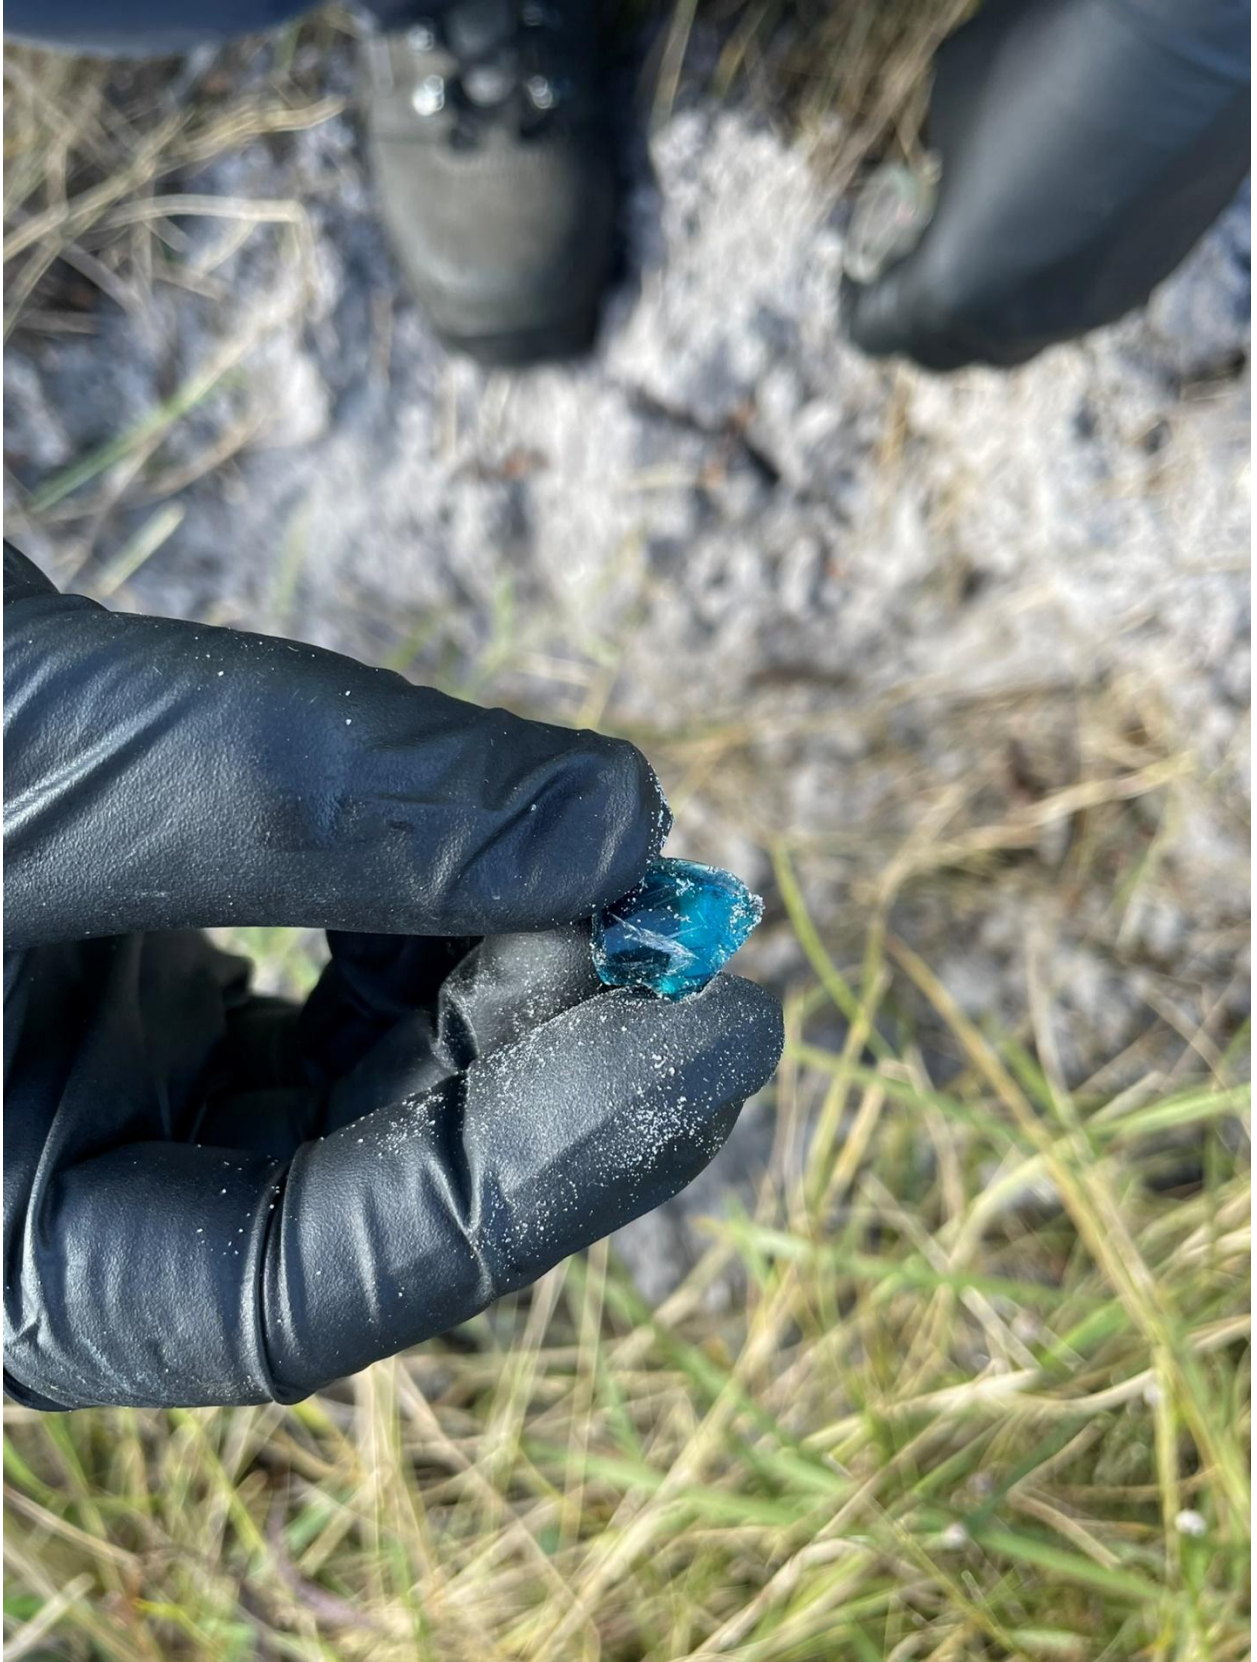
**Photo 8: Lens glass found in the initial ground impact scar.**

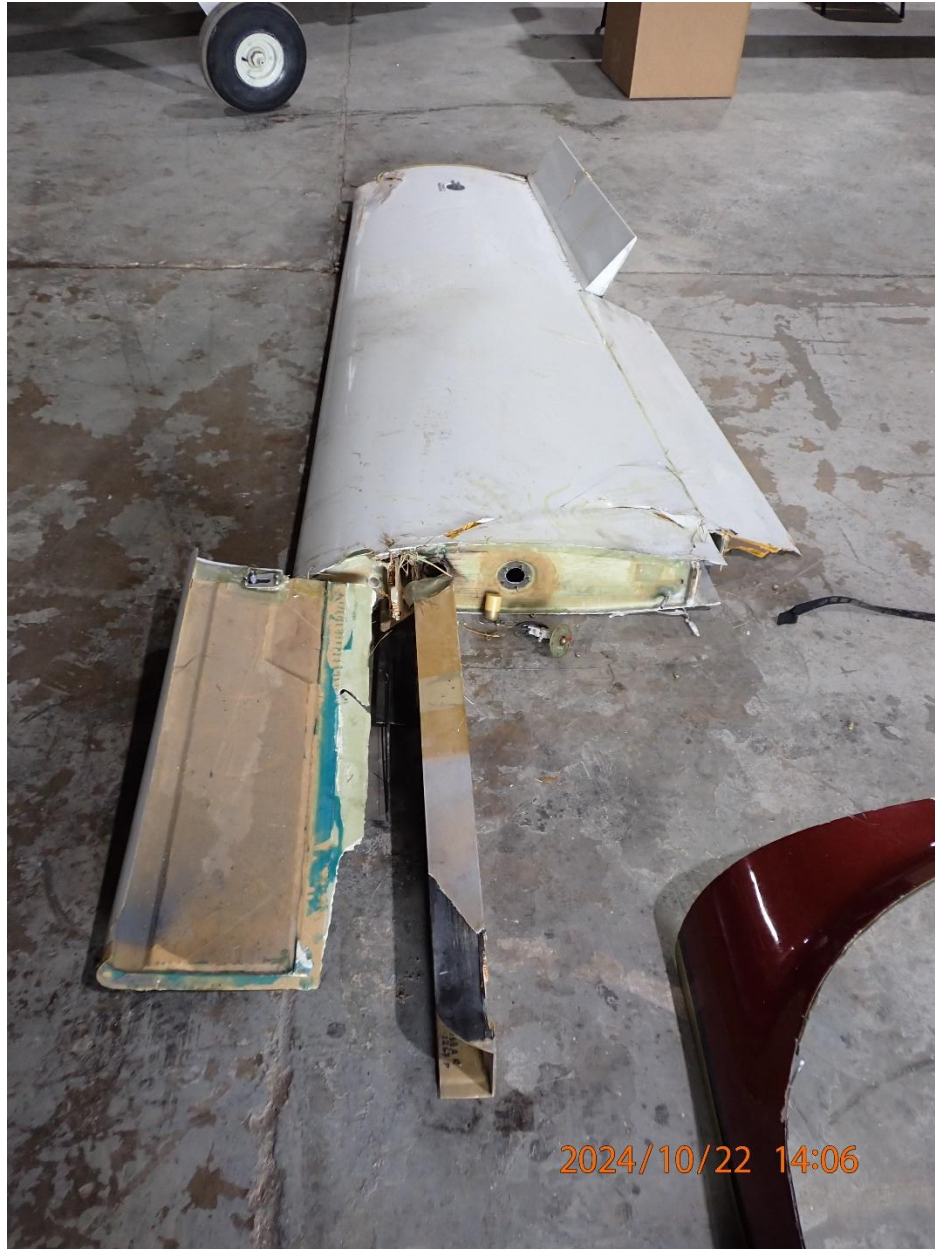
**Photo 9: Identifiable portions of the right wing laid out at the recovery facility.**

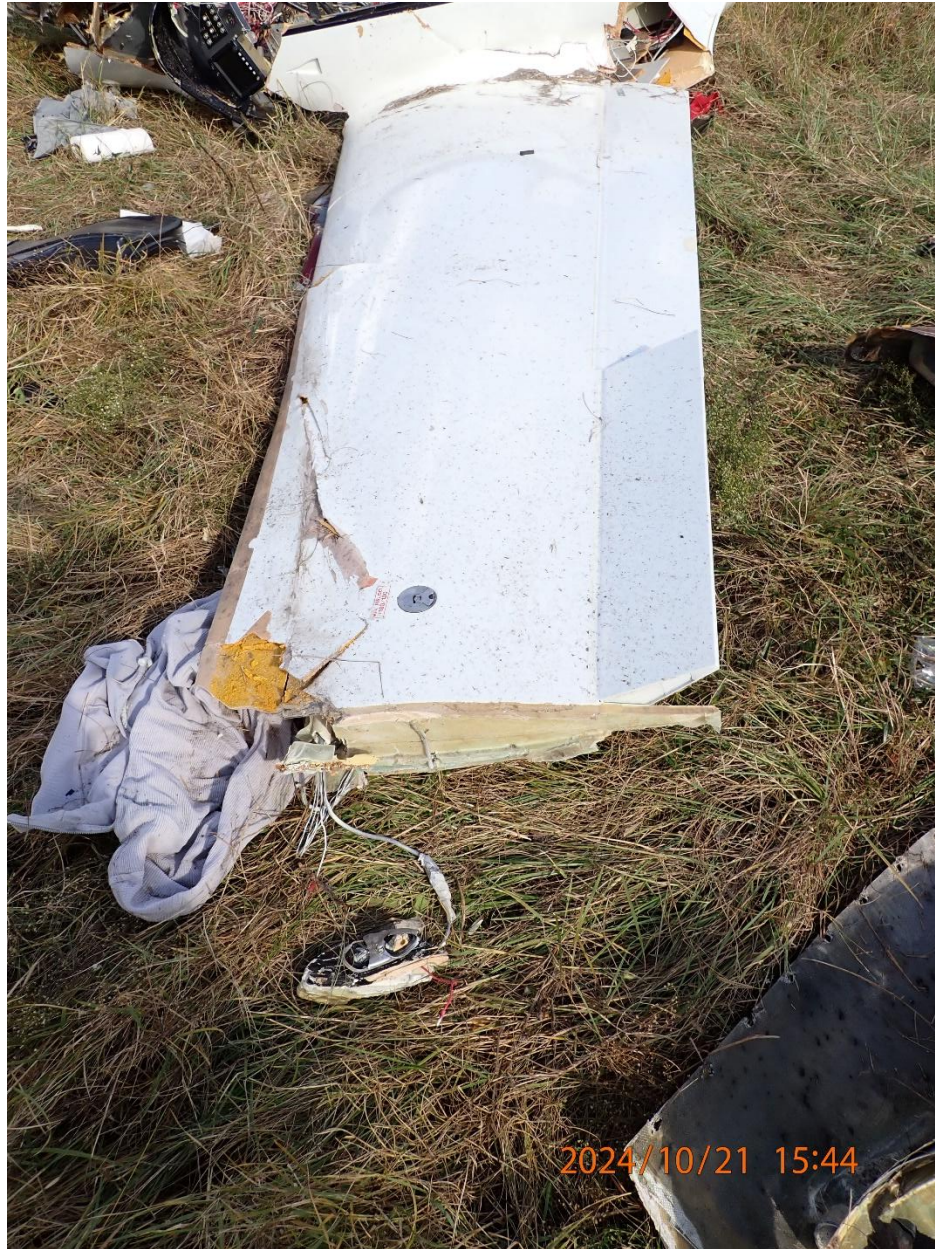
The left wing remained attached to the fuselage at all attachment points. The left wing tip exhibited impact damage, and the left wing navigation light assembly remained attached to the wing. The left aileron and flap remained attached to the wing at all attachment points. Control continuity was confirmed from the left aileron control surface to the controls in the cockpit. Continuity of the left flap was confirmed from the flap to the flap drive motor in the fuselage. The flap motor was fully retracted which according to the schematics for the kit would be a flap "neutral" or "in trail" condition. When the flap motor was removed and the actuator bellcrank was moved by hand the left flap operated as expected and the right flap control rod moved as expected.

**Photo 10: View of the left wing at the accident site.**

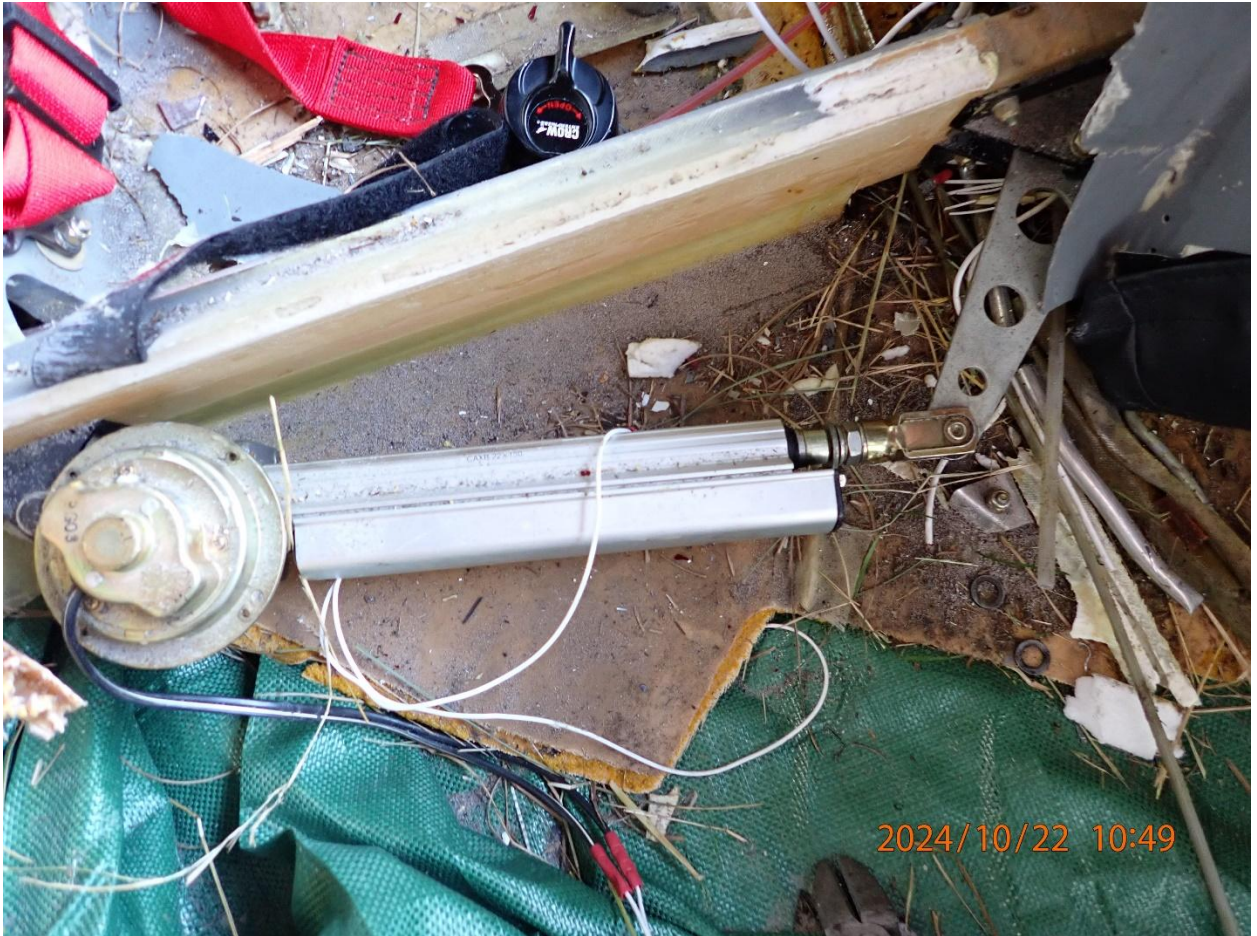
**Photo 11: View of the fully retracted flap motor at the recovery facility.**

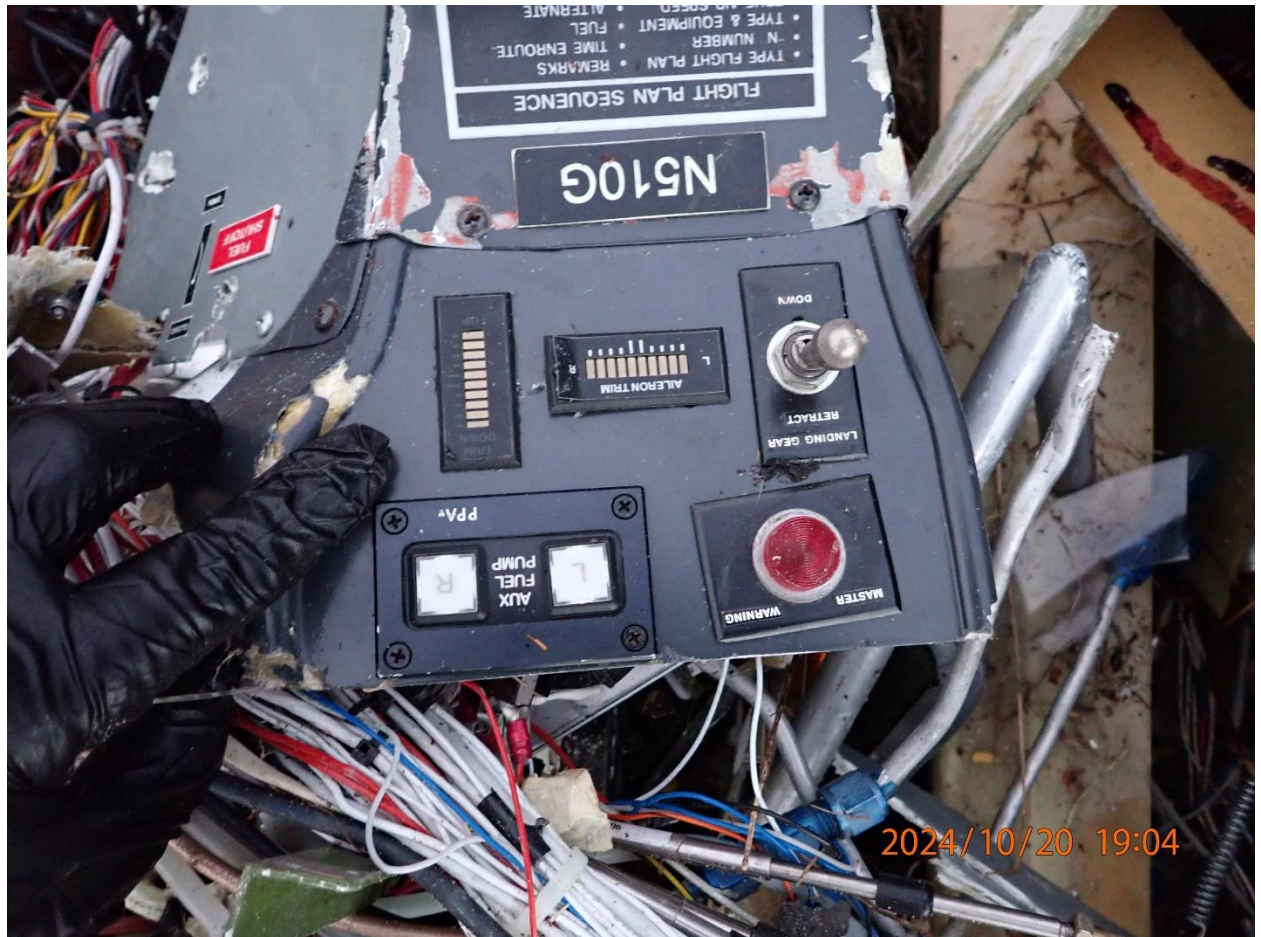
Both of the main landing gear and the nose landing gear were found within the main wreckage. The landing gear selector was found in the "retract" position. The landing gear dump valve was found about  $\frac{3}{4}$  of the way open and exhibited impact damage.

Photo 13: View of the landing gear selector switch.

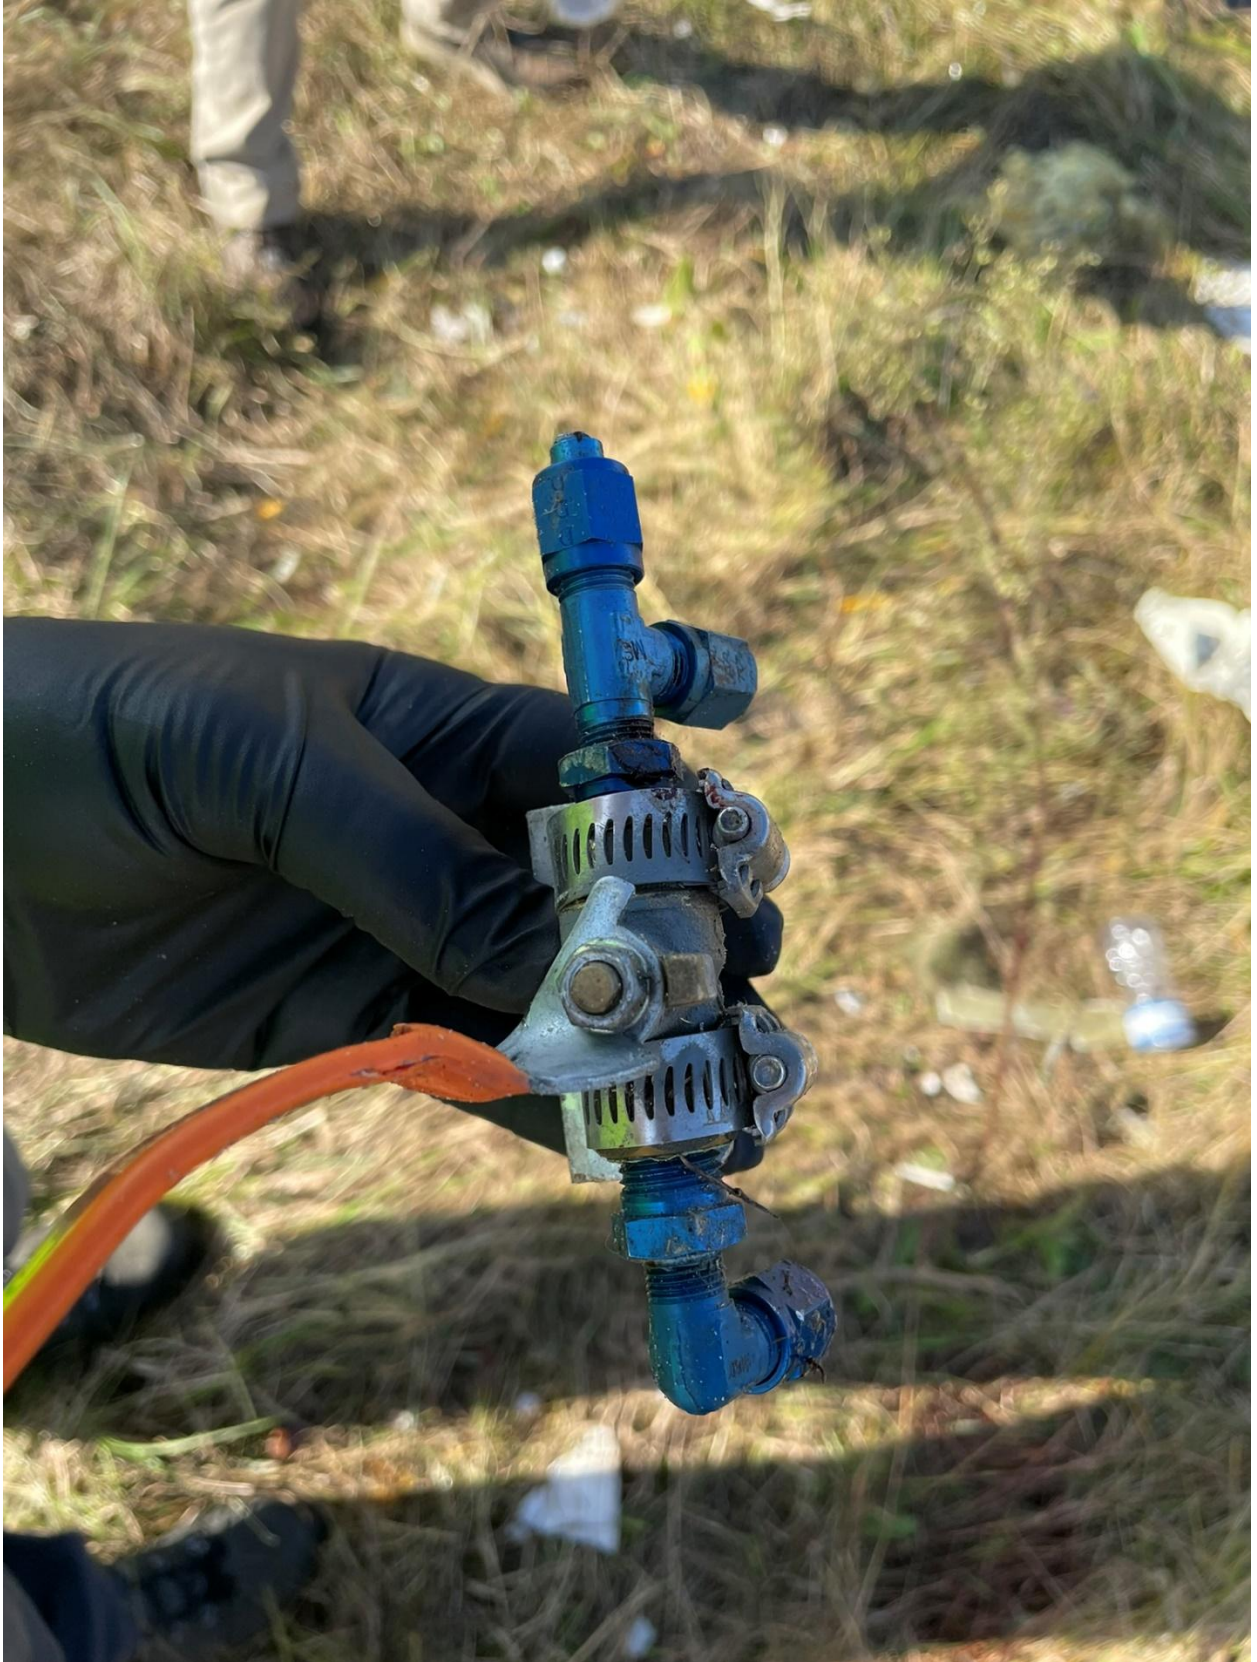
**Photo 14: Landing gear dump valve.**

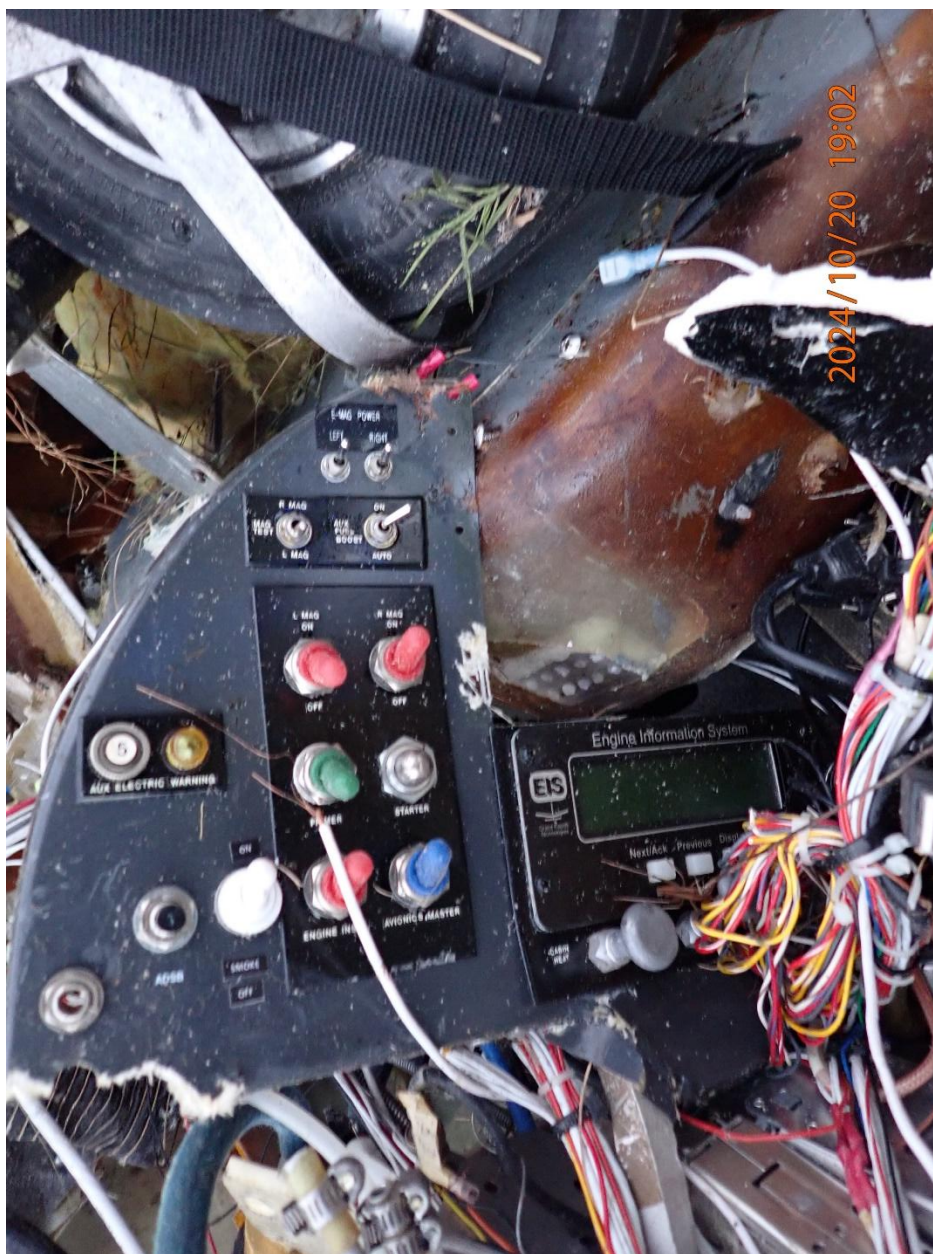
**Photo 15: Switch Panel**

- Landing gear selector switch – Retract
- E-mag Power Left – UP
- E-mag Power Right – UP
- Mag Test – L-Mag
- AUX FUEL BOOST – ON
- L MAG – OFF
- R MAG – ON
- Primer – OFF
- SMOKE – ON
- ENGINE INSTR – UP
- AVIONICS MASTER – UP
- MASTER – UNKNOWN (IMPACT DAMAGE)
- ALTERNATOR – UP
- BOOST PUMP – UP
- PITOT HEAT – UP
- NAV LIGHT – DOWN
- STROBES – DOWN
- LANDING LIGHT – UP
- PITCH TRIM CB – IN
- NAV – 1
- AUTO PILOT – LEFT
- FUEL SHUTOFF – ABOUT 90% CLOSED

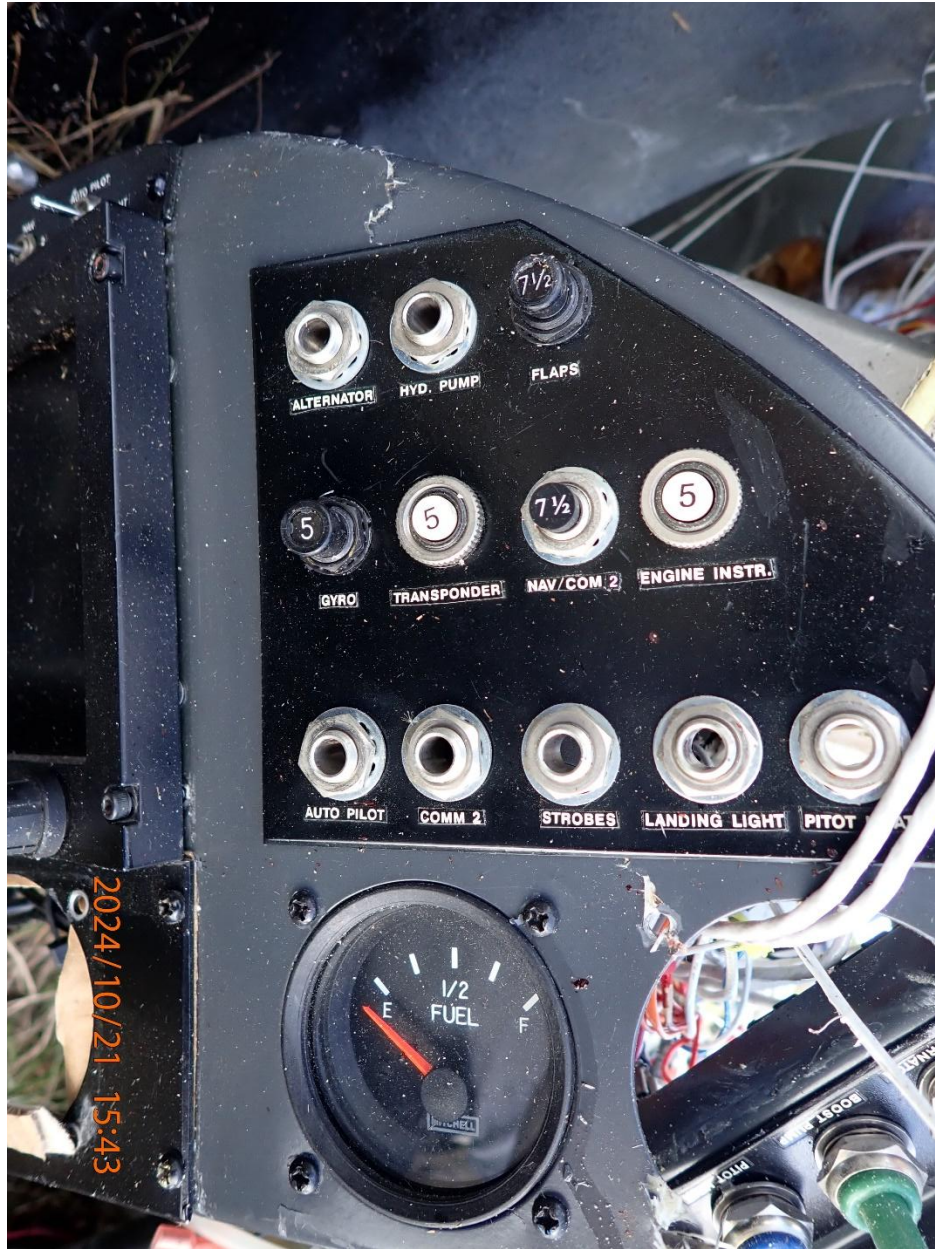
**Photo 17: Circuit breaker panel**
