# National Transportation Safety Board

ERA25FA020

## **WRECKAGE EXAMINATION**

Location: Cross City, FL  
Date: October 20, 2024  
Time: 1600 EDT  
2000 UTC  
Airplane: N510G; Lancair 360

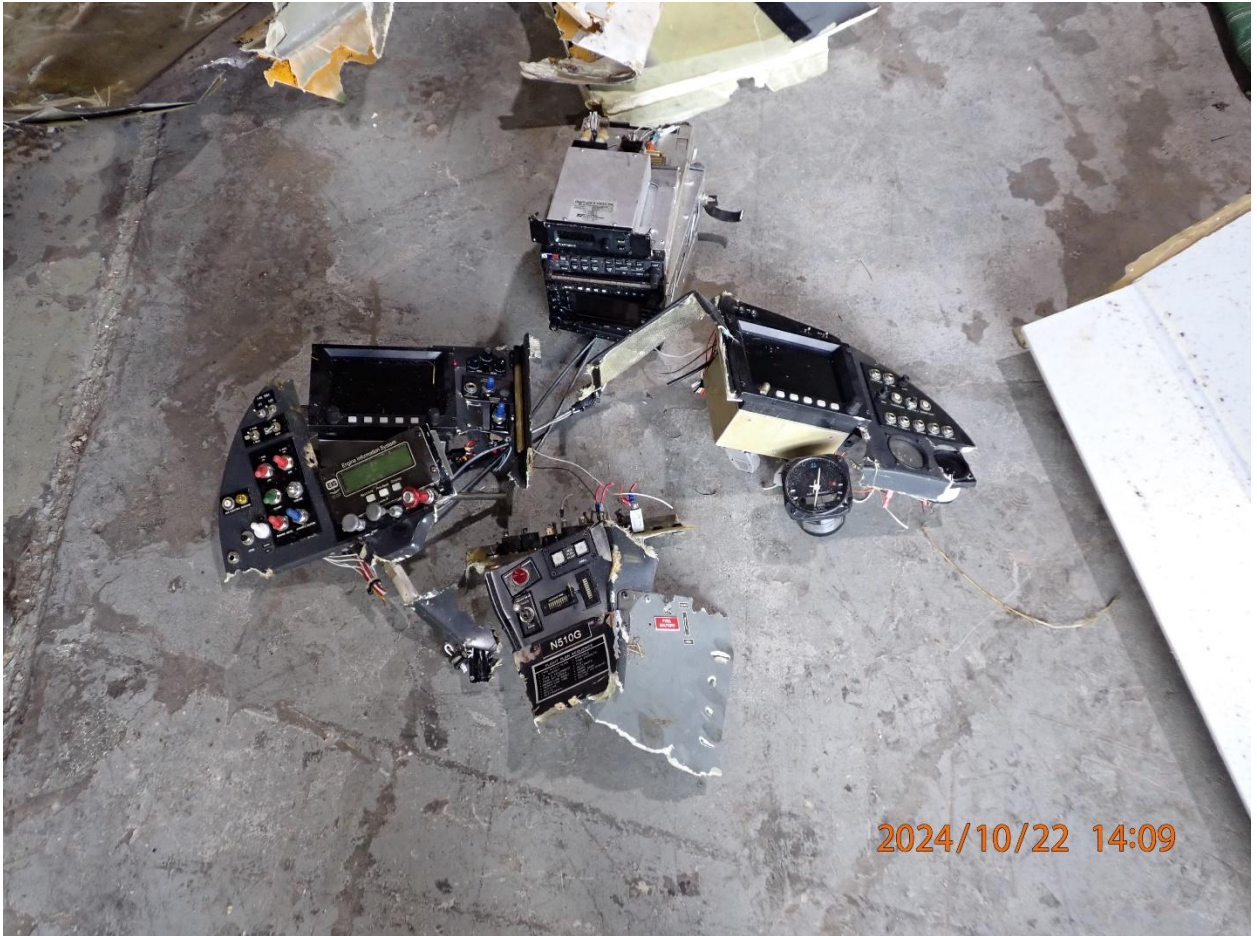
The cockpit was destroyed by impact and unrecognizable. The following switches and circuit breakers were observed:

**Photo 18: Layout of recovered pieces of the instrument panel.**

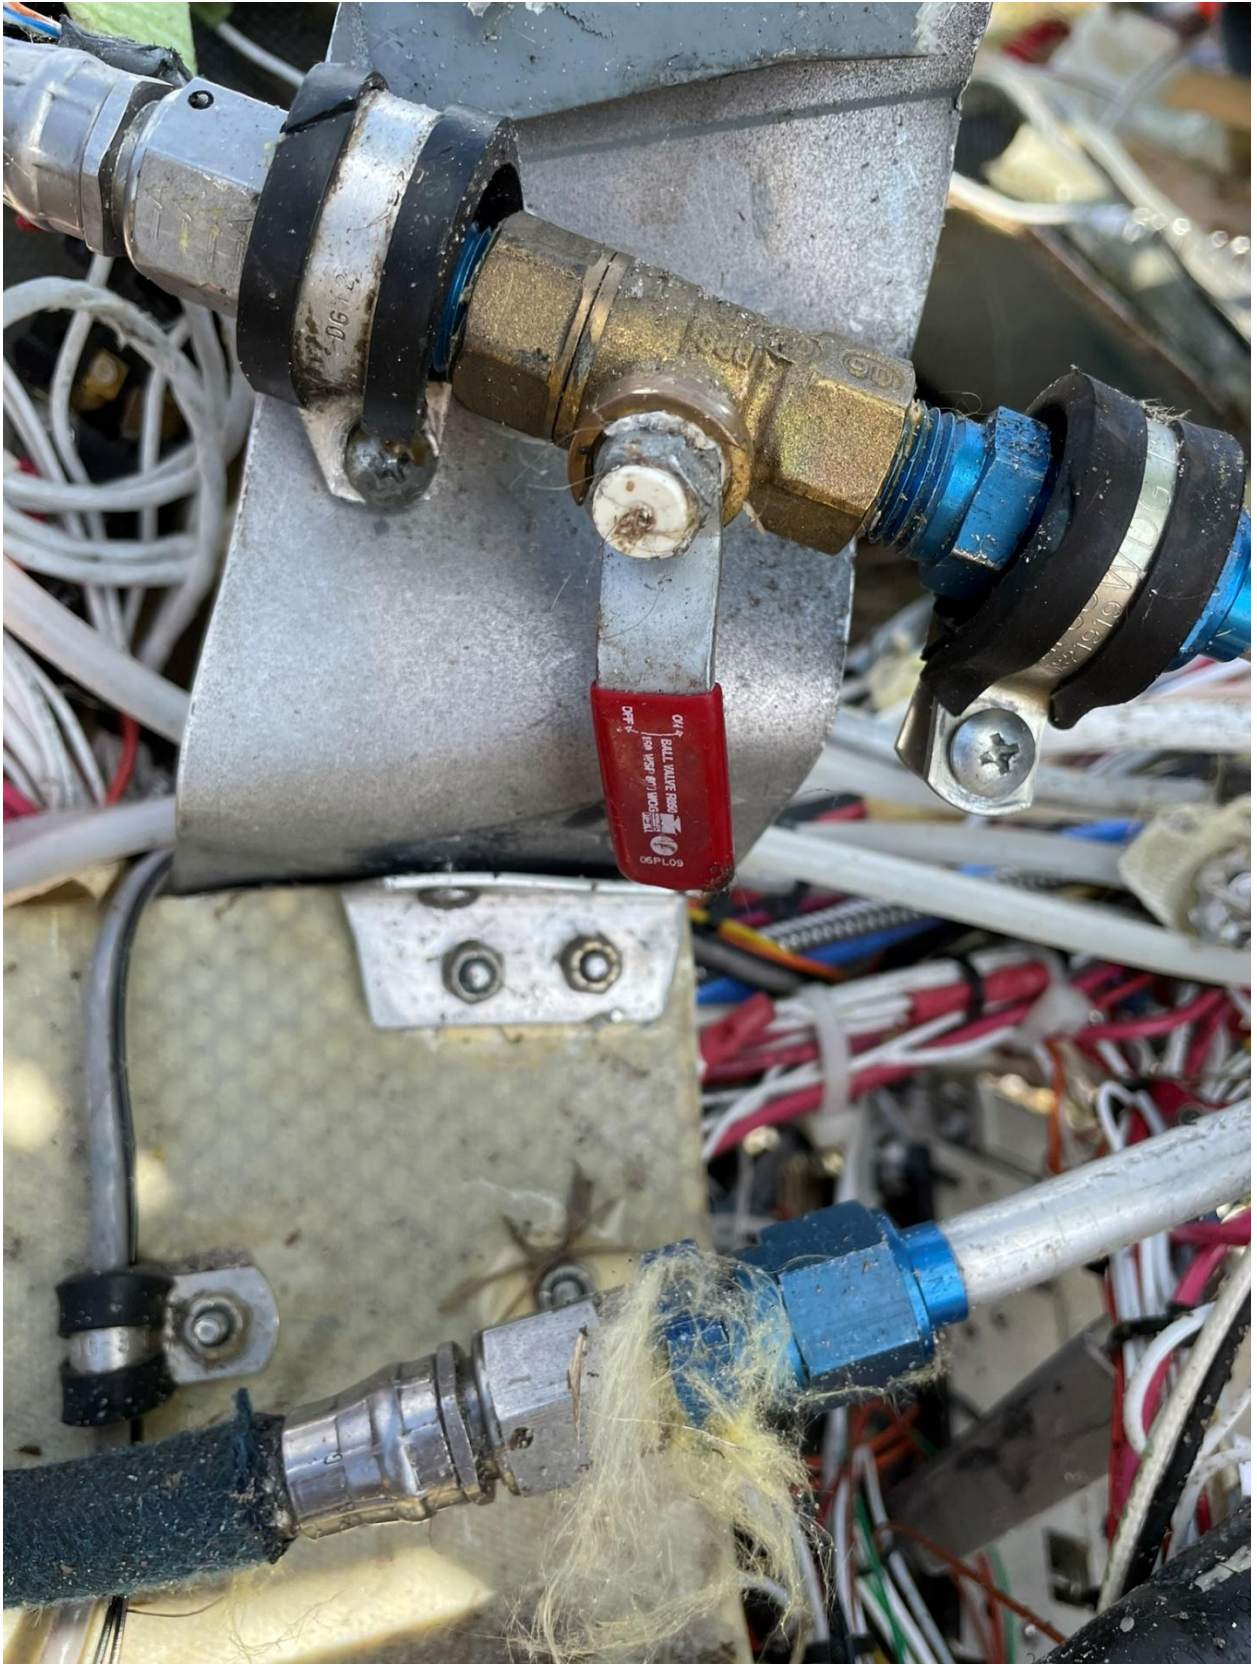
**Photo 19: Fuel shutoff as found on scene.**

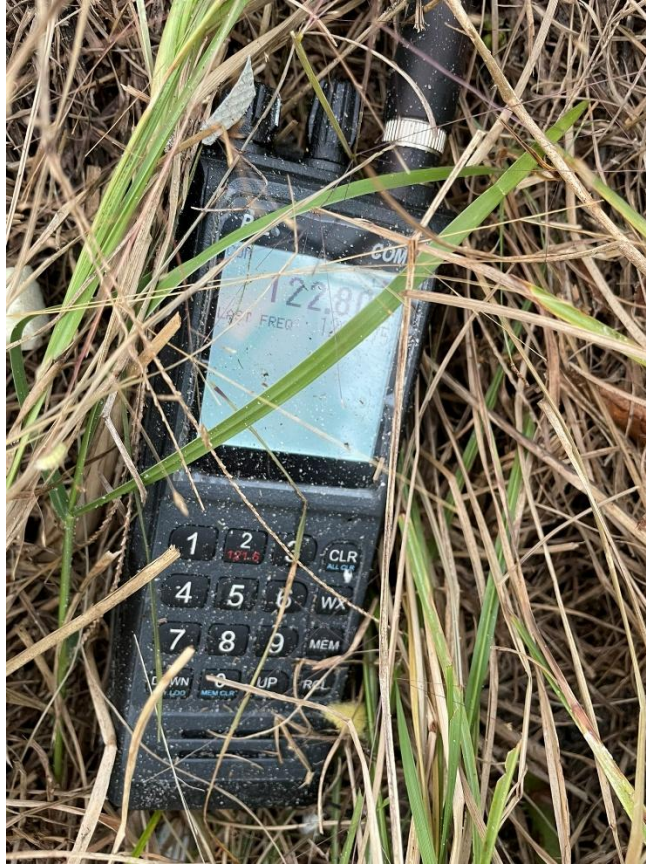
**Photo 20: View of handheld radio recovered in the debris.**

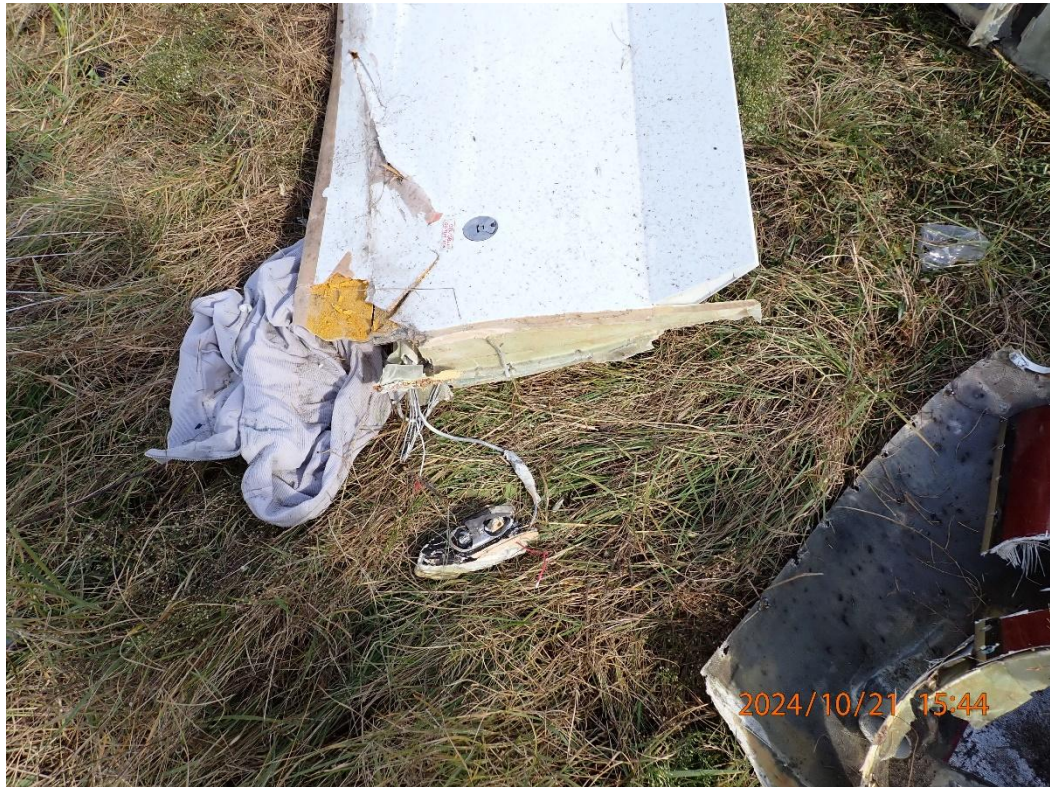
**Photo 21: Left wing fuel cap seated in place.**

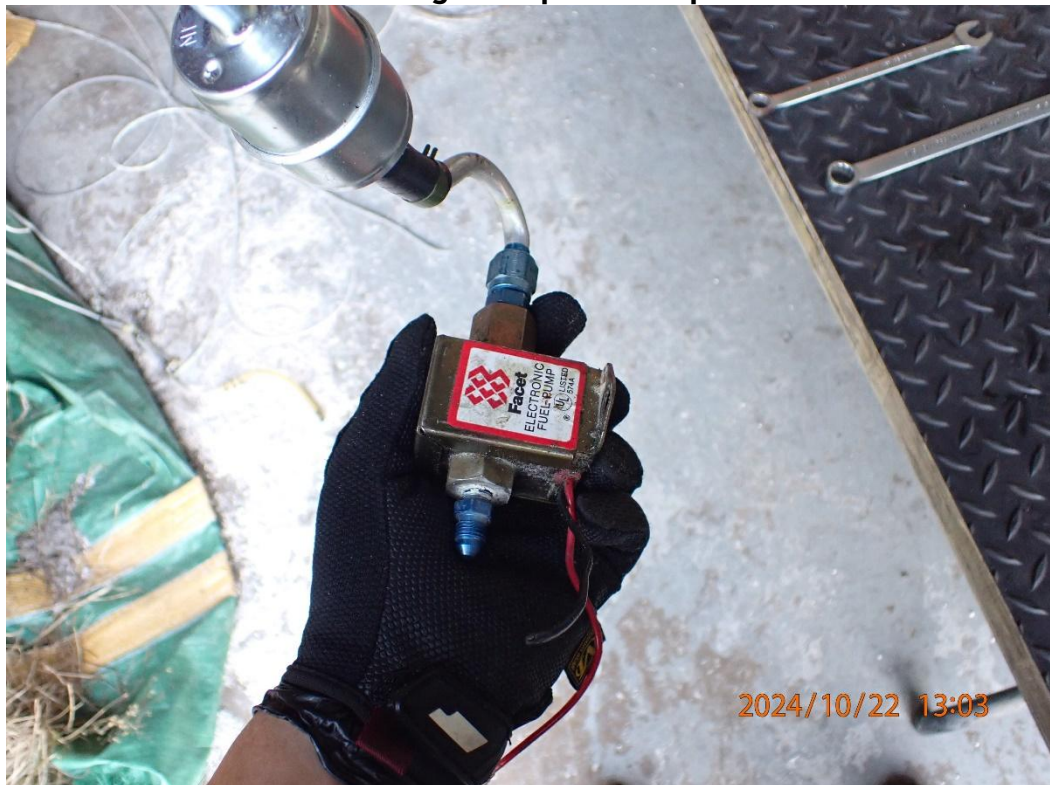
**Photo 22: Left wing fuel tank in line filter and pump.**

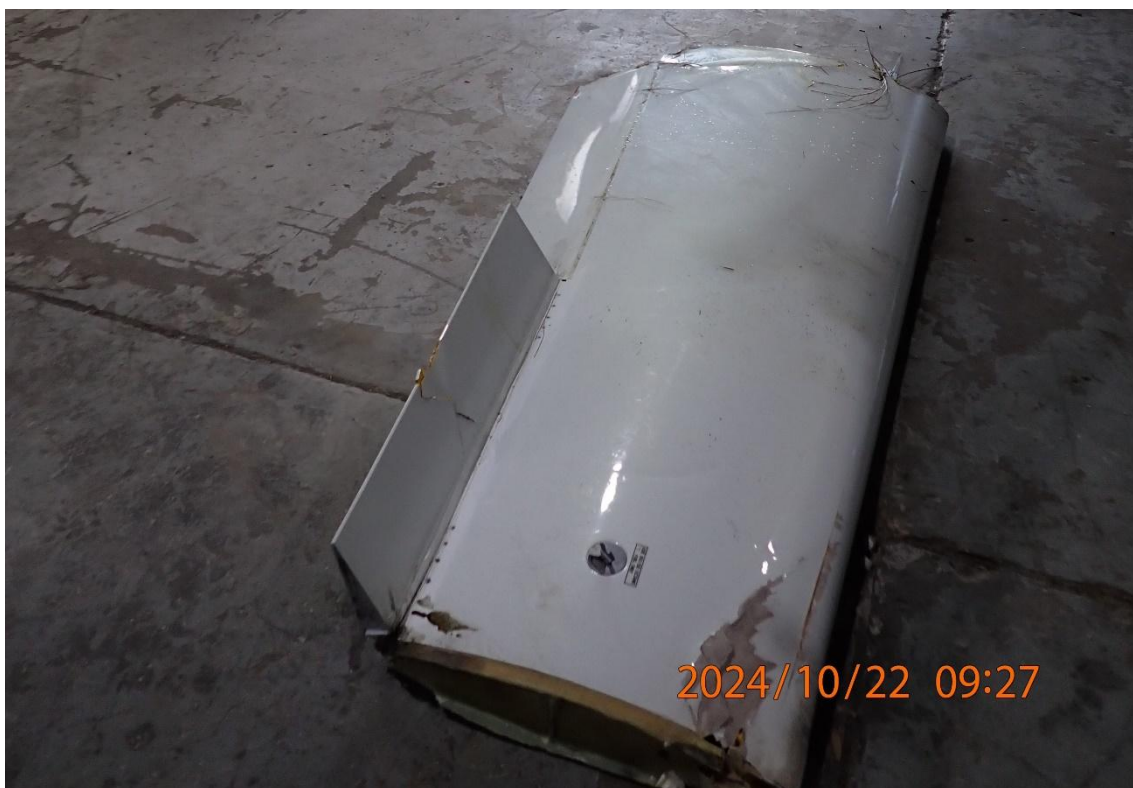
**Photo 23: Right wing with fuel cap seated in place.**

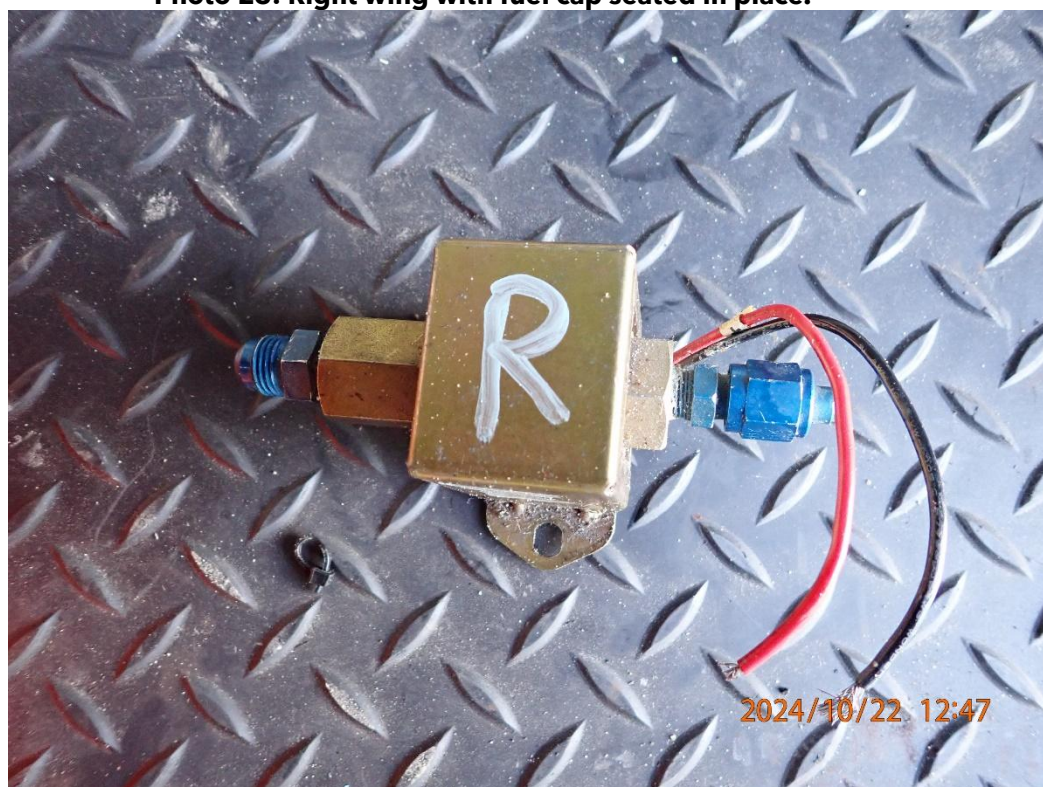
**Photo 24: Right wing fuel tank pump.**

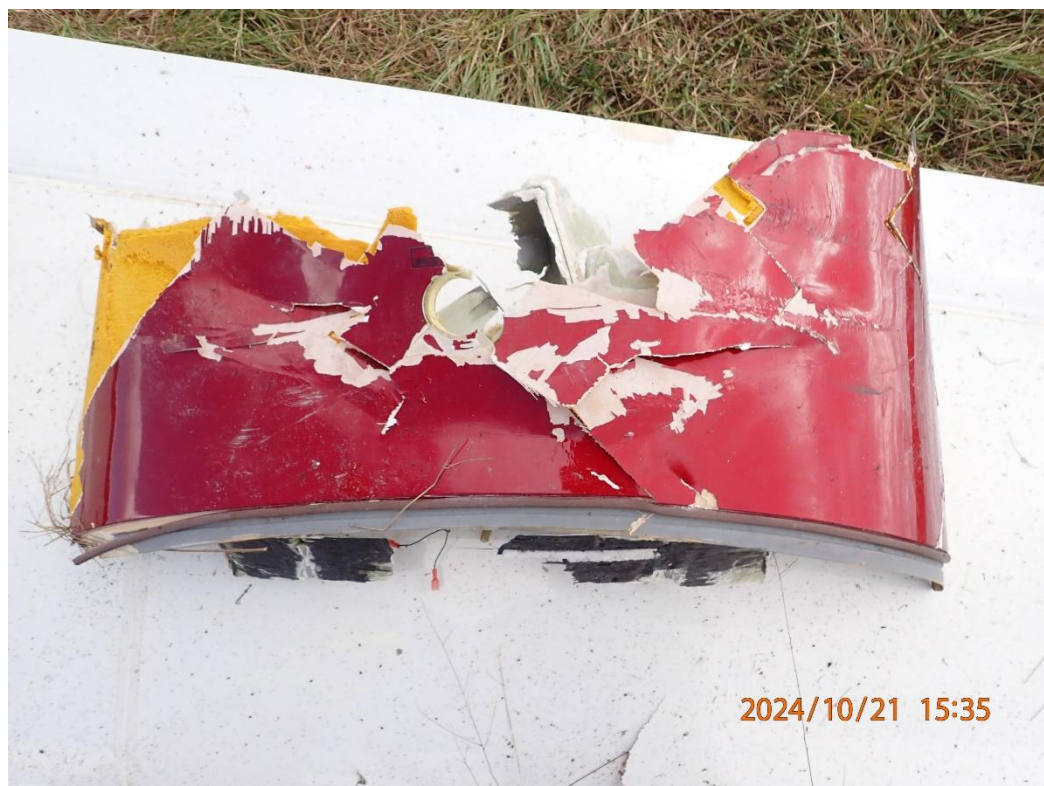
**Photo 25: Header tank.**

Both wing fuel tanks and the header tank were breached. The header tank was impact separated from the fuselage and the header tank fuel cap was impact separated from the tank. Both wing fuel tank caps remained attached, closed, and seated in place. Both the left and right wing fuel tank transfer pumps and inline filters contained fuel similar in color and smell to 100LL aviation fuel. Both pumps operated and pumped out fuel when power was applied. The finger screen for the header tank was impact separated from the tank but remained attached to the fuel shutoff valve. The screen was unobstructed. The fuel shut off valve was observed to be about 90% closed. An inline fuel filter from the fuel shutoff to the header tank electric boost pump was removed and contained fuel similar in color and smell to 100LL aviation fuel; the filter was unobstructed. The header tank electric boost pump was removed and contained fuel similar in color and smell to 100LL aviation fuel. The pump operated and pumped fuel when power was applied. The fuel strainer was drained and contained fuel similar in smell and color to 100LL aviation fuel.

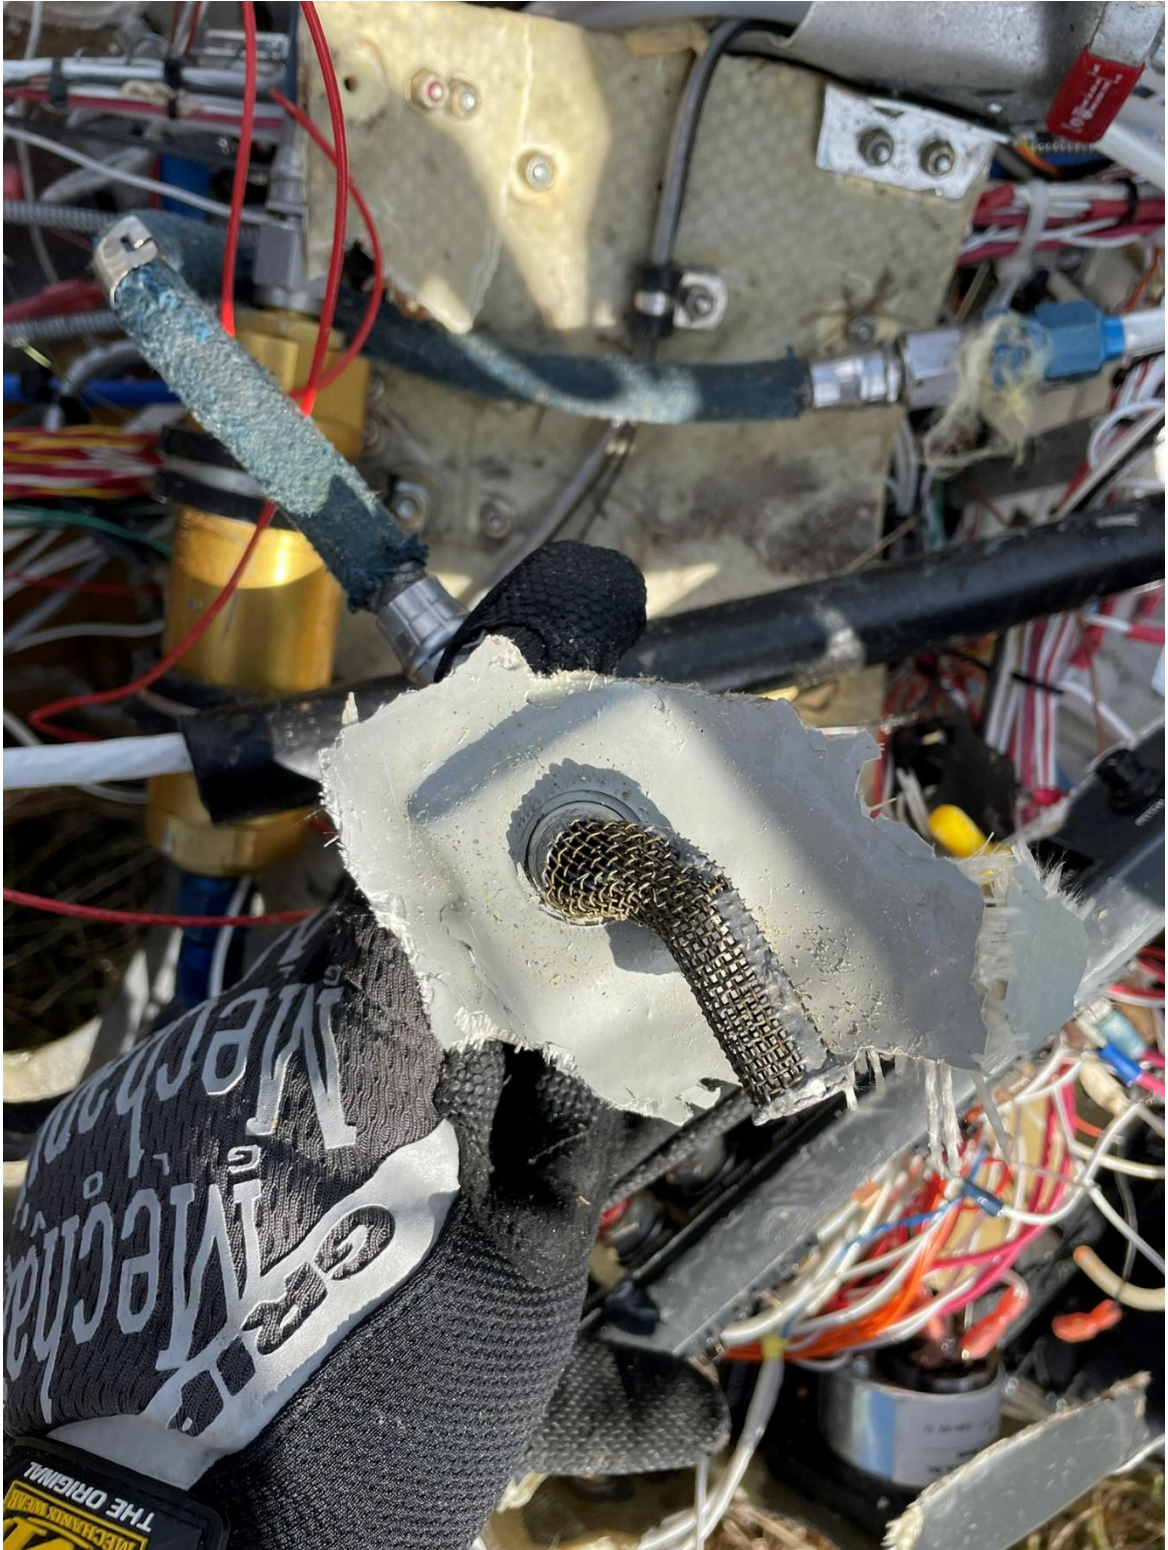
**Photo 26: Header tank finger screen.**

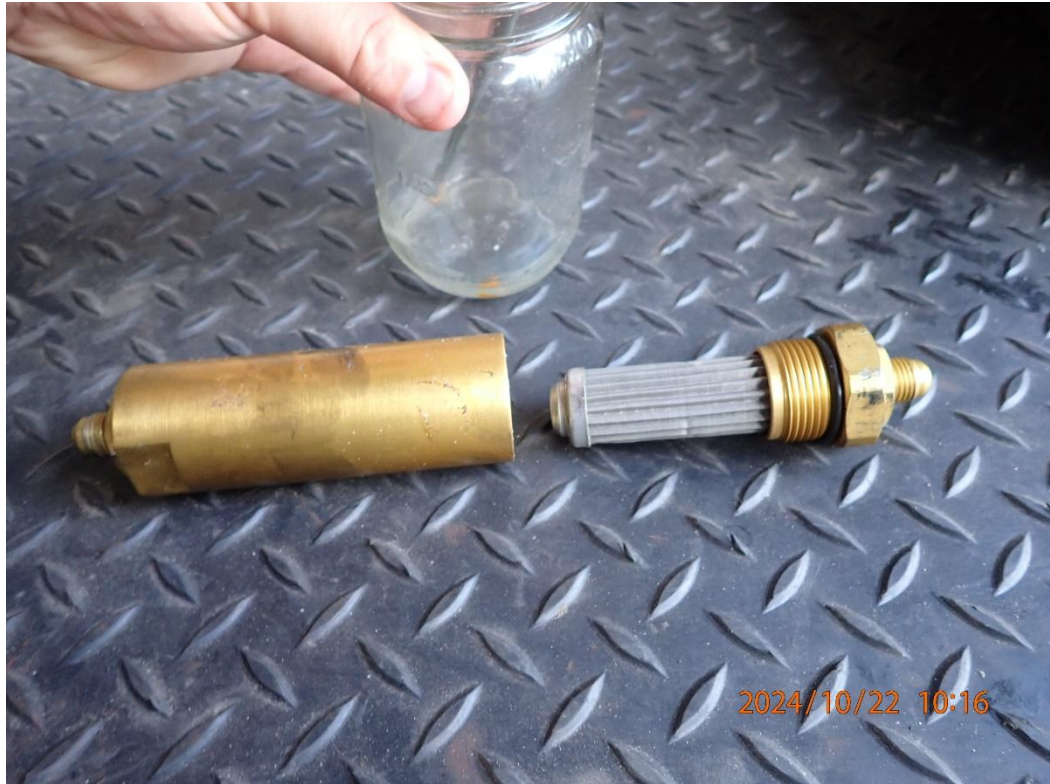
**Photo 27: In line fuel filter from header tank to engine.**

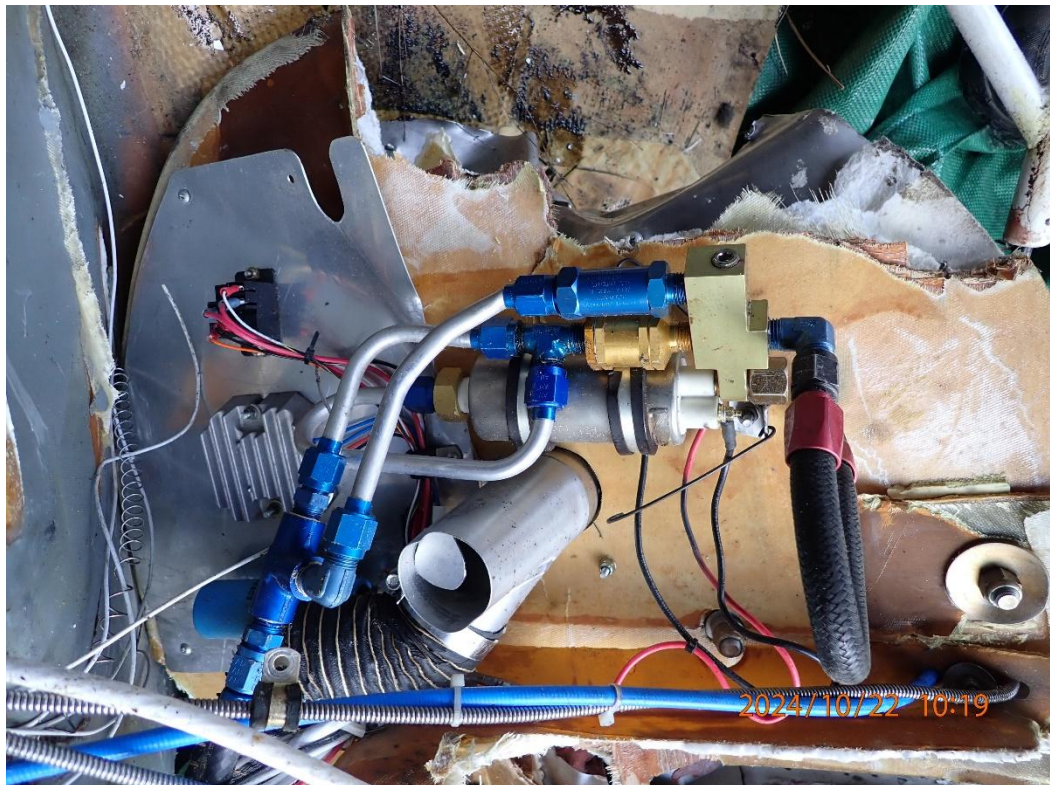
**Photo 28: Header tank fuel pump assembly.**

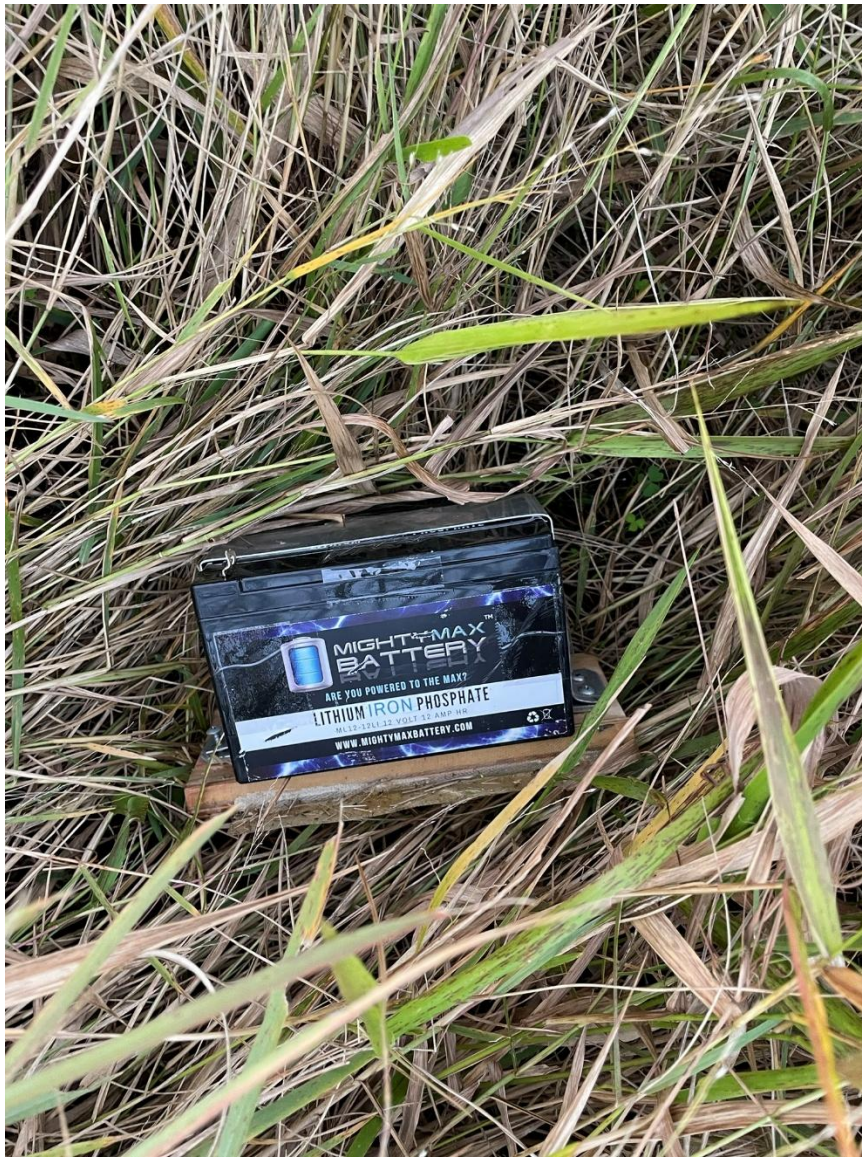
The standby battery was impact separated and found in the debris field, when measured using a multimeter it read 12.5 volts. The main battery remained installed in the aft fuselage and when measured using a multimeter it read 11.8 volts.

**Photo 29: View of the impact separated standby battery.**

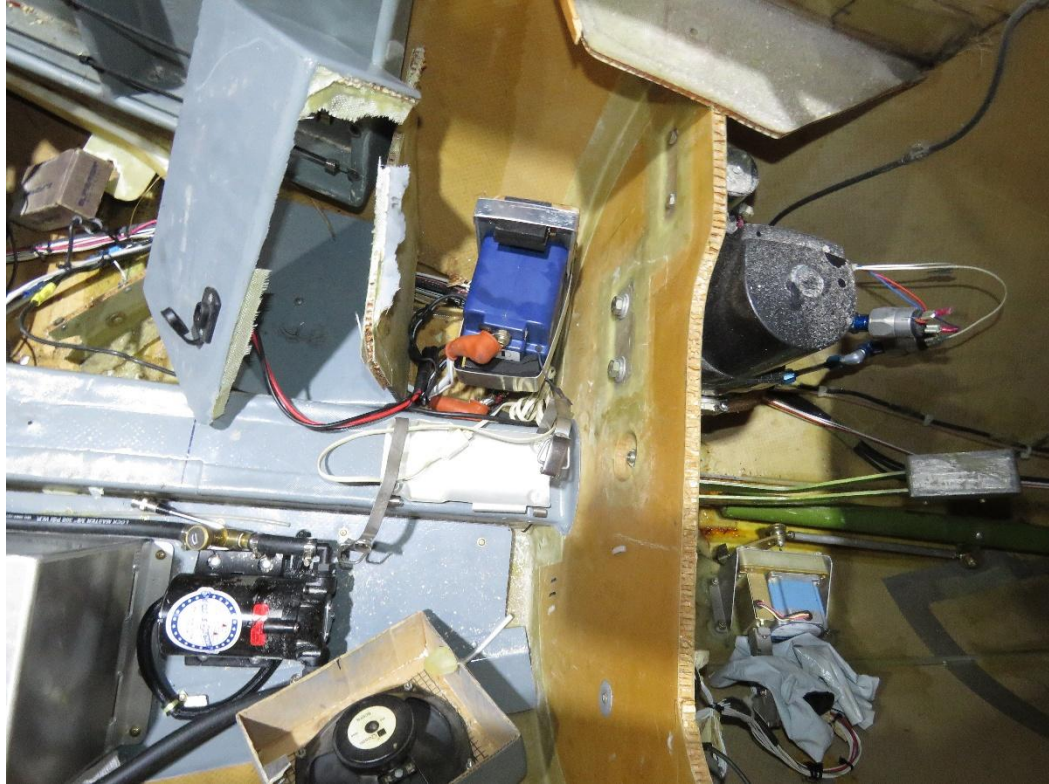
**Photo 30: View of the blue main battery installed in the airplane. (Courtesy of Lycoming)**

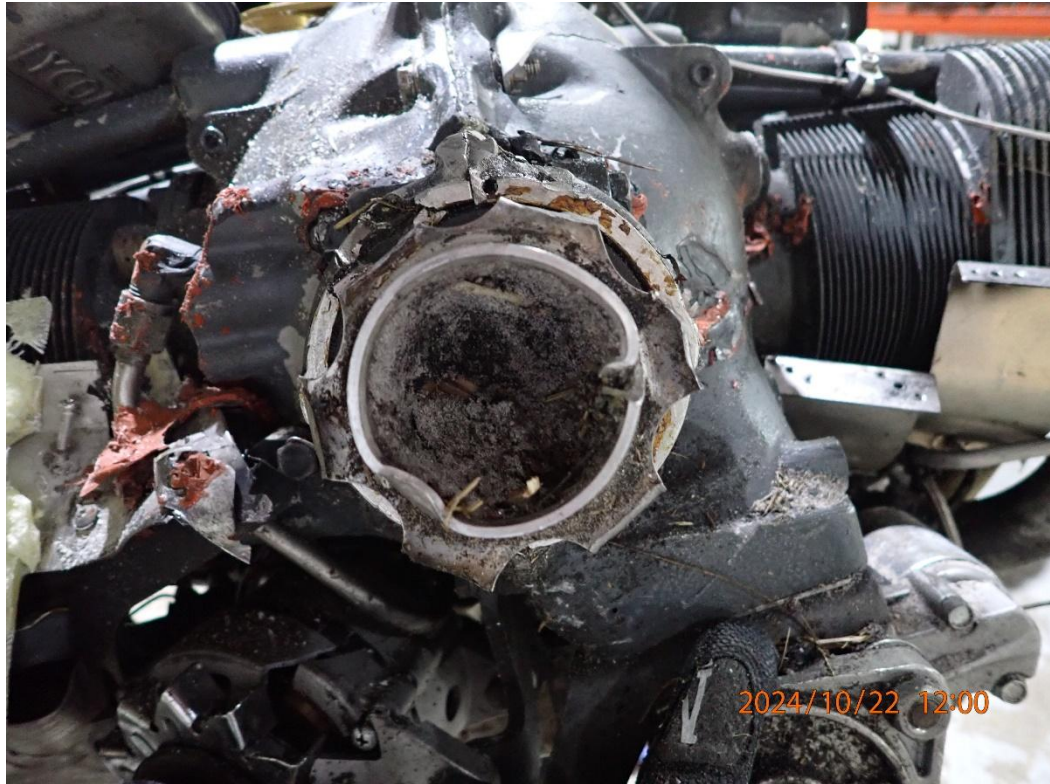
As first observed at Florida Air the engine was laying on the floor and was partially attached to the firewall and the engine mounting bracket. The engine was removed from the firewall and suspended in the air with the forks of a fork lift. The crankshaft propeller flange was sheared off from impact and remained attached to the propeller assembly. The rocker box covers were removed, the E-mags were removed, the back up alternator was removed and the engine driven fuel pump was removed. The engines crankshaft was rotated by turning the vacuum pump drive. The crankshaft rotation was stiff due to the impact damage at the flange of the crankshaft. Thumb compression and suction was observed on all four cylinders in the correct firing order, cylinder 1's valves had to be staked to observe thumb compression and suction. Normal valve action was observed on all rocker arms.

**Photo 31: View of the sheared crankshaft propeller flange.**

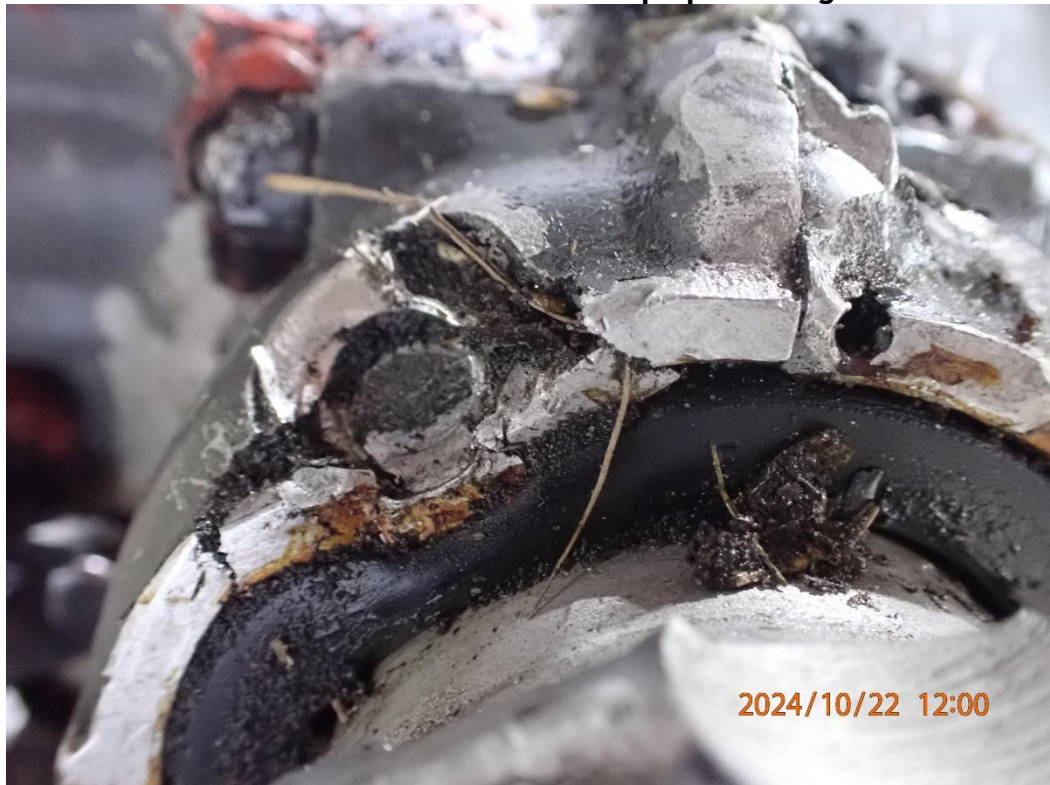
**Photo 32: Impact damage at the flange of the crankshaft.**

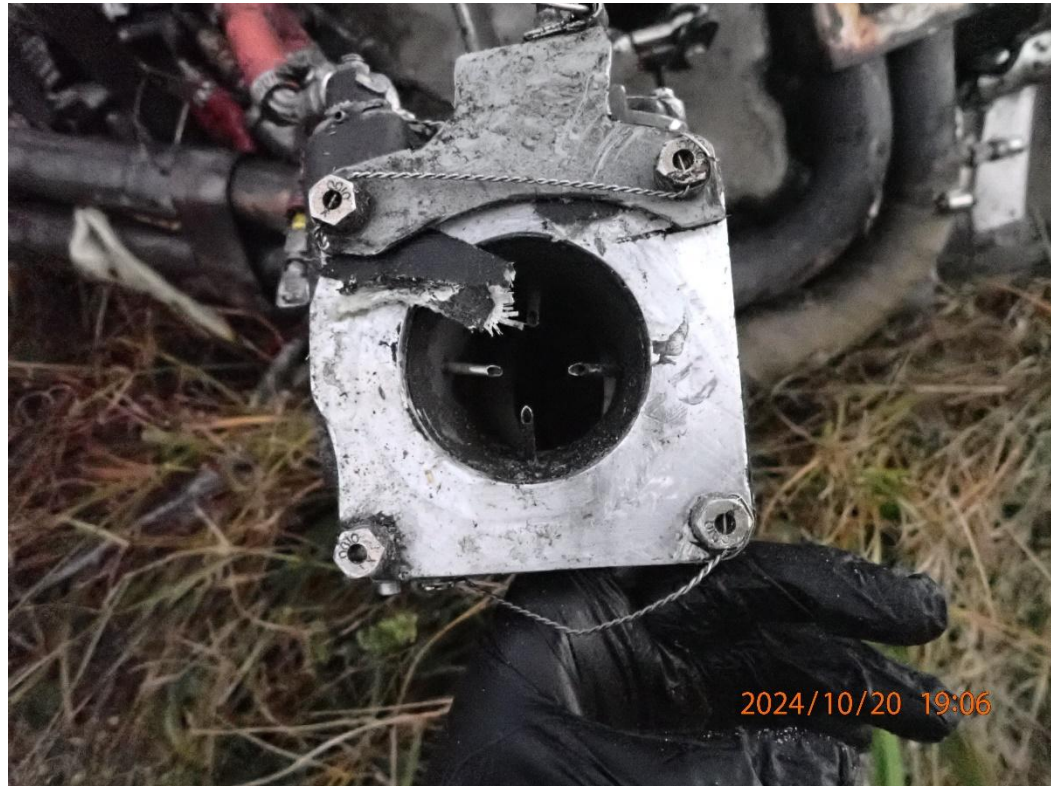
The fuel servo venturi was unobstructed. The intake and exhaust pipes exhibited some impact damage and remained attached to the engine.

**Photo 33: View of the unobstructed fuel servo venturi at the accident site.**

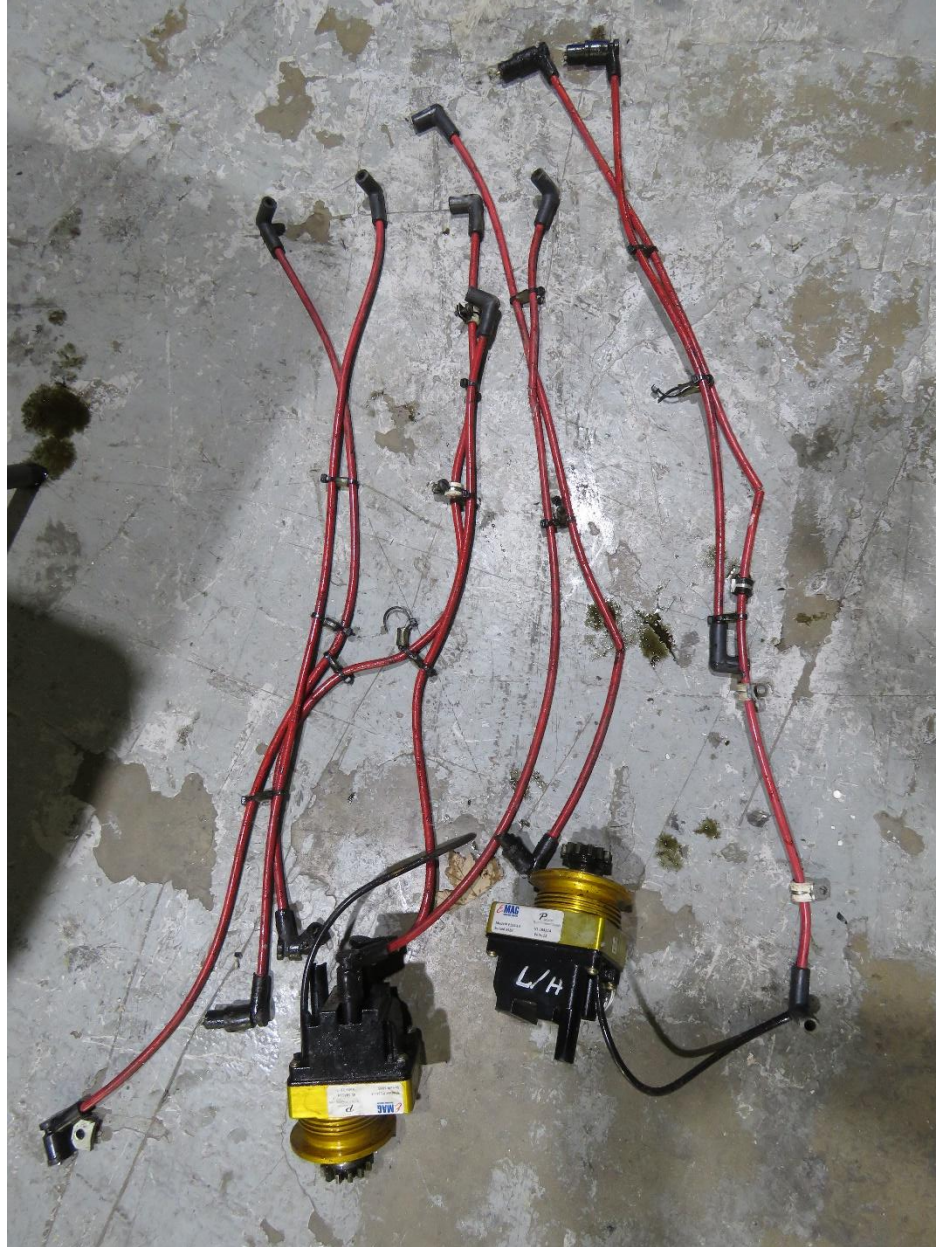
The engine had dual E-mag electronic ignition systems installed. Timing was not checked for the ignition system, both E-mags were damaged from impact forces. With an ignition lead that appeared to be undamaged from the impact sequence and attached to a post on each E-mag that appeared undamaged from the impact sequence and a spark plug installed on the ignition lead, power was applied to the B terminal and ground to G terminal of both E-mags and the drives were rotated by hand, an electrical shock was felt by hand while rotating the drive, spark was not observed arcing from the spark plug electrode to a ground source.

**Photo 34: View of both magnetos and ignition harness.**

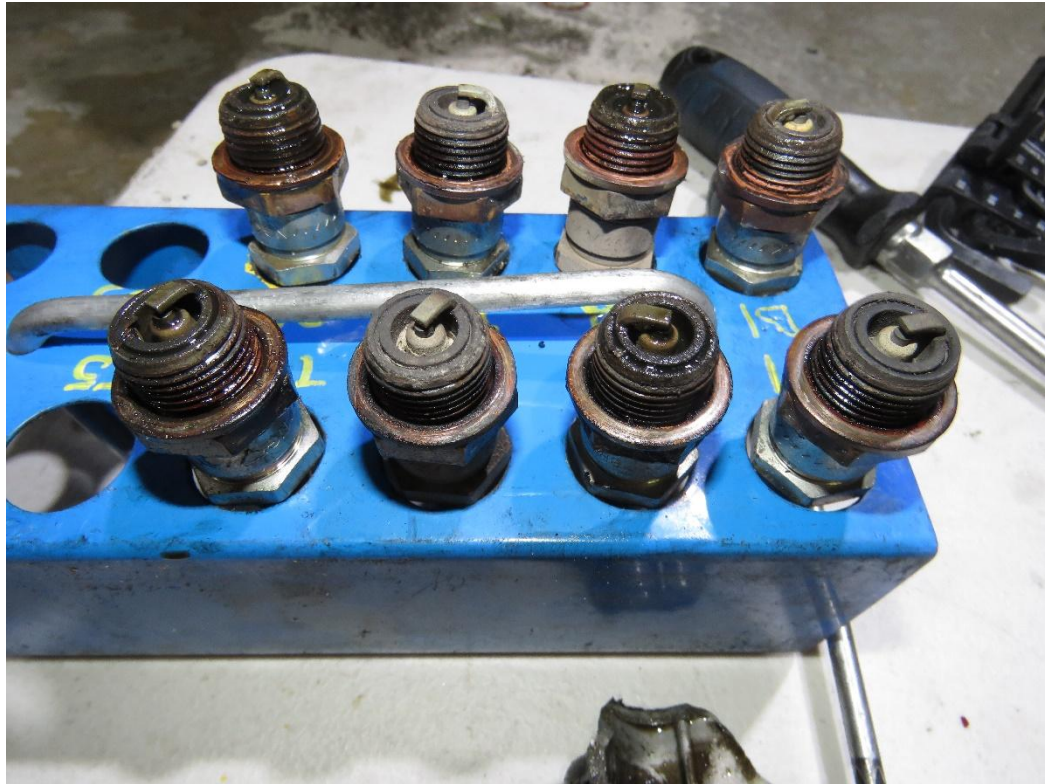
Automotive style NGK spark plugs were installed in all four cylinders, the plugs in cylinders 2 and 4 were soaked in oil, the spark plugs in cylinders 1 and 3 showed normal in-service wear. The ignition harness exhibited impact damage and was unable to be tested.

**Photo 35: View of spark plugs. (Photo courtesy of Lycoming)**

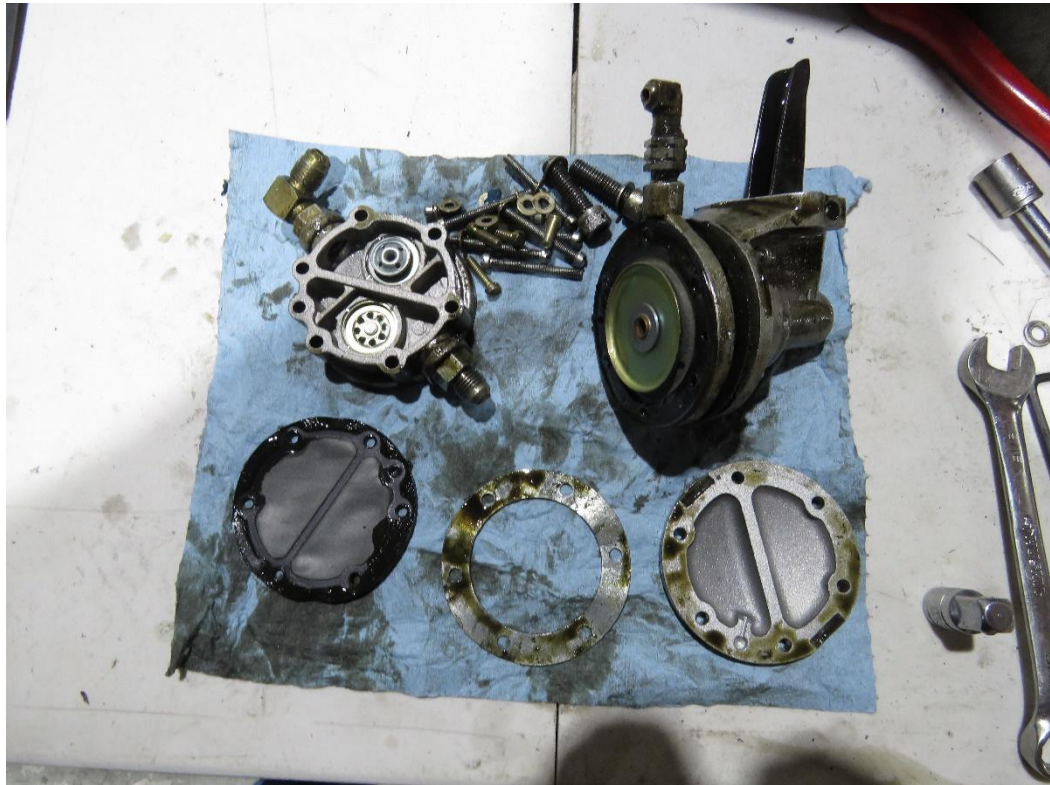
The diaphragm style engine driven fuel pump remained secured to the accessory housing and was safety-wired. The engine driven pump was removed and placed in a vice. The pump produced suction at its inlet and pressure at its outlet when actuated by hand. The pump was disassembled, fuel was present in the engine driven pump, the diaphragms were pliable and undamaged, no discrepancies were observed with the engine driven fuel pump.

**Photo 36: View of the disassembled engine driven fuel pump. (Photo courtesy of Lycoming)**

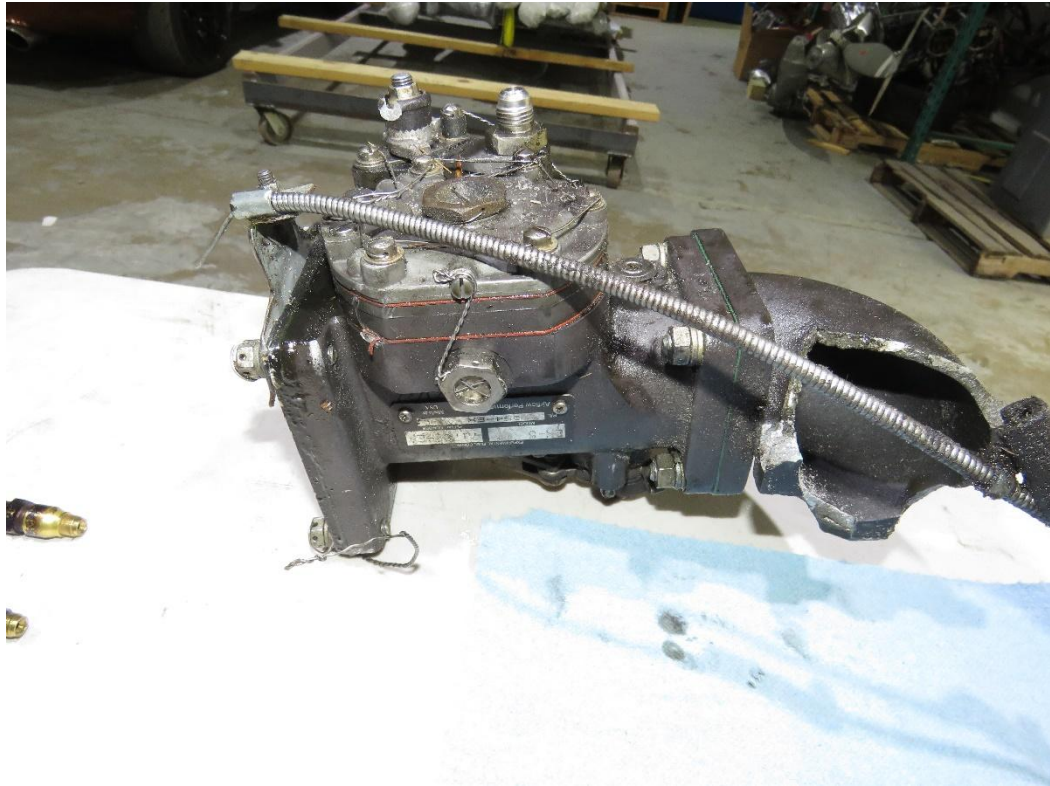
The fuel injection servo was impact separated from the engine at its mounting flange and the throttle and mixture controls were impact separated from the fuel servo body. The diaphragm assembly was opened and examined, the fuel and air diaphragms were pliable and undamaged, fuel was present in the servo and no contamination was observed.

**Photo 37: View of the fuel injection servo. (Photo courtesy of Lycoming)**

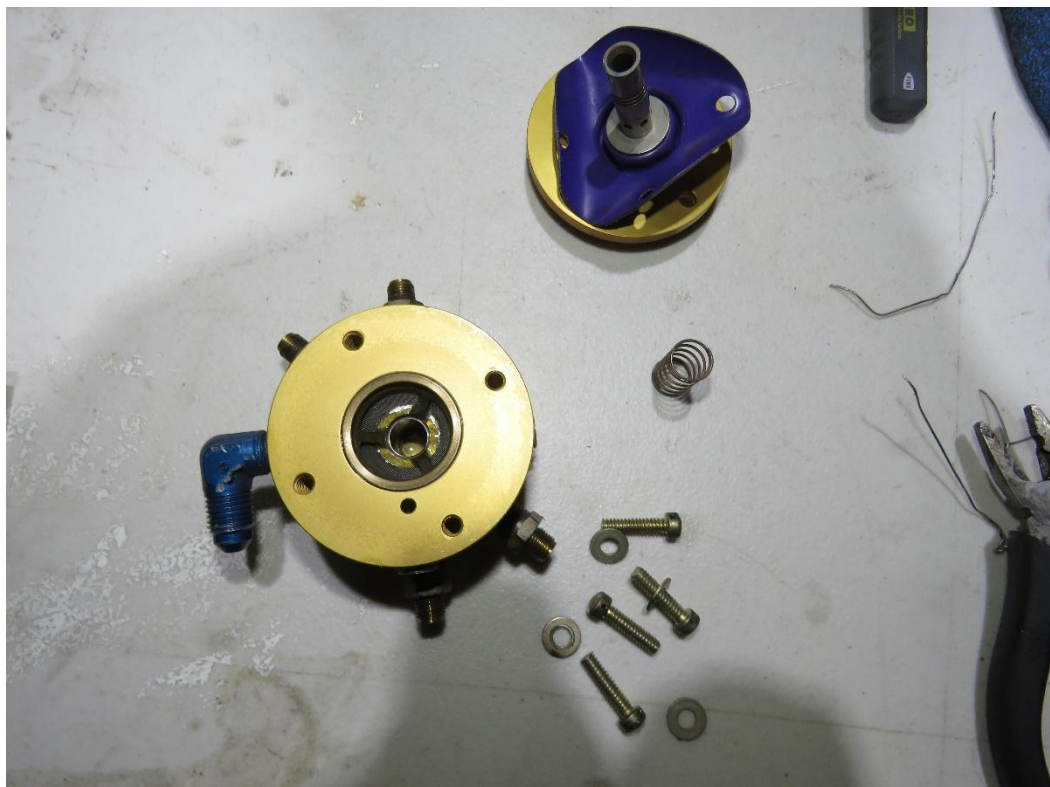
The flow divider remained attached to the spine of the crankcase assembly via its attaching bracket. The flow divider was removed and disassembled, fuel was present in the flow divider and no contamination or obstructions were observed.

**Photo 38: View of the disassembled flow divider. (Photo courtesy of Lycoming)**

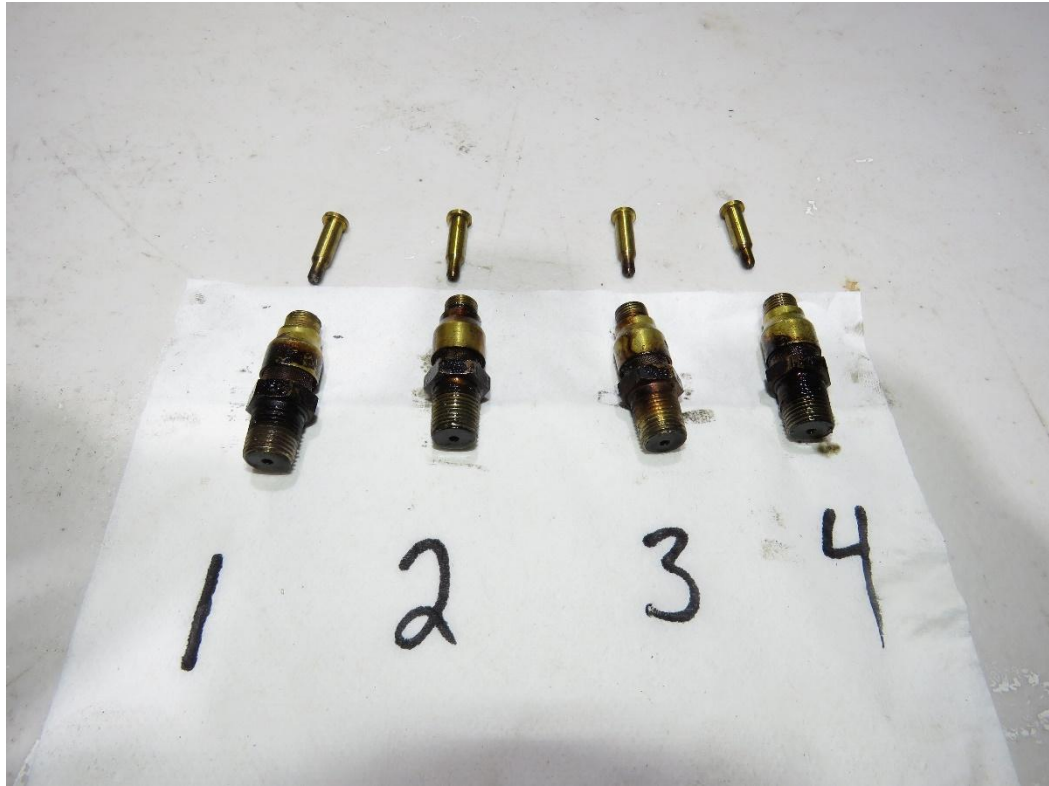
The fuel injection nozzles were removed from all four cylinders. All nozzles had the fuel injection nozzle insert installed. The injection nozzles from cylinders 2 and 4

had oil in the passage, the oil was removed from the Nos. 2 and 4 injection nozzles by blowing air through the nozzle.

**Photo 39: View of the fuel injection nozzles. (Photo courtesy of Lycoming)**
