# National Transportation Safety Board

ERA25FA020

## **WRECKAGE EXAMINATION**

Location: Cross City, FL  
Date: October 20, 2024  
Time: 1600 EDT  
2000 UTC  
Airplane: N510G; Lancair 360

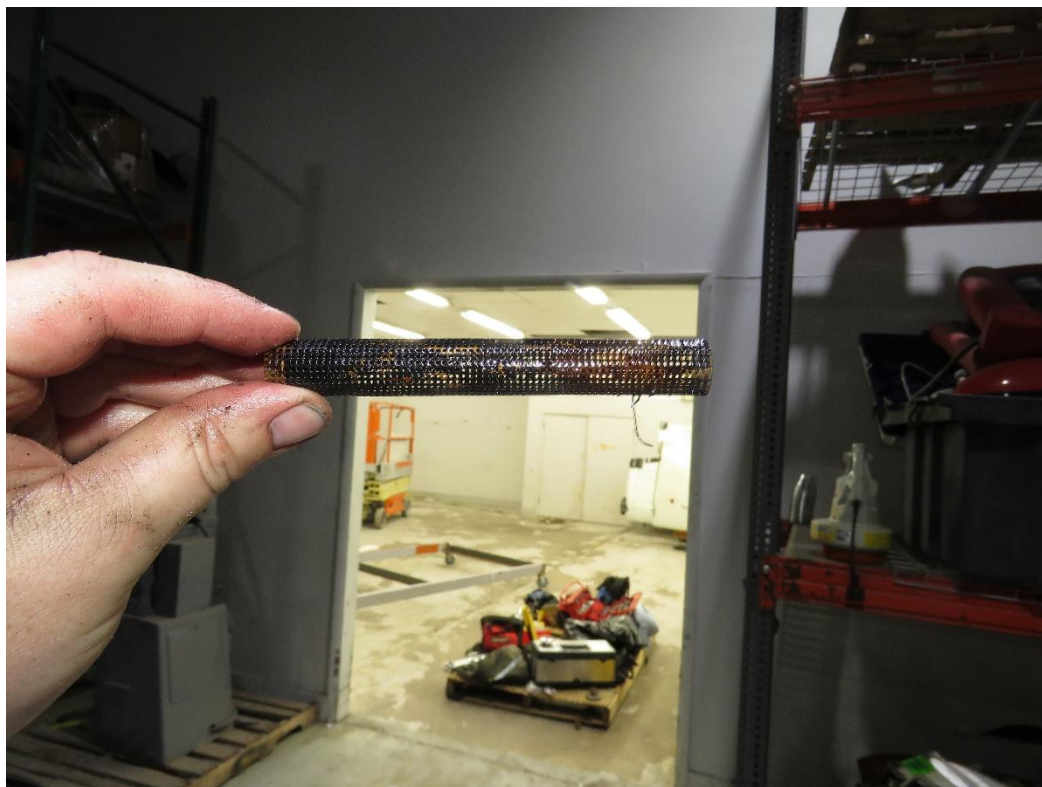
Oil was present in the oil sump, the suction screen was removed, some carbon build-up was observed on the suction screen and a small piece of wire was attached to the suction screen. The oil filter was impact separated from the engine, was damaged, and was dated 7-13-24. Due to the damage on the oil filter, it was cut open with a reciprocating saw, no contamination was observed in the pleats of the oil filter element.

**Photo 40: View of the oil suction screen. (Photo courtesy of Lycoming)**

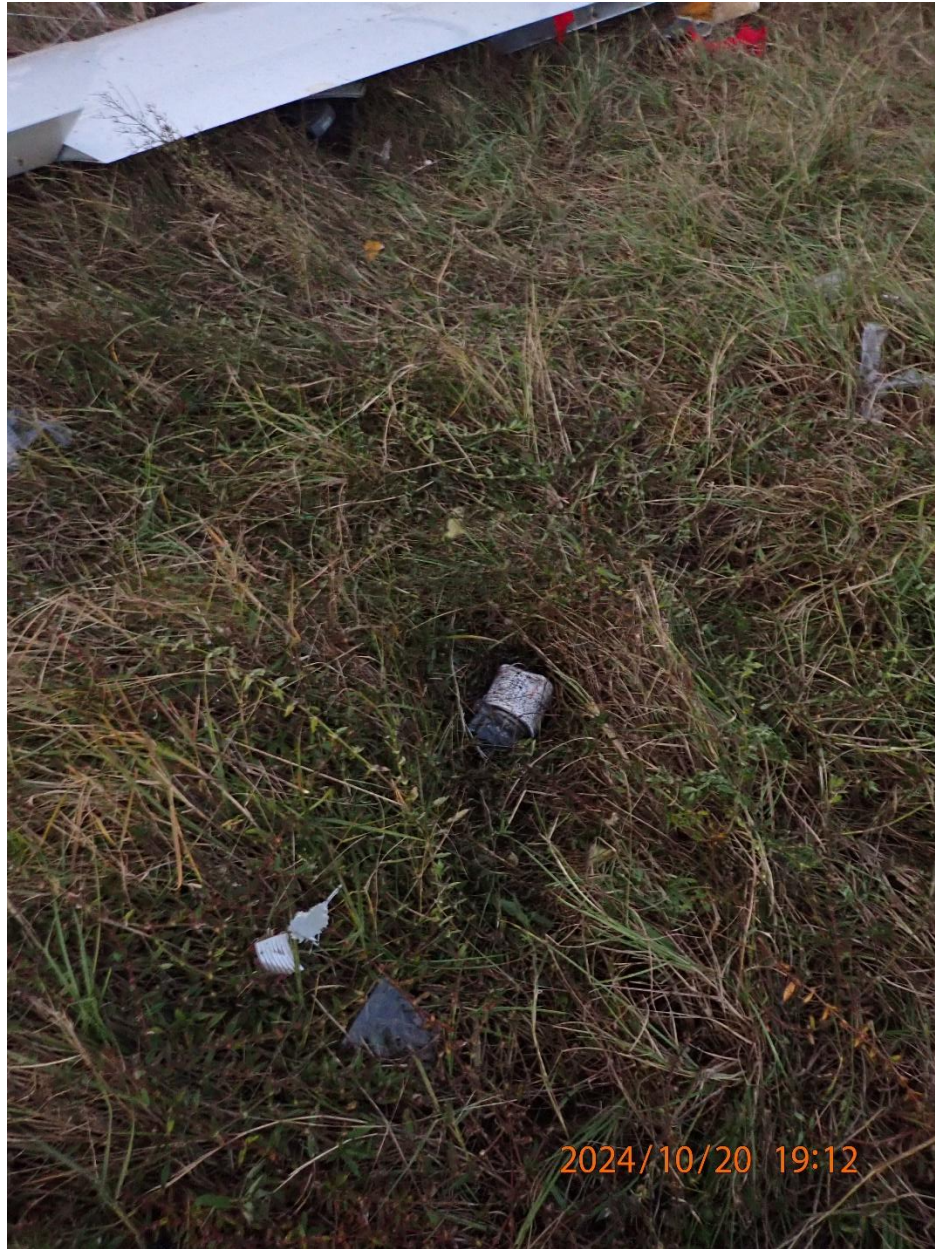
**Photo 41: View of the impact separated oil filter at the accident site.**

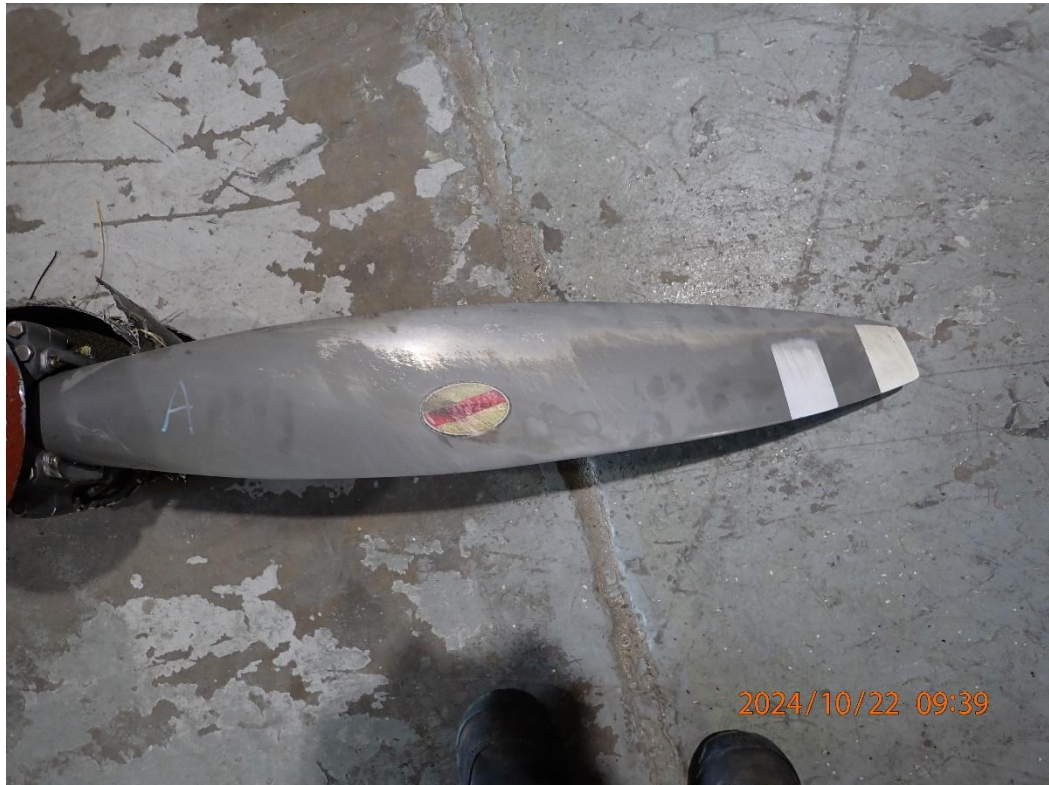
**Photo 42: Overview of blade A.**

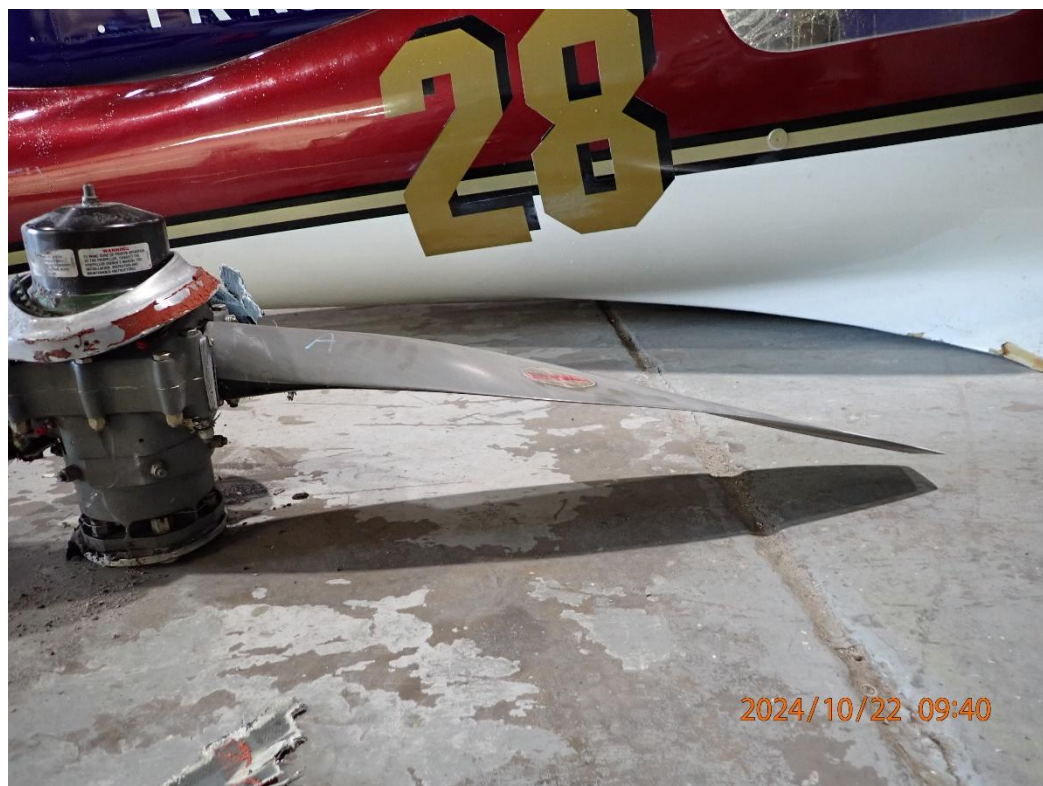
The Hartzell two-bladed metal constant speed propeller was impacted separated from the engine. It was sheared at the crankshaft flange. The propeller blades were marked A and B for narrative purposes. Blade A was bent aft about 20°, blade B appeared straight. Both blades remained secure in the propeller hub and had leading edge polishing.

**Photo 43: View of bend in blade A.**

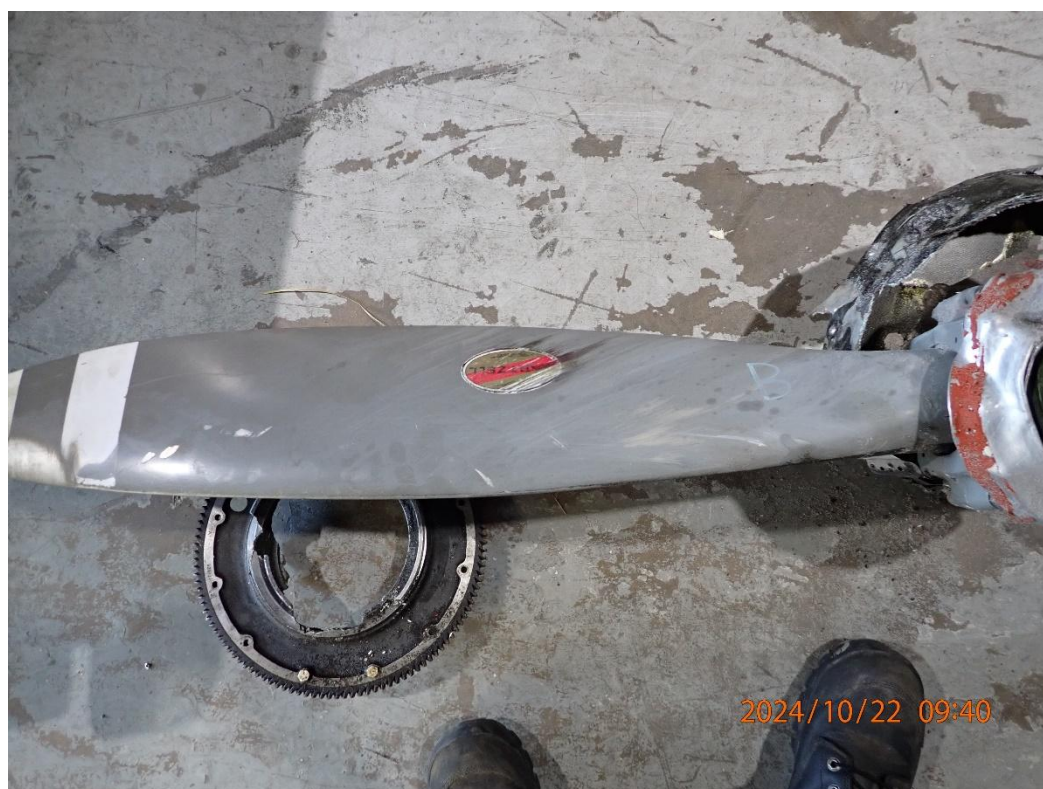
**Photo 44: Overview of blade B.**

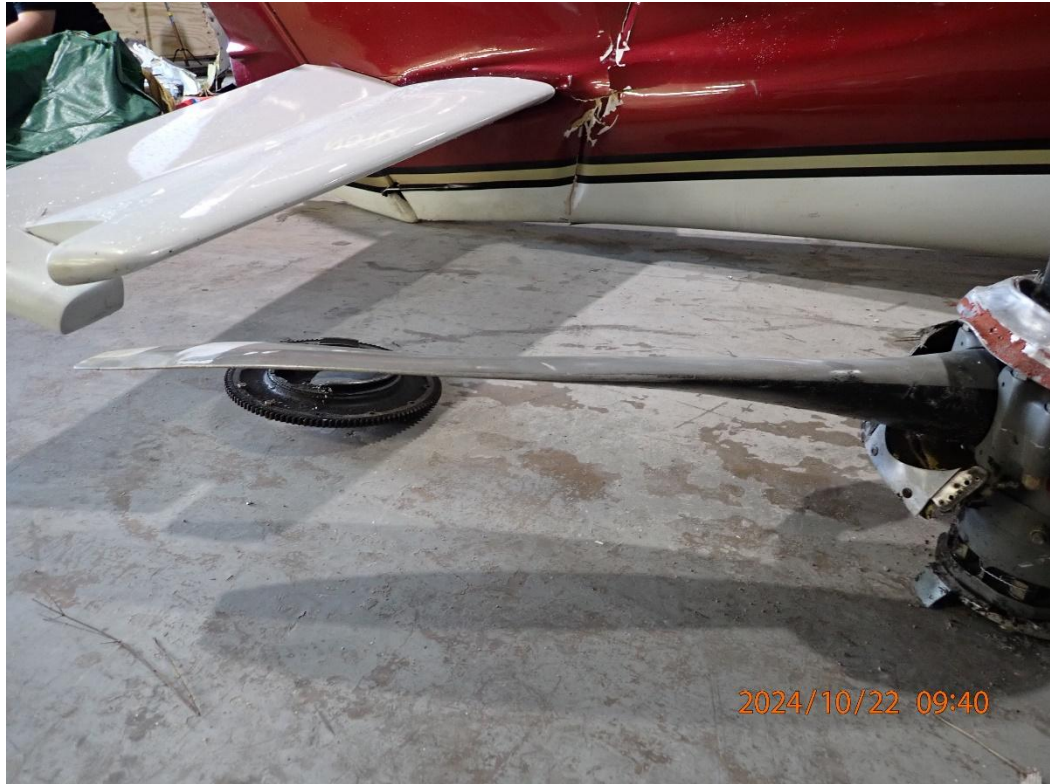
**Photo 45: View of the leading edge of blade B.**

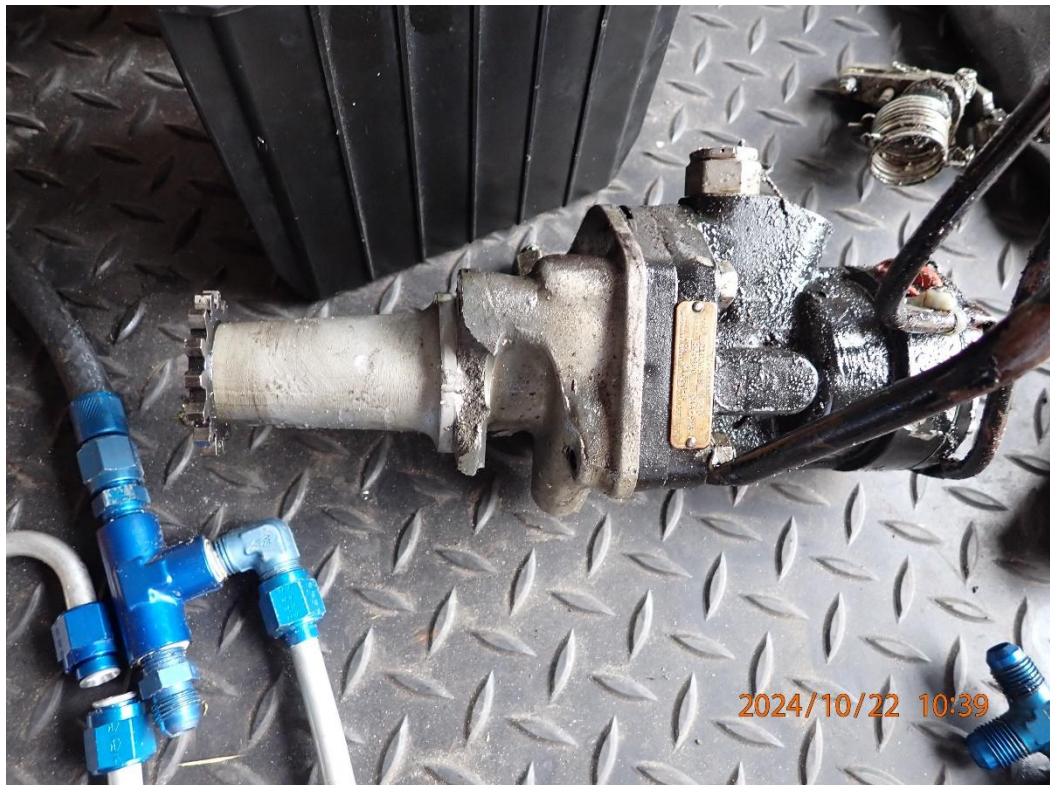
The propeller governor was impact separated from the engine. The drive rotated by hand.

**Photo 46: View of the impact separated propeller governor.**
