# National Transportation Safety Board

ERA25FA037

## **WRECKAGE EXAMINATION**

Location: Wilder, Tennessee 38589  
Date: October 31, 2024  
Time: 1837 CDT  
2337 UTC  
Airplane: N8110S; Cessna 150F

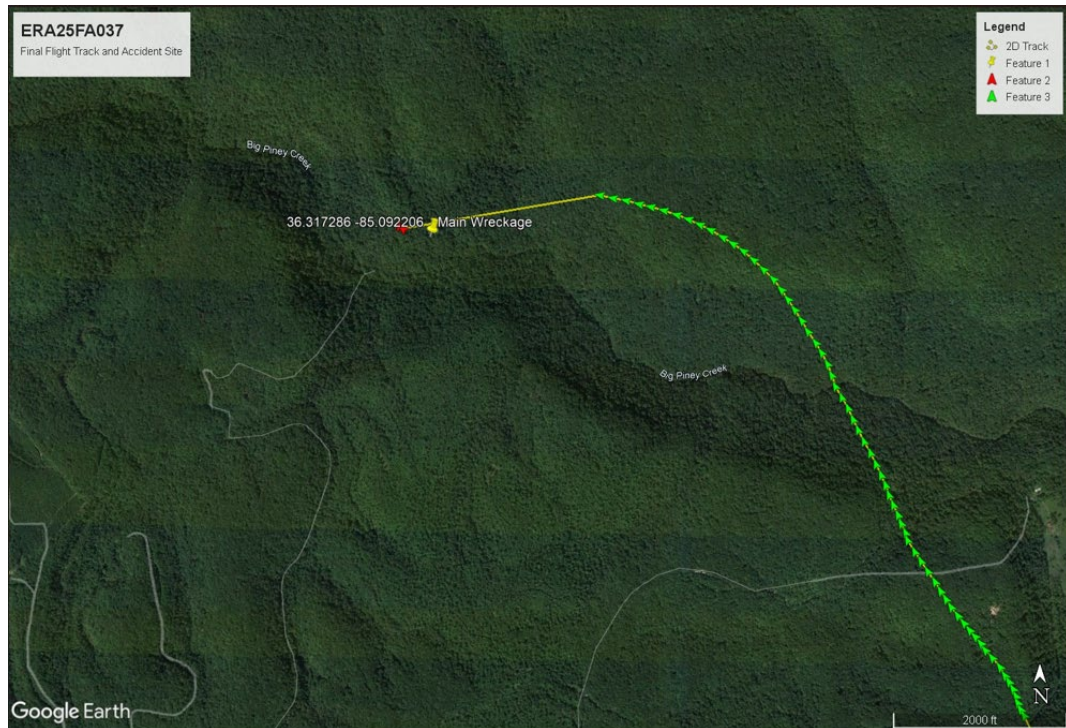
Figure 1 – Flight Path and Accident Site

The airplane crashed in wooded, mountainous terrain at coordinates 36.317286, -85.092206. The accident site was about 22 nm north of Crossville Memorial Airport (CSV), Crossville, Tennessee. CSV was the departure airport for the accident flight.

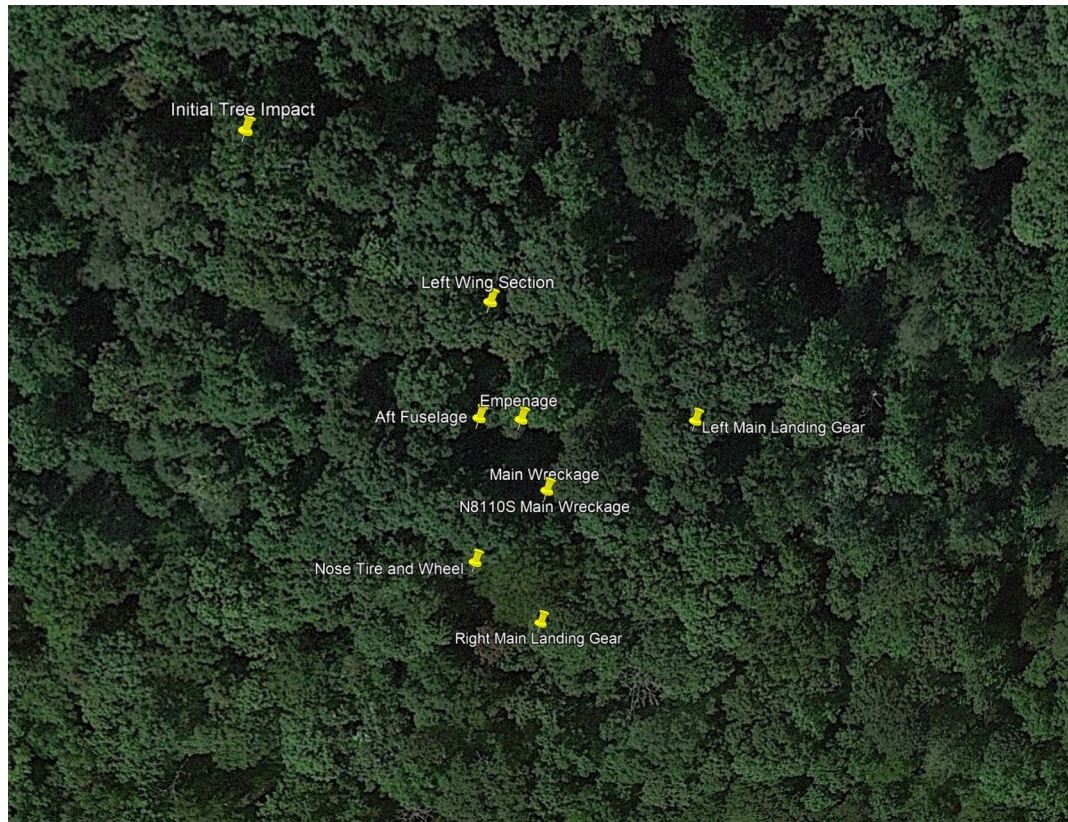
Figure 2 - Wreckage Distribution

The aircraft initially impacted near the tops of 100-ft-tall trees and came to rest inverted near the base of the final tree impact. The wreckage distribution area was about 250-ft-long by 125-ft-wide. Portions of wing skin and windshield fragments were found along the first 165 ft of the wreckage path. The heading between the first tree impact and the main wreckage was about 140° (Figures 1 and 2).
