# National Transportation Safety Board

ERA25FA082

## **WRECKAGE EXAMINATION SUMMARY**

Location: Cintrona, Puerto Rico  
Date: December 20, 2024  
Time: 1400 AST  
1800 UTC  
Airplane: N22088; Cessna 172S

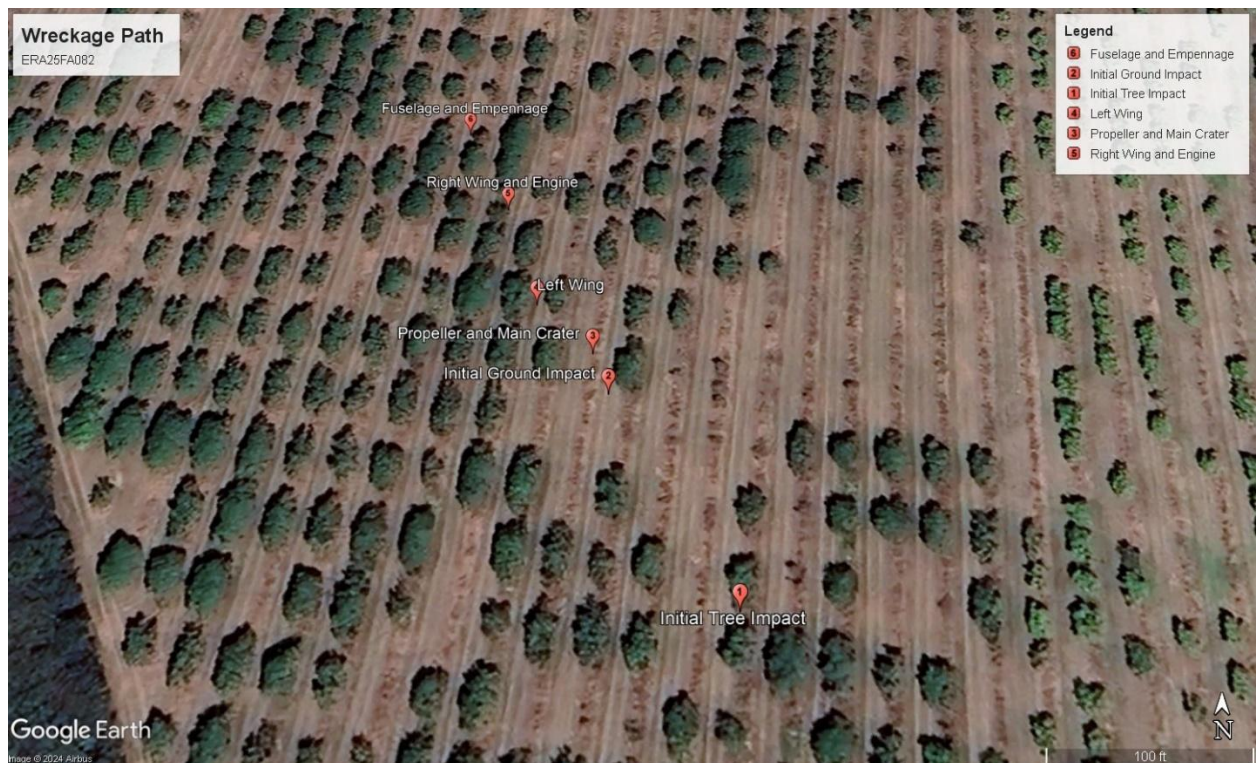
The accident site was located in a mango orchard about 1.8 nautical miles (nm) from the departure end of runway 12 at Mercedita Airport (TJPS), Ponce, Puerto Rico. There was debris strewn along about a 360ft path oriented on a magnetic heading of 345° at an elevation of 46ft mean sea level. The initial impact point was about 15ft up a mango tree. The initial ground impact scar was about 140 ft from the tree impact and contained pieces of wheel fairing imbedded in the scar. The main impact crater which contained the propeller was about 30 ft from the initial ground impact scar. The tree next to the main impact crater contained pieces of wing leading edge and

**Photo 1: Wreckage path.**

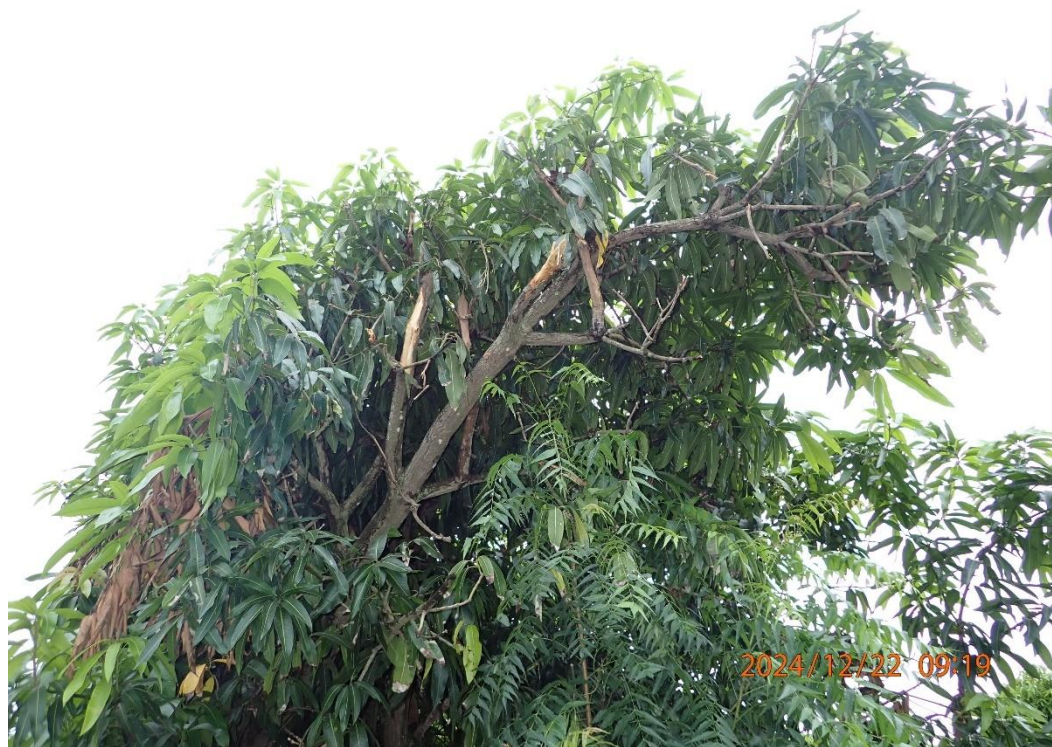
**Photo 2: View of the initial tree impact.**

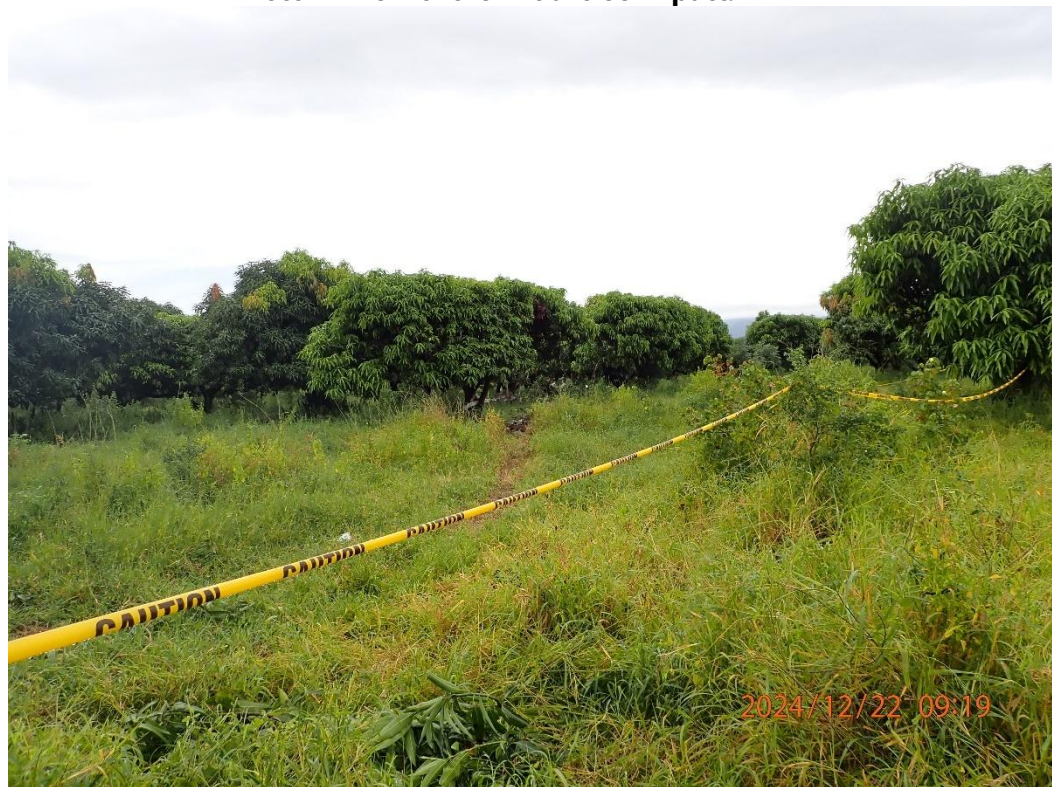
**Photo 3: View of the wreckage path from the initial tree.**

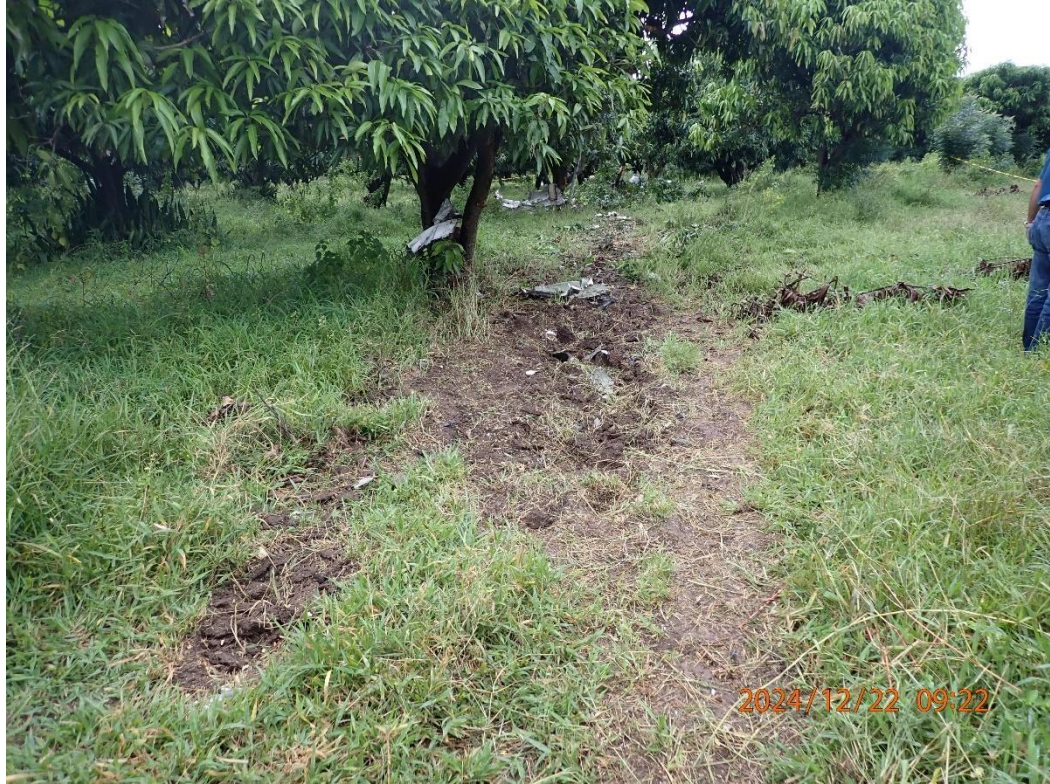
**Photo 4: View of the main impact crater.**

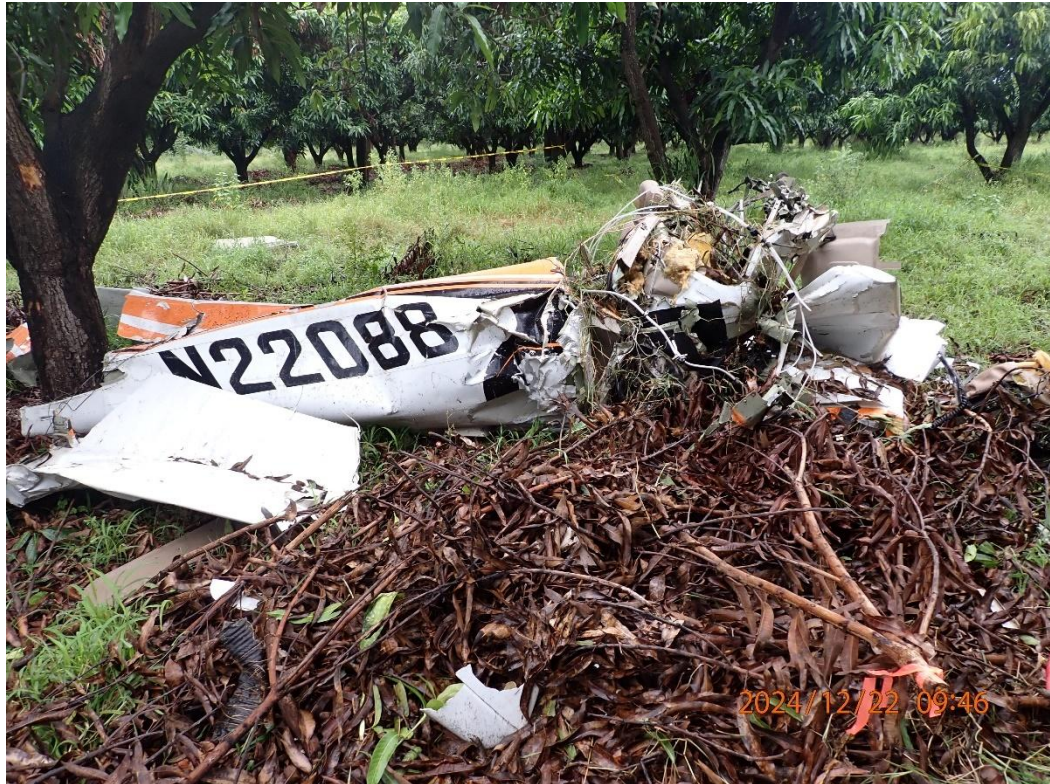
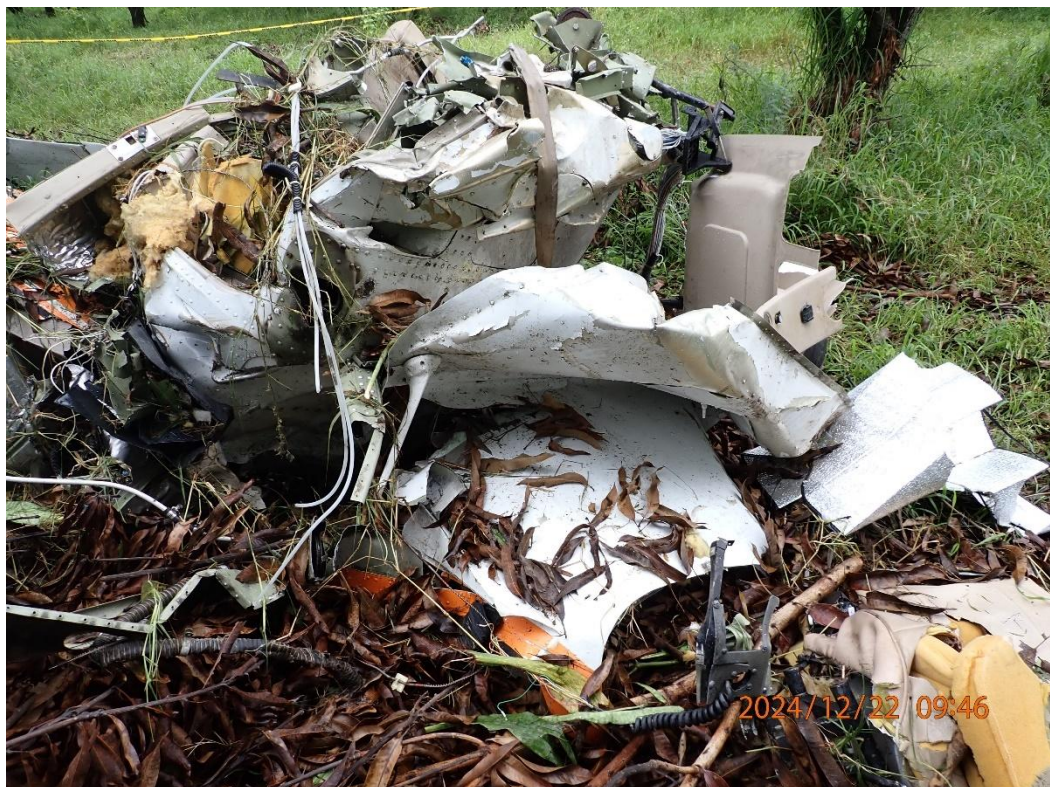
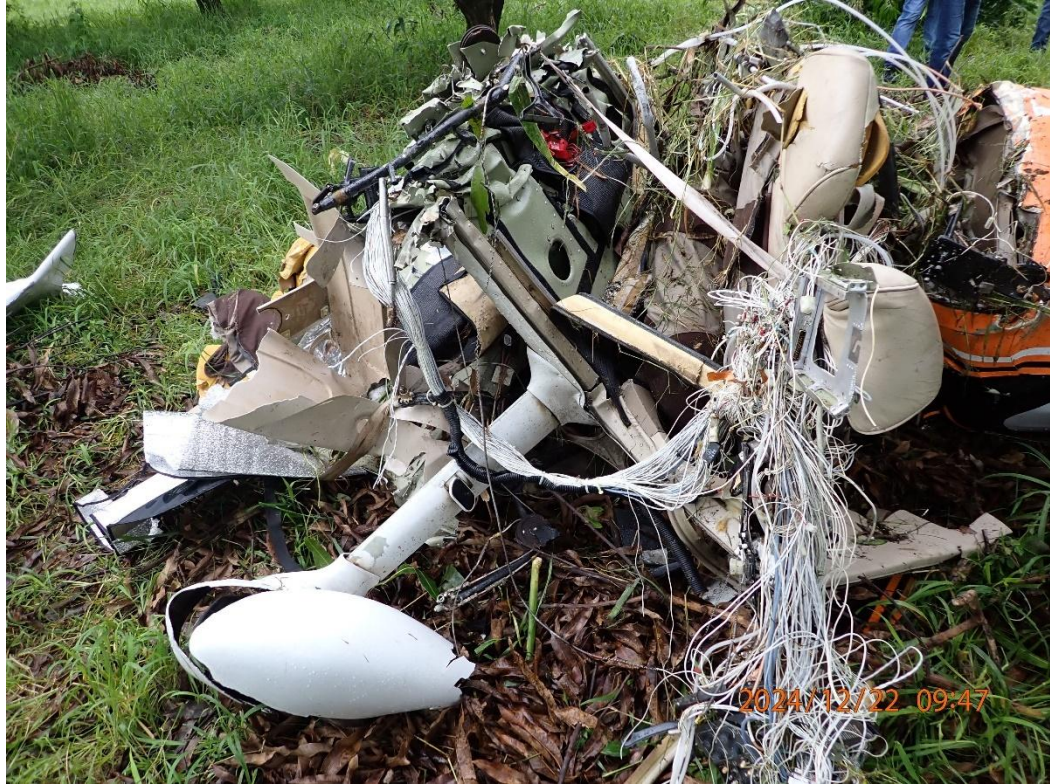
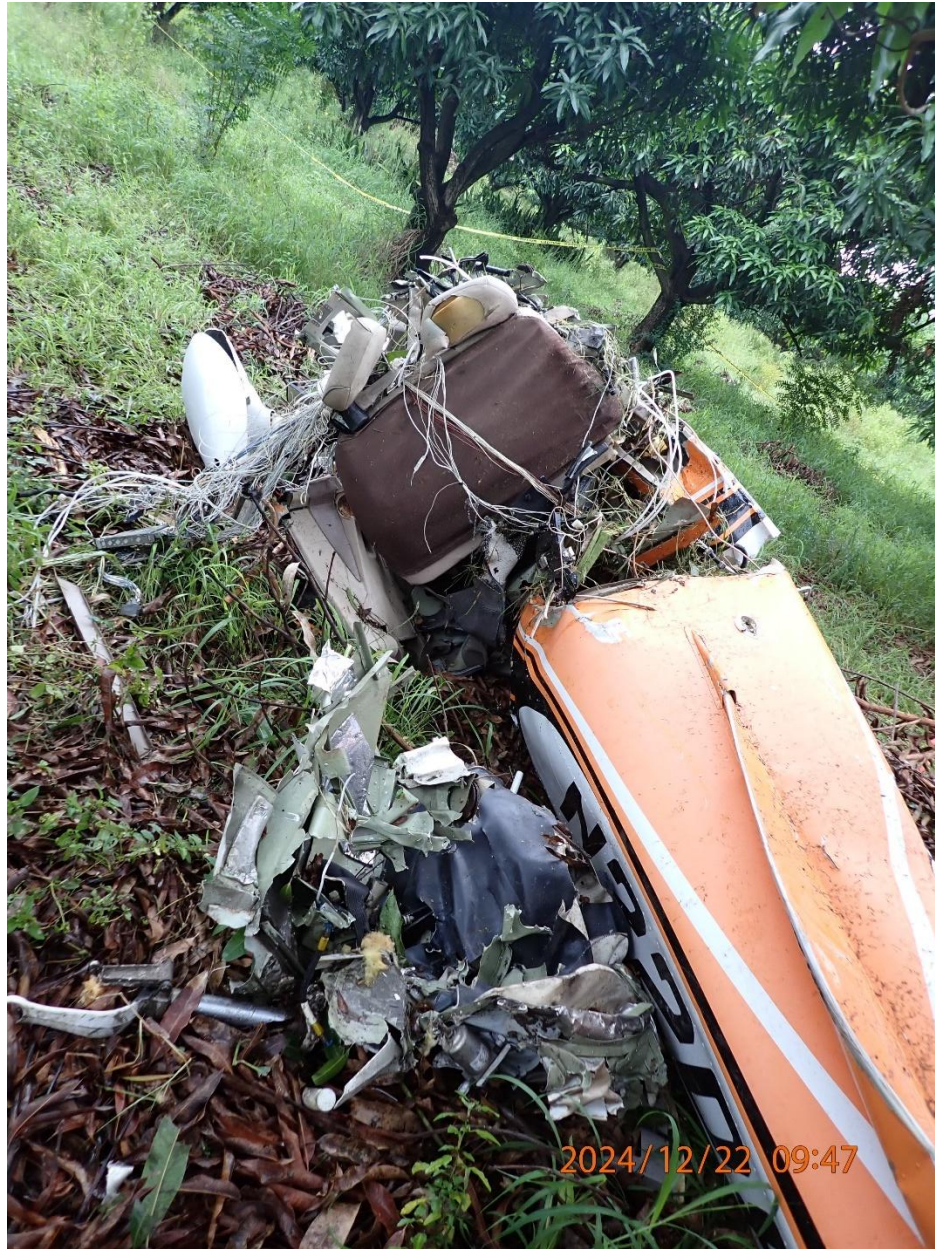
The fuselage was twisted and exhibited extreme impact damage. Multiple pieces of fuselage were scattered along the debris path.

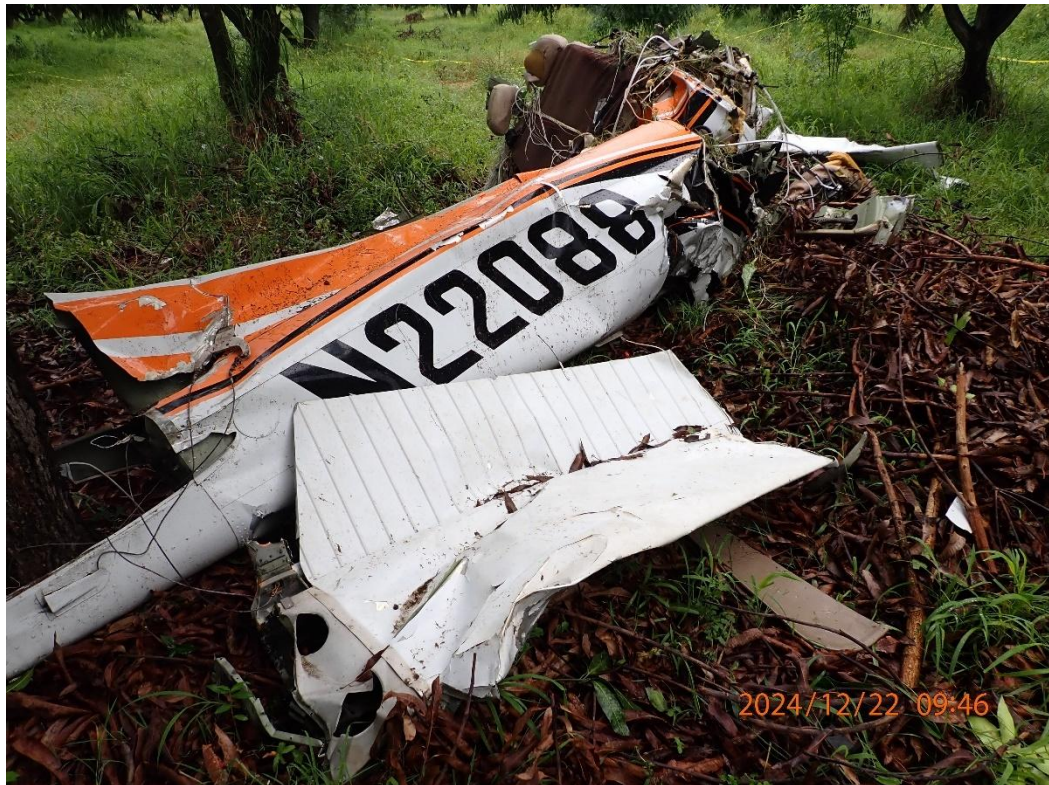
The empennage remained attached to the fuselage. The vertical stabilizer and rudder were impact separated. The rudder control cables remained attached to the rudder flight control horn and were continuous to the rudder pedals. The left horizontal stabilizer and elevator remained as one piece and attached only through the control cables. The right horizontal stabilizer, elevator and elevator trim remained

**Photo 9: View of the empennage and left horizontal stabilizer with elevator attached.**

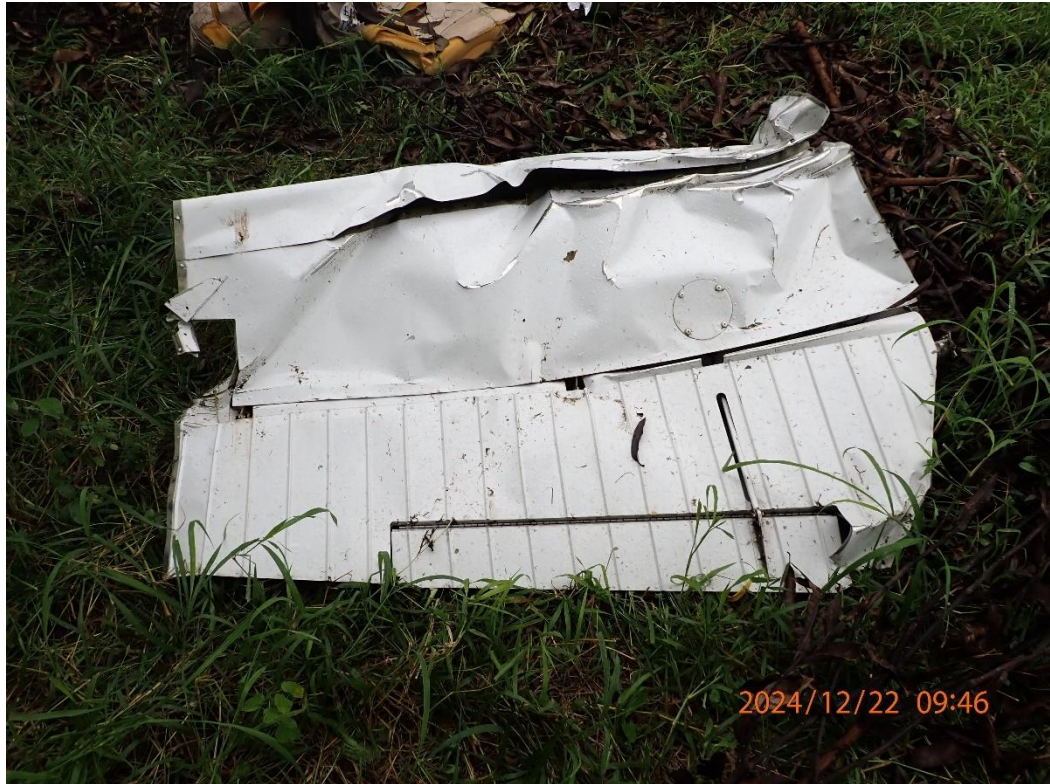
as one piece and were impact separated from the empennage. The elevator control was continuous from the flight control surface bellcrank to the cockpit bellcrank. The elevator push pull tube from the control Y was impact separated. The elevator trim cable was impact fractured and exhibited broomstraw and unraveling, a portion of the cable was sent to the NTSB materials laboratory for further examination. The trim tab actuator was measured and equated to 5° tab trailing edge up.

**Photo 10: View of the right horizontal stabilizer, elevator, and elevator trim tab.**

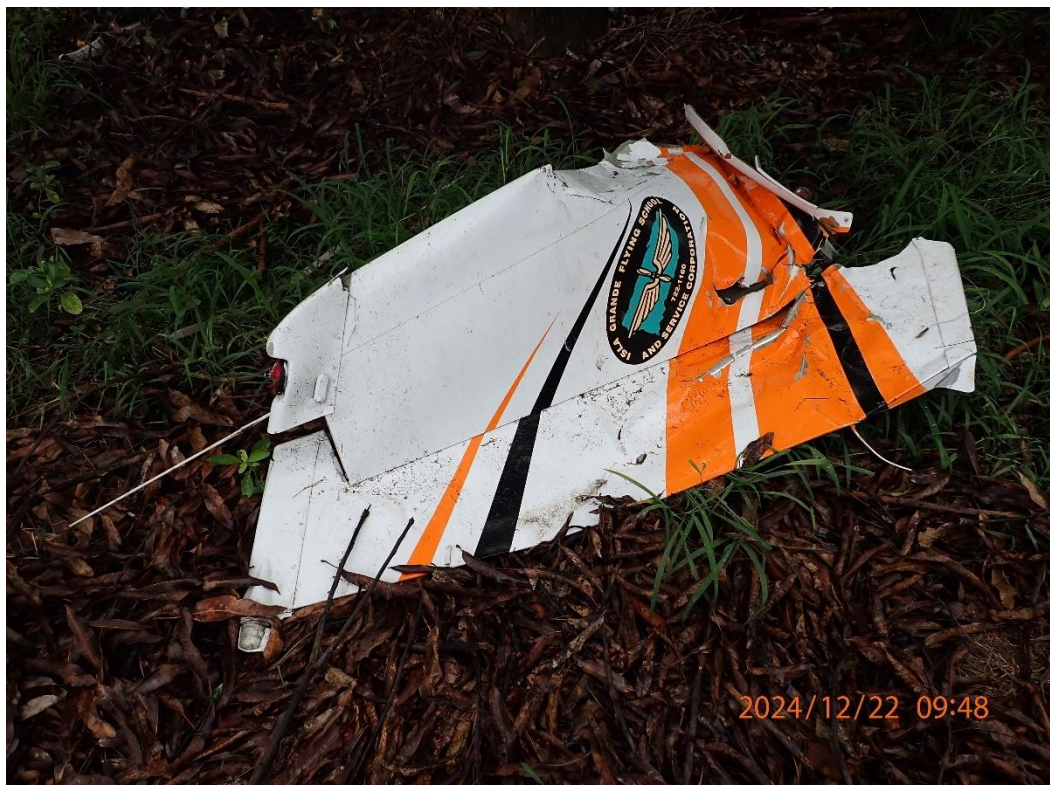
**Photo 11: View of the vertical stabilizer and rudder.**

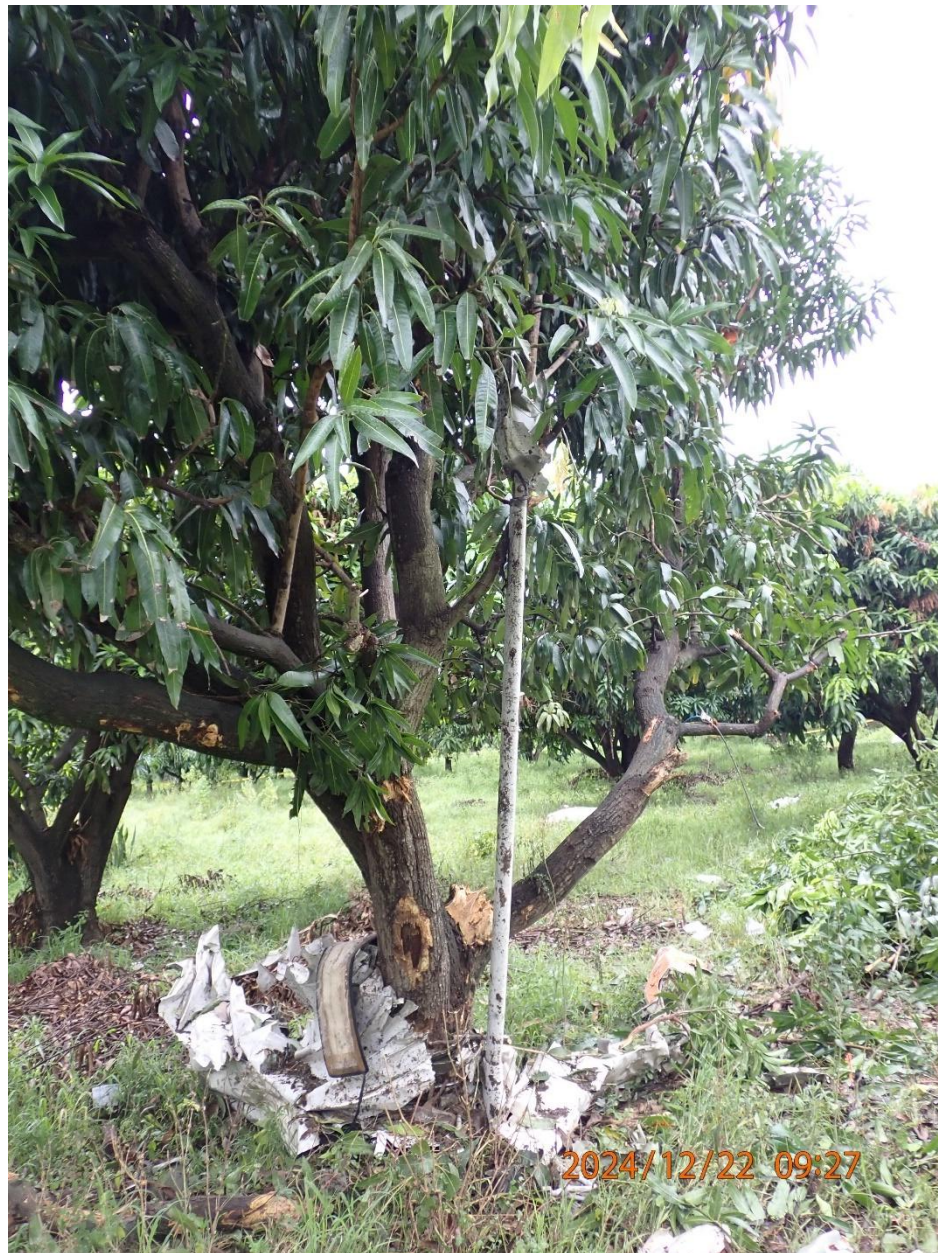
The left wing was impact separated, wrapped around a tree, and exhibited extreme impact damage. The left wing strut remained attached to the wing. The left aileron remained partially attached to the wing with pieces of it impact separated and strewn in the debris path. The inboard aft portion of the left wing including the fuel tank and flap were impact separated and found about 75 ft past the left wing. Left aileron continuity was confirmed from the control surface bellcrank to the flight control in the cockpit through multiple impact overload fractures. The overload fractures exhibited broomstraw appearance and unraveling of the control cable.

**Photo 12: View of a tree with the left wing wrapped around the trunk.**

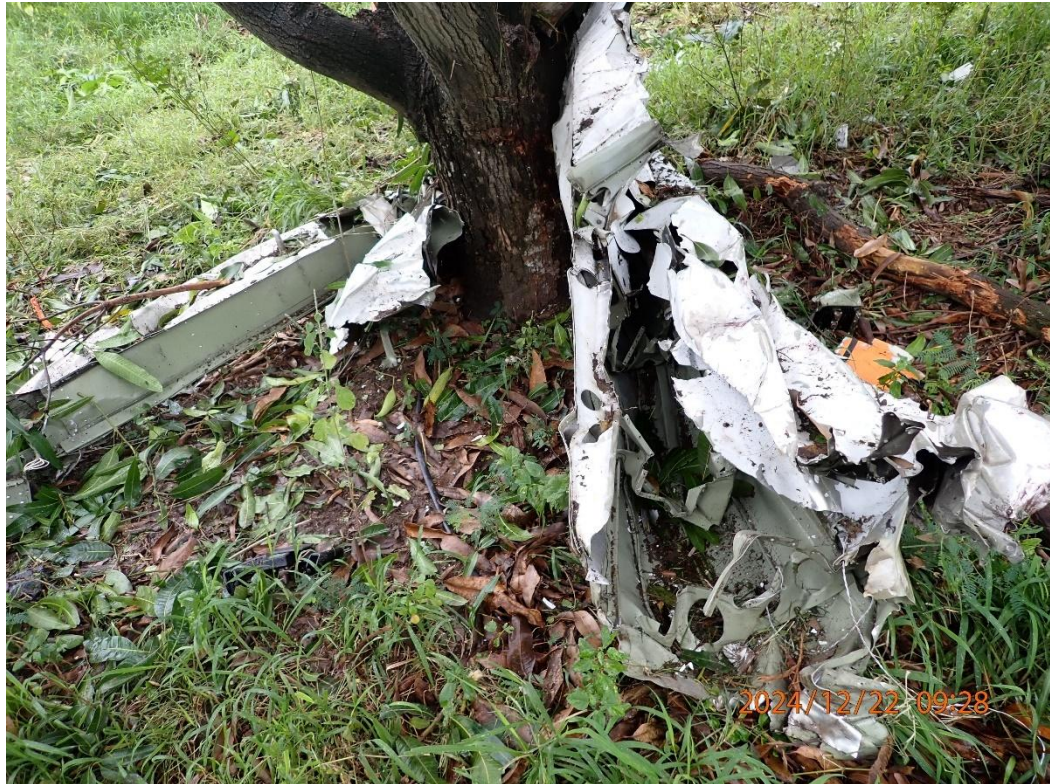
**Photo 13: View of the left wing wrapped around a tree.**

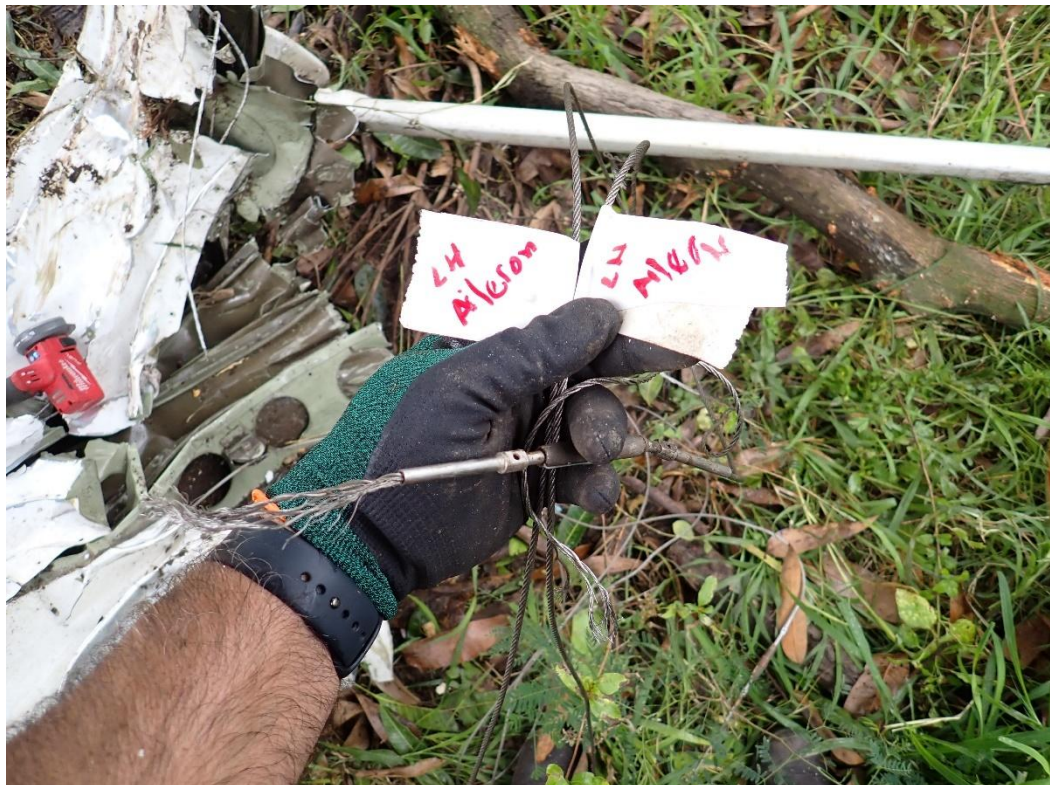
**Photo 16: View of the left aileron control cables.**

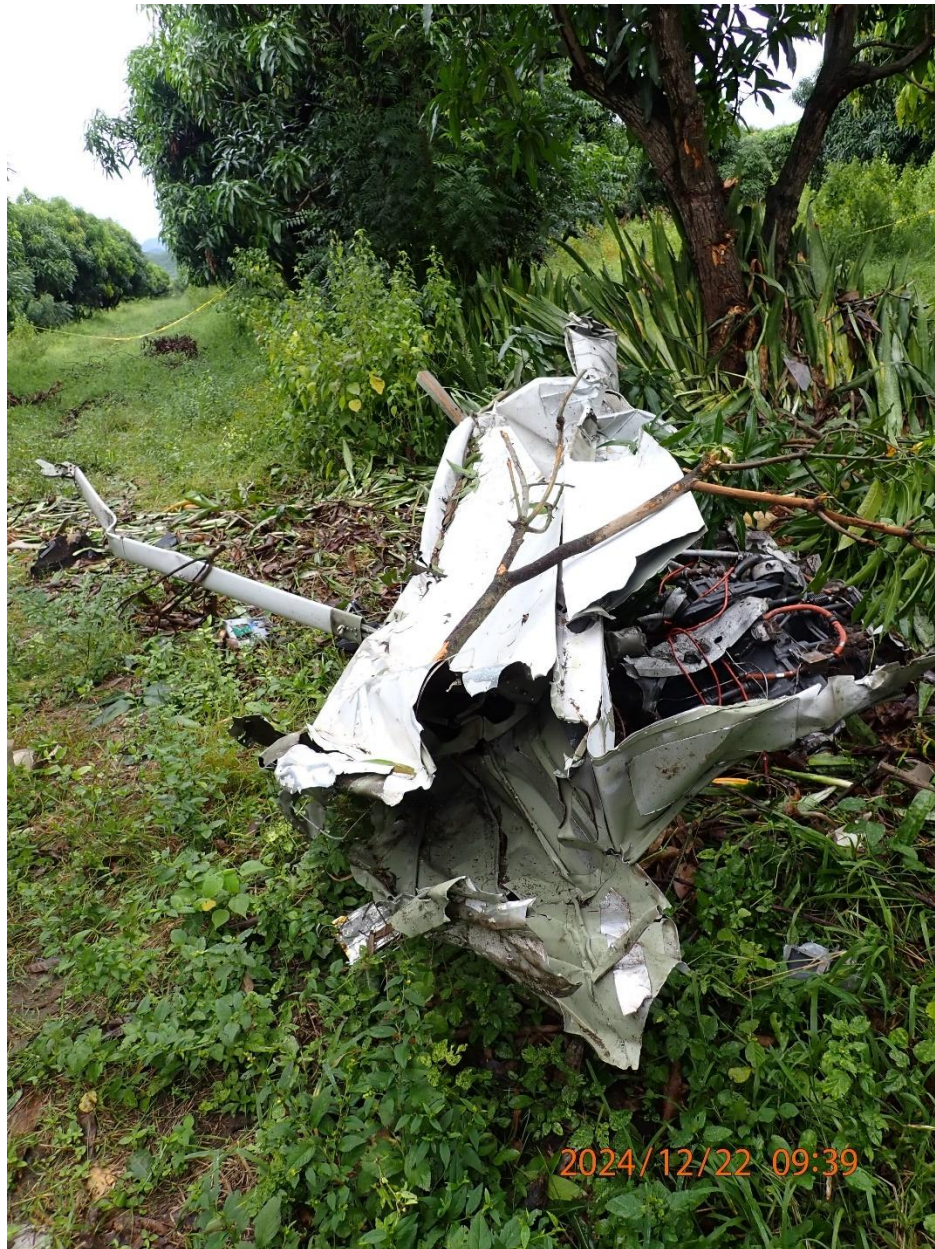
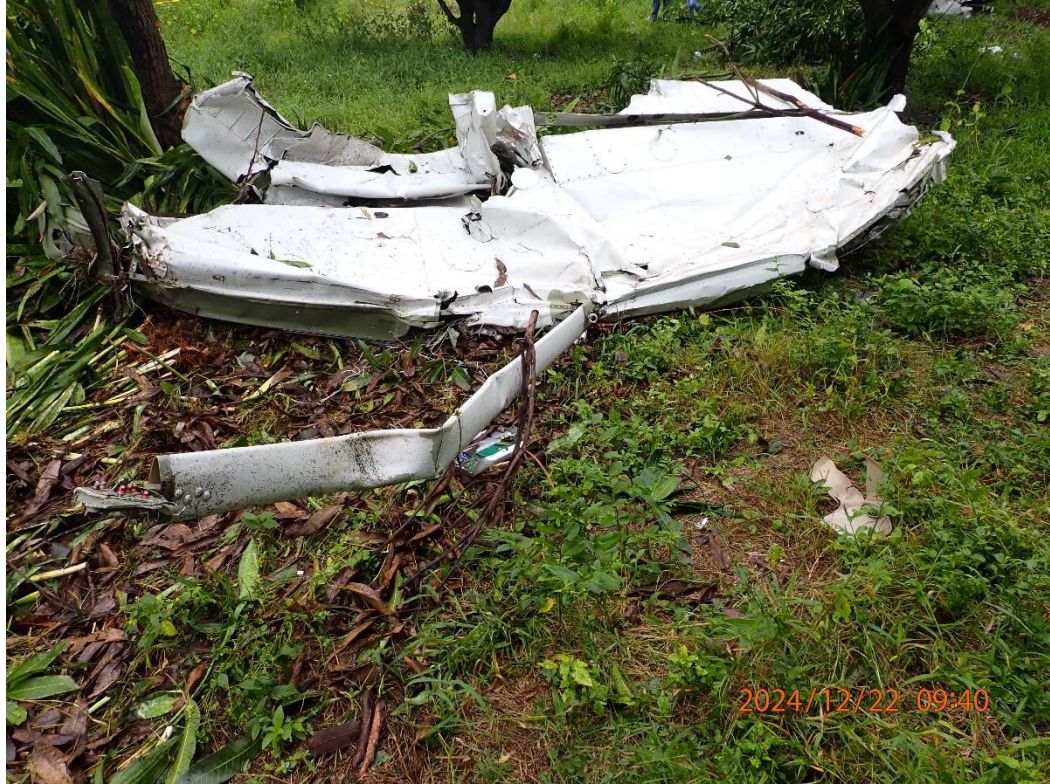
The right wing was impact separated and exhibited impact crushing. The right wing strut remained attached to the wing. The right aileron remained partially attached with pieces of aileron strewn along the debris path. The right flap remained attached to the wing and was in the UP position. The flap motor was examined and when measured the jackscrew was consistent with the flaps being in the UP position. Right aileron continuity was confirmed from the control surface bellcrank to the flight control in the cockpit through multiple impact overload fractures. The overload fractures exhibited broomstraw appearance and unraveling of the control cable.

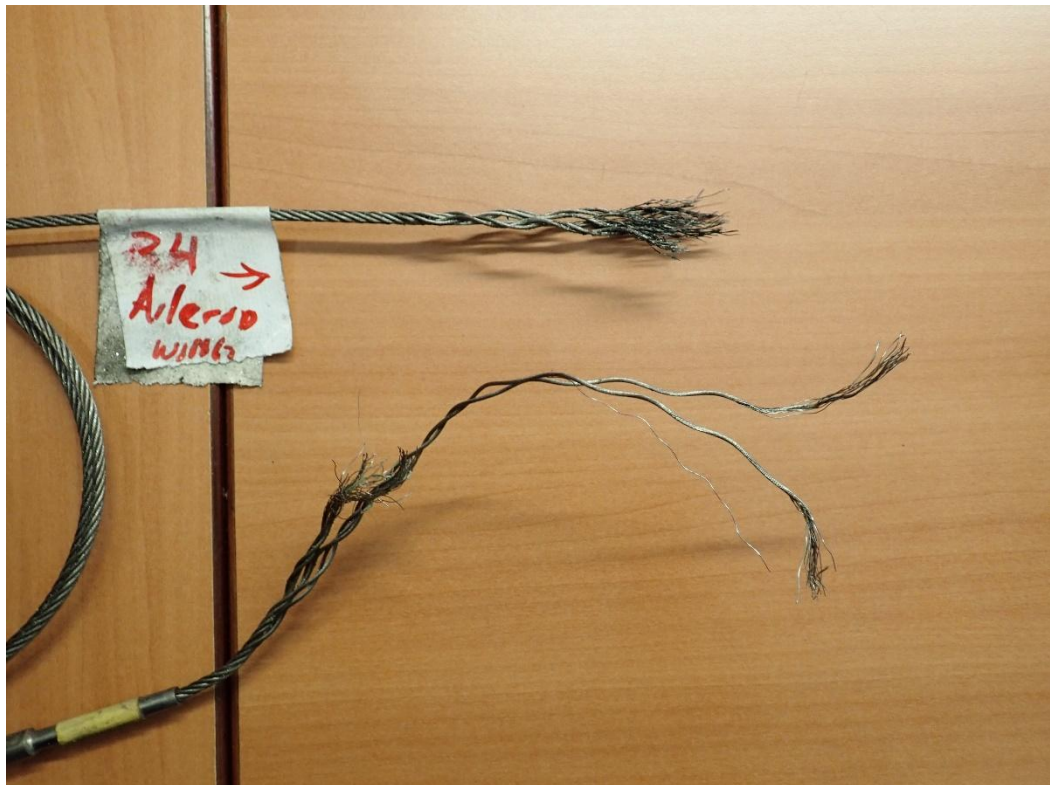
**Photo 19: View of the right aileron control cable ends.**

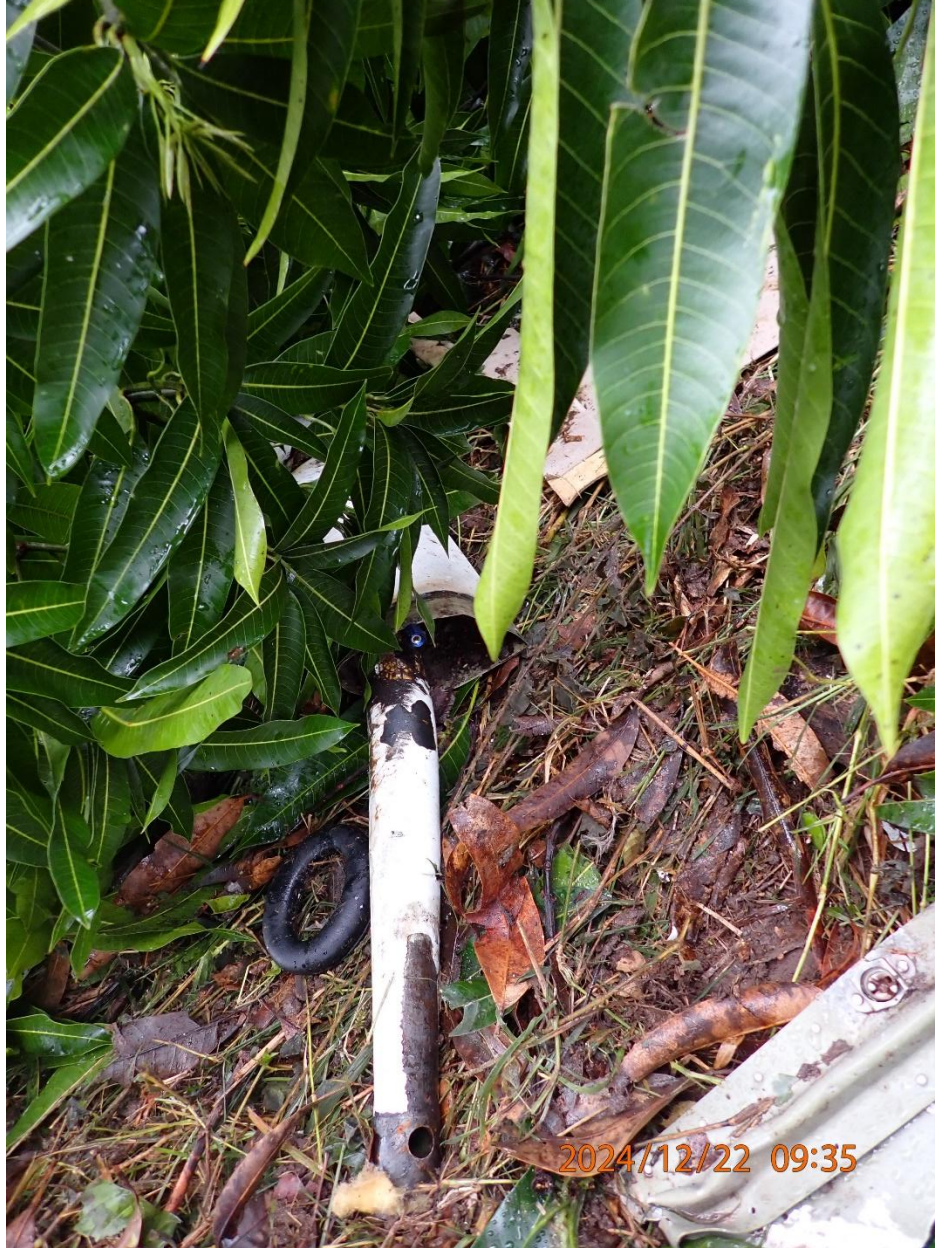
The left main landing gear remained attached to the fuselage. The right main landing gear was impact separated and located in the vicinity of the left wing. The right main landing gear tire was not located. The nose landing gear strut remained attached to the firewall and exhibited impact damage. The nose landing gear tire was located about 30 ft past the main impact crater and had wood wedged between the tire and wheel rim.

**Photo 21: View of the impact separated right main landing gear.**

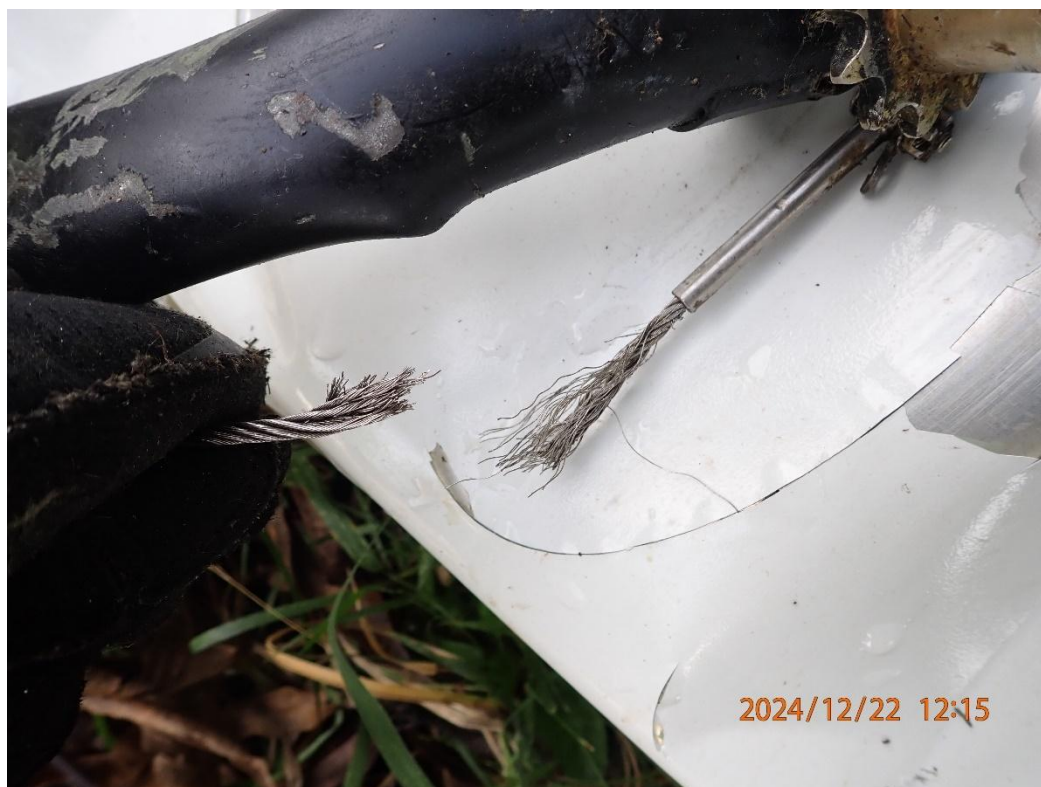
The cockpit was destroyed by impact forces. The control yoke interconnect cable was found separated. The aileron cables were overload separated at the cockpit.

**Photo 23: View of the control cable fracture.**

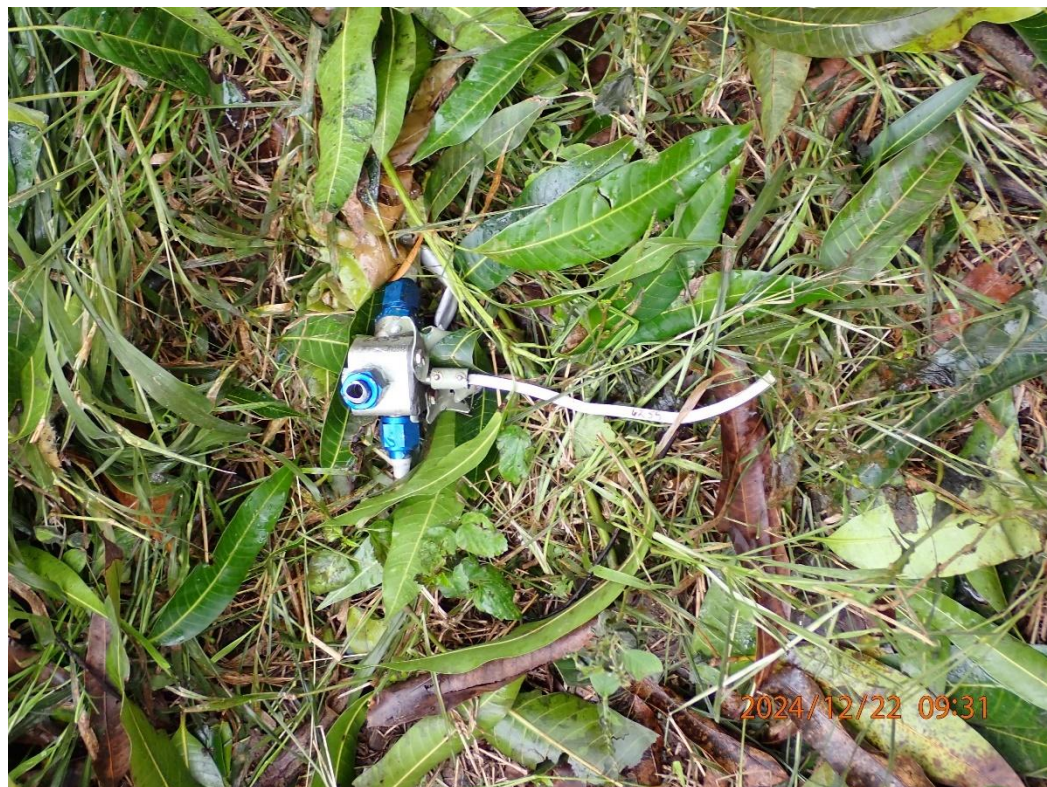
Both wing fuel tanks were breached, and the fuel caps were not installed. One fuel cap was located in the debris field and exhibited bending consistent with it being locked in place prior to impact. The other fuel cap was not located. The fuel selector was impact separated and found in the debris field exhibiting impact damage. Examination of the fuel selector found it in the both position. The fuel strainer remained attached to the firewall.

**Photo 24: View of the fuel selector as found.**

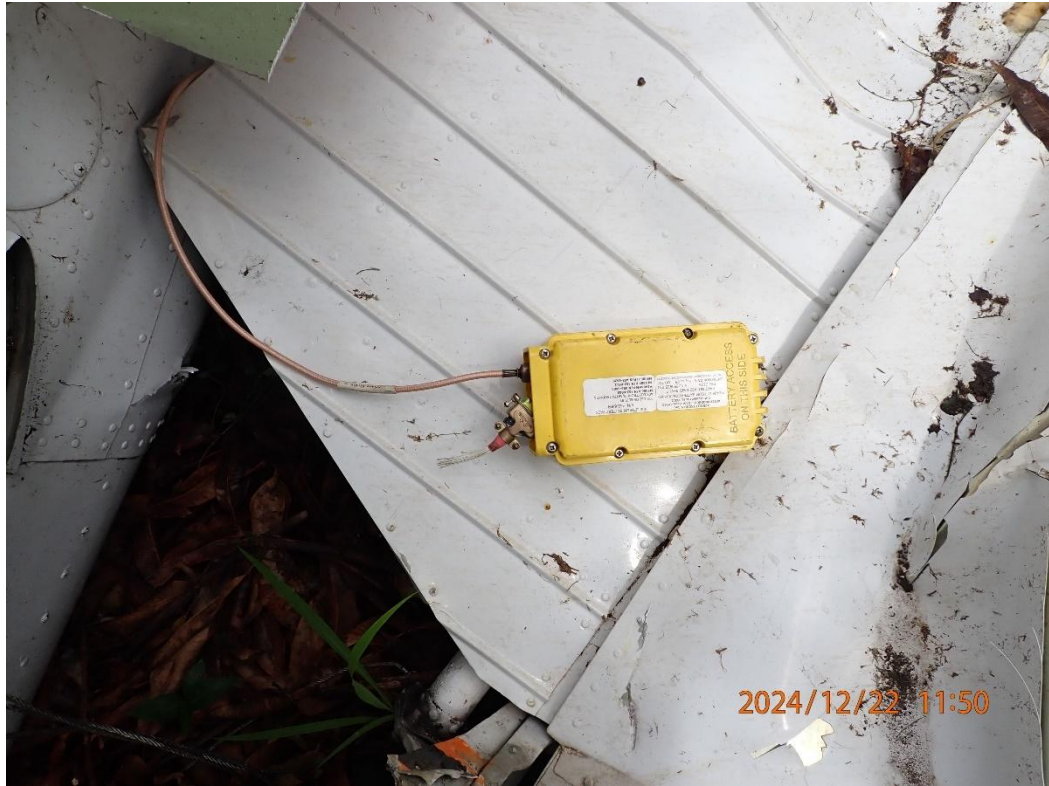
The ELT was found in the fuselage and was attached to the antenna. When examined the ELT was armed and active.

**Photo 25: View of the ELT.**
