# National Transportation Safety Board

ERA25FA082

## **WRECKAGE EXAMINATION SUMMARY**

Location: Cintrona, Puerto Rico  
Date: December 20, 2024  
Time: 1400 AST  
1800 UTC  
Airplane: N22088; Cessna 172S

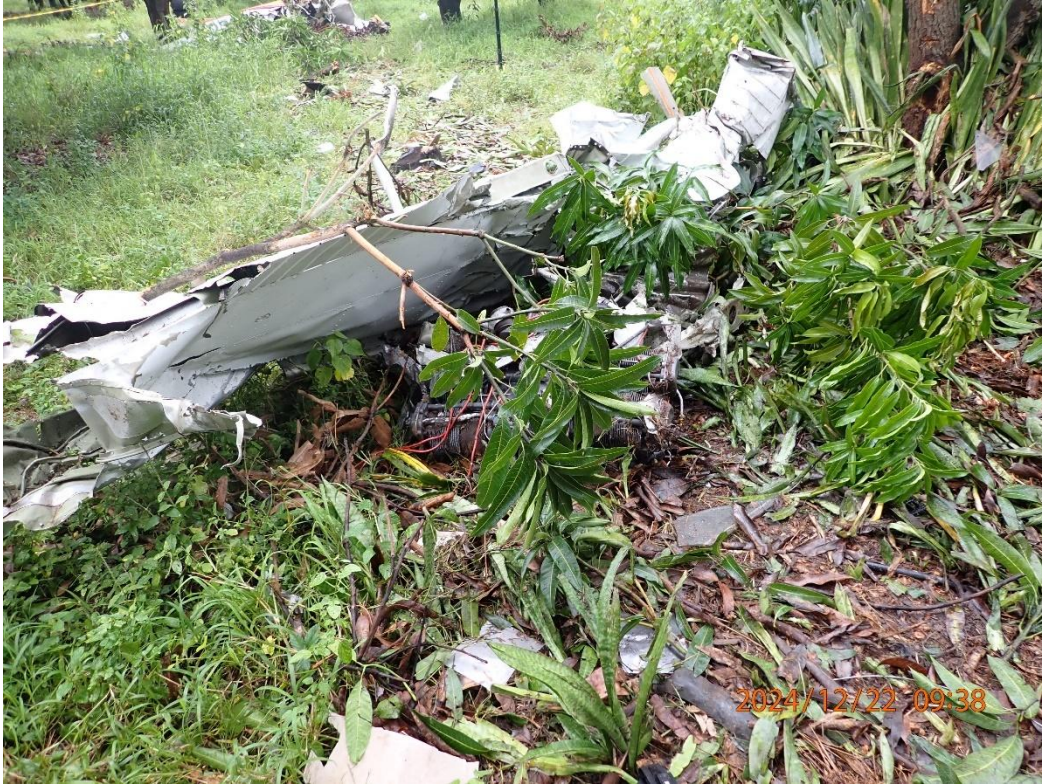
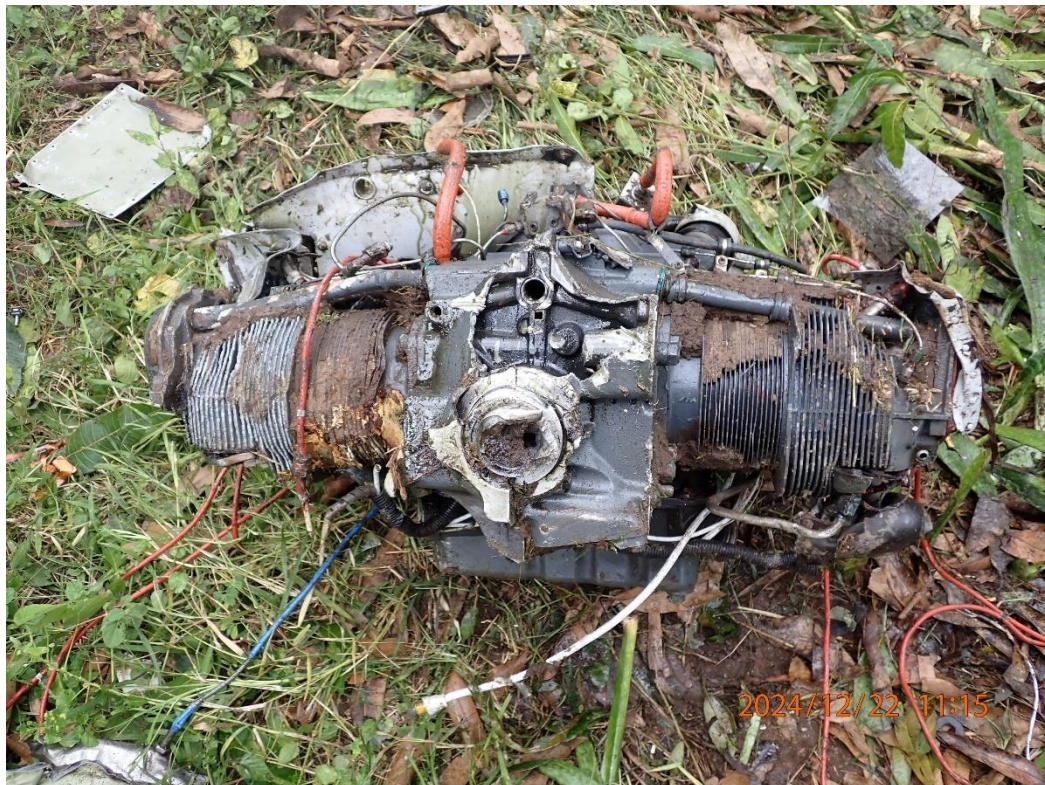
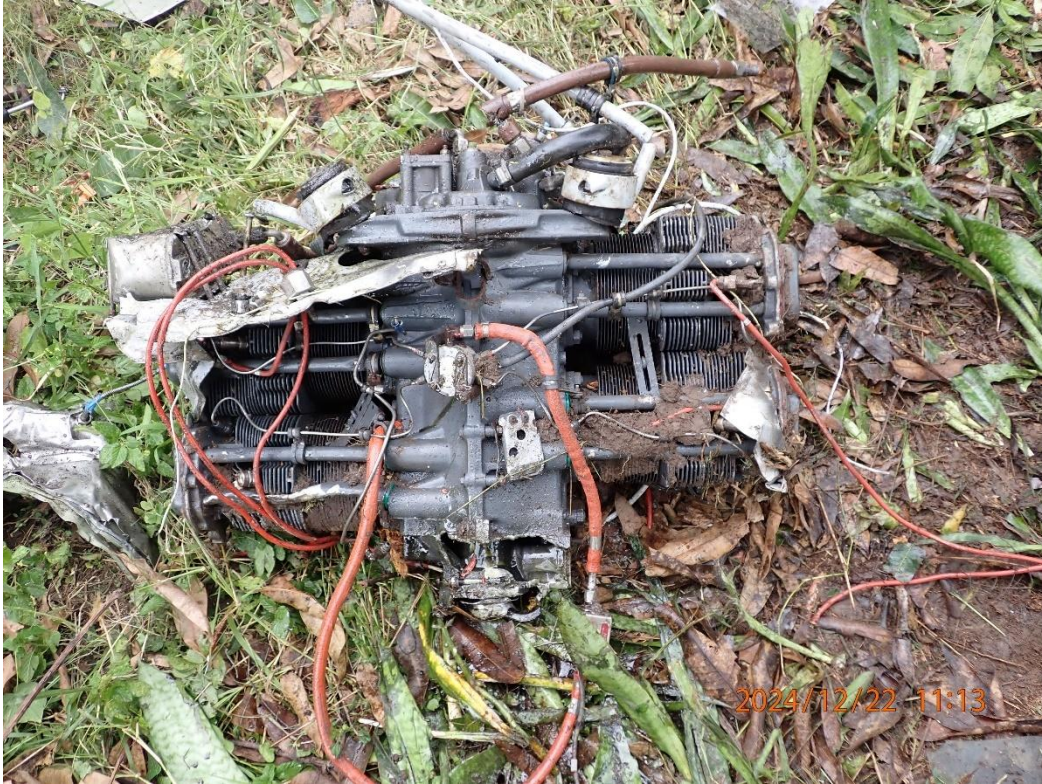
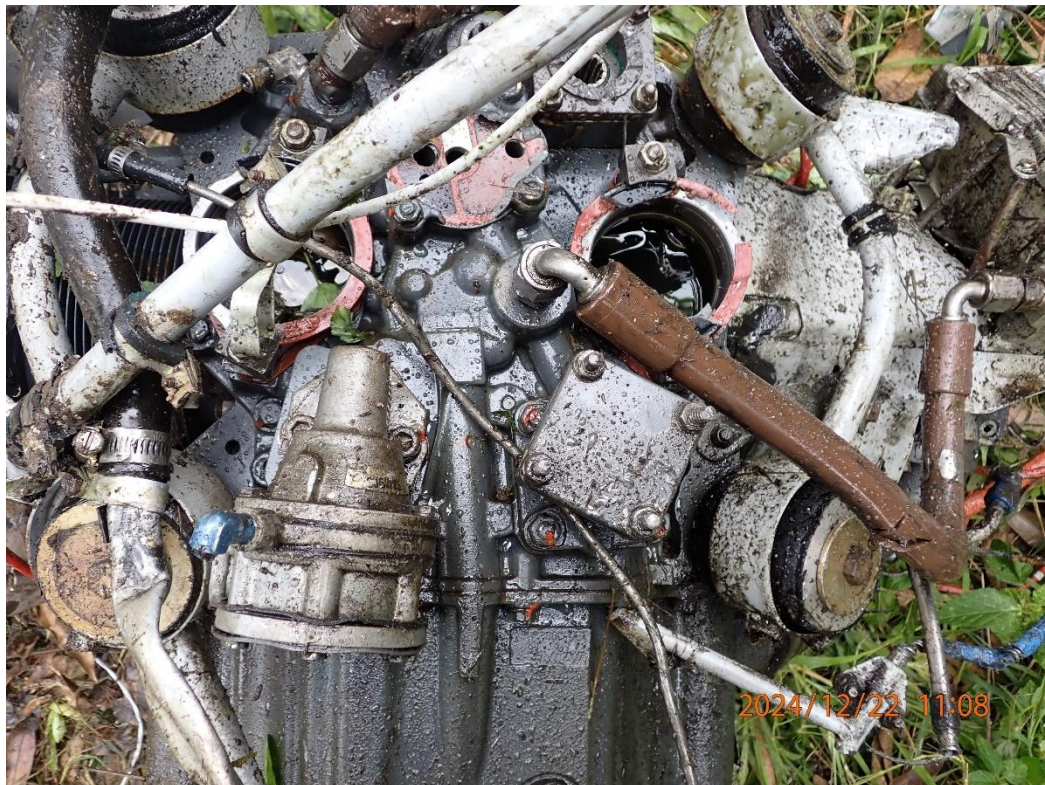
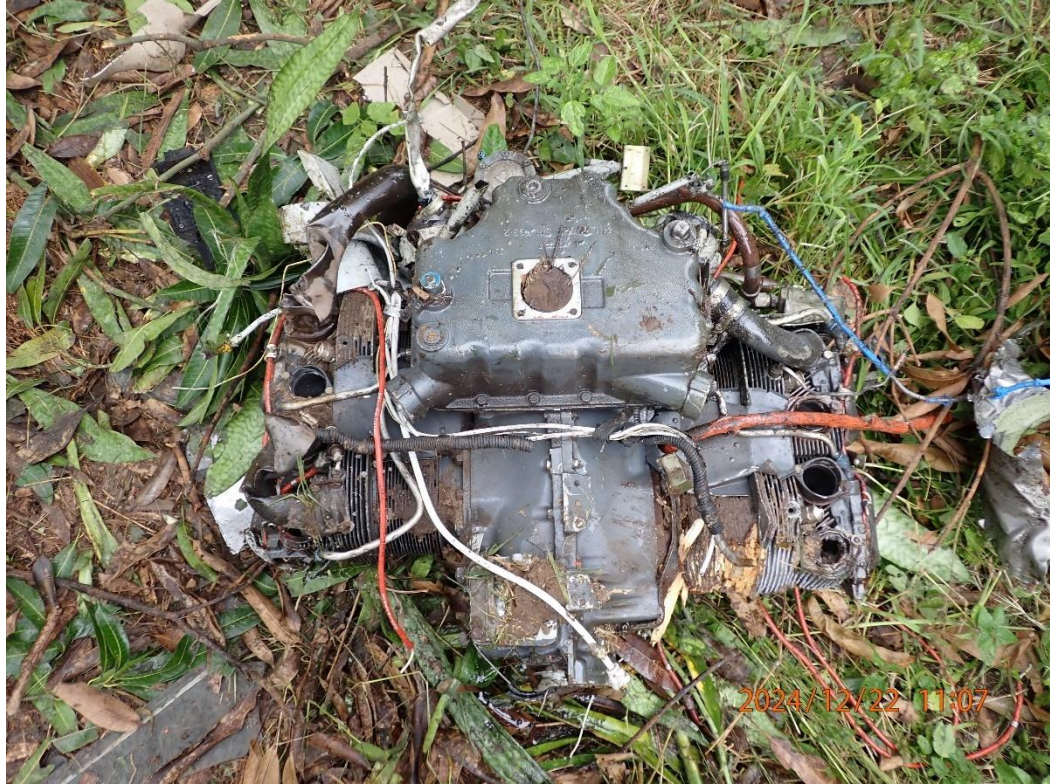
The engine exhibited impact damage to the case. The crankshaft flange was impact separated and remained attached to the propeller.

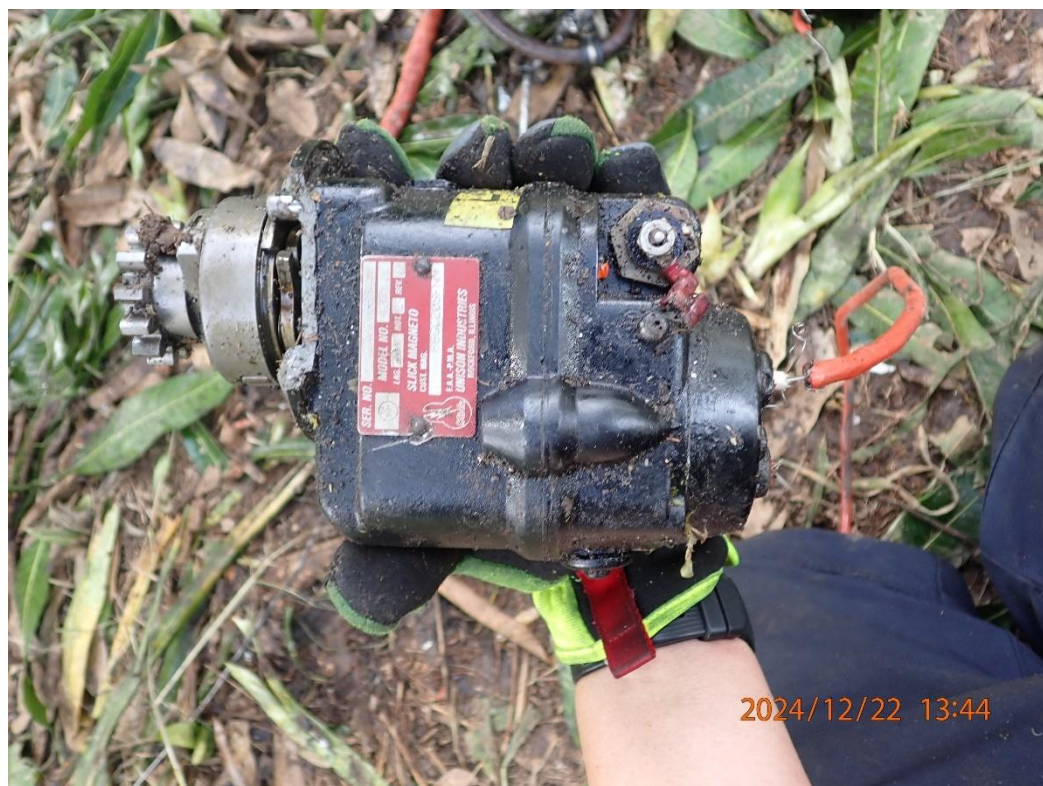
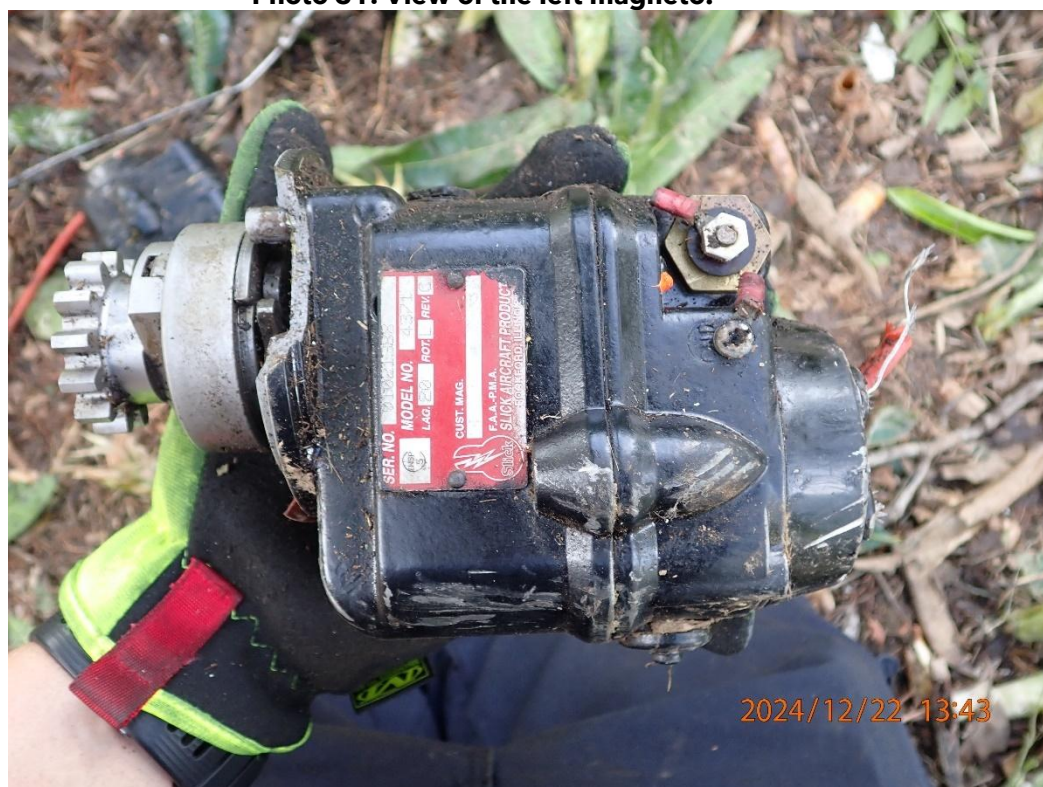
Both magnetos were impact separated from the engine and found in the debris path. Both magnetos impulse couplings snapped when the magneto was rotated by hand.

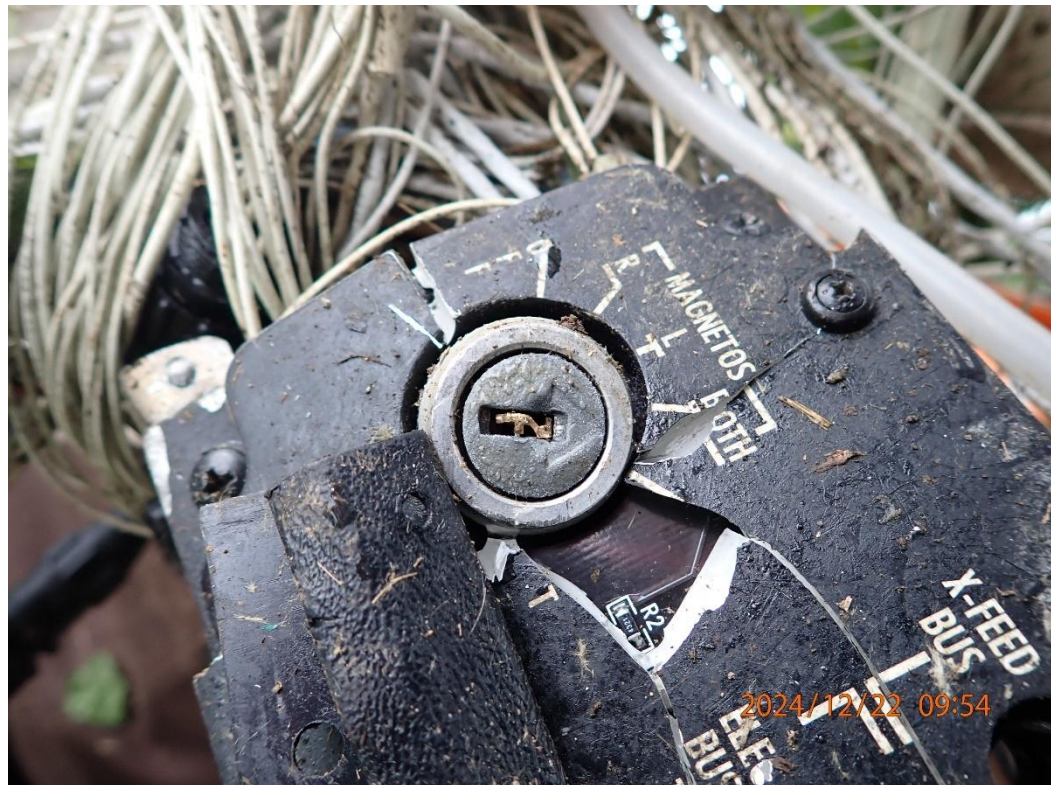
The ignition key was found in the both position and the key was broken. The ignition leads from the magnetos to the sparkplugs were impact separated. All sparkplugs remained in their respective positions and exhibited impact damage.

**Photo 33: View of the ignition key broken in the BOTH position.**

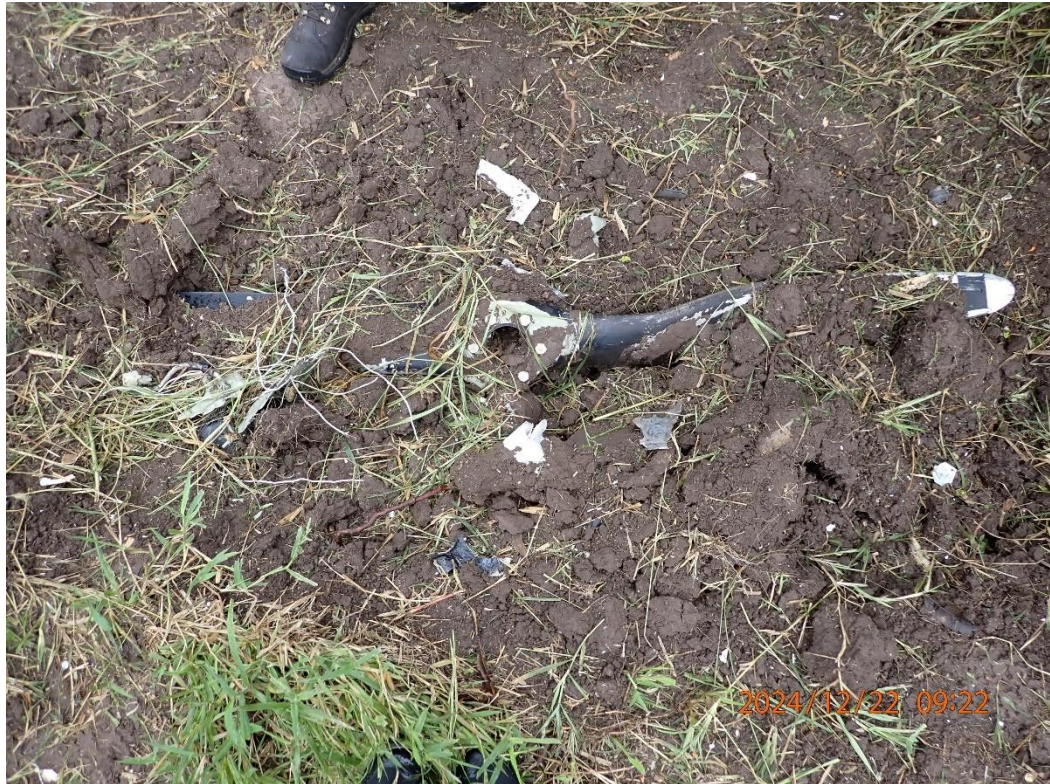
The propeller exhibited S bending, leading edge polishing, and chordwise scratching. The propeller was buried about 8 inches in the dirt in the main impact crater.

**Photo 41: View of the propeller as found.**

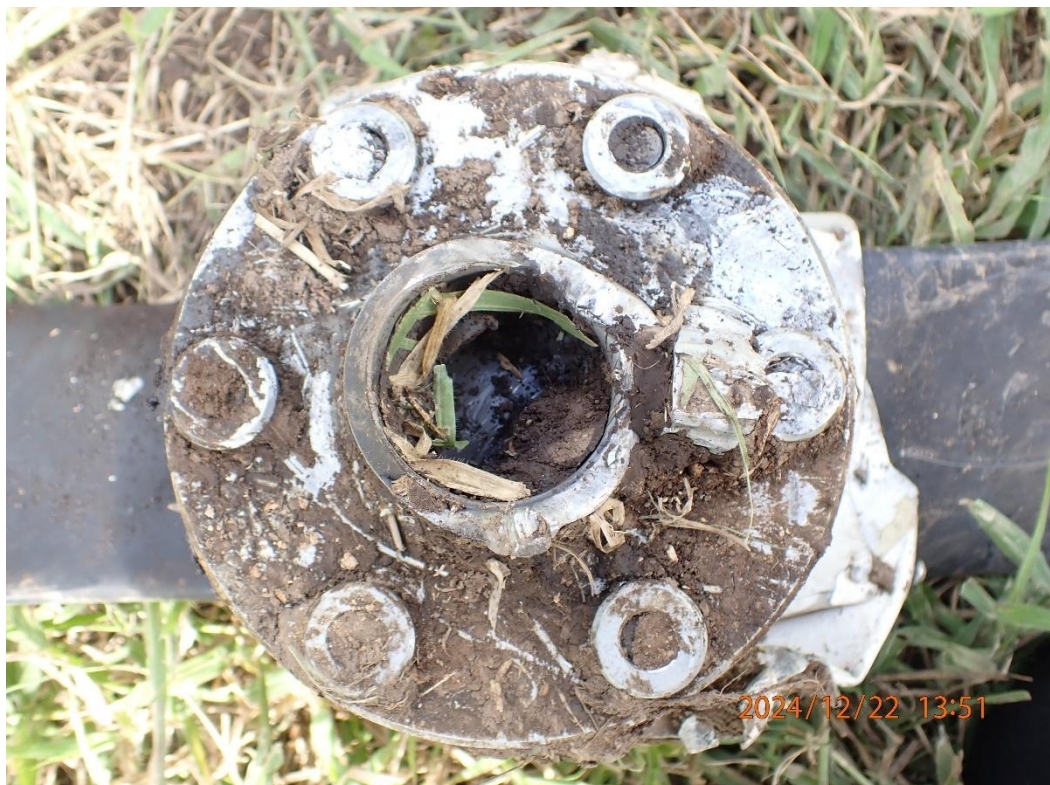
**Photo 42: View of the crankshaft flange attached to the propeller.**

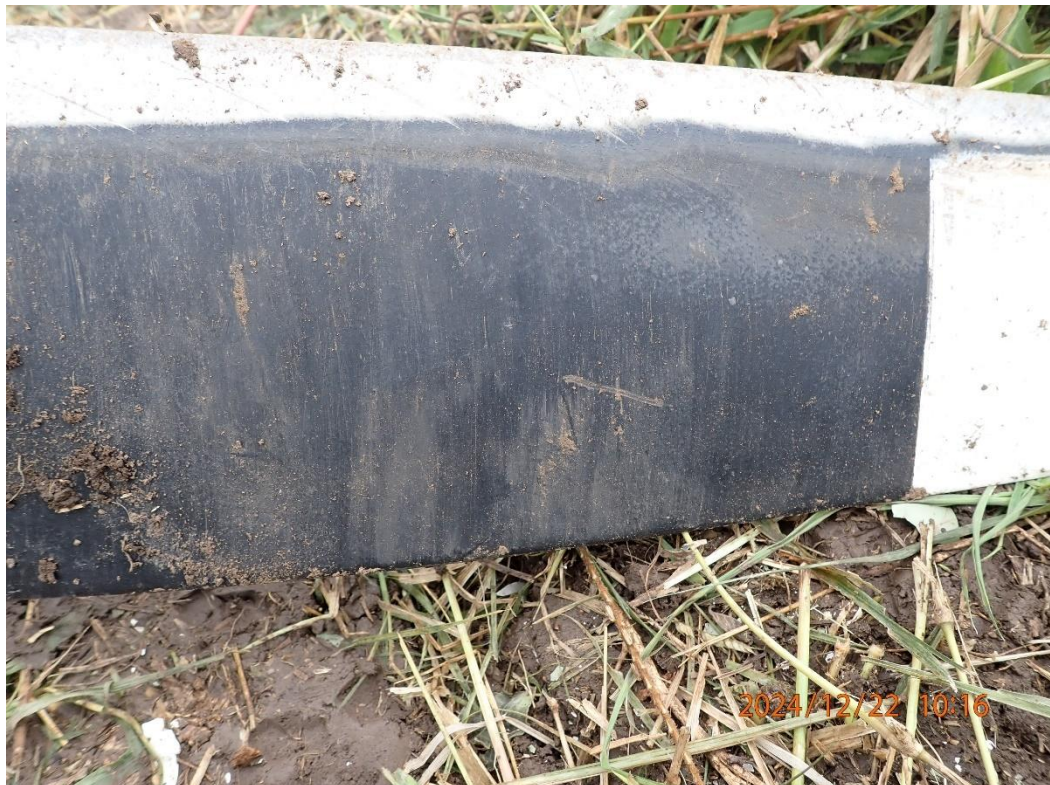
**Photo 46: View of chordwise scratching and leading edge polishing/scratching.**

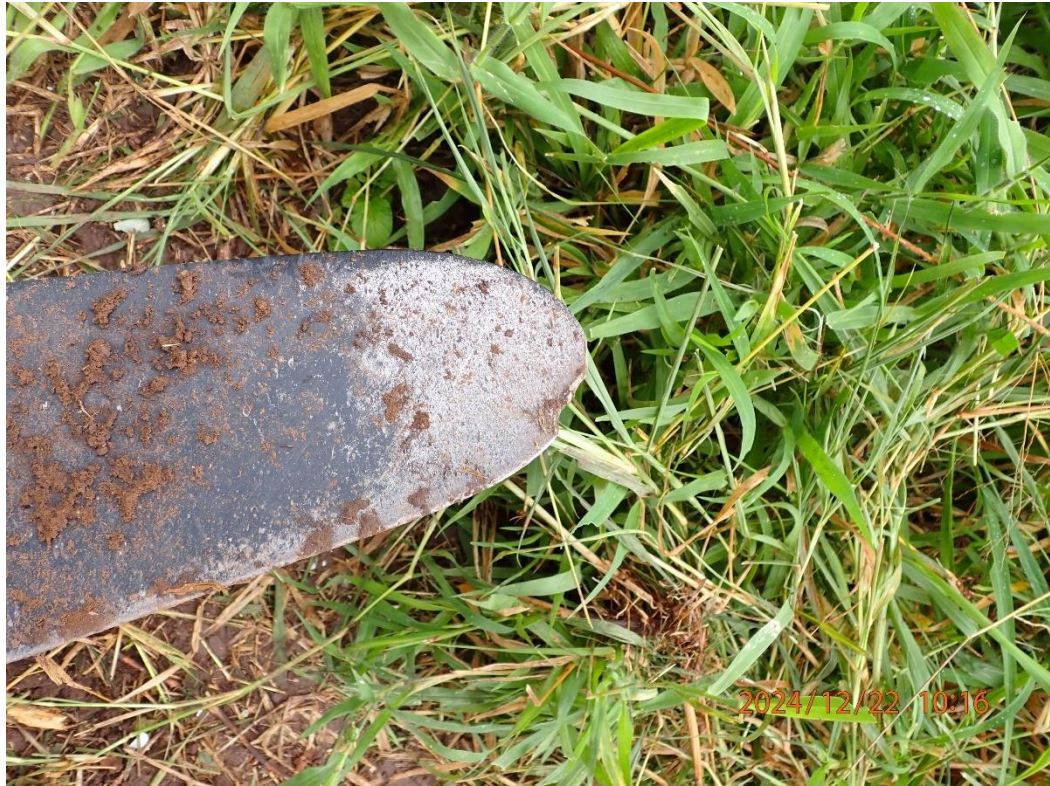
**Photo 47: View of blade tip damage.**

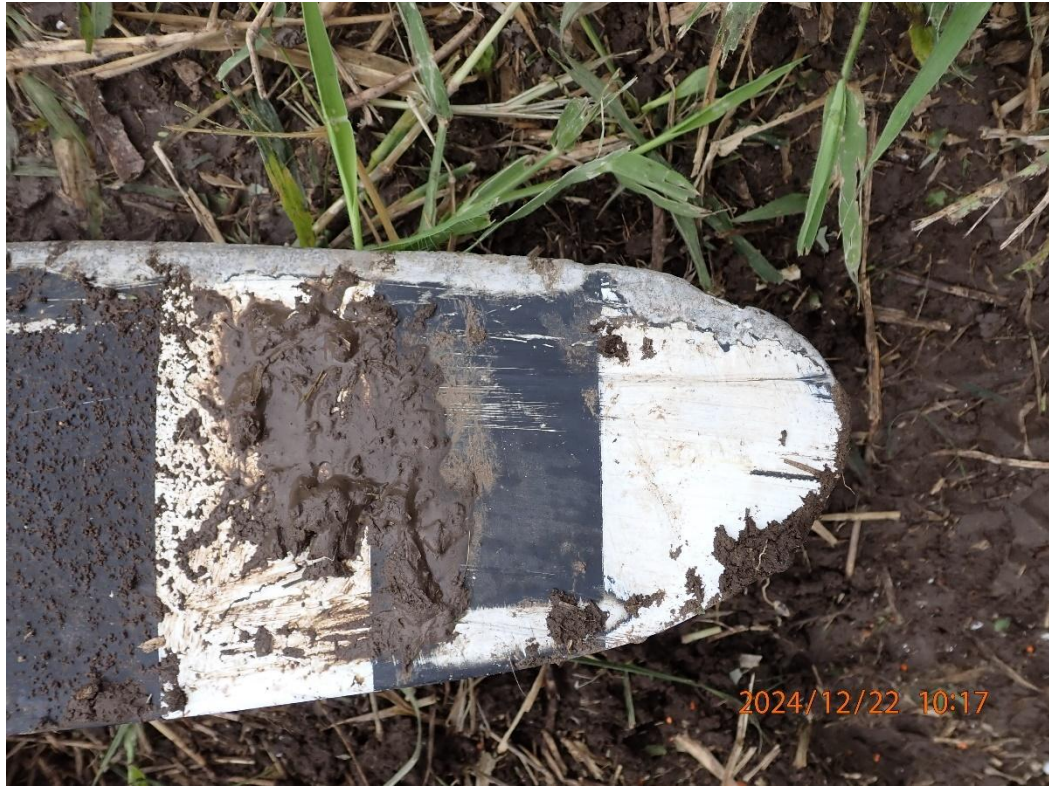
**Photo 49: View of blade tip damage.**
