Joshua Young  
Air Safety Investigator  
AS-ERA

**Date:** 5/13/2026

**Subject:** ERA25FA082, Controllability

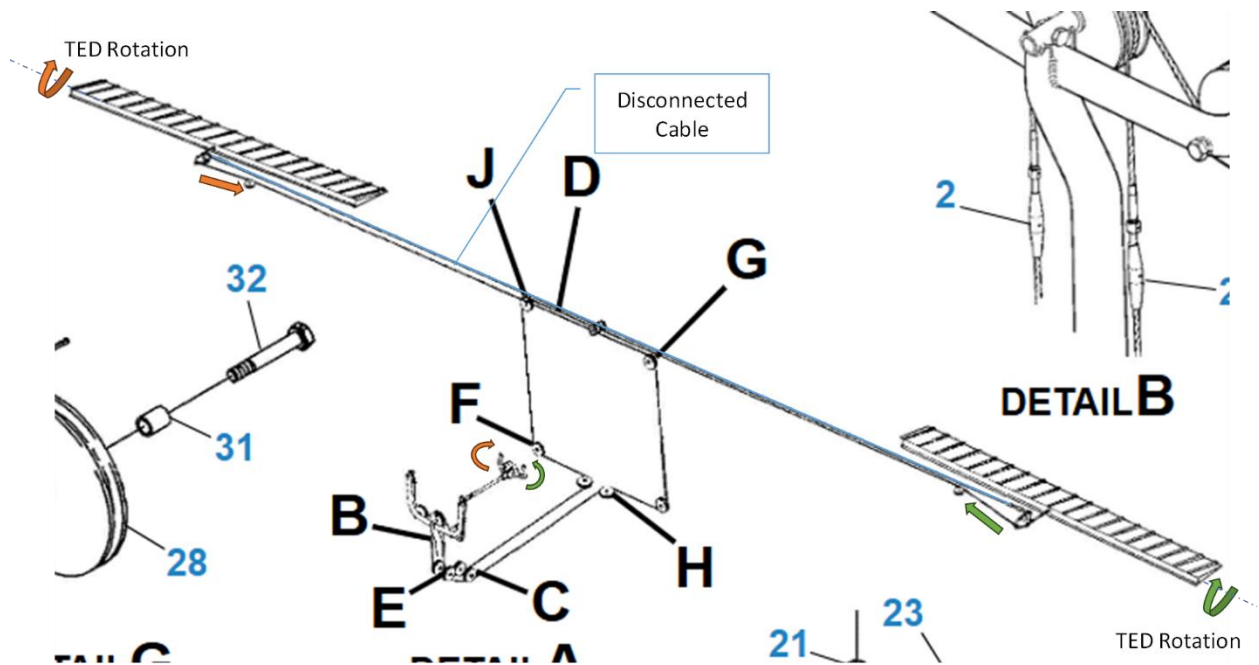
*On a Cessna 172S, a disconnection of the aft most wing (aileron) cable would interrupt the closed-loop control system. In this condition, control wheel inputs would tension only a single cable run, effectively transmitting load to one wing in both directions of wheel travel.*

*As a result, the aileron on the unloaded side would tend to float toward its zero hinge-moment (aerodynamically neutral) position, while the aileron on the loaded side would remain responsive to pilot input. This condition would occur in both left and right roll commands.*

*The pilot would retain partial roll control; however, control effectiveness would be reduced because only the lift-increasing aileron would be actively driven, while the opposing surface would not provide a corresponding aerodynamic response.*

Figure 1: Cessna 172 aileron control system and the transfer of pilot inputs to the control surfaces. (Courtesy of Textron Aviation)

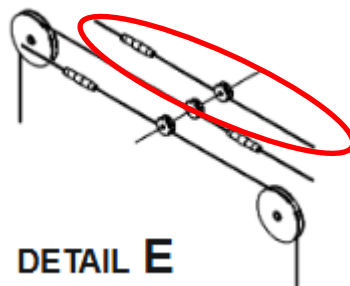
A review of the Cessna Model 172 (Series 1996 and on) Maintenance Manual showed the position of the aileron crossover cable turnbuckle to the right side of a pulley (figure 2). The NTSB IIC asked investigator Asensio if the turnbuckle was always on that side of the pulley and he responded stating "The left crossover cable length is longer than the right crossover cable locating the turnbuckle always on the right side of the cabin as shown in the manual."

Figure 2: Cessna Model 172 maintenance manual figure 201 excerpt; the aileron crossover cable is circled in red.
