# National Transportation Safety Board

ERA25FA119

## EXAMINATION REPORT

Location: Pierson, Florida  
Date: February 14, 2025  
Time: 1840 EST  
2340 UTC  
Airplane: 1985, Cessna 208, N40EA

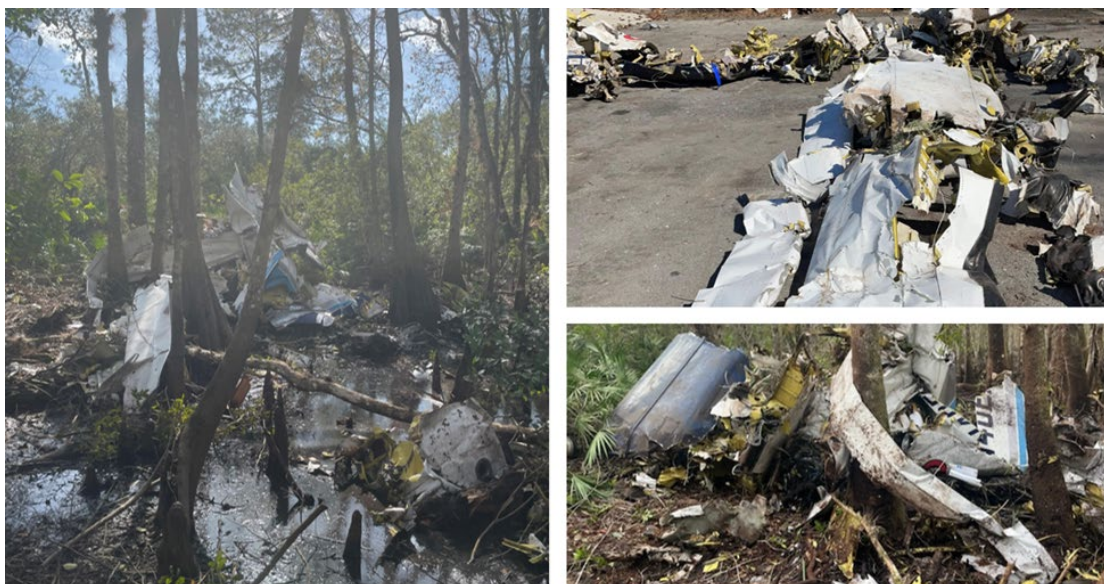
The airplane impacted a densely wooded swamp at an elevation of about 50 to 60 ft. The wreckage was scattered along a fan-like pattern from the primary impact point and was oriented on a 279° magnetic heading with a debris field that was about 75 yards long. The initial impact point was the tops of 65-ft-tall trees with associated tree and limb fractures progressively lower to the terrain where the propeller and engine assembly impacted the ground creating a 30-inch-deep crater.

The main body of the wreckage consisting of the fuselage and cockpit was discovered wrapped around trees. Both wings and the empennage separated during impact, and the debris field contained severely fragmented parts consistent with a high energy impact. The accident site and debris field was covered in 2 ft deep water, mud, and densely populated palmetto trees.

The accident site had a strong odor of jet fuel and there was a fuel slick in the water. There was no evidence of a post impact fire observed at the accident site and no evidence of an inflight fire was observed on the airplane wreckage.

**Figure 1 Accident site, wreckage, and layout.**

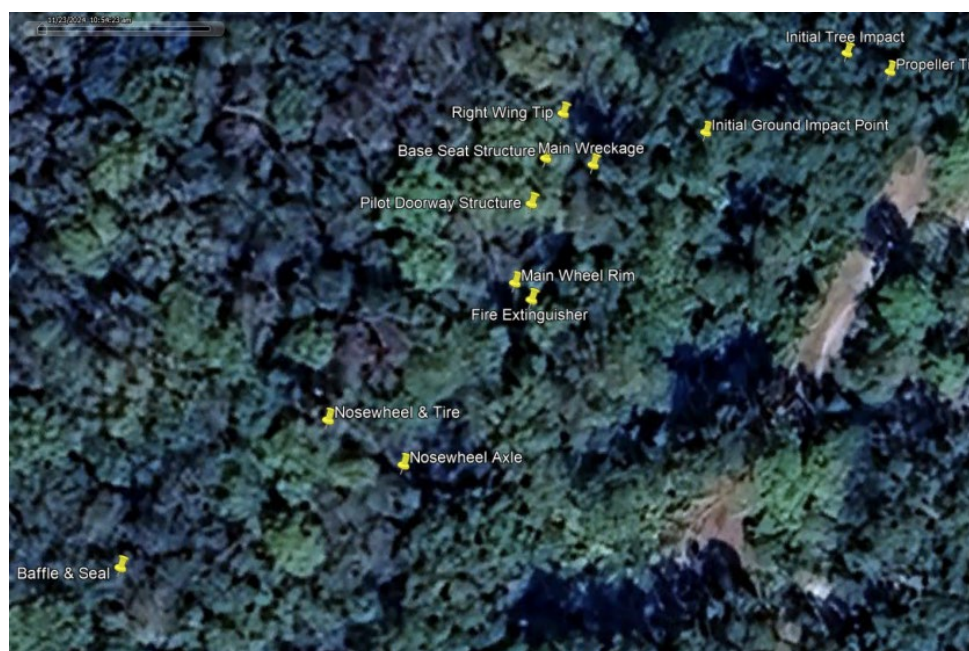
**Figure 2 Accident site wreckage locations.**

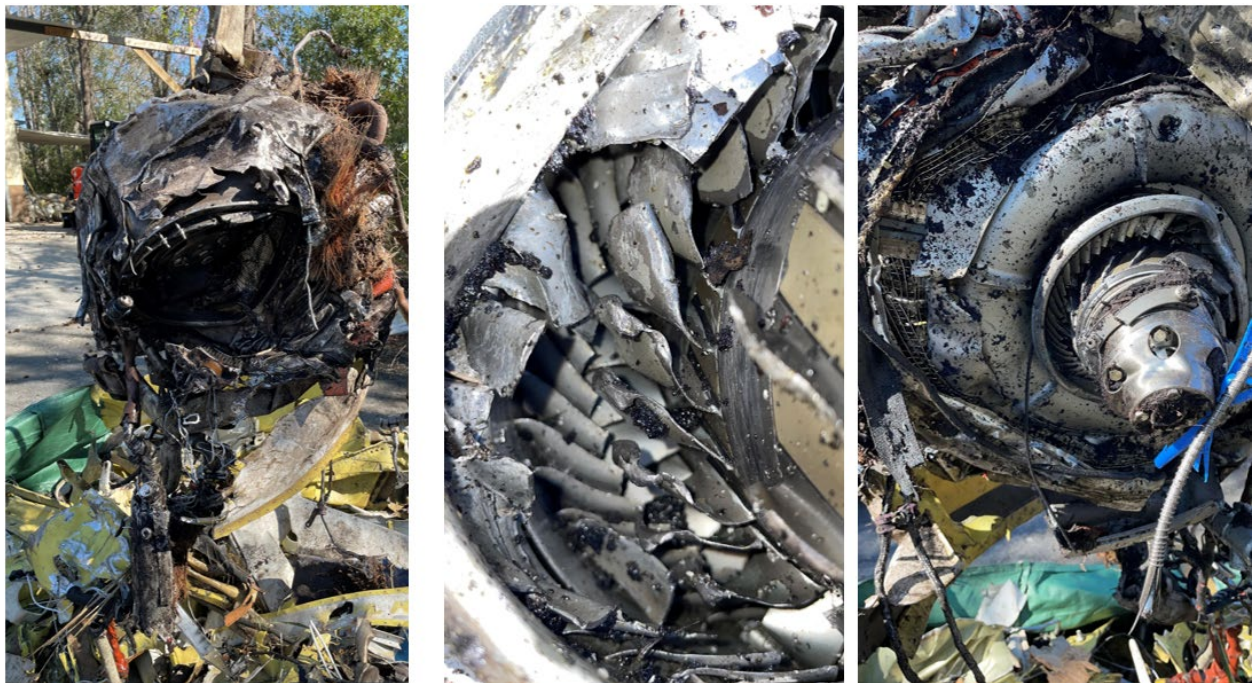
The Pratt & Whitney Canada, PTCA-114 engine exhibited severe impact damage, and the compressor section was bent 90° from the gearbox. Several engine components, such as the fuel control unit and fuel pump were missing or severely damaged. The first stage compressor rotor airfoils and air inlet struts were fractured.

The second stage compressor rotor airfoils were bent in the opposite direction of rotation with the compressor stator airfoils bent in the direction of rotation. The first stage planetary gear pins exhibited rubbing damage, and the first stage carrier was scored, and the splined adapter was fractured.

A follow up examination on the engine was conducted; it confirmed the initial findings on site. The engine displayed contact signatures to its internal components that were indicative of engine rotation at the time of impact. There were no preimpact anomalies discovered.

**Figure 3 Three views of engine damage.**

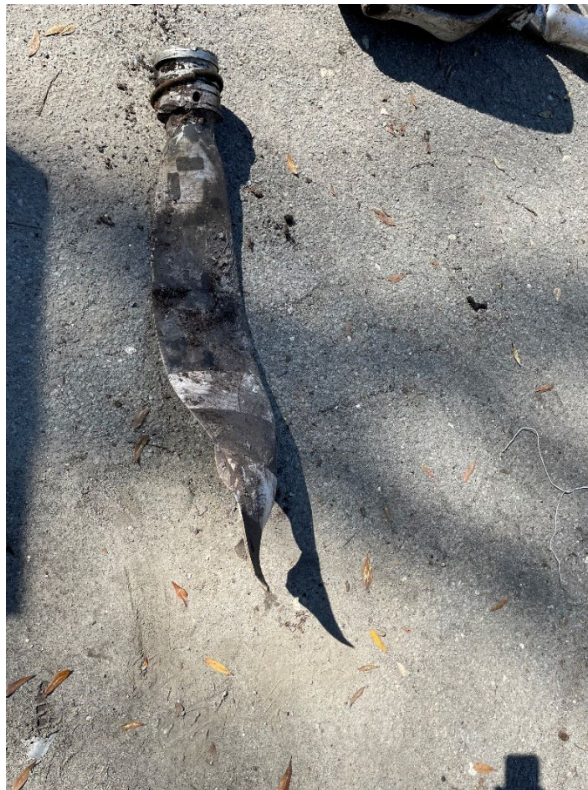
The propeller assembly was buried into the ground. The propeller assembly reduction gearbox was severely damaged and exhibited features consistent with impact and rotational damage. Two of the three propeller blades were discovered in the primary impact crater and both blades completely separated from the hub.

The blades were severely deformed with s-bending and exhibited chordwise scraping and gouges on the upper camber of the blades. Both propeller blades were fractured and missing about 10 inches of the tips. An extensive search for the missing blade was conducted but it was not located. Trees leading up to the main accident site exhibited chopping and slicing features consistent with propeller strikes as the airplane travelled through the trees.

**Figure 4 Propeller damage.**
