ERA25FA143

## INVESTIGATION PHOTOGRAPHS

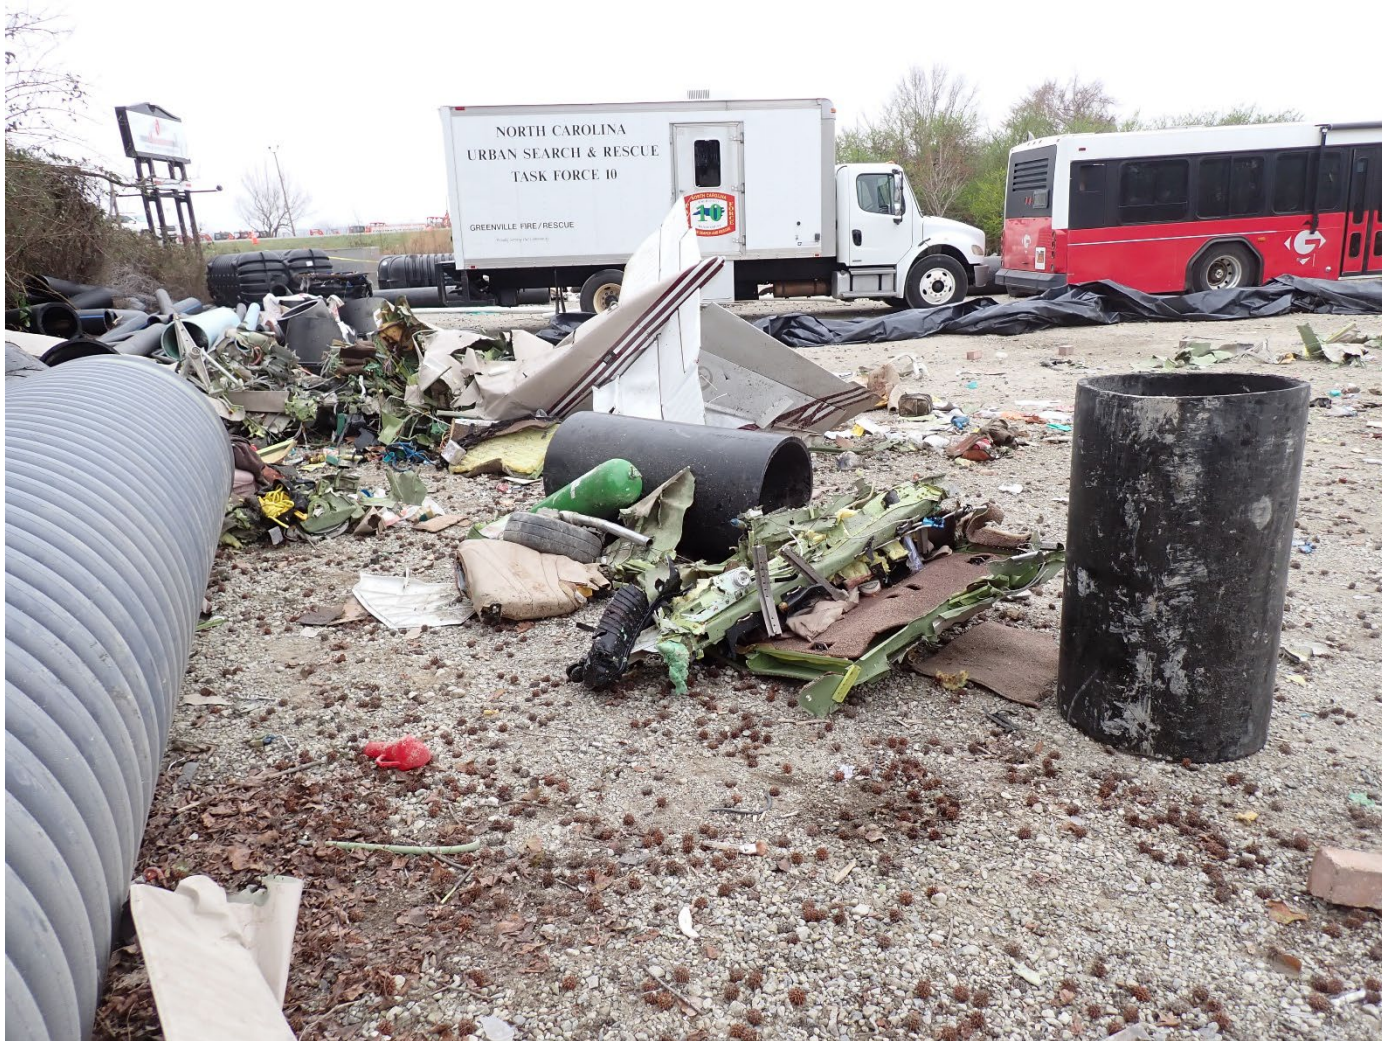
**Photograph 1 - Empennage near end of wreckage path. (NTSB)**

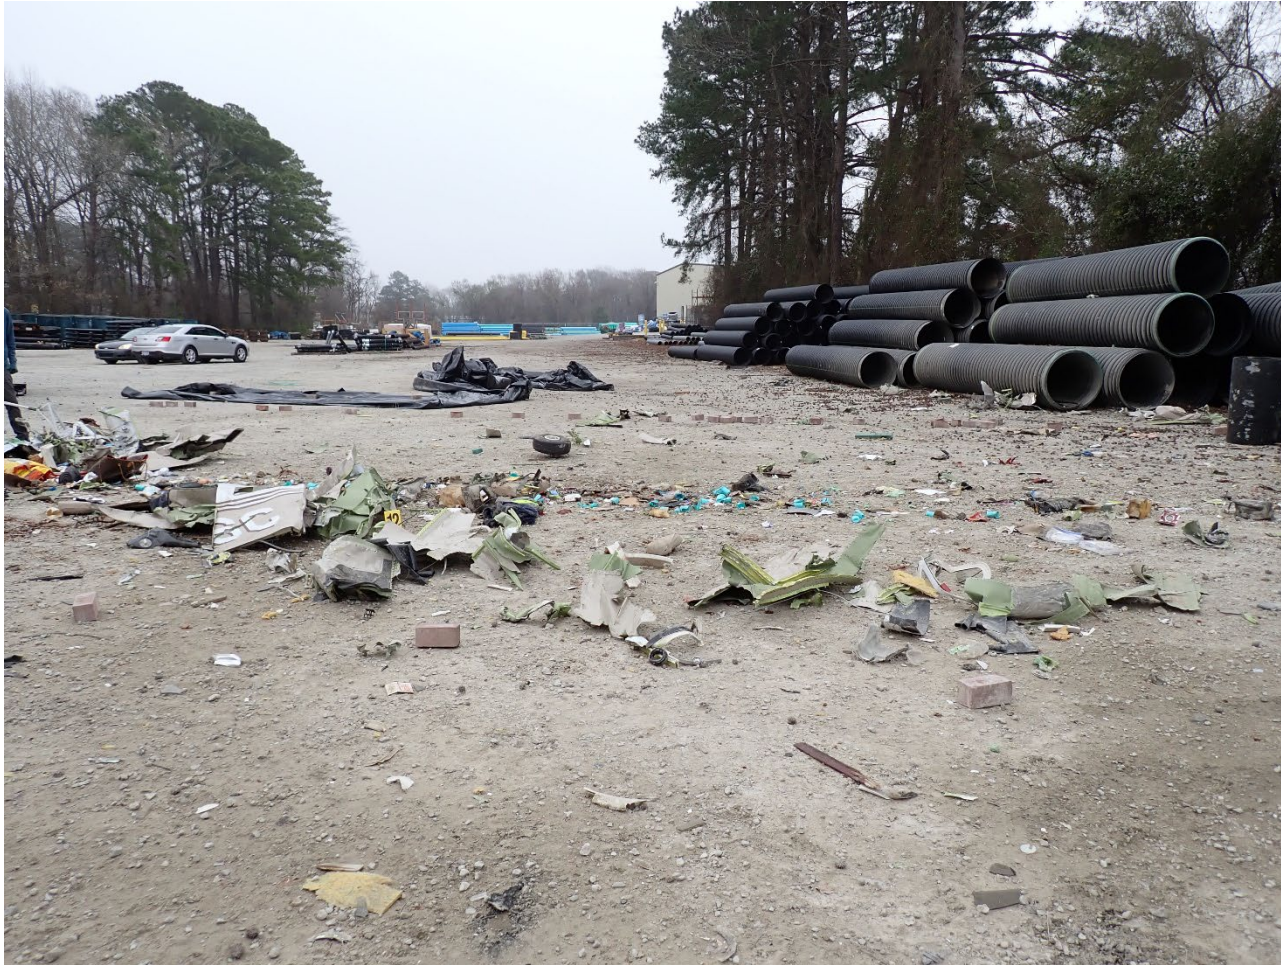
**Photograph 2 - Wreckage path left to right. (NTSB)**

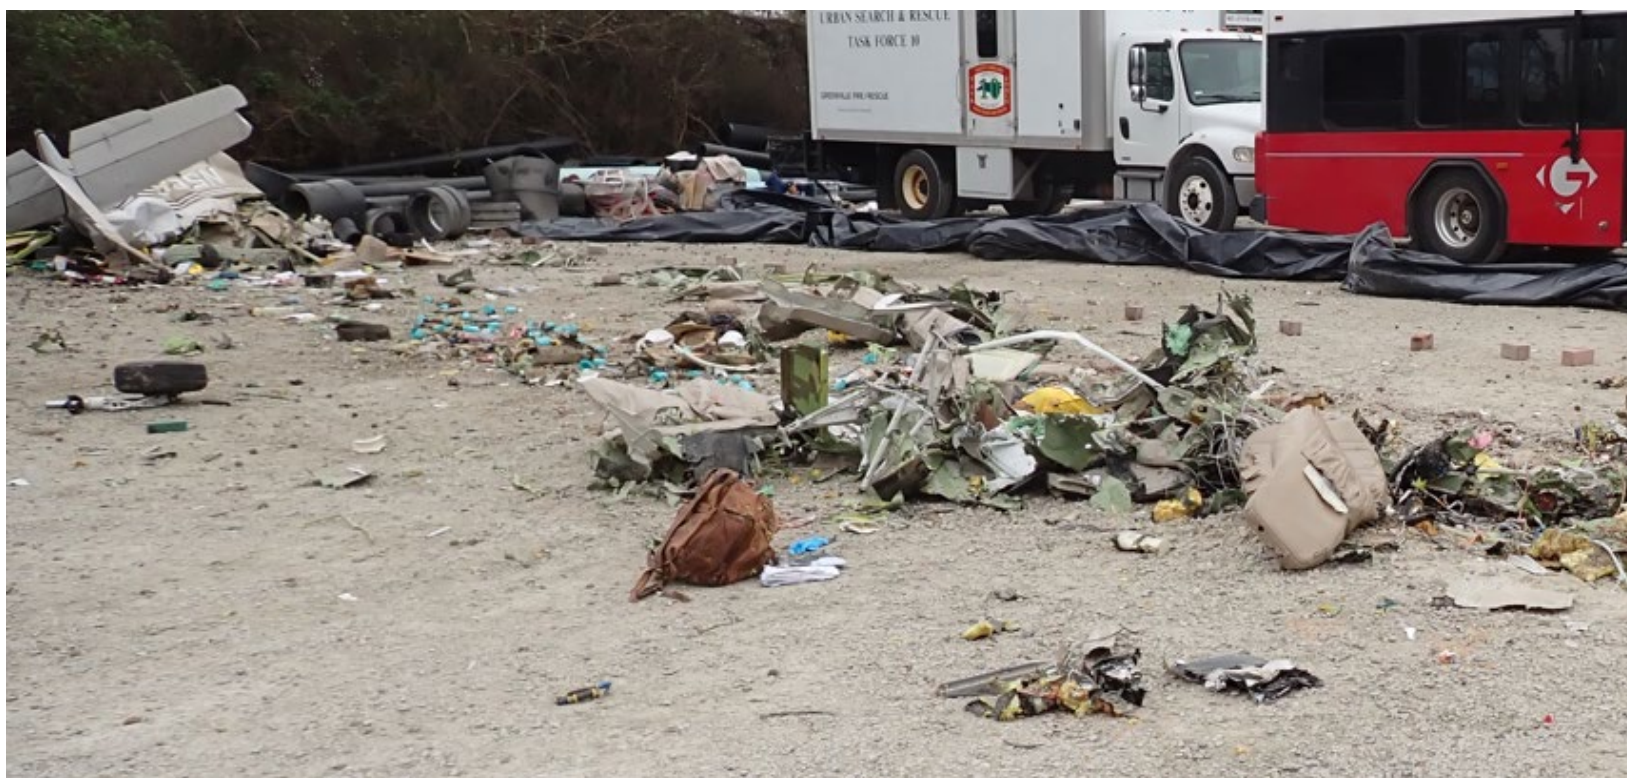
**Photograph 3 - Wreckage path looking towards empennage. (NTSB)**

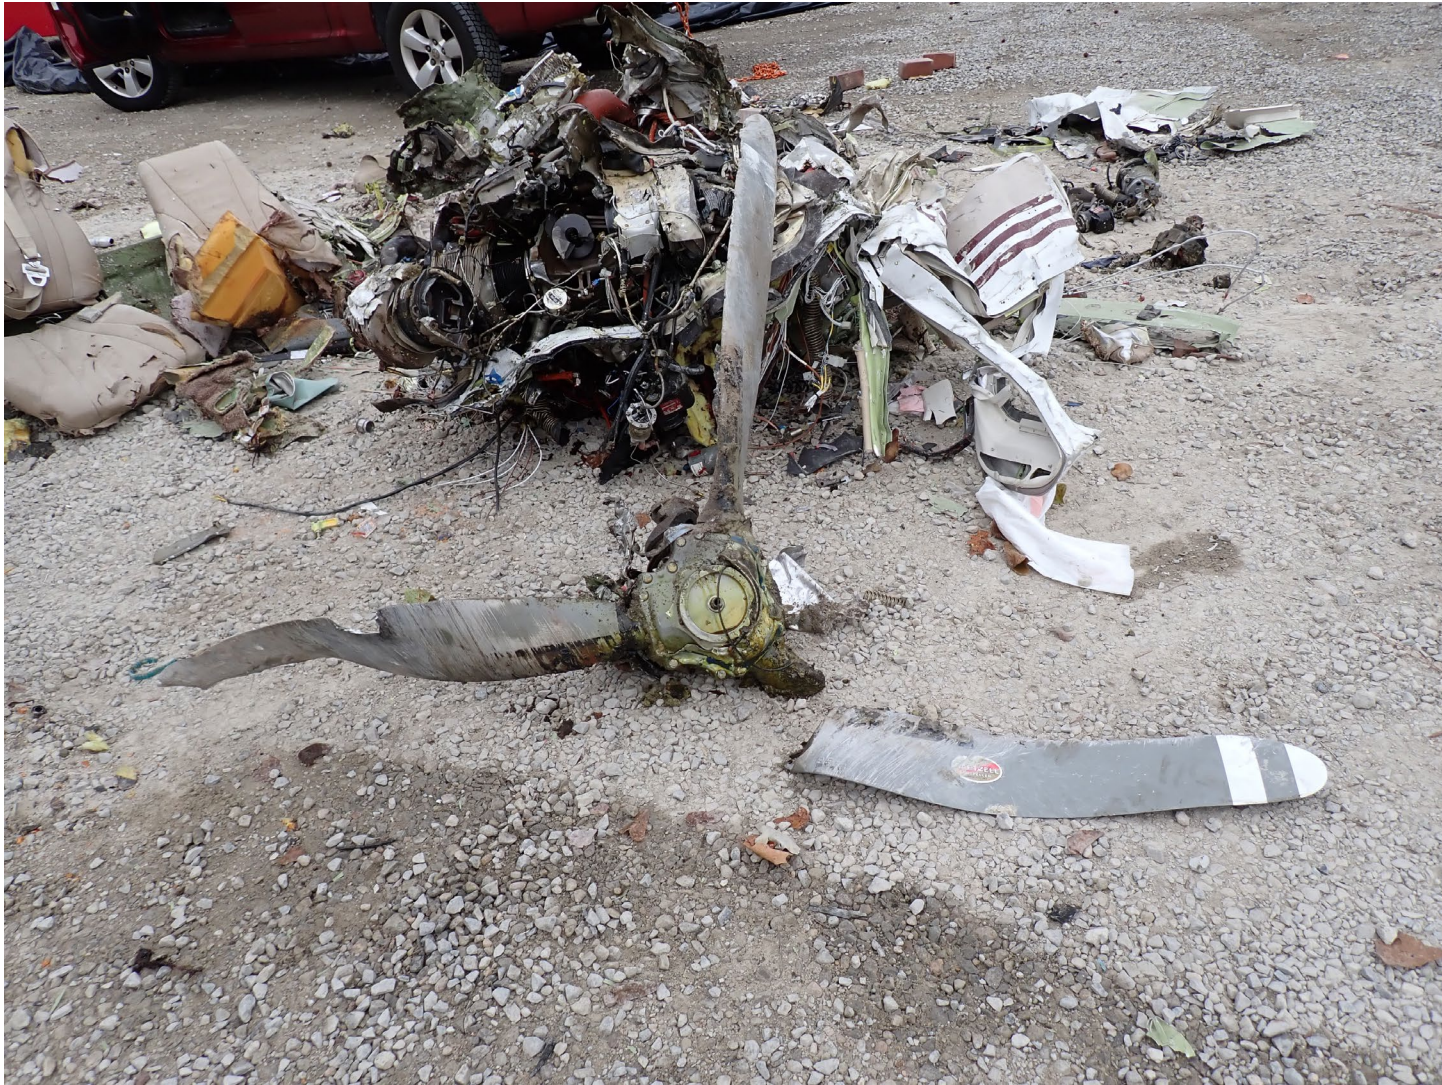
**Photograph 4 - Propeller damage after recovery. (NTSB)**
