# National Transportation Safety Board

ERA25LA143

## EXAMINATION REPORT

Location: Greenville, North Carolina  
Date: March 14, 2025  
Time: 0749 EDT  
Airplane: Beechcraft (Raytheon Aircraft Company) A36; N566C

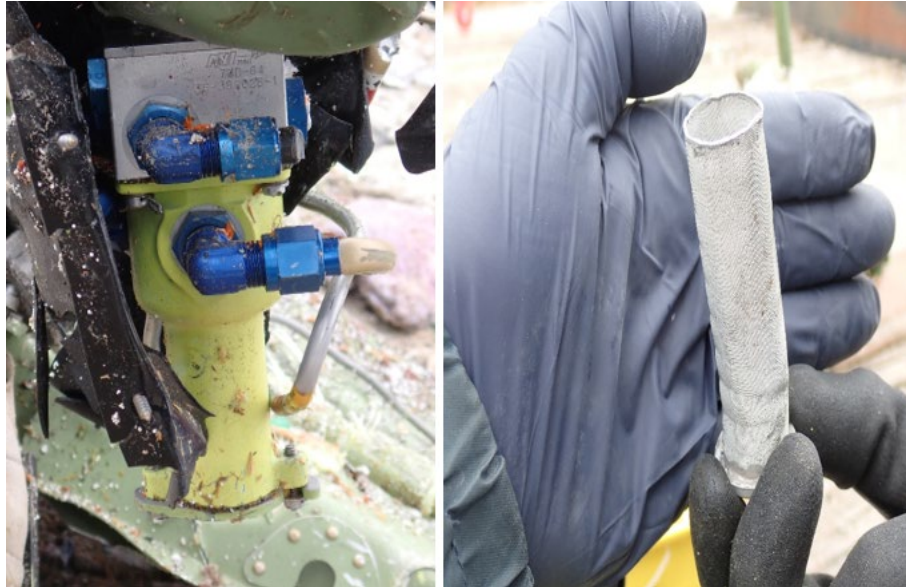
The fuel strainer (which was integral to the fuel selector valve), contained a small amount of fuel. The fuel selector mounting plate was deformed around the handle due to impact forces. The handle was observed to be between detents. The selector position had rotated past its most counterclockwise position (right fuel tank). After disassembly from its deformed mounting plate, the selector operated as designed when air was blown through the ports. (Figure 1)

**Figure 1: Fuel selector valve and screen.**

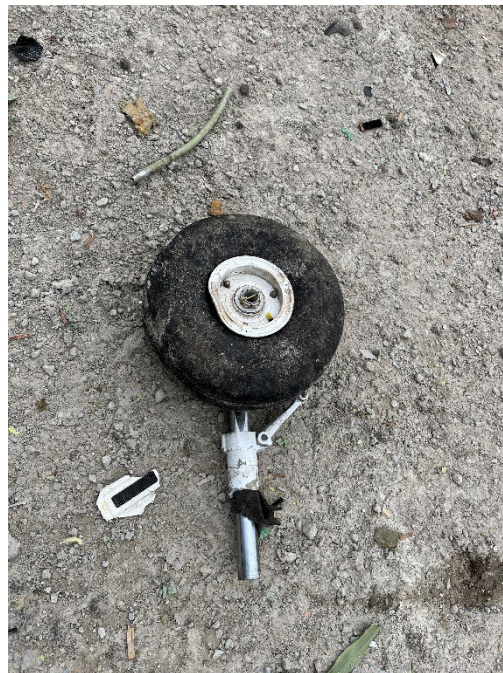
The left and right main landing gear trunnions were found loose in the debris field with each respective wheel and brake assembly separated from them. The landing gear actuator was found loose in the debris field, and its housing was impact-damaged. The drive gear inside the housing was found at an intermediate position between the landing gear up and gear down position. The emergency landing gear extension handle was separated from the actuator and was not observed in the wreckage. (Figure 2)

**Figure 2: Landing gear.**

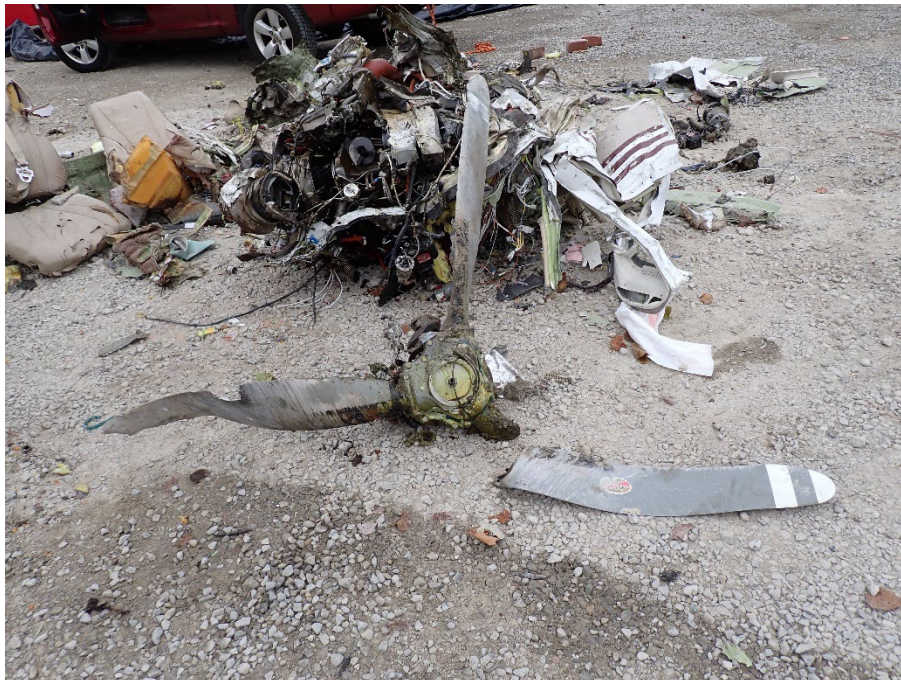
The propeller hub was separated from the engine and remained attached to a portion of the crankshaft that had impact-separated from the engine. The three blade bases had remained seated in the hub. All three blades displayed varying degrees of S-bending, leading edge damage, tip damage, and chordwise scratching, with one of the blades having been sheared off near the root. (Figure 3)

**Figure 3: Propeller after recovery.**

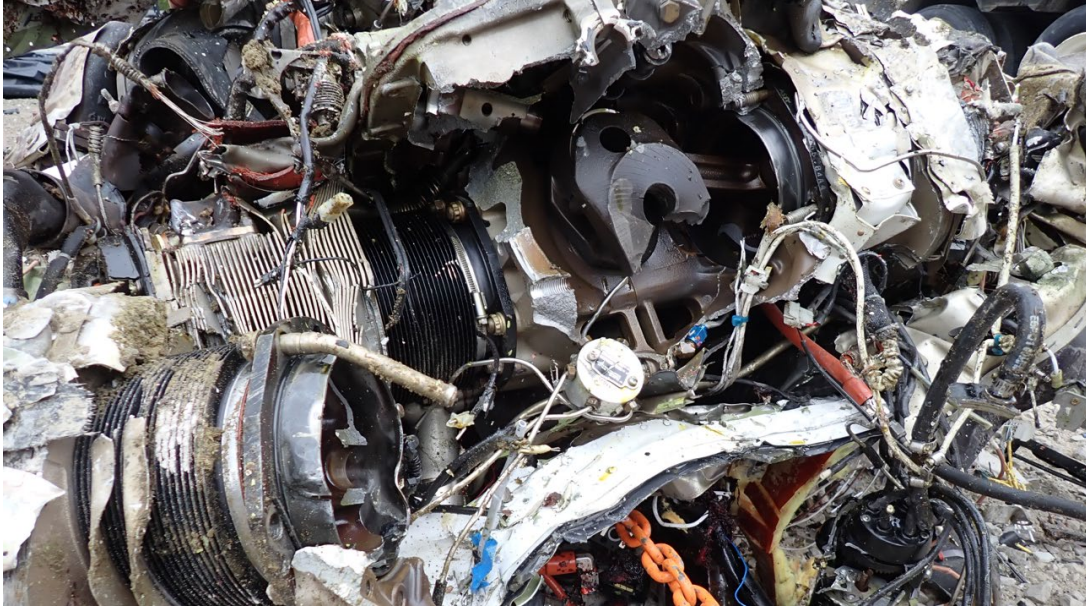
The engine was heavily impact-damaged. The crank case, oil sump, and accessory cases displayed multiple cracks and were missing pieces. Cylinder No. 6 was separated from the crank case but remained in place due to the intake and exhaust tubing. The crankshaft was impact-separated forward of the No.5 connecting arm journal. (Figure 4)

**Figure 4: Overall engine condition.**
