# National Transportation Safety Board

ERA25FA151

## **WRECKAGE EXAMINATION**

Location: LaFayette, Georgia  
Date: March 20, 2025  
Time: 1430 EDT  
1830 UTC  
Airplane: N969SS; Cirrus SR22

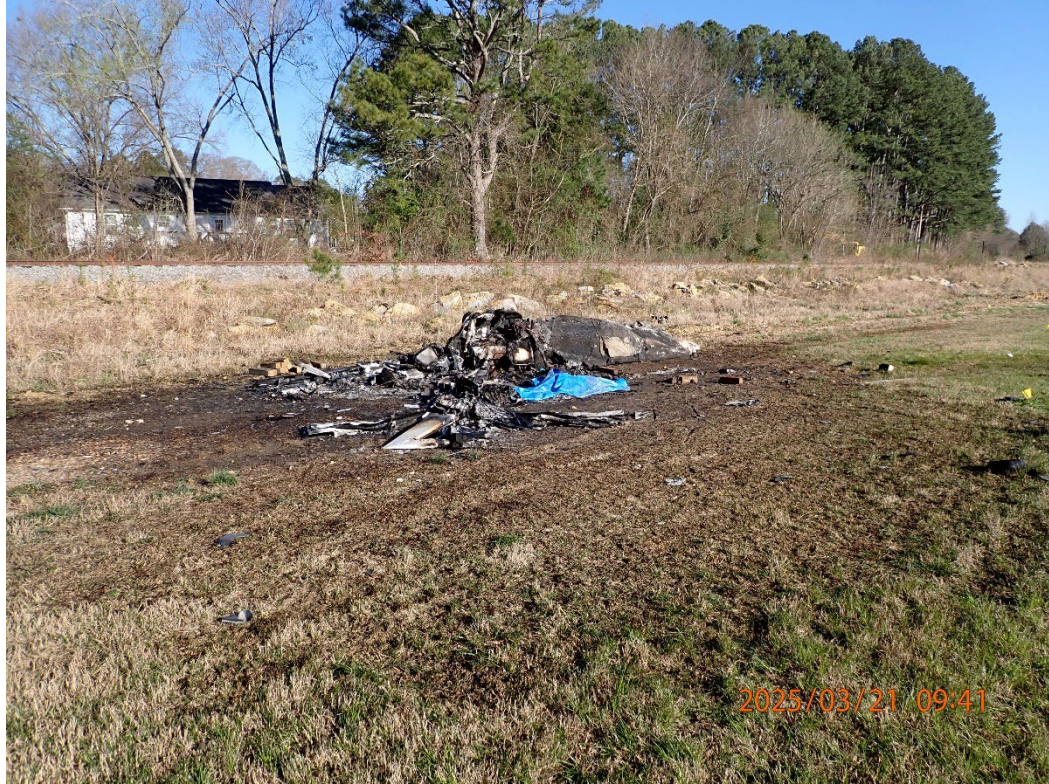
The airplane came to rest about 25 ft in the grass off the right side of runway 20 at Barwick LaFayette Airport (9A5), Lafayette, GA about 20 ft past the runway threshold. The wreckage was located at an altitude of 776 ft and on a magnetic heading of about 340° and was inverted. There was extensive thermal damage to the airplane. An initial impact mark and scraping to the runway was located about 175 ft.

**Photo 1: Overview of the main wreckage.**

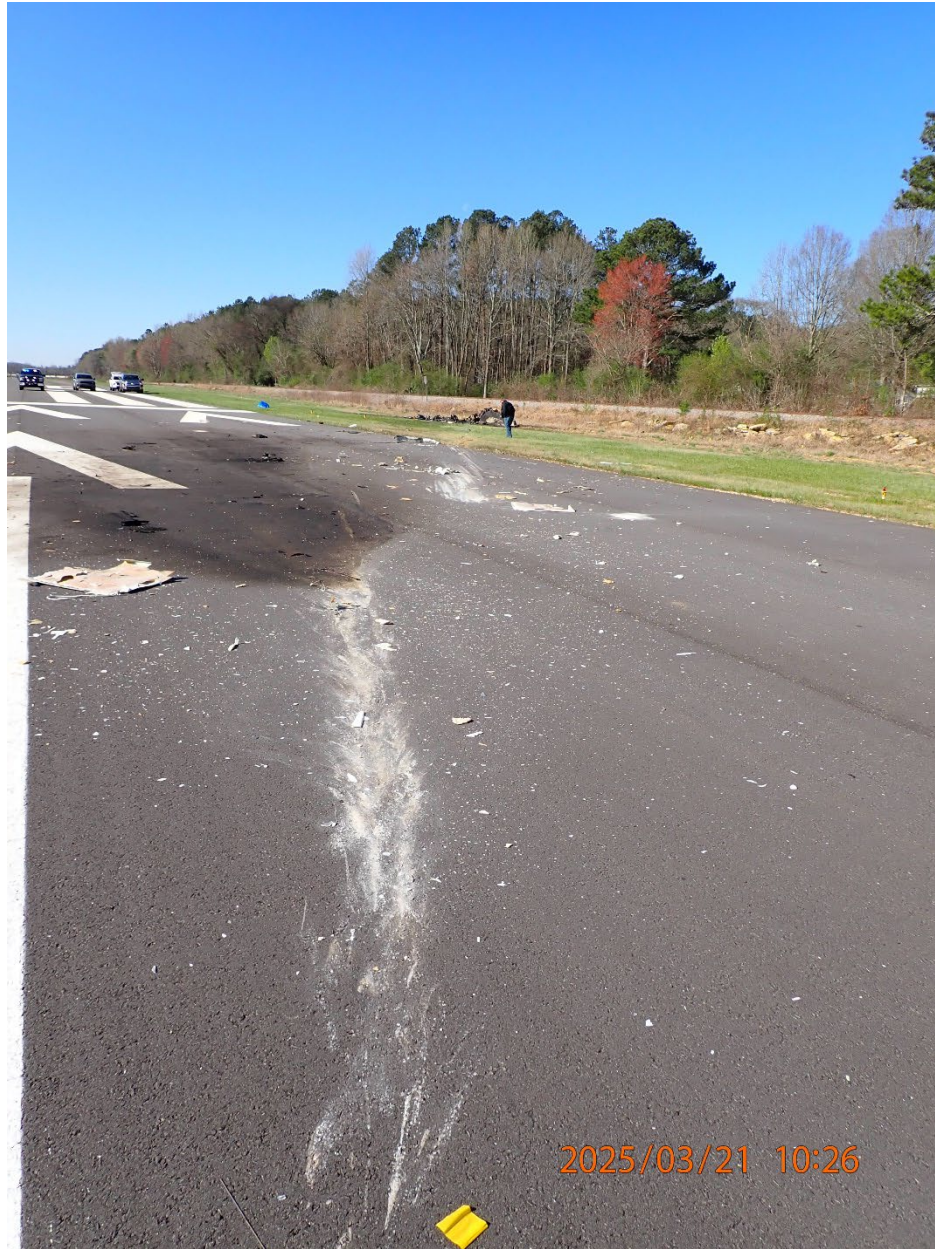
Multiple pieces of right wing structure were found strewn along the debris path. Multiple propeller strike marks were found on the runway pavement about 20 ft from the initial impact mark. A Sentry ADS-B receiver was found about 40 ft from the main wreckage in the debris path.

**Photo 2: View from initial impact point of the accident site.**

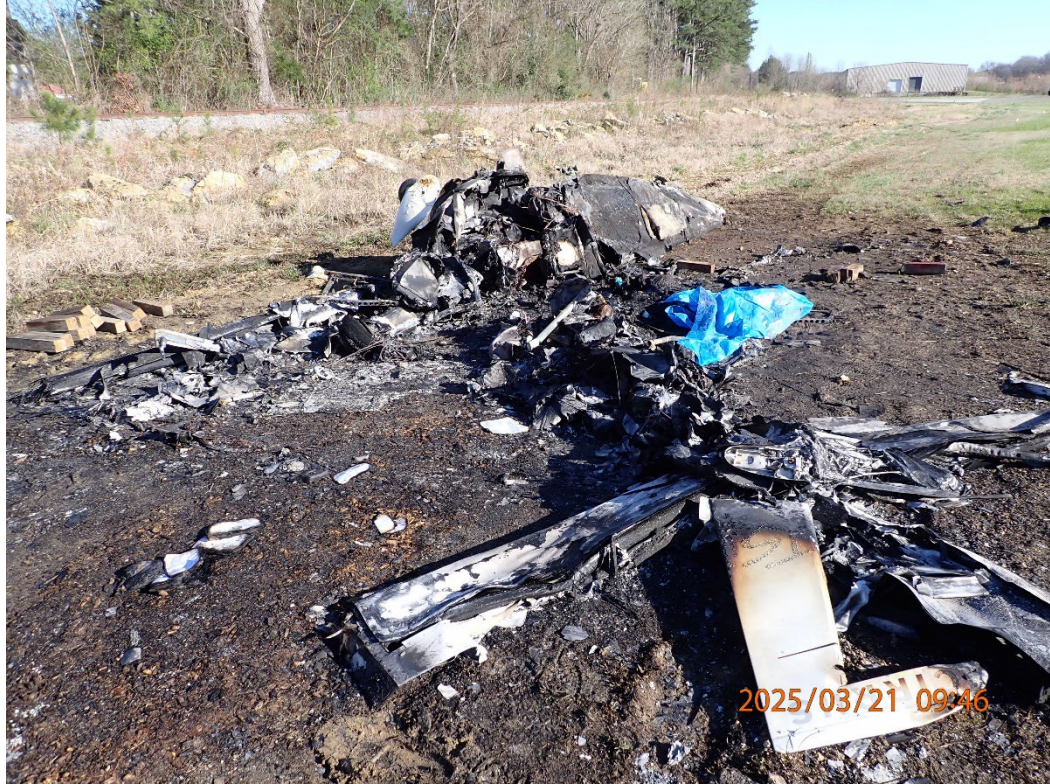
The fuselage exhibited extensive thermal damage from firewall to tail with postaccident fire damage to all components. The bonded roll cage was consumed by postaccident fire.

**Photo 3: View of the remnants of the fuselage.**

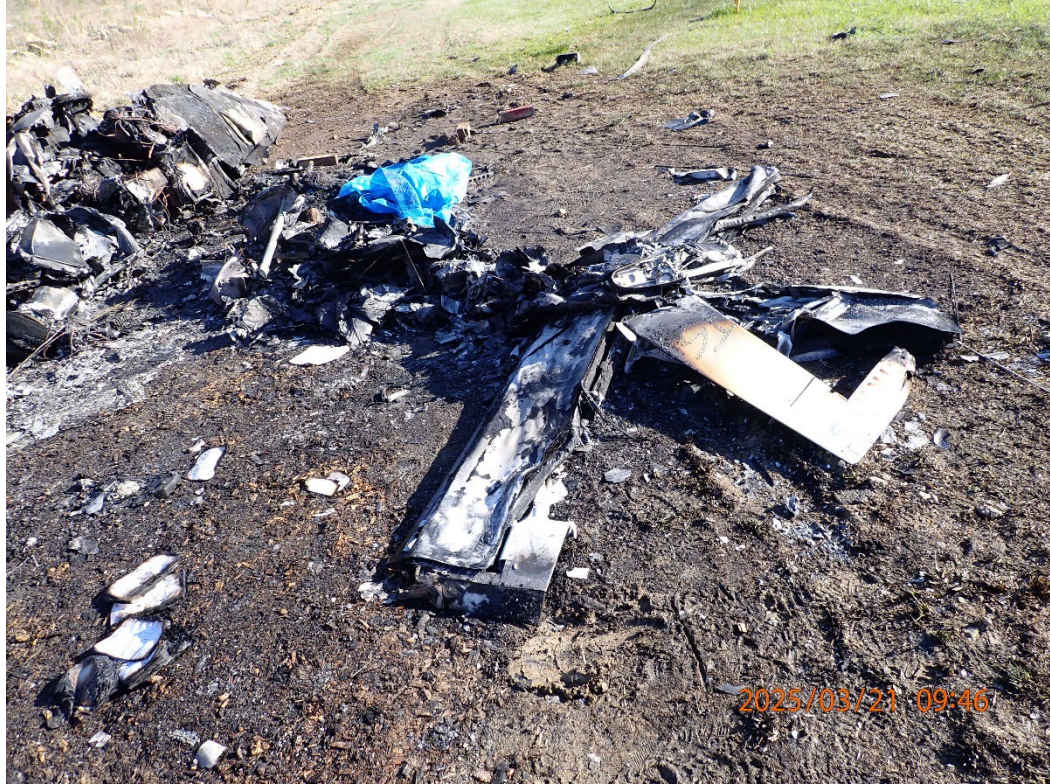
The empennage exhibited extensive thermal damage. Elevator and rudder control continuity were confirmed from the attachment at the flight control surfaces to the cockpit through an area of thermal damage consistent with the location of the oxygen bottle.

**Photo 4: View of the empennage.**

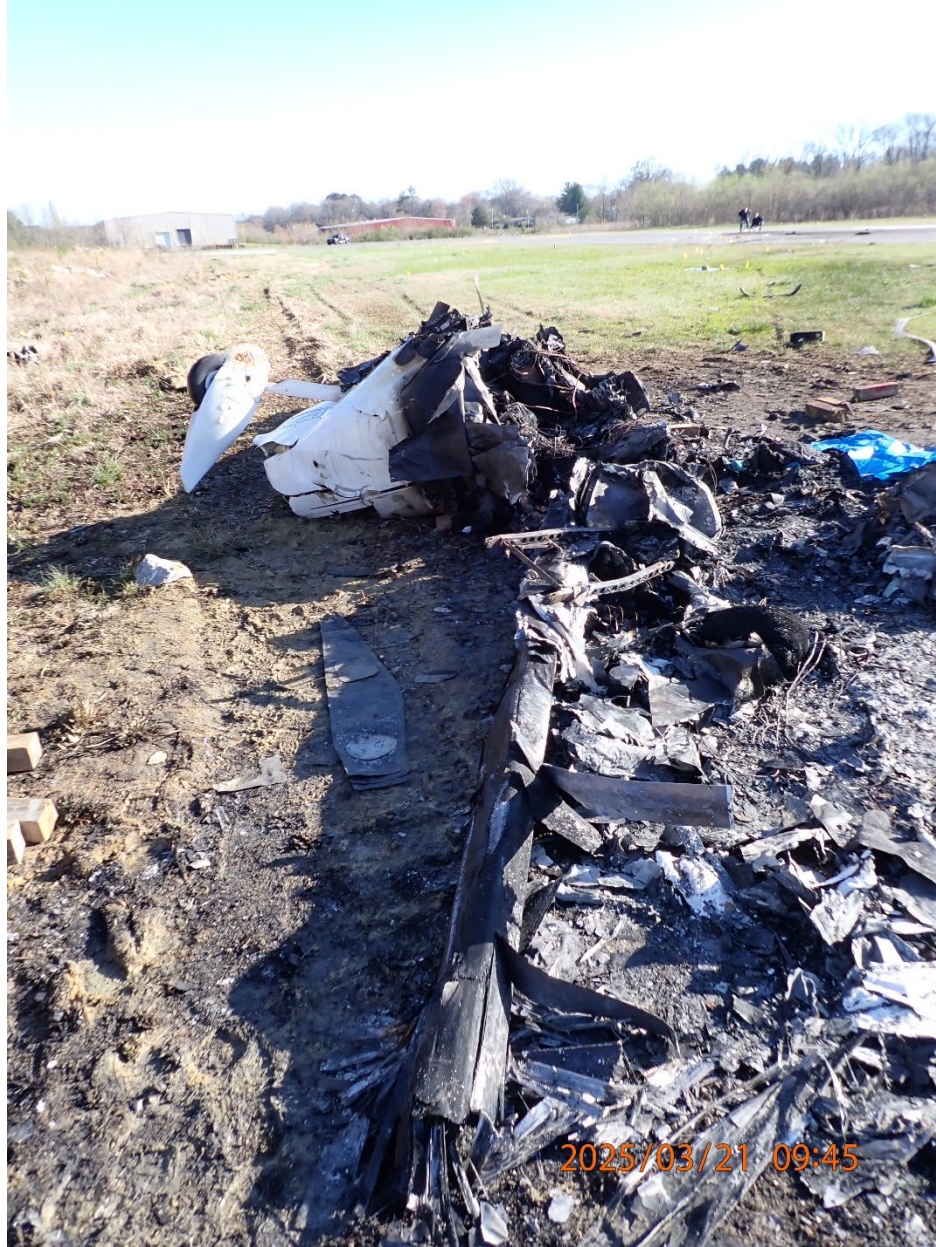
The right wing exhibited thermal damage with remnants of the spar remaining. The flap actuator jackscrew and shaft were found in the wreckage with 3 inches of the jackscrew exposed. The left wing exhibited thermal damage. Aileron control for both wings was confirmed from the flight control surface bellcranks to the cockpit through impact fractured turnbuckles. The aileron console actuator pulley was intact with cables going around and through the pulley gang.

**Photo 5: View of the right wing.**

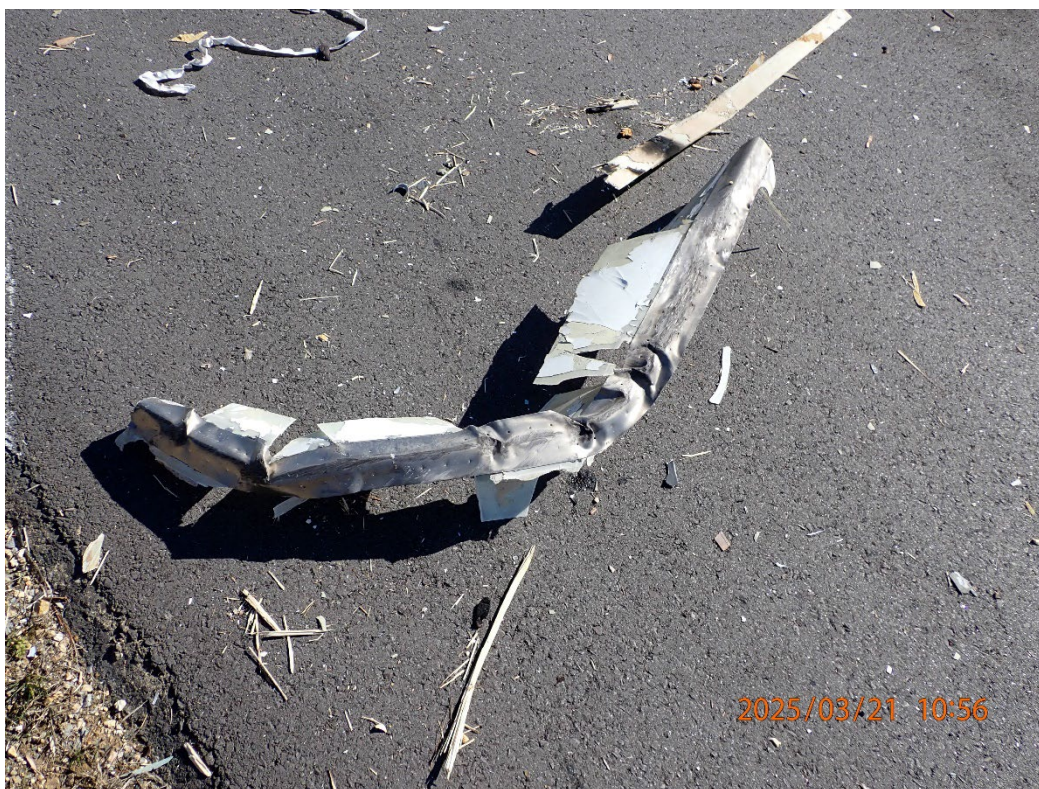
**Photo 6: View of a piece of right wing leading edge found in the debris path.**

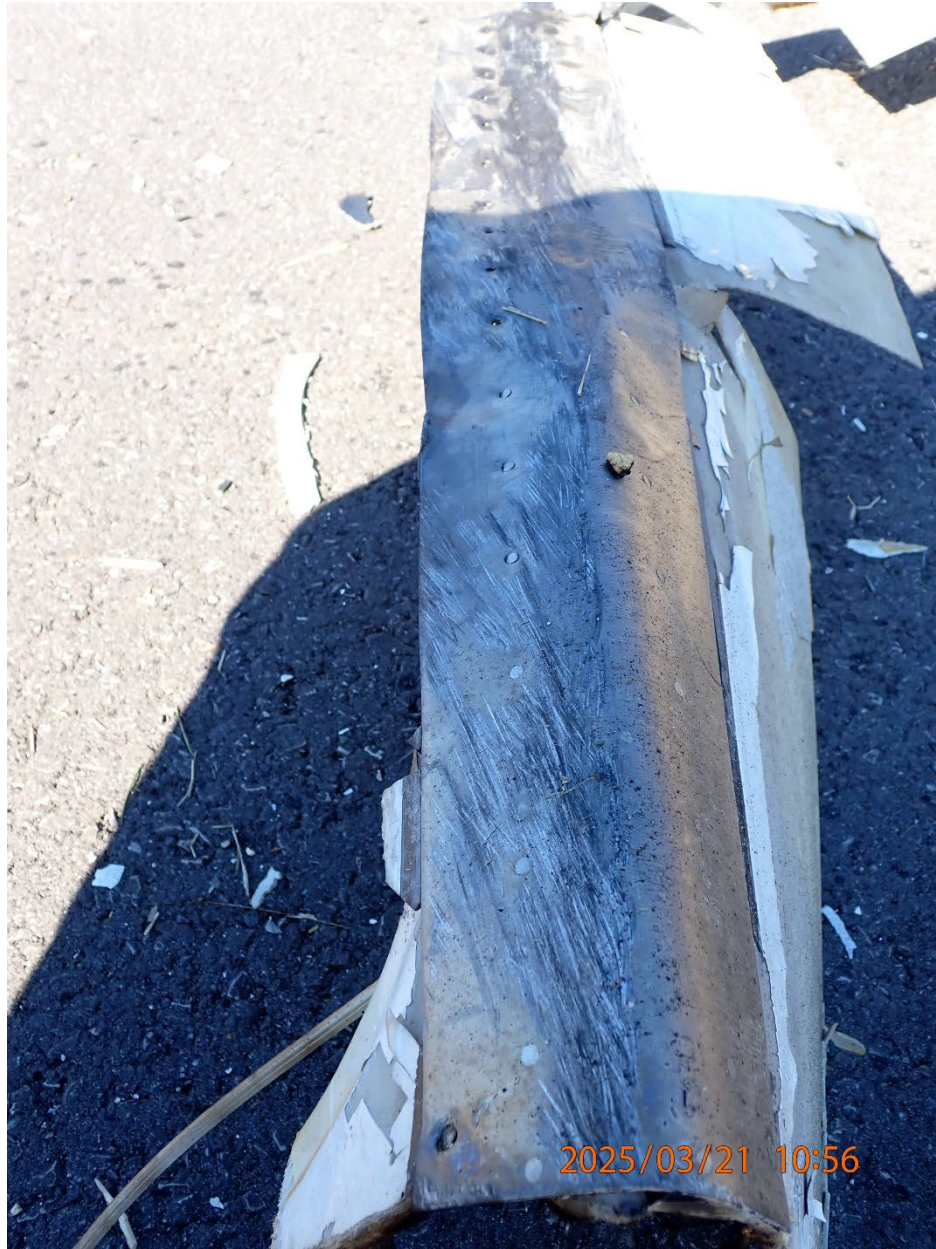
**Photo 7: View of lateral scratching on the right wing leading edge piece.**

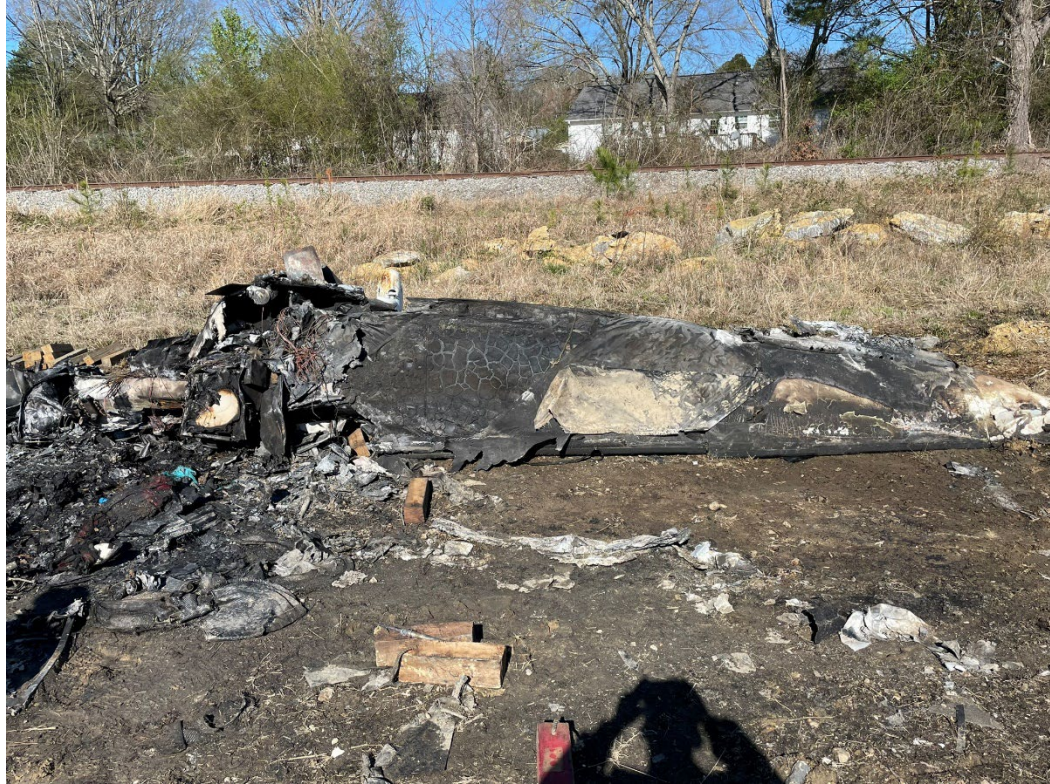
**Photo 8: View of the left wing.**

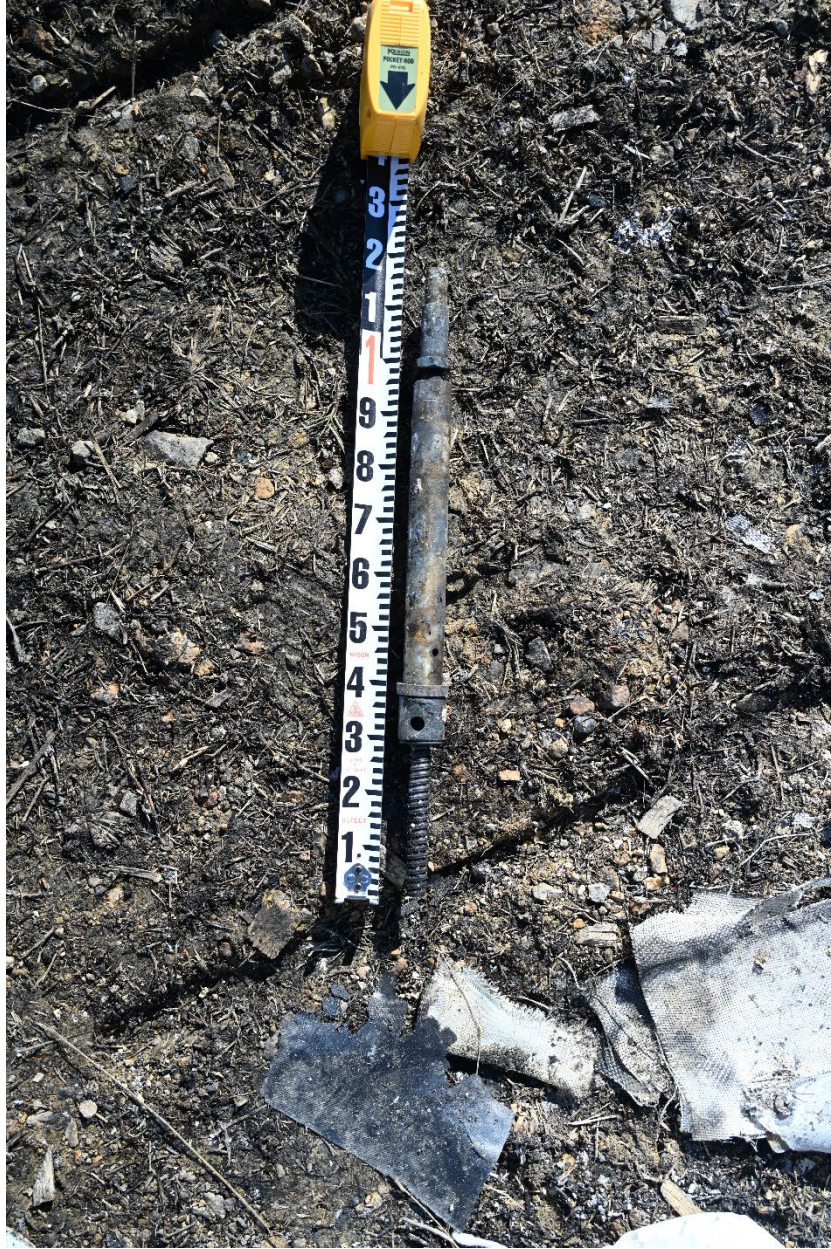
**Photo 9: View of flap jackscrew with scale. (Cirrus Photo)**

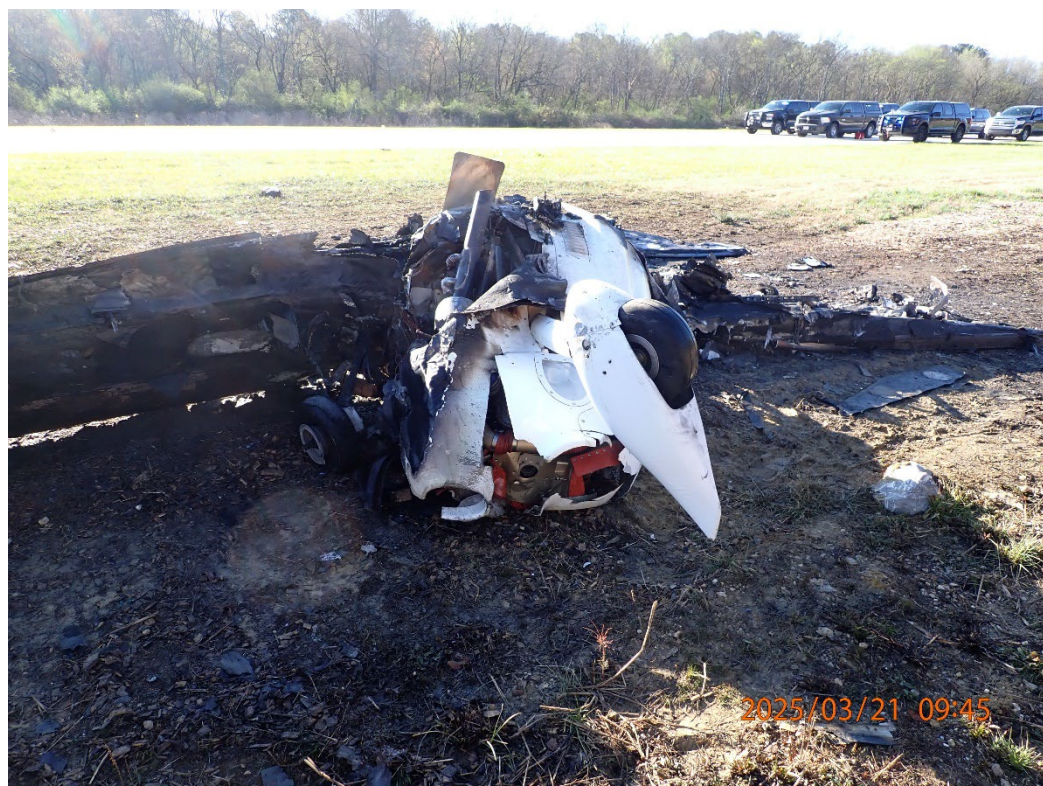
The nose landing gear remained attached to the fuselage with damage to the nose wheel fairing. The main landing gear exhibited thermal damage.

**Photo 10: View of the nose and left main landing gear.**

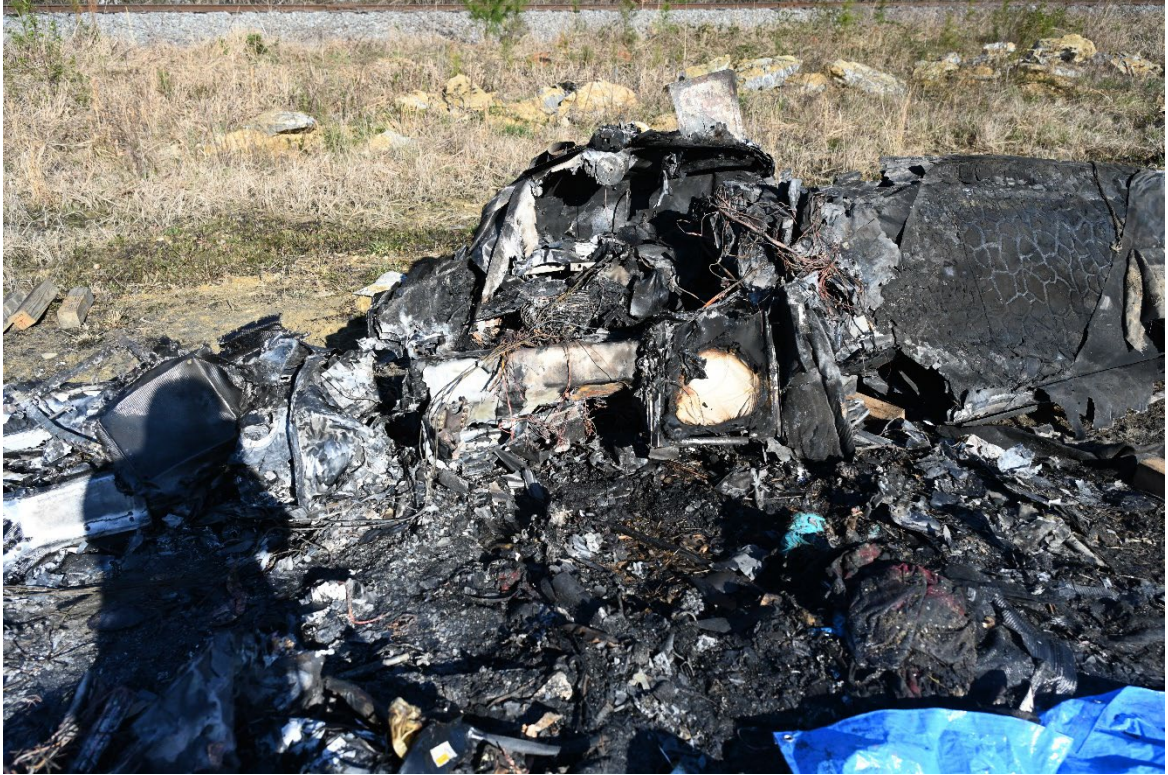
The cockpit exhibited extensive thermal damage and was unrecognizable.

**Photo 11: View of the cockpit area. (Cirrus Photo)**

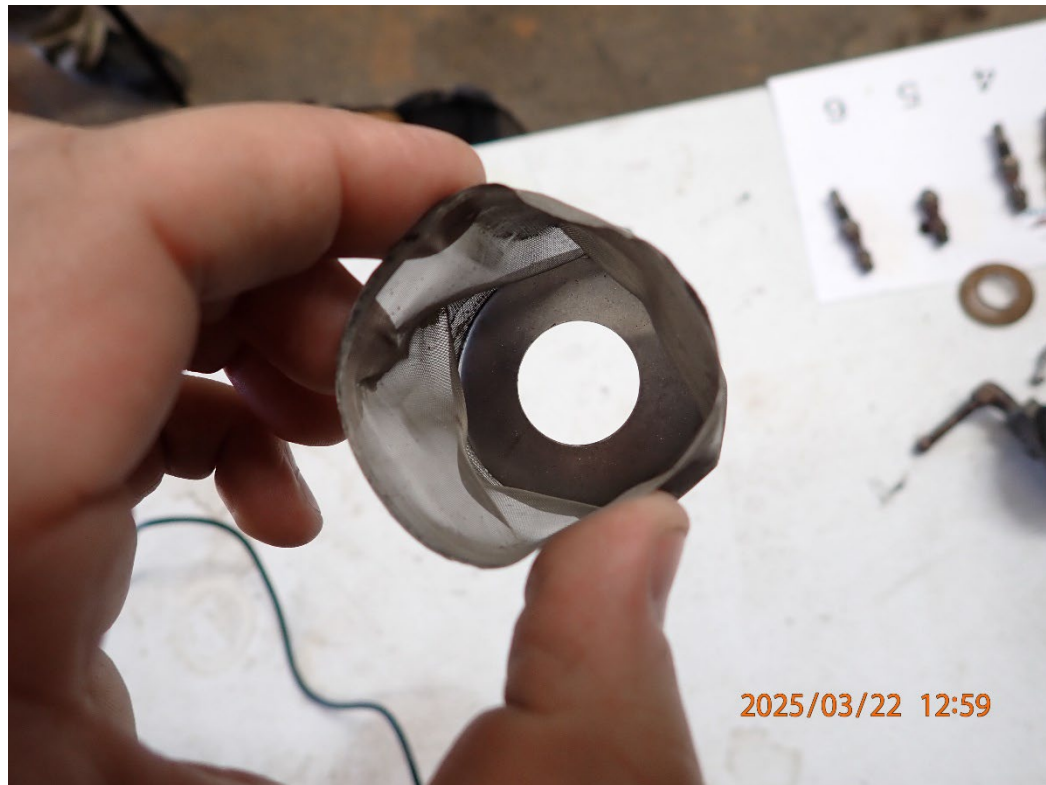
The fuel selector was not located in the wreckage debris. The gascolator remained attached to the firewall. It was removed and examined and was free of debris.

**Photo 12: View of the gascolator screen.**

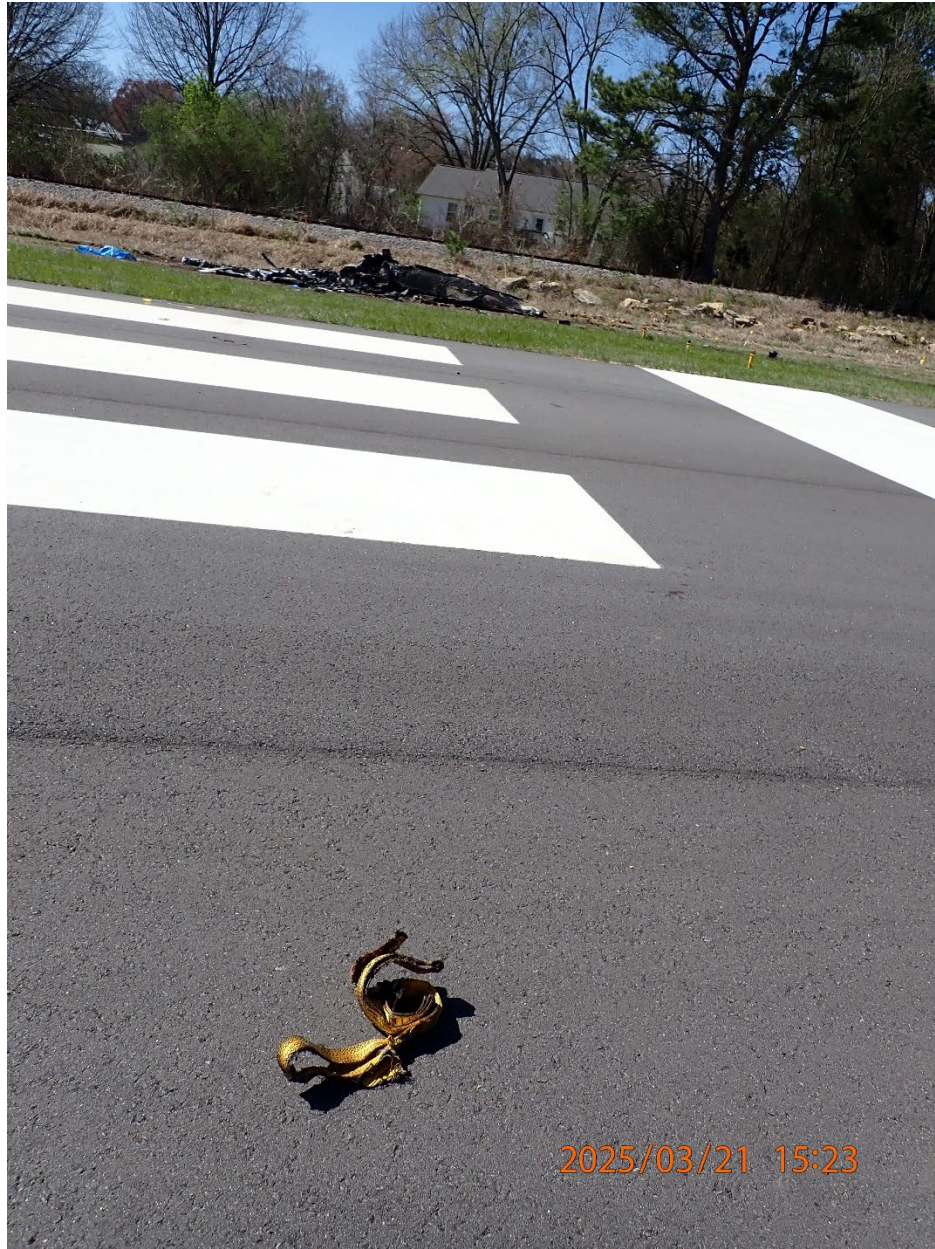
The CAPS system rocket ignited during the postaccident fire. The CAPS parachute was found in the wreckage still packed and exhibited thermal damage. The CAPS parachute risers were consumed by fire. Part of a strap found in the middle of the runway was still folded with red thread used to keep it folded unbroken. Lanyards were found with no collar, broom strawed, and shackled together. The strap cover was partially intact and found about 125 feet from the wreckage.

**Photo 13: View of a portion of a CAPS strap on the runway.**

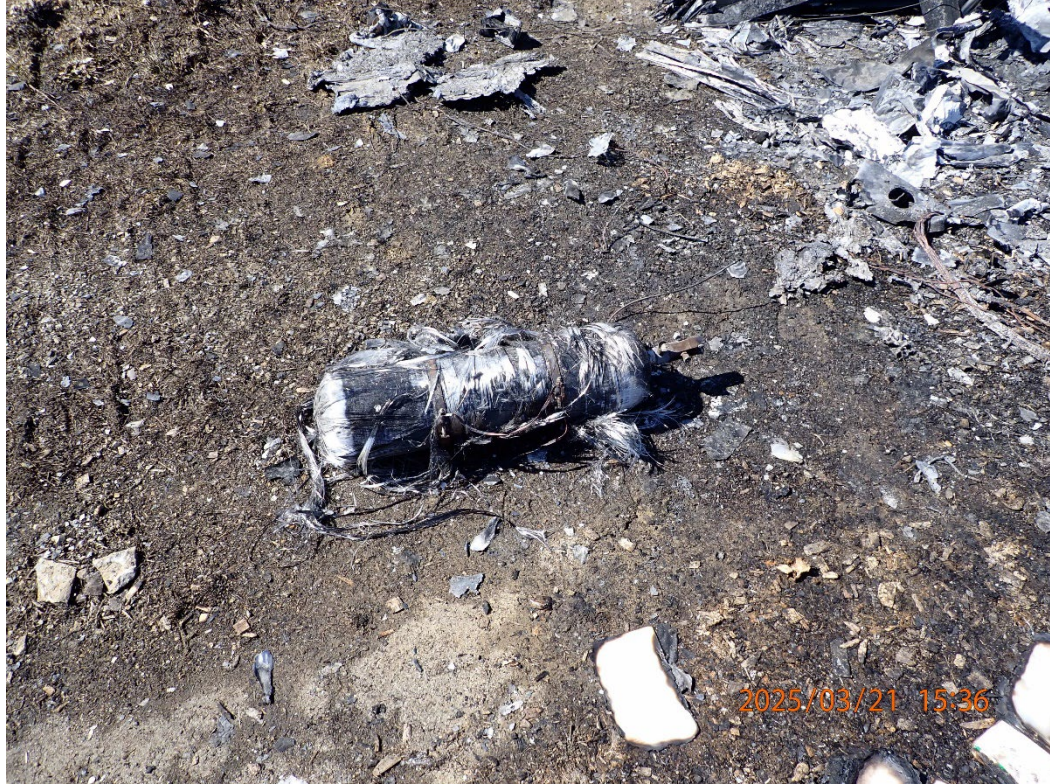
The oxygen bottle was found discharged in the wreckage and the valve stem exhibited impact damage.

**Photo 14: View of the oxygen bottle.**

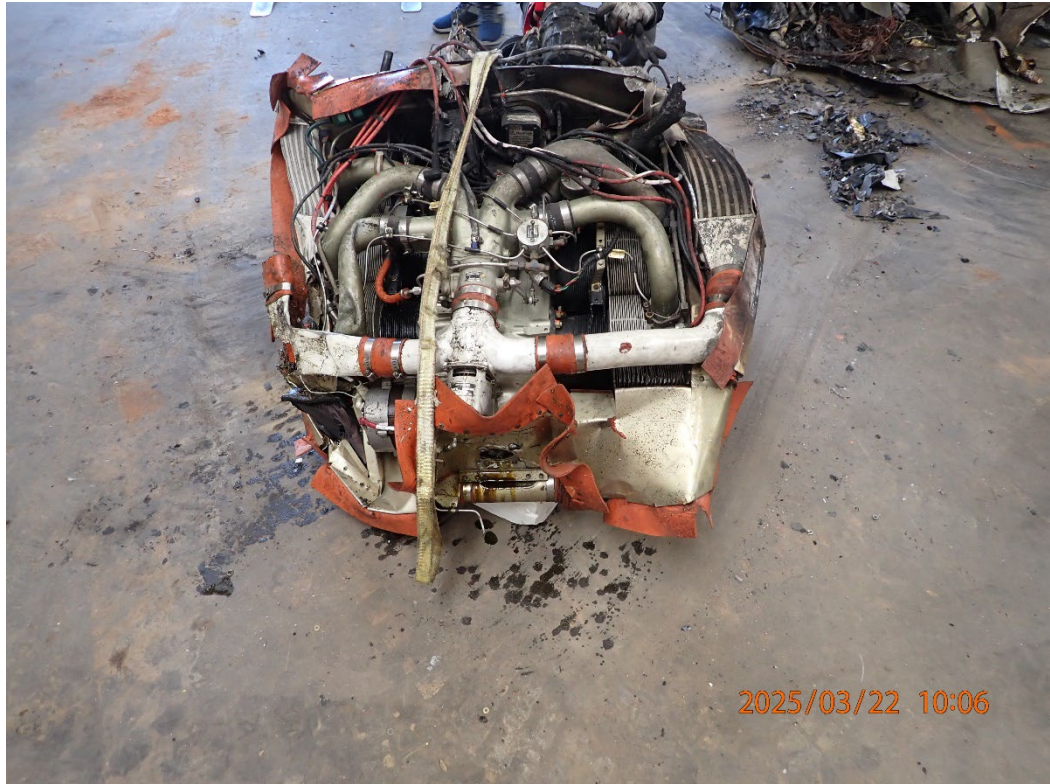
The engine exhibited thermal and impact damage. The crankshaft was rotated by hand using a tool inserted into an accessory drive pad. Crankshaft, camshaft, and valvetrain continuity was confirmed through multiple rotations of the crankshaft. Valves for cylinder Nos. 1, 2, 3, 4, and 6 moved freely. The No. 5 cylinder exhibited impact damage.

**Photo 15: Overview of the engine.**

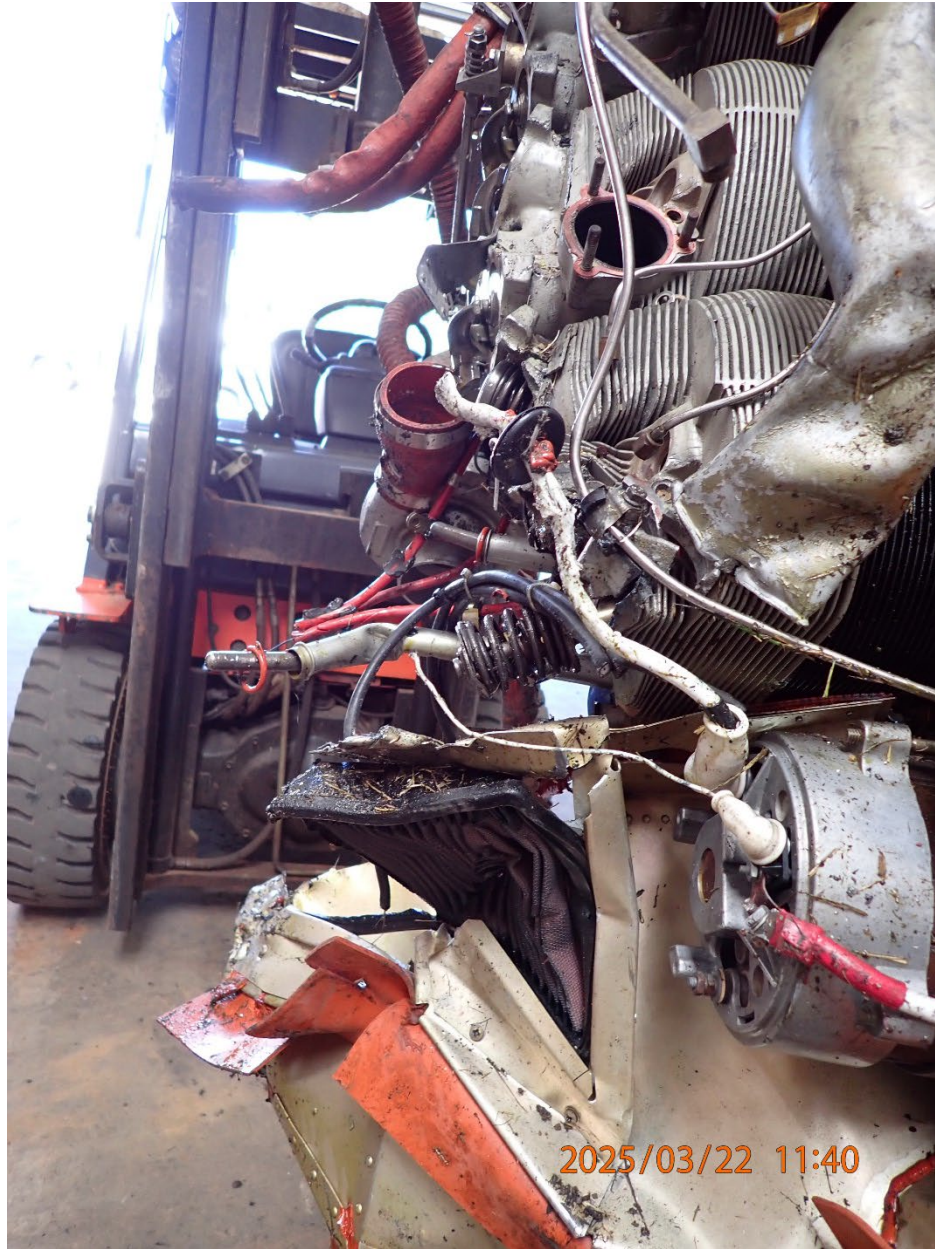
**Photo 16: View of damage to the No. 5 cylinder.**

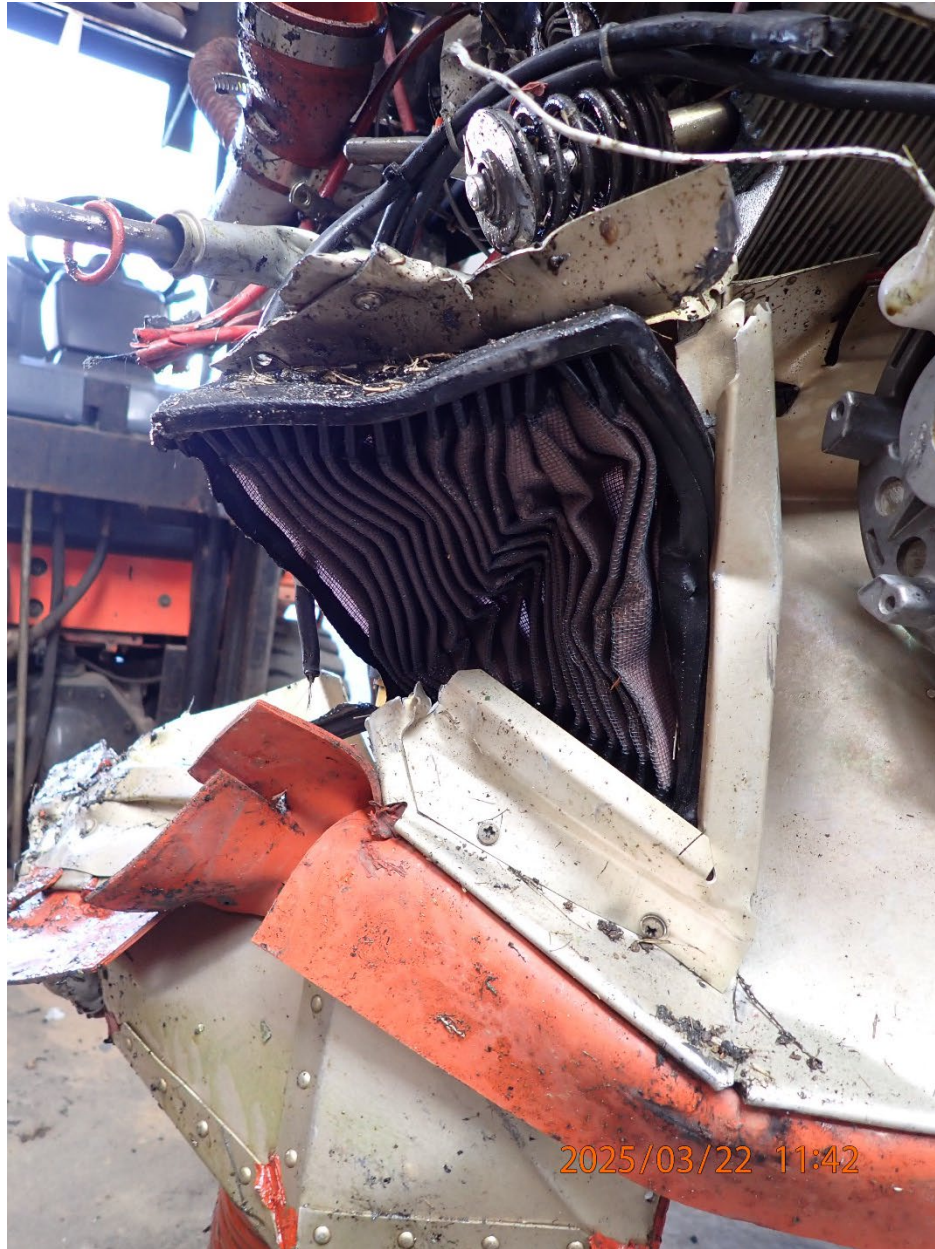
The induction air filter contained a small amount of organic debris. The induction tubing and piping exhibited impact and thermal damage. Both turbo charger shafts spun freely when rotated by hand.

**Photo 17: View of the induction air filter.**

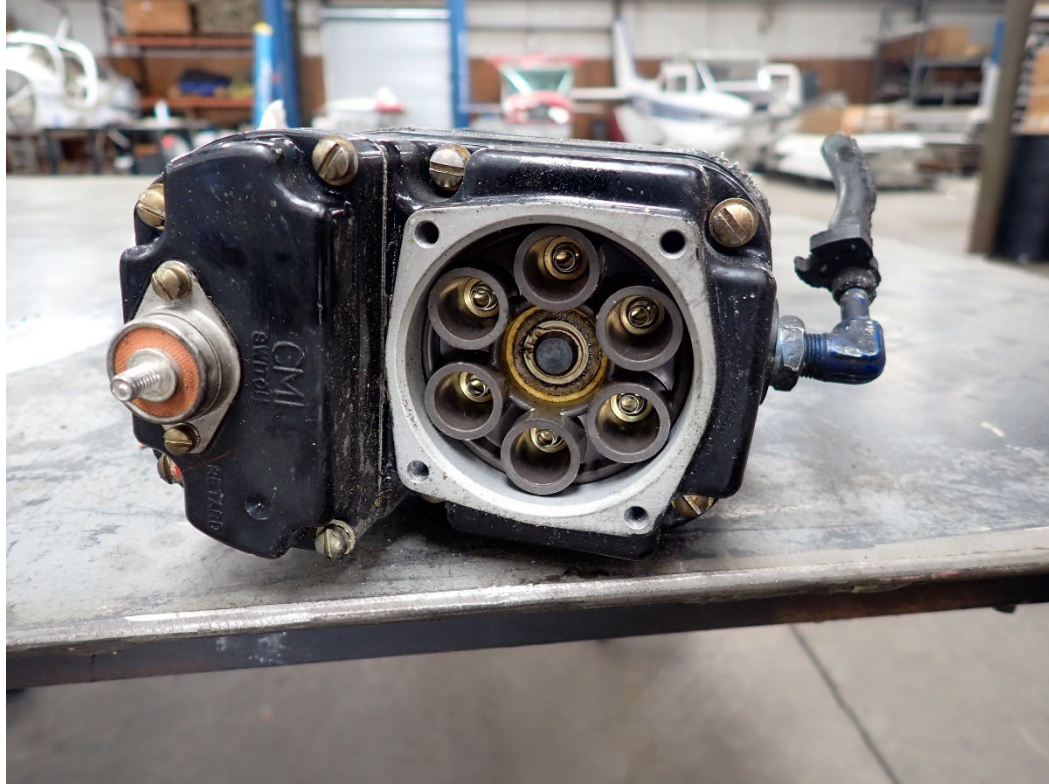
The airplane was equipped with one standard magneto and one electronic magneto both of which remained secure to the engine. The standard magneto was removed from the engine and rotated by hand. The impulse coupling snapped, and spark was observed from all towers. The electronic magneto was not removed.

**Photo 18: View of the standard magneto. (Continental Photo)**

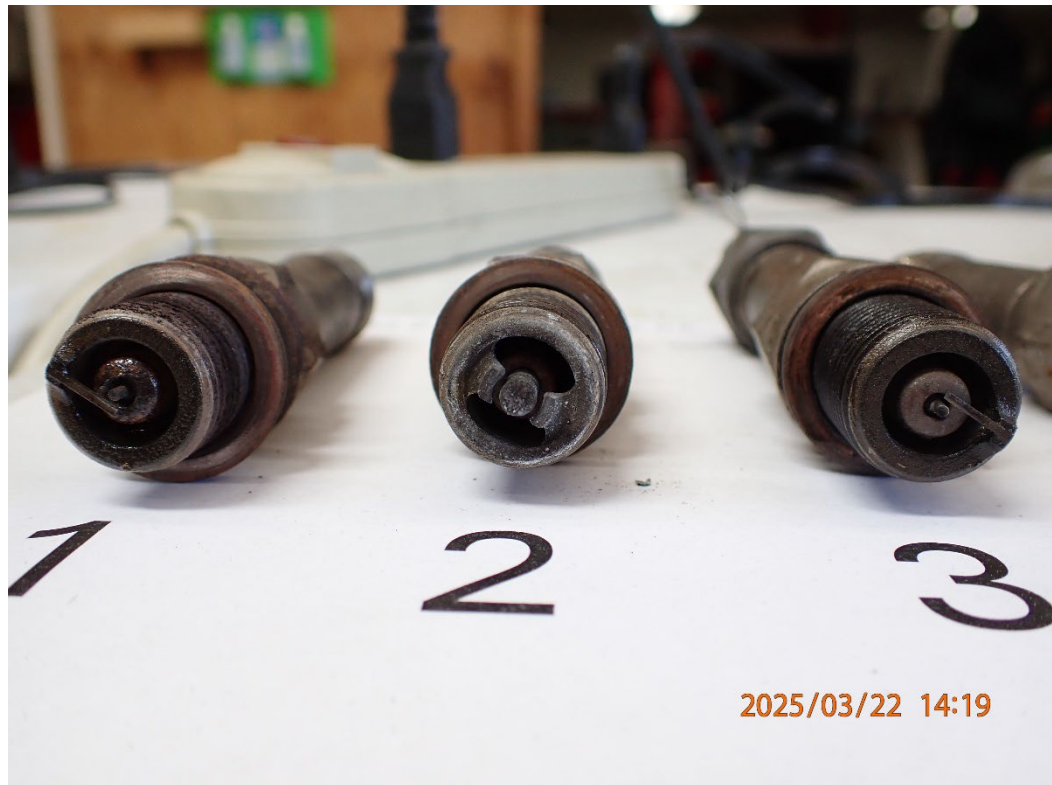
The ignition harness exhibited thermal and impact damage. All 6 top sparkplugs were removed and examined; the No. 5 sparkplug exhibited impact damage. Nos. 1, 3, and 5 were a fine-wire type sparkplug consistent with use of the electronic magneto installed. Nos. 2, 4, and 6 were a massive electrode type sparkplug consistent with use of the standard magneto installed. All sparkplugs exhibited normal wear when compared to the Champion Aerospace Aviation Check-A-Plug chart.

**Photo 19: View of sparkplugs Nos. 1-3.**

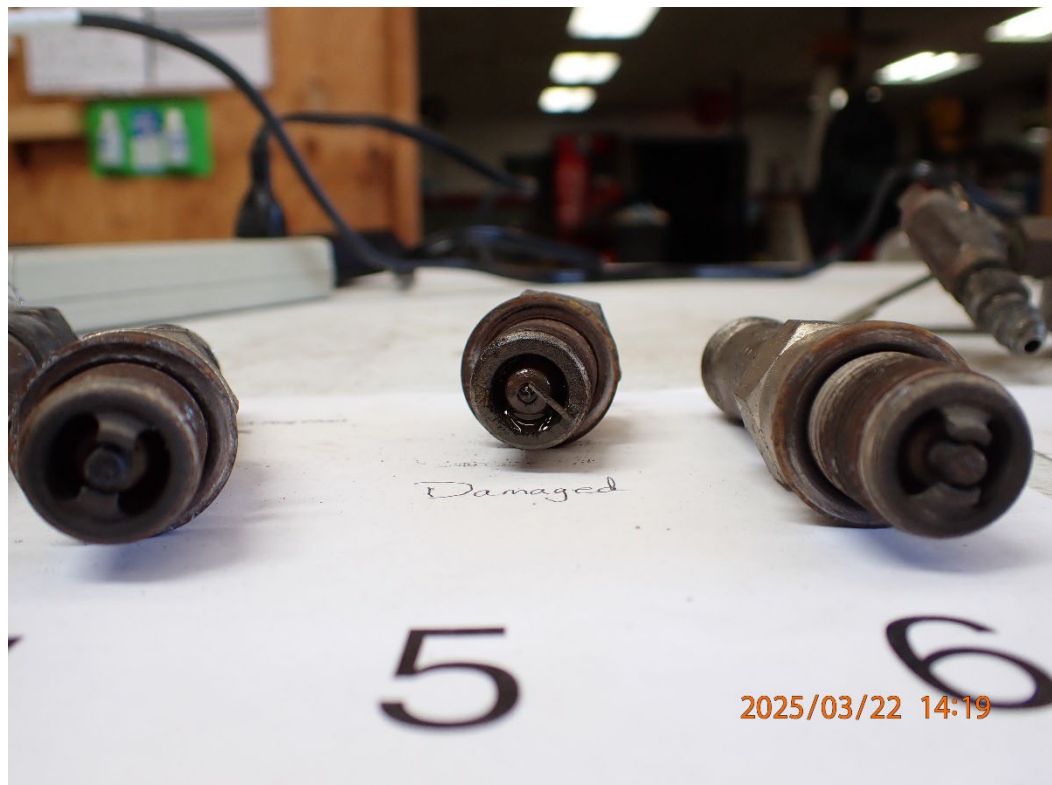
**Photo 20: View of sparkplugs Nos. 4-6.**

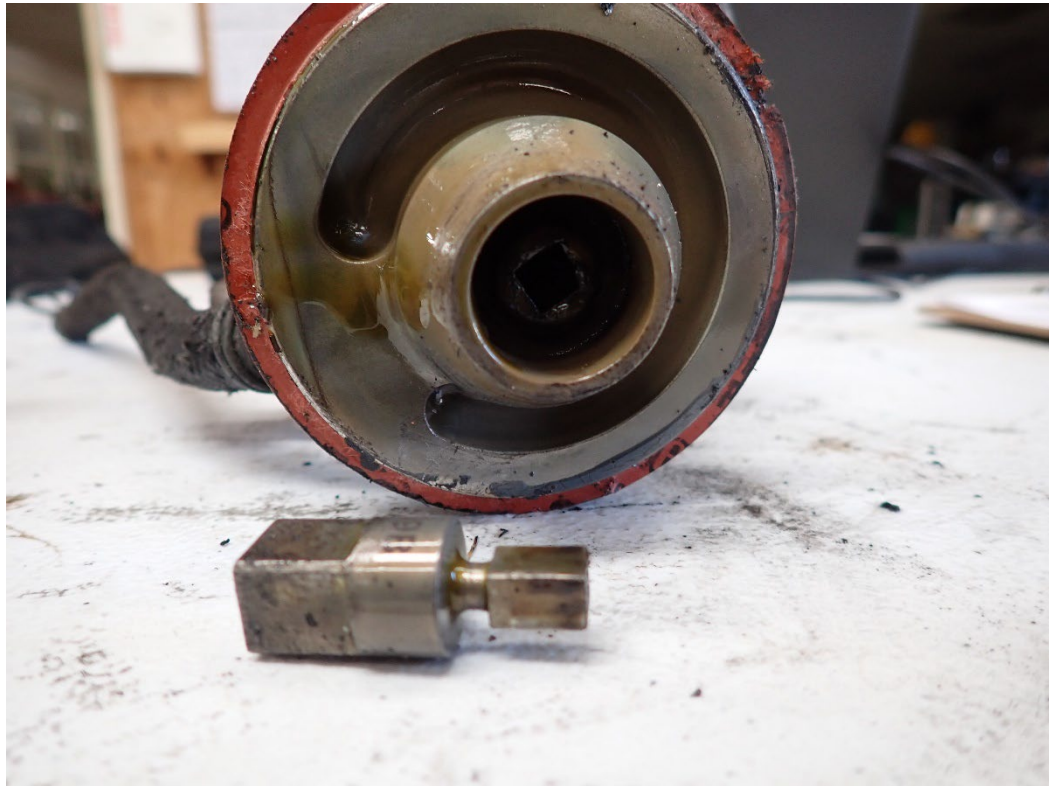
The fuel pump remained attached to the engine with the throttle control installed correctly. The pump was removed and there was fuel present. The driveshaft remained intact, and the pump turned freely by hand. The mixture control was found to be installed correctly on the throttle body/fuel control manifold and the valve operated as expected. The fuel manifold was installed correctly, and all lines were tight. Fuel was present inside the valve and a minimal amount of debris was noted in the fuel screen. The fuel injector nozzles were installed correctly and upon removal for examination were found normal and clear.

**Photo 21: View of the fuel pump and driveshaft. (Continental Photo)**

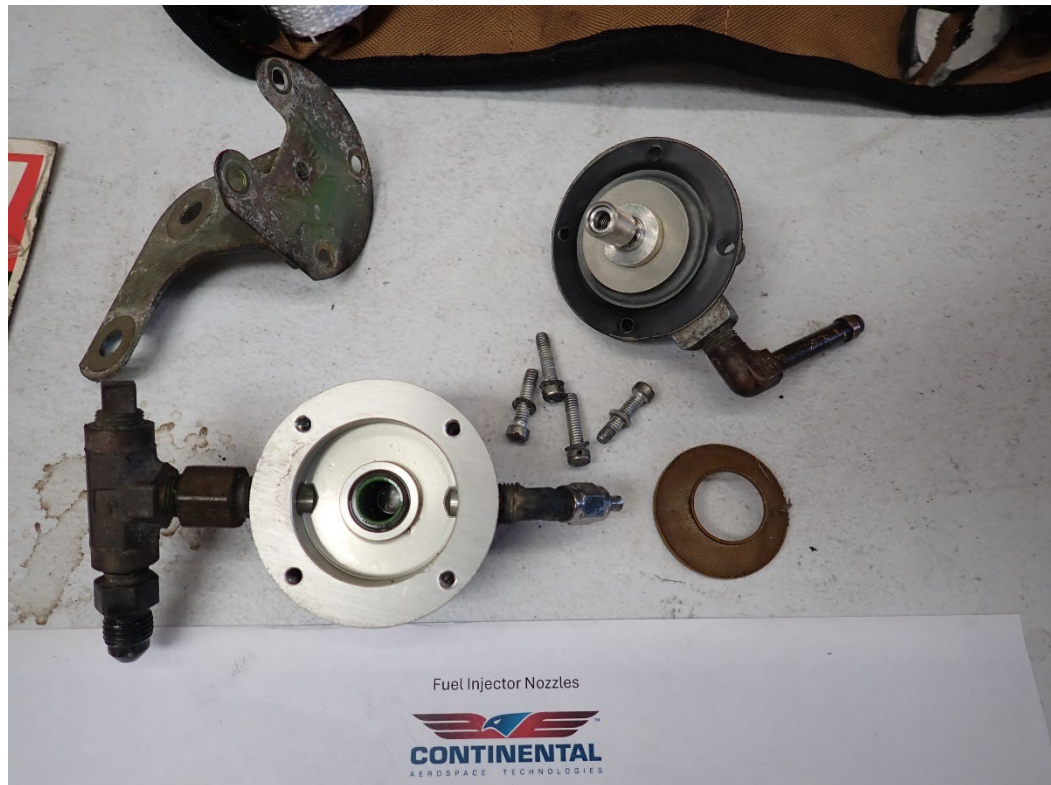
**Photo 22: View of the disassembled fuel manifold. (Continental Photo)**

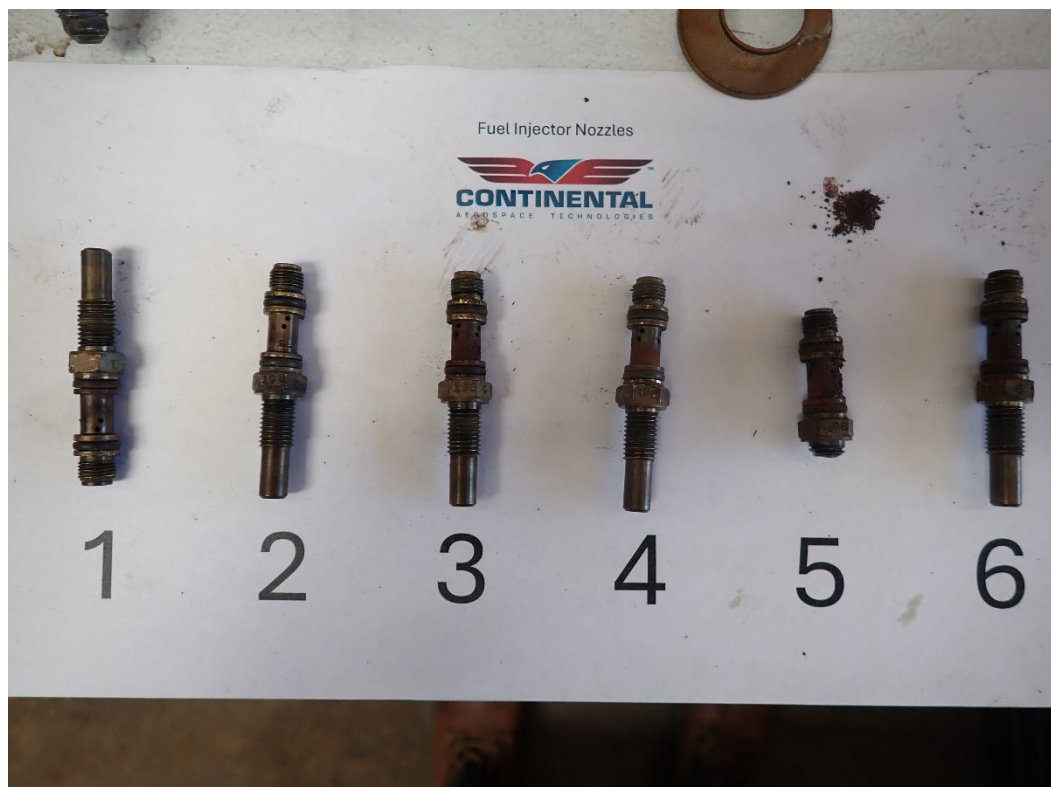
**Photo 23: View of the fuel injector nozzles. (Continental Photo)**
