# National Transportation Safety Board

ERA25FA151

## **WRECKAGE EXAMINATION**

Location: LaFayette, Georgia  
Date: March 20, 2025  
Time: 1430 EDT  
1830 UTC  
Airplane: N969SS; Cirrus SR22

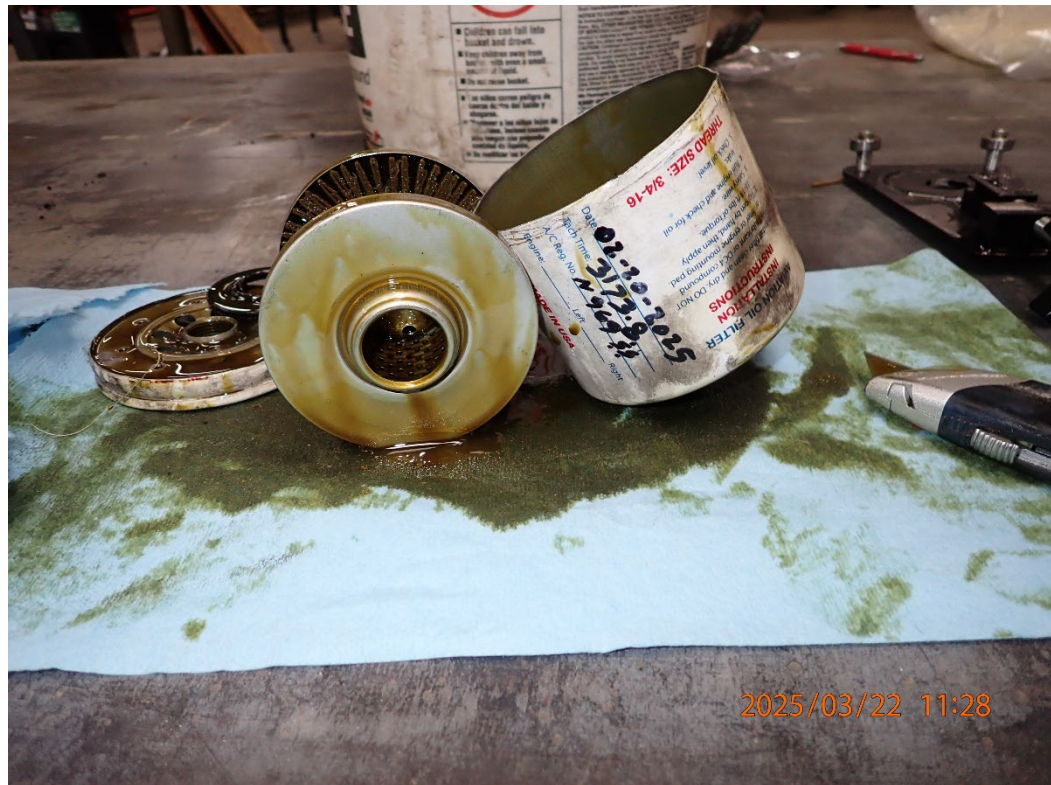
The oil filter remained installed on the engine. The oil filter was dated 2/20/2025 with a time of 3173.8. The filter was removed and cut open and no contamination was noted in the filter pleats.

**Photo 24: View of the oil filter canister.**

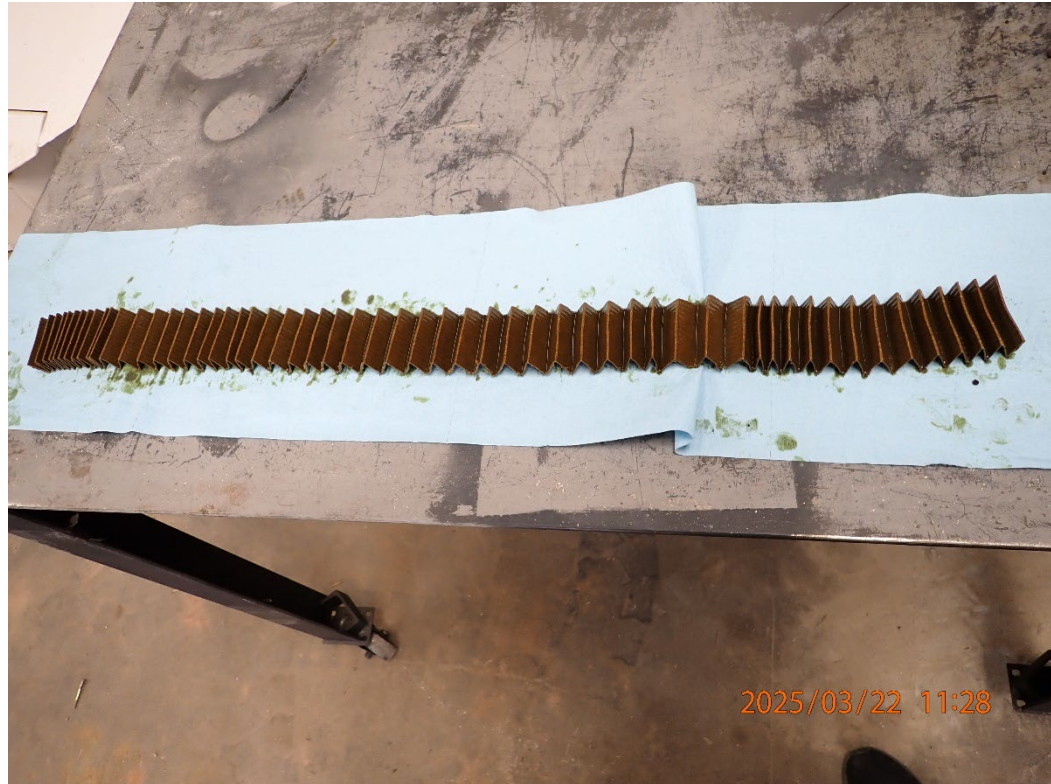
**Photo 25: View of the oil filter pleats.**

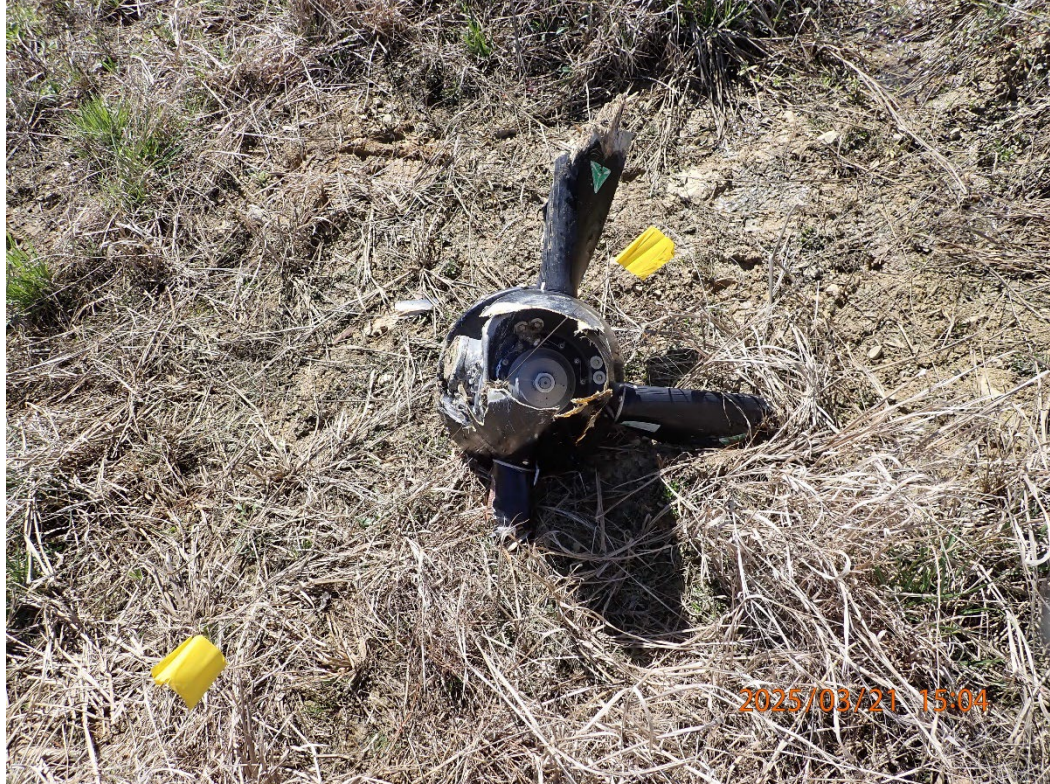
The 4 bladed M&T propeller remained attached to the crankshaft flange and was impact separated from the engine. All 4 blades remained secure in the propeller hub and were equipped with an anti-icing system. The propeller blades were found as follows:

- Ground down to the hub.
- Impact separated 6 inches from the hub.
- Impact separated 12 inches from the hub.
- Impact separated 15 inches from the hub.

**Photo 26: View of the propeller at the accident site.**

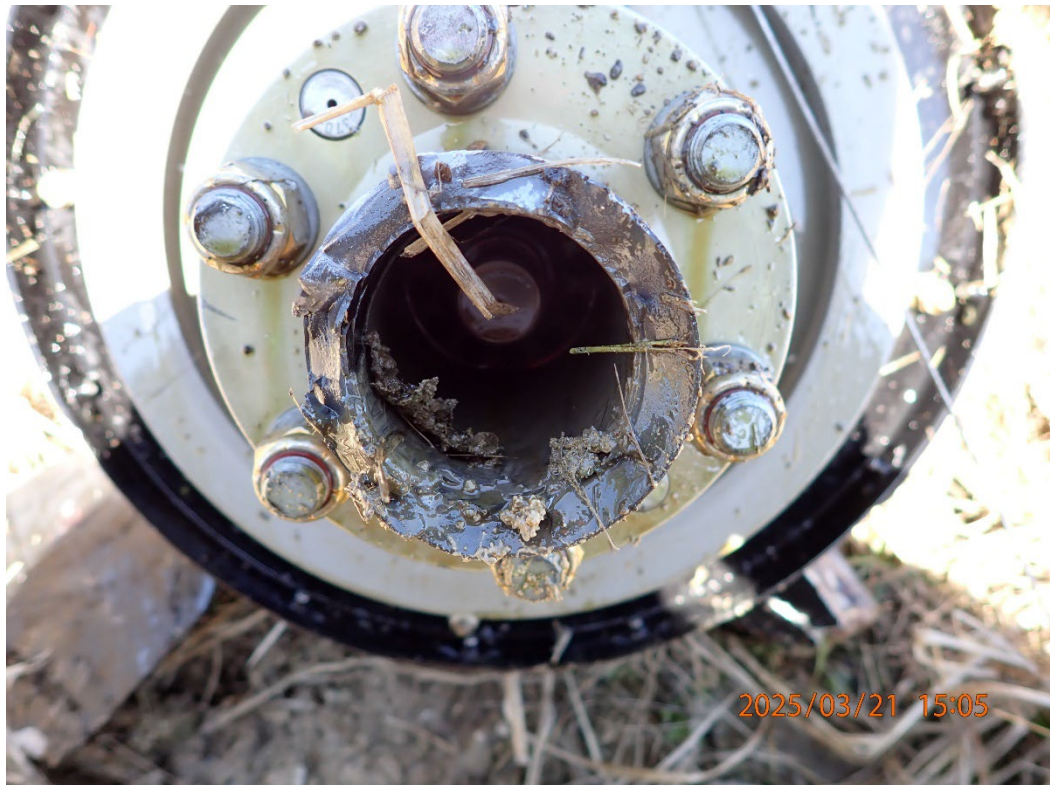
**Photo 27: View of the sheared crankshaft flange attached to the propeller.**

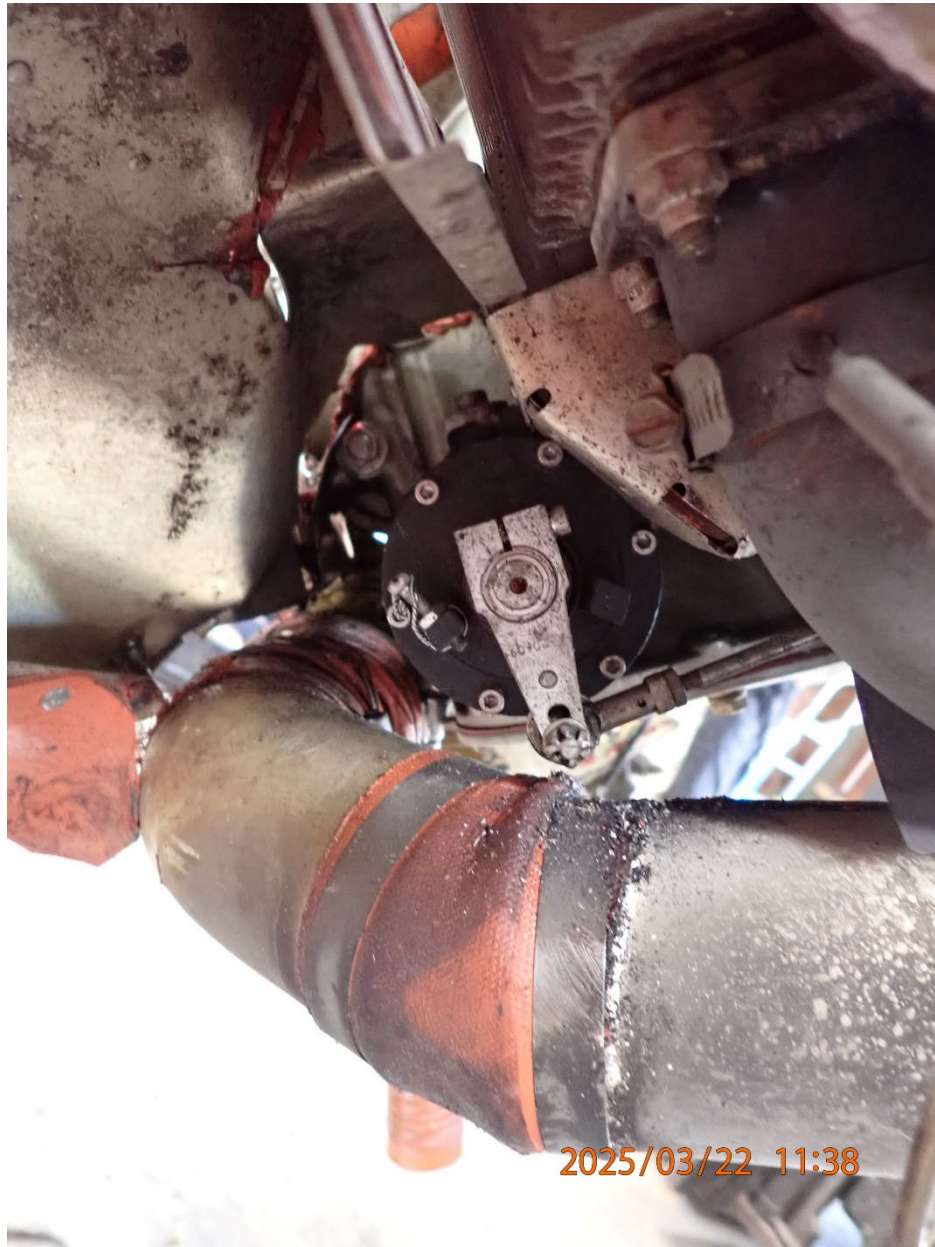
The propeller governor remained attached to the engine and the control arm remained attached to the governor. The governor oil gasket screen was free of debris.

**Photo 28: View of the propeller governor installed on the engine.**
