Joshua Young  
Air Safety Investigator  
AS-ERA

**Date:** 10/22/2025

**Subject:** ERA25FA151, Engine RPM from Propeller Strike Marks

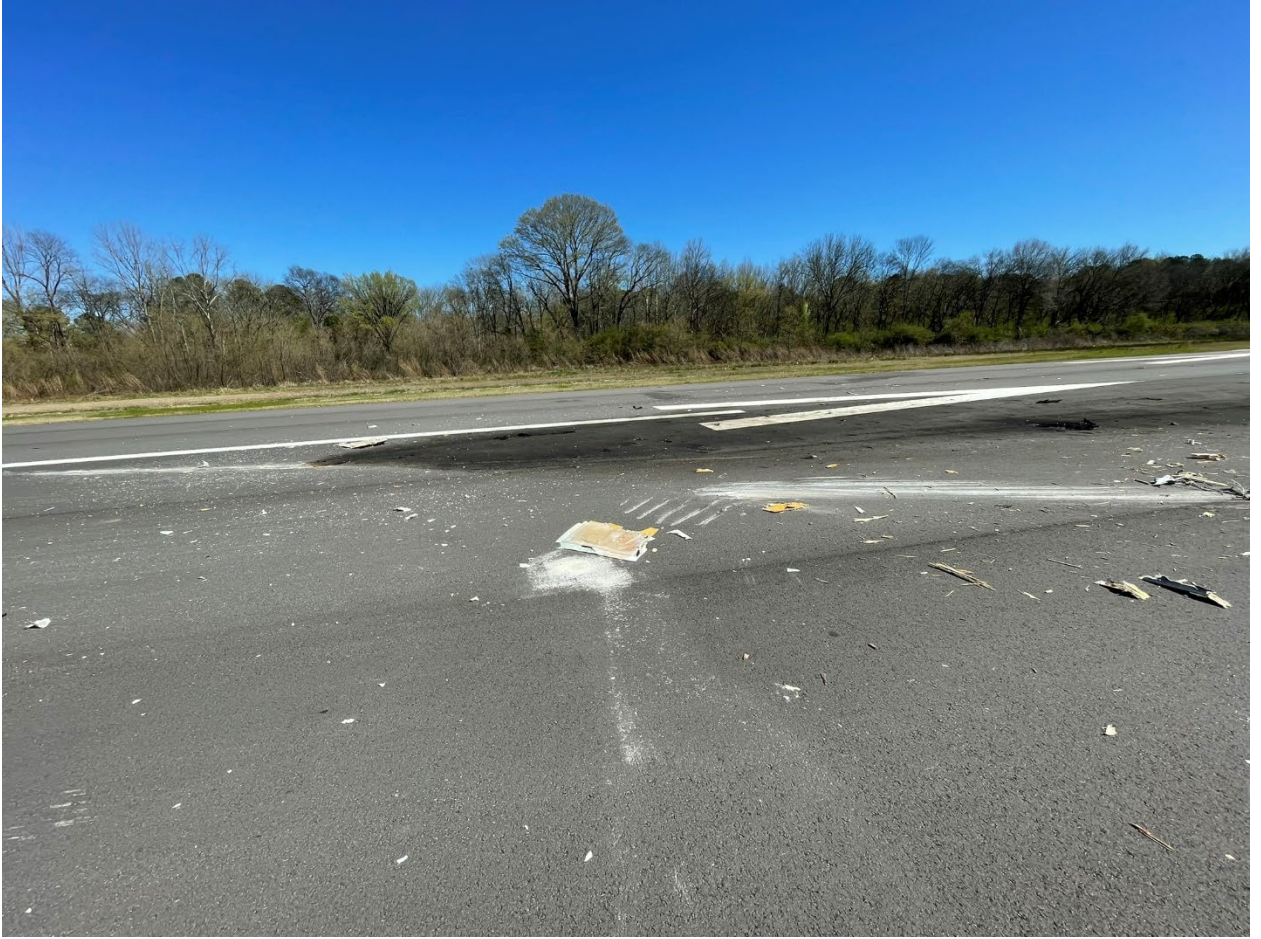
At the scene of this accident propeller strike marks were observed on the runway pavement consistent with the accident airplane's wreckage path. Measurements of these strike marks were taken. Based on the number of propeller blades, last recorded ground speed from the onboard avionics, and distance between strike marks an estimated engine RPM was calculated. The estimated RPM was calculated at 2659 RPM, which would be consistent with full power operation at the time the propeller struck the pavement.

*Figure 1: View of the propeller strike marks along the wreckage path.*

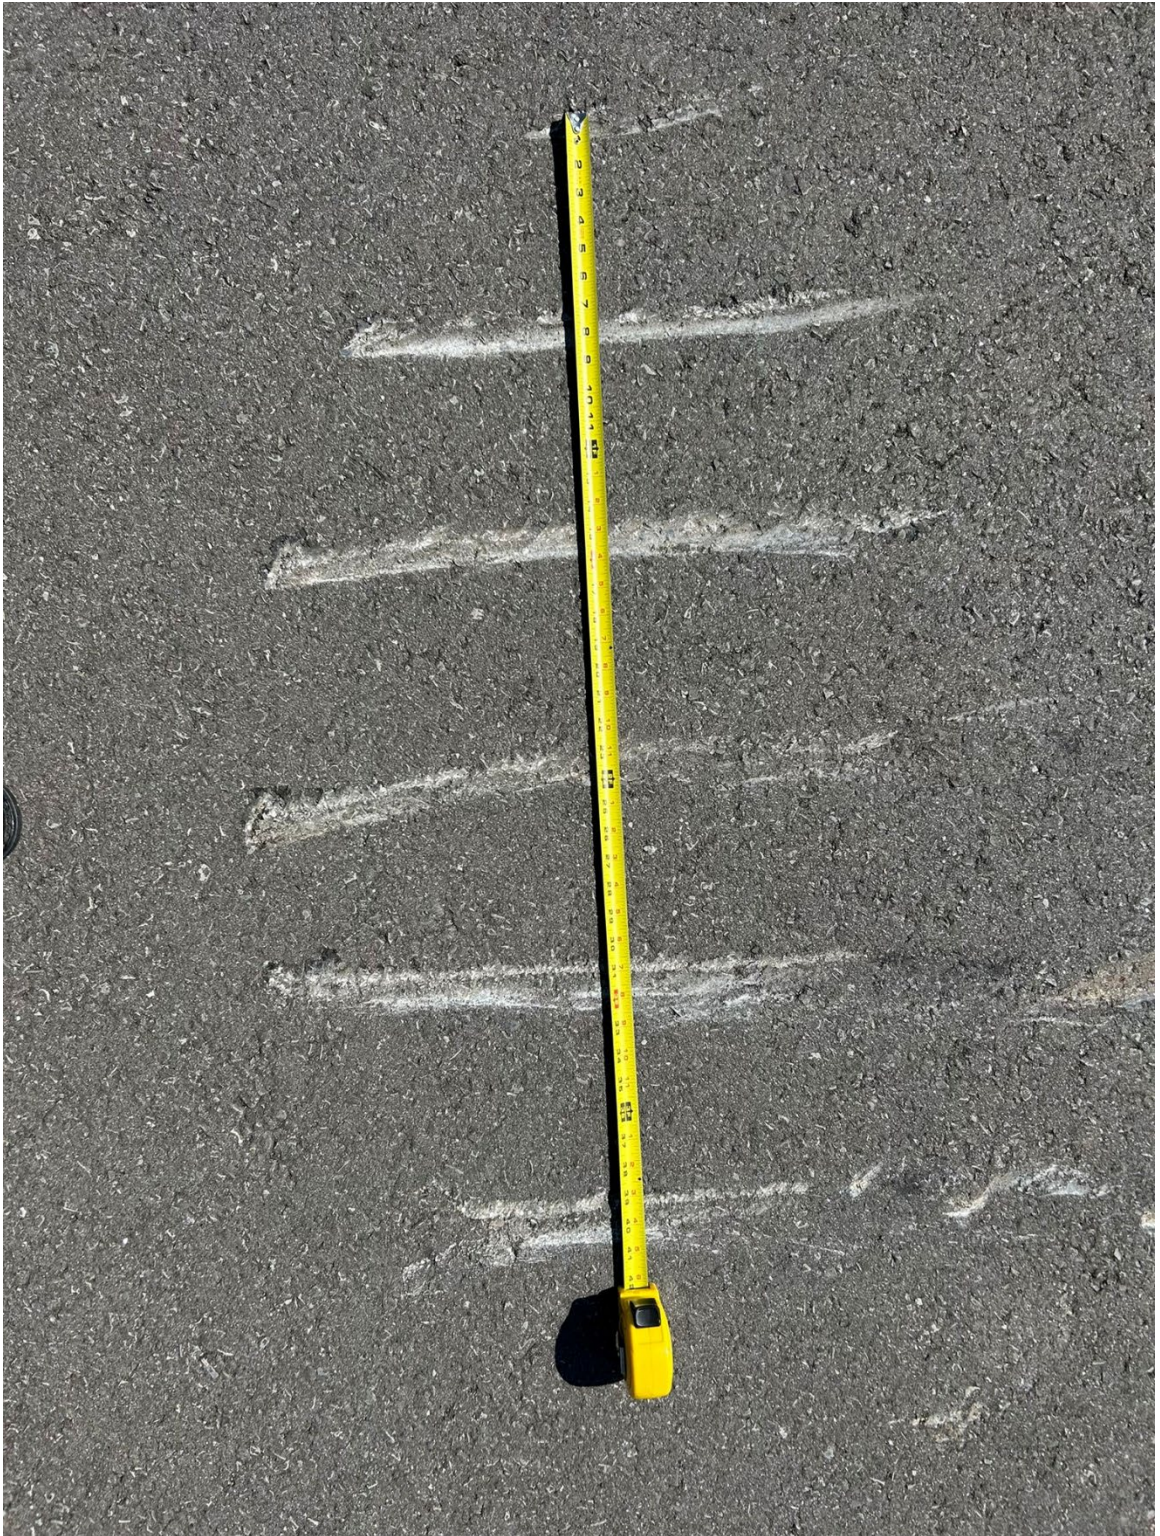
*Figure 2: View of the propeller strike marks with a scale for reference.*
