## **Mandatory Safety Notice SN 2025-01**

**Subject:** Elevator Balance tube removal.  
**Model Affected:** MXS and MX2 Aircraft fitted with adjustable balance tubes.

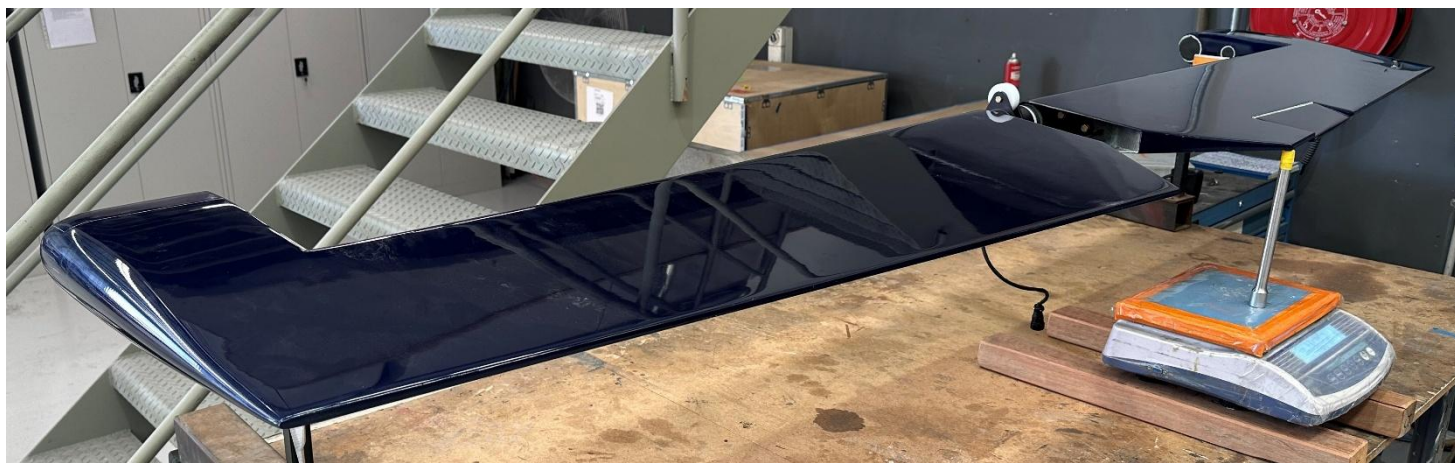
**Elevators resting as one**

Firstly, remove the elevators from the aircraft. The balance should be conducted with both elevators bolted together acting as one unit. See photo below. Place the elevator onto knife edges and then place a scale as shown below on the trailing edge of the elevator and there should be a weight on the scale from between 0.4kg to 0.65kg. This indicates a trailing edge heavy elevator. If this is not the case balance controls until this is achieved. If weight is required mix a lead shot/resin mixture and pour it into the balance tubes. If more is required, it can be placed into the elevator horns.

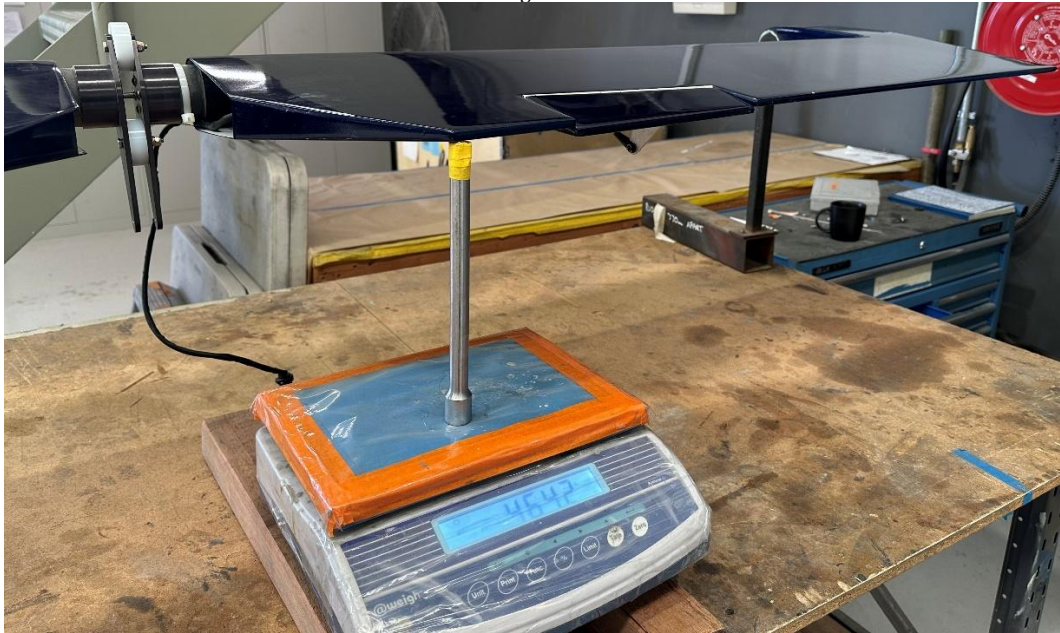
**Elevator resting on the scales indicating trailing edge heavy weight**

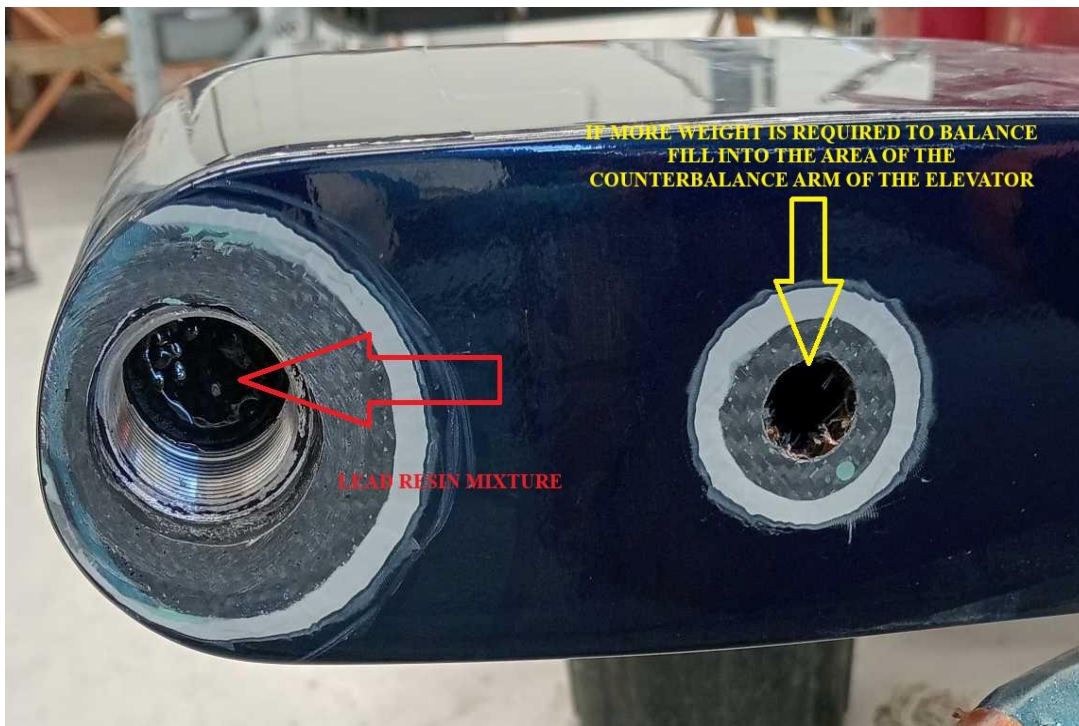
**The reference elevator in the image had initially had an exceeding trailing edge heavy weight. Image below shows where the lead/resin mixture was filled. Image also indicated where more weight may go if required.**
