# National Transportation Safety Board

ERA25FA185

## WRECKAGE EXAMINATION SUMMARY

On April 24, 2025, about 1135 eastern daylight time, an MX Aircraft Tech PTY LTD, MXS , N530RH, was substantially damaged when it was involved in accident near Hampton Virginia. The pilot was fatally injured. The airplane was operated as a Title 14 *Code of Federal Regulations* Part 91 personal flight.

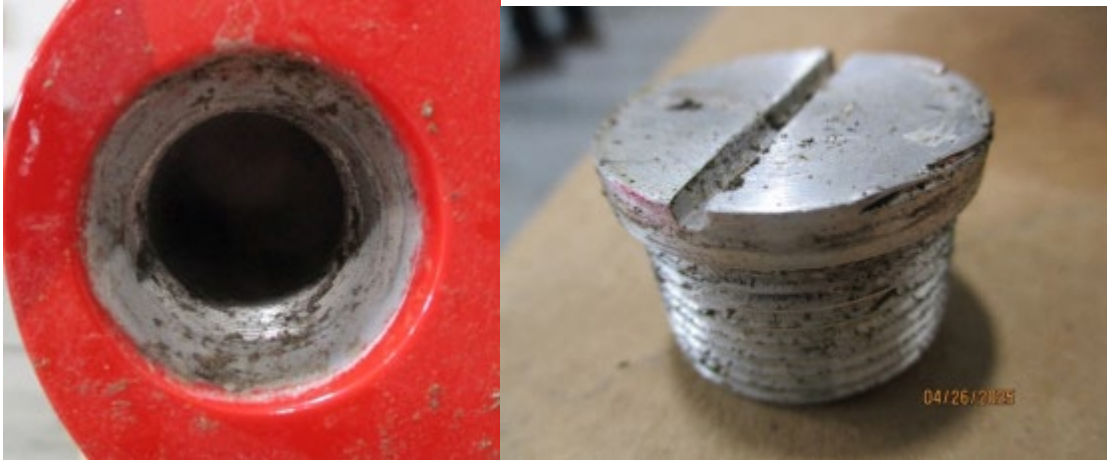
**NOTE:** The left elevator counterweight plug had impression marks on the side from the stainless-steel washer that holds the elevator tip cap in place. The washer was dented on the side from the plug, and paint scrapes were present on the elevator from the plug. I placed the plug back in the elevator hole and loosened it up, the elevator jammed when moved.

Dirt consistent with that found in the vicinity of the accident site was identified on the elevator, as well as in the counterbore and threaded area where the left elevator counterweight plug would have been installed. The counterweight plug threads were intact and also contained similar dirt contamination consistent with that found on the elevator. About half the circumference of the left elevator counterweight plug displayed gouging, and an area showed evidence of paint transfer. No O-ring associated with the left elevator plug was found. The right elevator counterweight plug remained installed and was tight. It was removed and found to contain no O-ring.

Figure. Left elevator counterweight installation hole (left) and recovered counterweight plug (right). Gouging and paint transfer are visible on the counterweight plug.

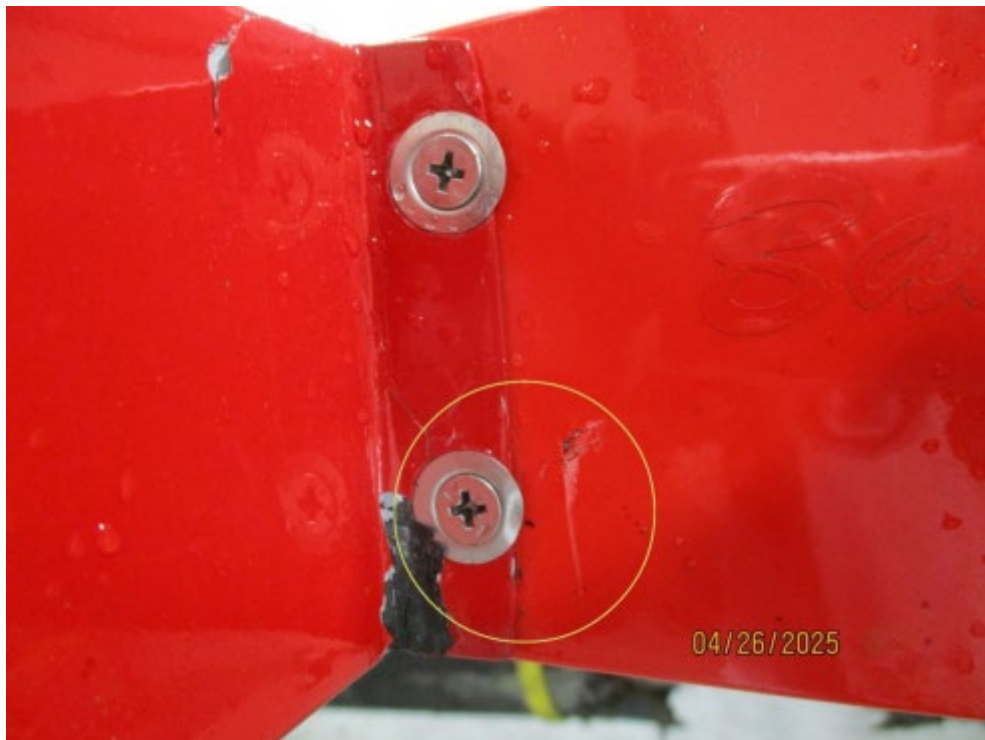
The horizontal stabilizer structure adjacent to the elevator position where the counterweight plug would have been installed displayed dents and paint scrapes that appeared visually consistent with contact with the counterweight plug. A washer beneath a stainless-steel screw secured to the horizontal stabilizer structure (near where the paint scrapes were observed) was also dented.

Figure. Horizontal stabilizer structure adjacent to the left elevator counterweight plug, showing paint scrapes and a dented washer (circled in yellow).
