# National Transportation Safety Board

ERA25FA201

## **WRECKAGE EXAMINATION**

Location: Yulee, FL  
Date: May 10, 2025  
Time: 0938 EDT  
1338 UTC  
Airplane: N30689; PA-32R-300

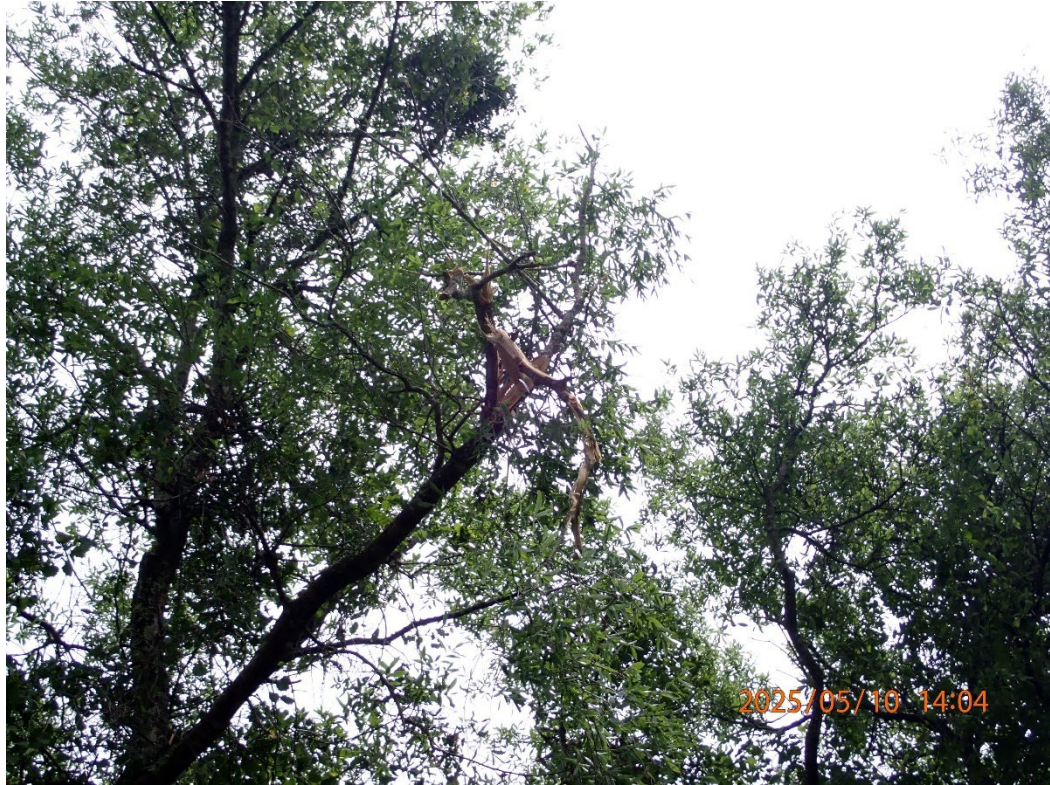
The airplane first impacted a branch about 40 ft up a tree which was located about 24 ft from the main impact crater. The estimated measurement of the descent angle was about 50° from the initial tree impact to the main impact crater. The wreckage came to rest upright about 15 ft from the main impact crater on a heading of about 264° magnetic. Some small branches were located near the ground crater, with diagonal cuts present on them, consistent with having been cut by the rotating propeller. The outboard section of the left wing was located near and to the right of the ground crater. Drag marks produced by the left wing were observed crossing a

**Photo 1: View of broken tree branches at initial impact.**

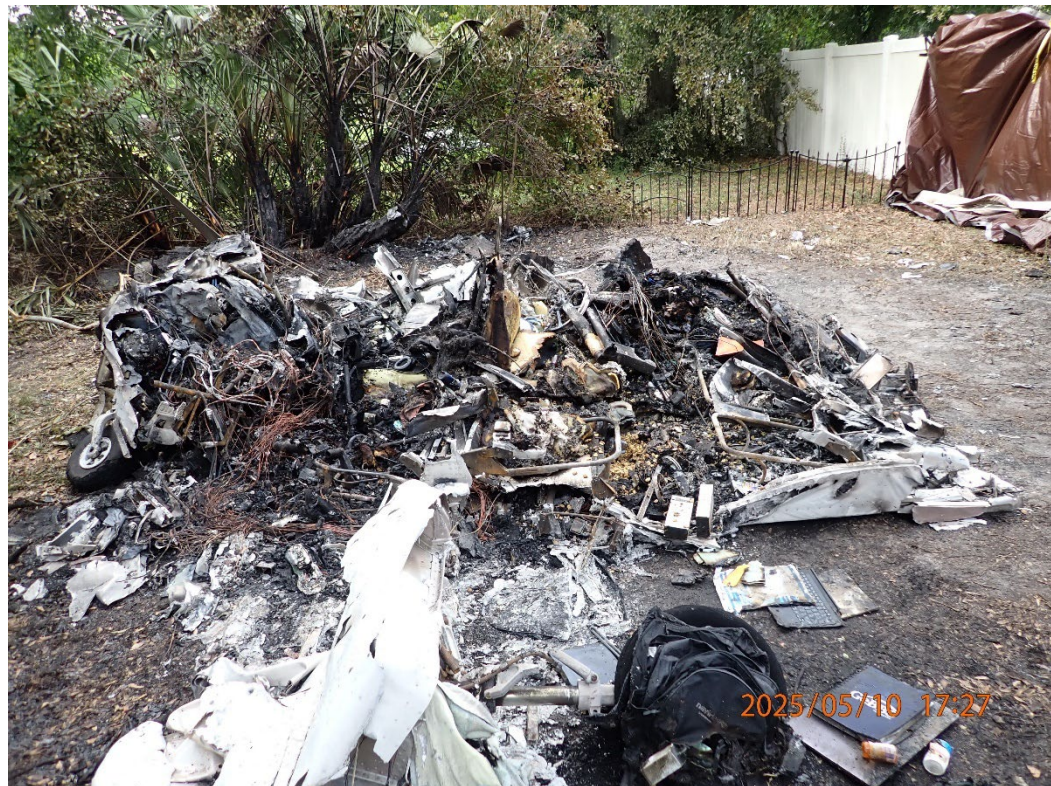
The fuselage was destroyed by impact forces and post-impact fire. The cabin seating area remained attached to the firewall and engine. The cockpit location was destroyed by fire and did not yield any useful instrument or flight control position information. The fuselage came to rest upright and facing the initial impact crater. The cabin seating area, behind the pilot seats, contained remnants of two E-bikes, batteries and dog food. The nose baggage door was not located in the wreckage; the location of the nose baggage door was consumed by postaccident fire. The right front cabin entry door was damaged by impact forces and post-impact fire. It was separated from the fuselage and came to rest near the propeller.

**Photo 4: Overview of the fuselage.**

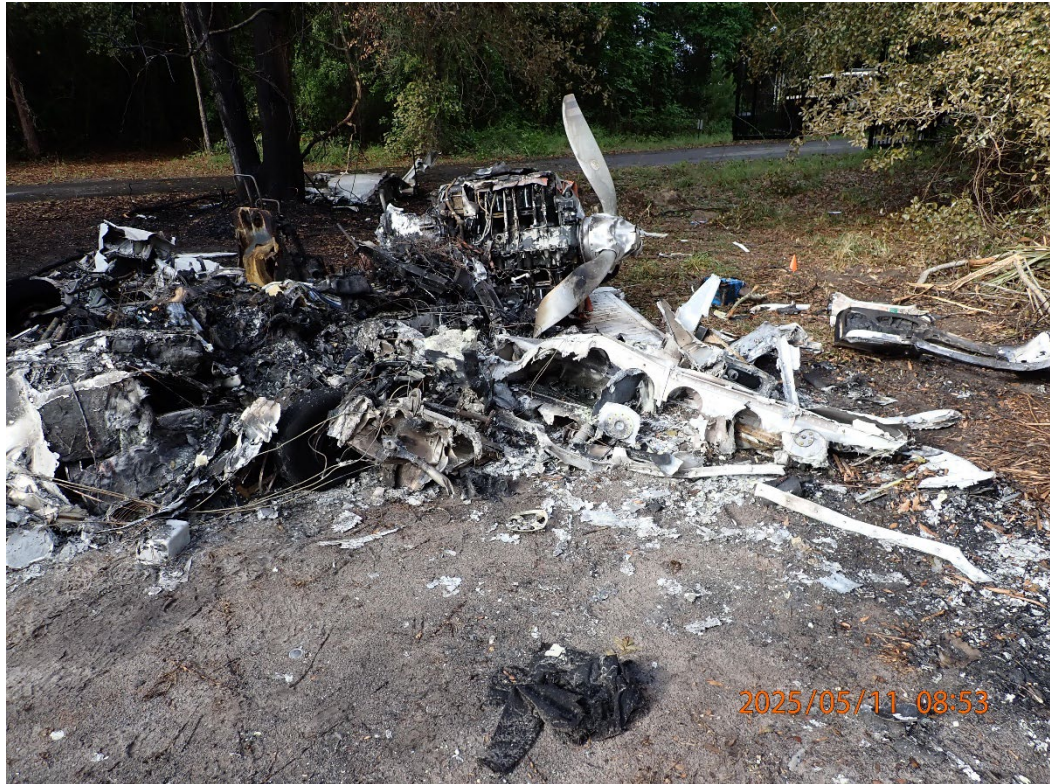
**Photo 5: View of the right side of the fuselage.**

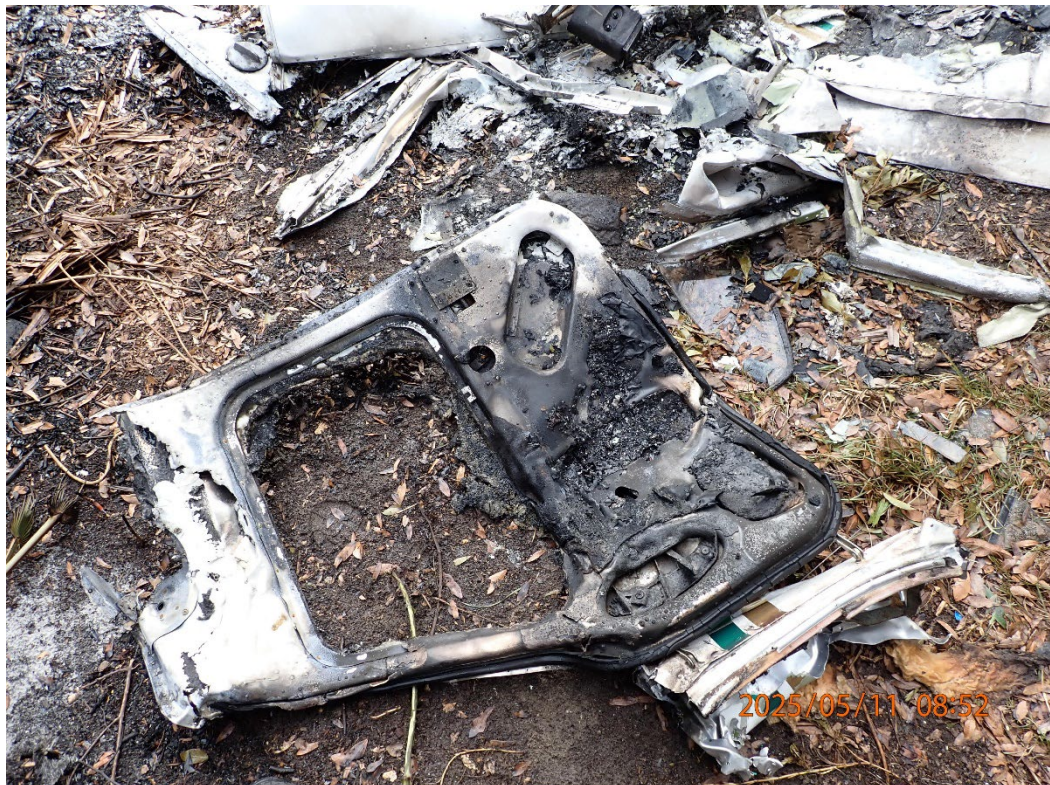
**Photo 6: View of the right front cabin entry door.**

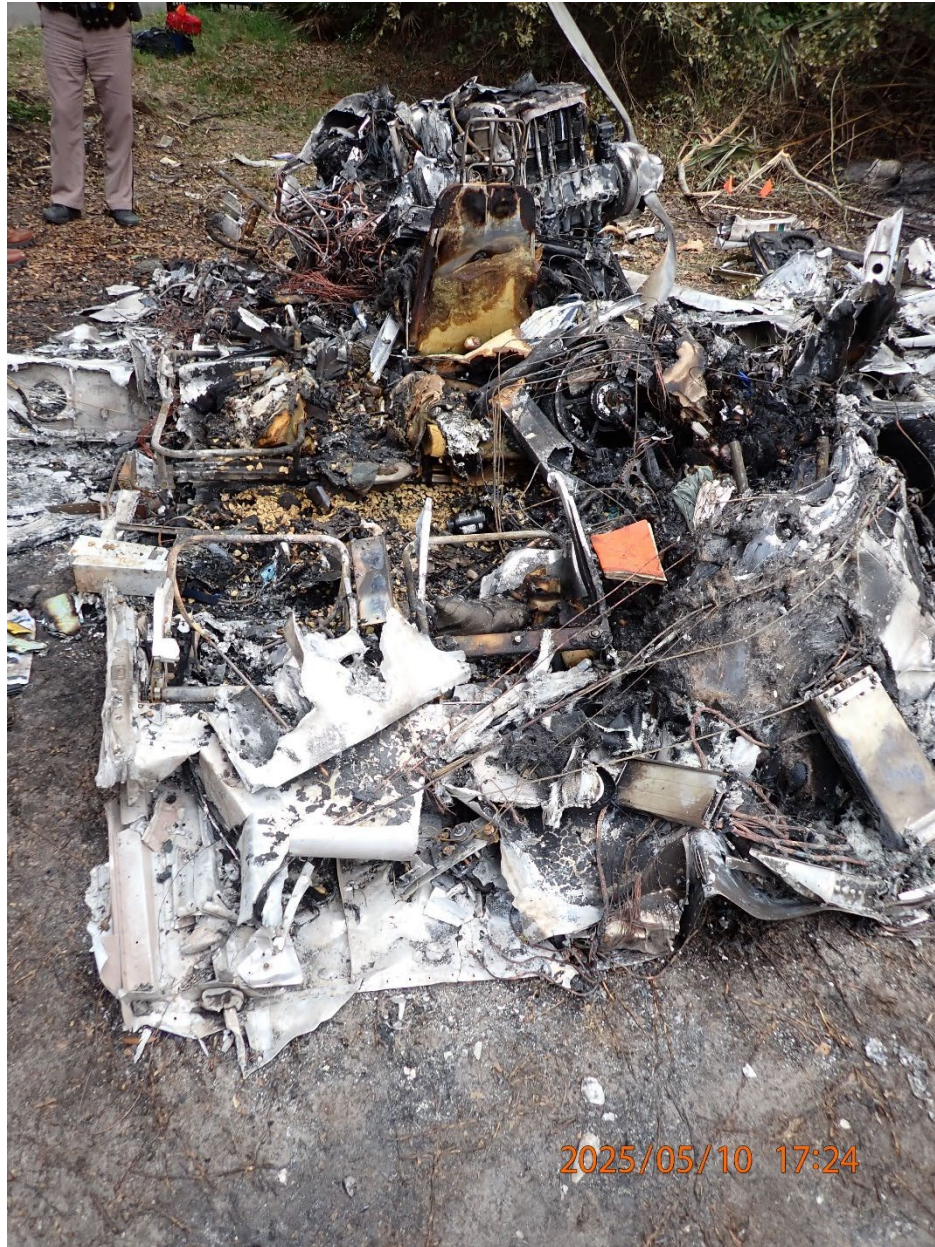
The empennage was impact separated 80 inches aft of the aft wing spar and folded over the fuselage. The separated portion remained attached to the fuselage via the stabilator, rudder, and stabilator trim cables. The vertical stabilizer and rudder were destroyed by postimpact fire. About a 58-inch piece of the stabilator was found with about a 45-inch piece of stabilator trim attached. The rest of the stabilator and trim were consumed by postaccident fire. Both stabilator cables remained attached at the stabilator control tube and were continuous to the base of the control column. The cables remained attached at the control column. The stabilator balance weight remained attached to the stabilator control tube. The stabilator trim was measured at 0.4 inches extension on the forward side of the drum, which equates to a trim position between approximately half way between neutral and full nose down. Both rudder cables remained attached to the sector in the empennage and were continuous to the rudder pedal bar in the forward cabin. The cables remained secured at both ends.

**Photo 7: View of the separation of the empennage.**

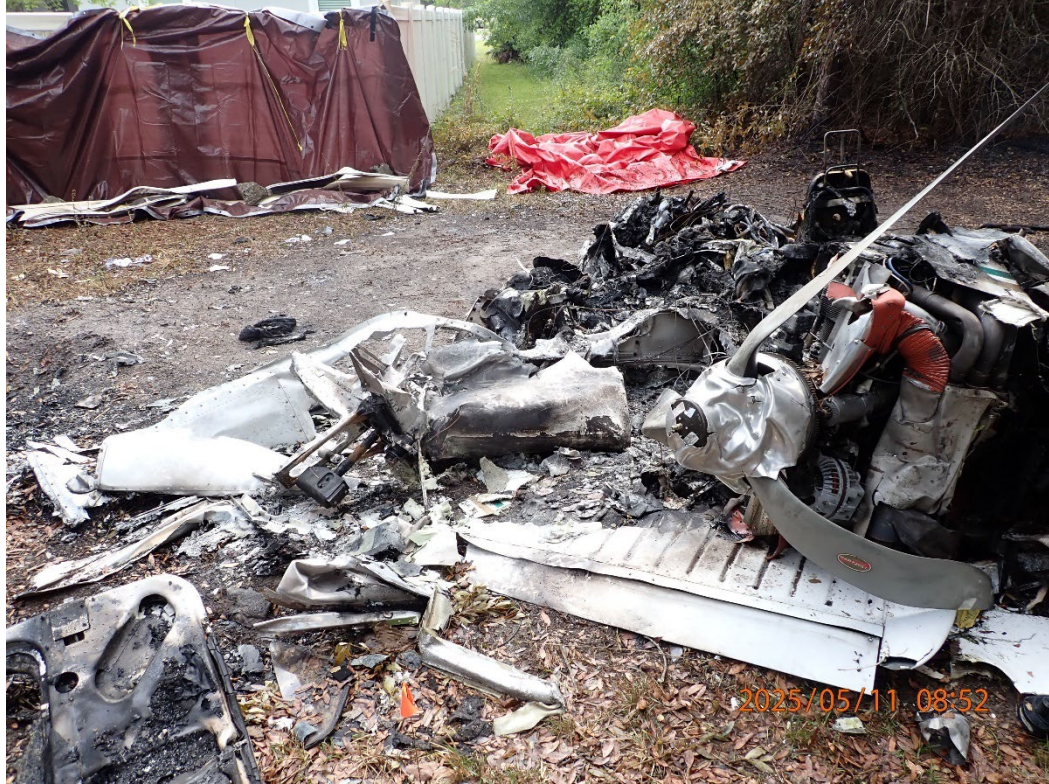
**Photo 8: View of the remaining stabilator under the engine.**

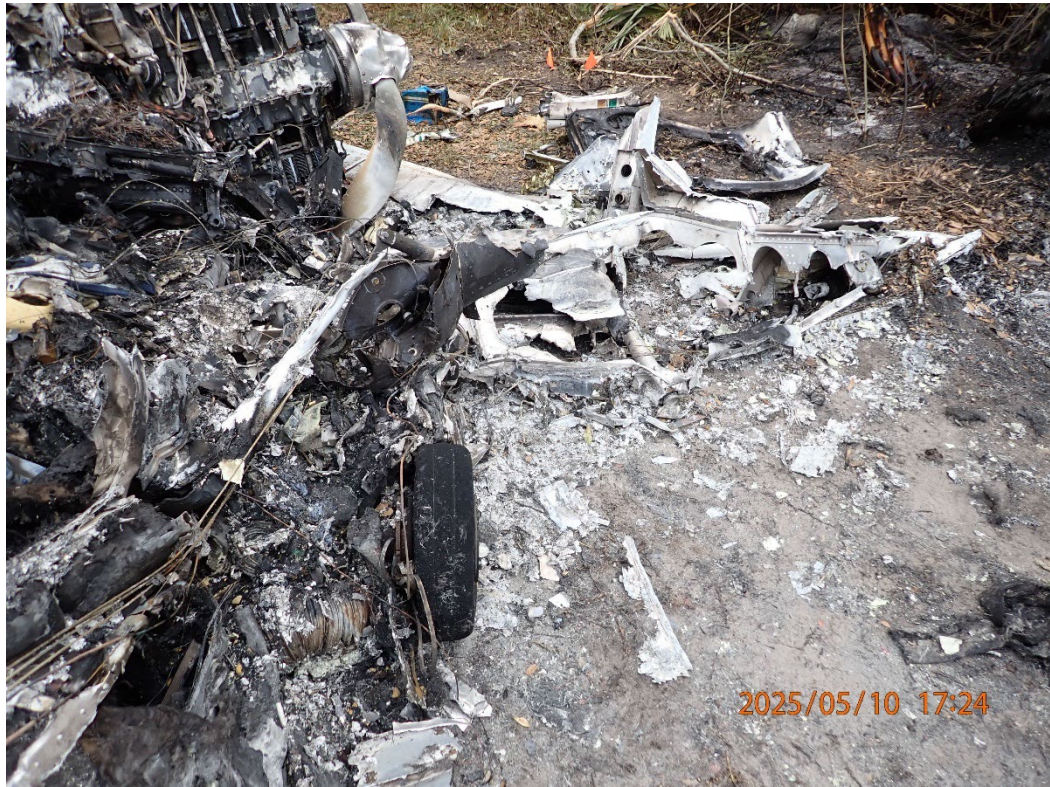
The right wing was consumed by a postaccident fire. A 106-inch portion of the right-wing main spar remained attached to the fuselage. The right aileron bellcrank was thermally separated from the wing. Both aileron cables remained attached to the bellcrank. The aileron balance cable was intact and complete from the left bellcrank to the right bellcrank. The aileron drive cable on the right side was partially burned away by an area of intense fire and re-solidified metal near the center of the cabin. Full aileron cable continuity was confirmed from each side of the re-solidified metal.

**Photo 9: View of the right wing.**

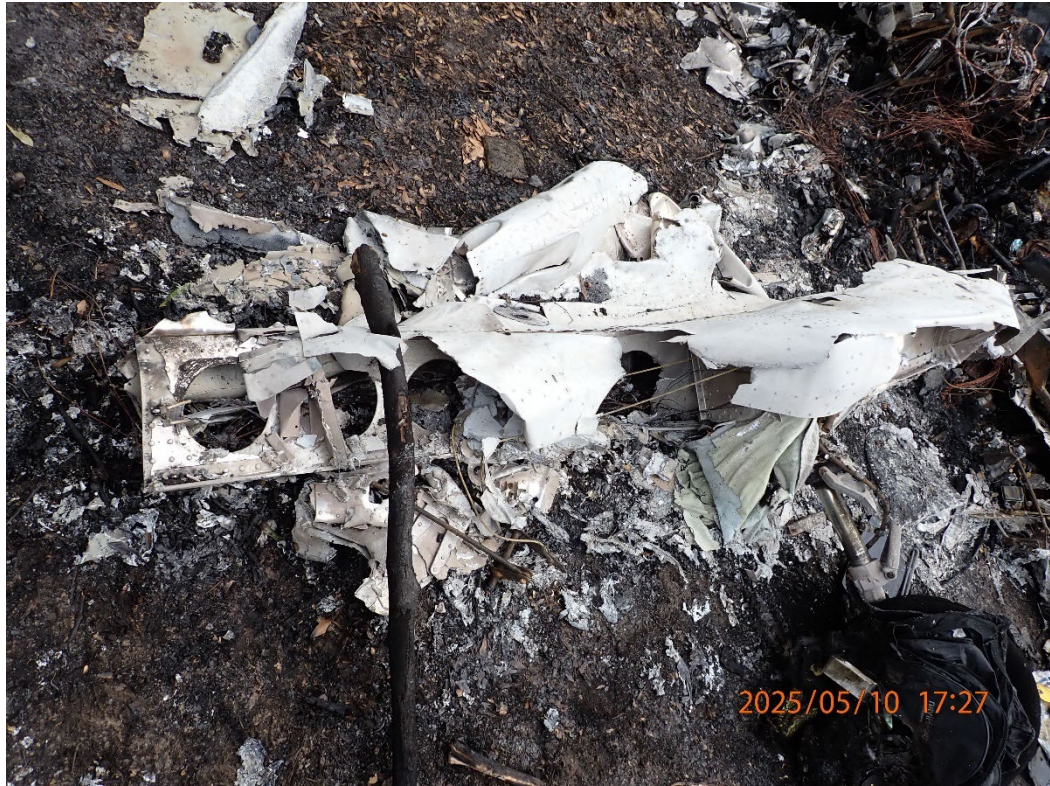
An 84-inch outboard portion of the left wing was impact separated and found about 15 ft from the main wreckage and was inverted. The aileron remained attached to the impact separated portion of the left wing. A 91-inch portion of the left main wing spar remained attached to the fuselage and exhibited thermal damage. The right flap was consumed by postaccident fire.

The left aileron bellcrank was separated from the wing and came to rest with the inboard portion of the wing. Both aileron cables remained attached to the bellcrank. The primary aileron cable on the left side was partially burned away by an area of intense fire and led into an area of re-solidified metal near the center of the cabin. The aileron drive chain at the control column was broken. Both aileron drive

**Photo 10: View of the inboard portion of the left wing.**

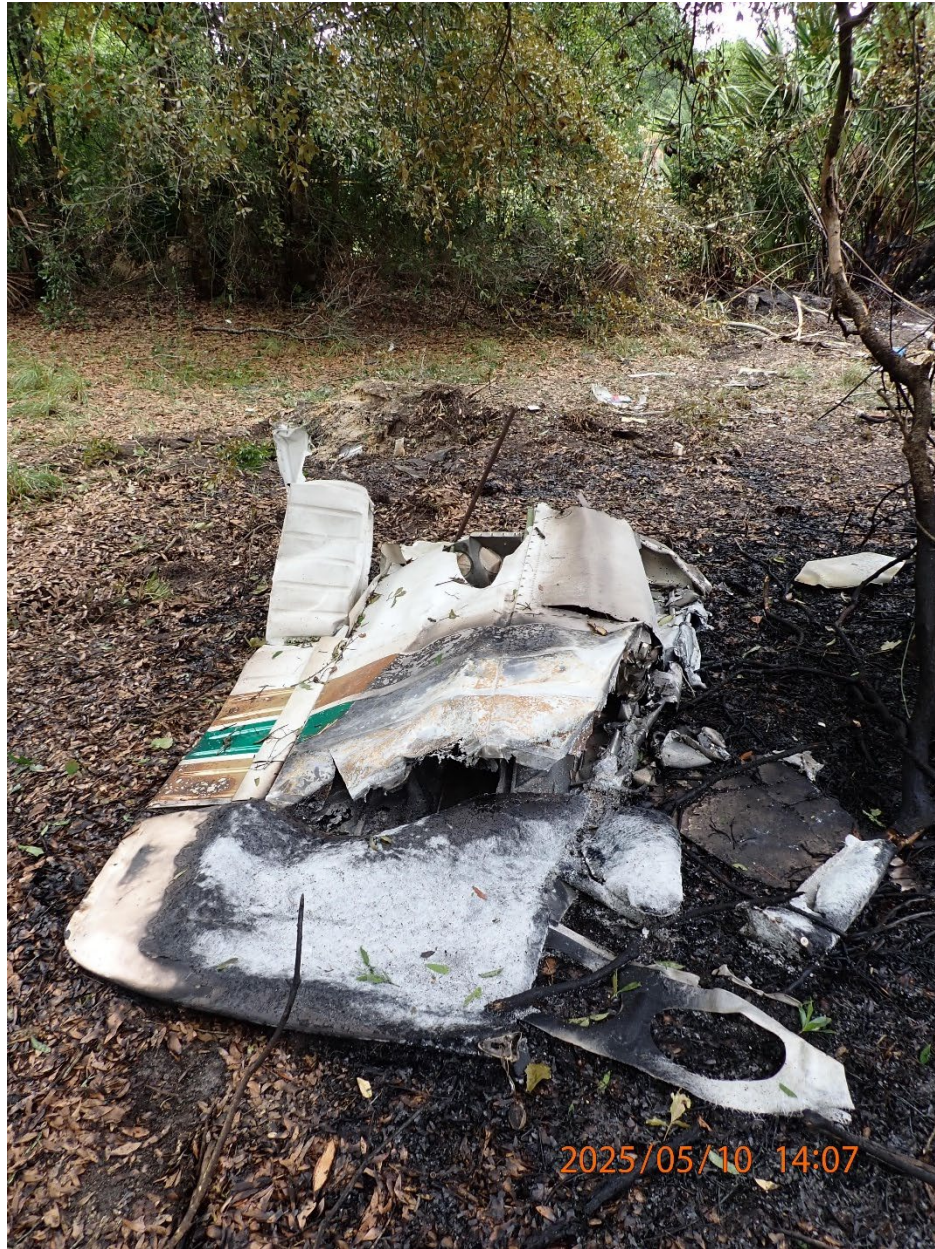
**Photo 11: View of the impact separated portion of the left wing.**

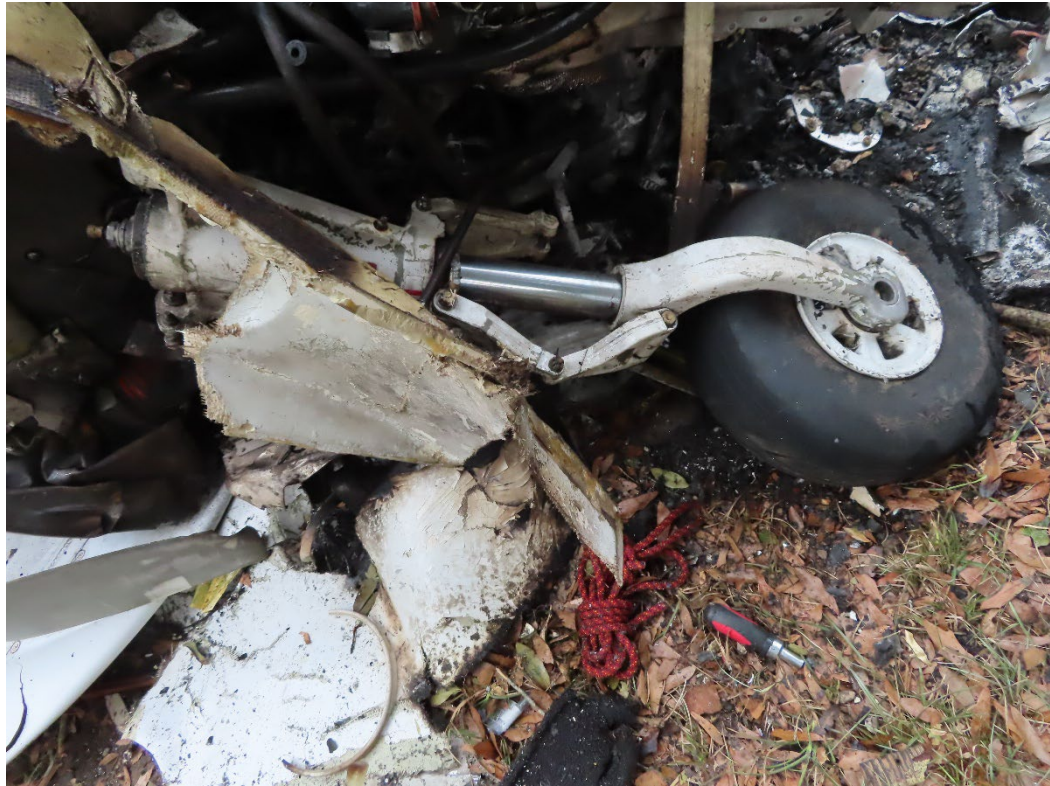
The landing gear was found in the main wreckage and exhibited thermal damage. The nose landing gear displayed impact and post-impact fire damage and was found in a position between retracted and extended. The left main landing gear was found in an extended position with the down-lock engaged. The right main landing gear was found in an extended position.

**Photo 12: View of the nose landing gear. (Courtesy of Piper)**

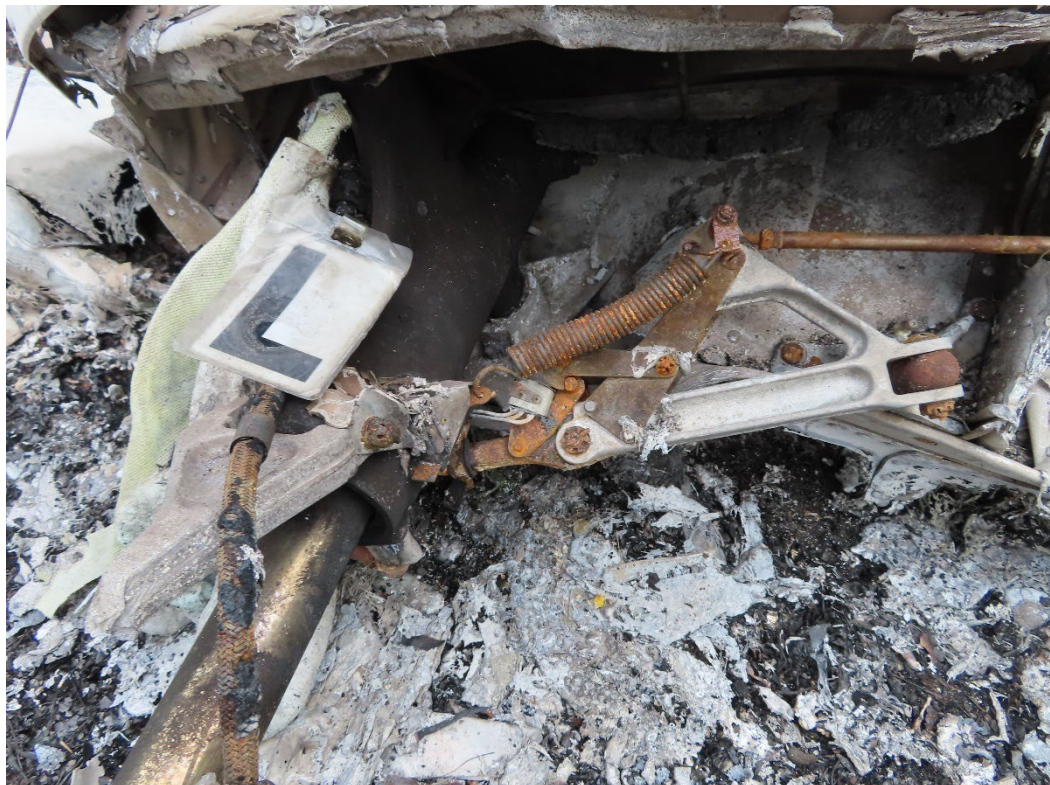
**Photo 13: View of the left main landing gear. (Courtesy of Piper)**

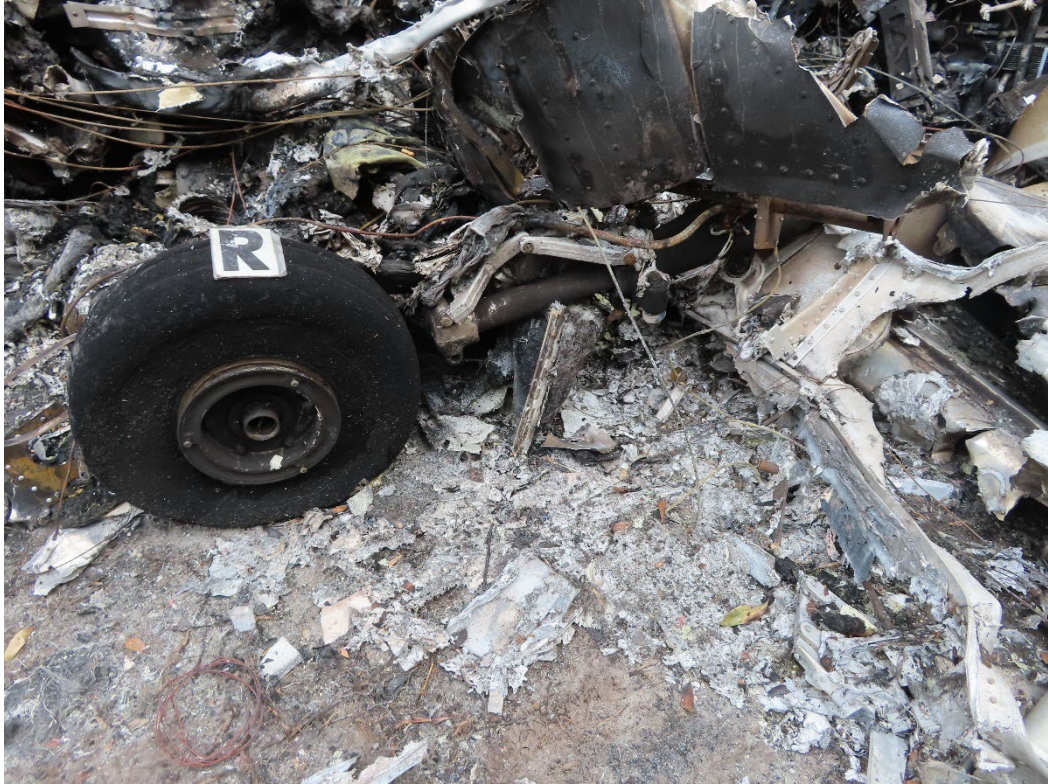
**Photo 14: View of the right main landing gear. (Courtesy of Piper)**

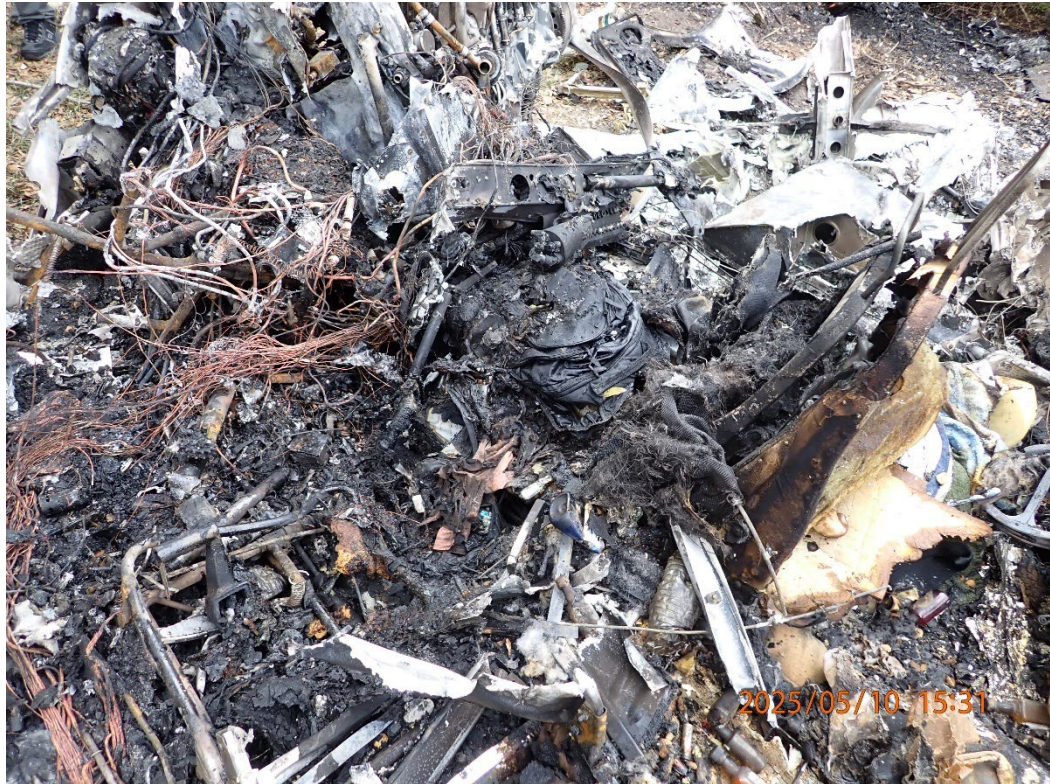
The cockpit was consumed by postaccident fire and was unrecognizable. The flap selector was impact and post-impact fire damaged. It was found in the flaps 25° extended position. This position was verified by examination of the flap torque tube.

**Photo 15: View of the cockpit area.**

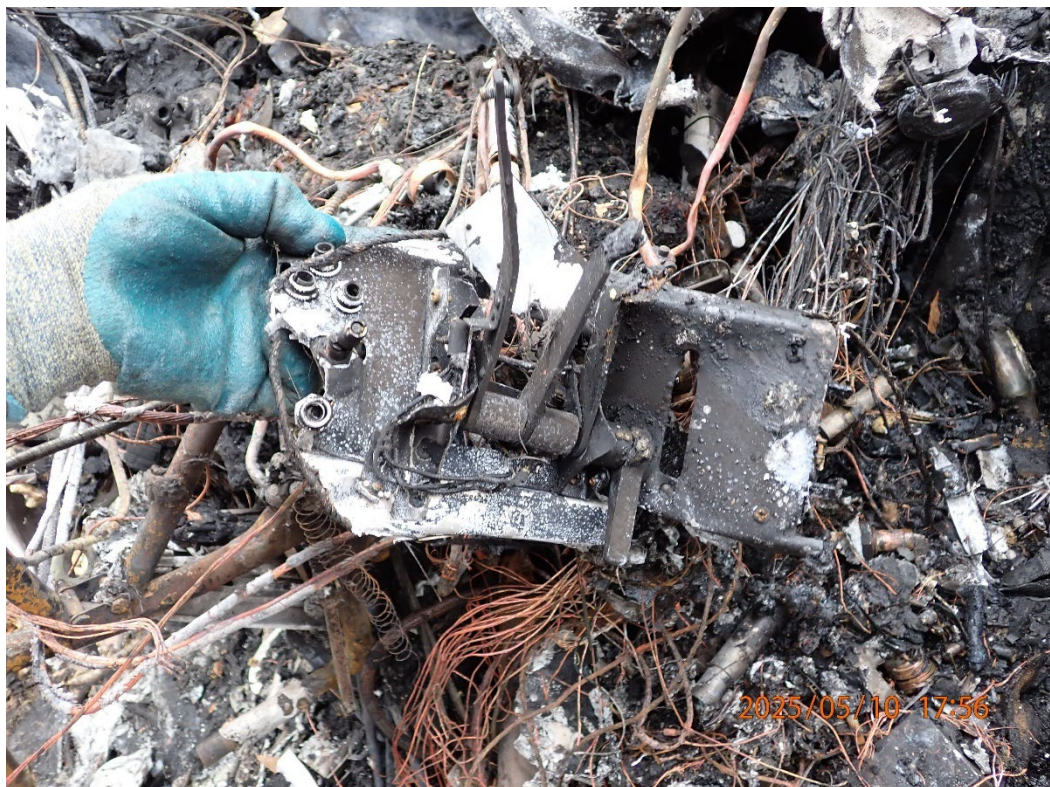
**Photo 16: View of the throttle quadrant.**

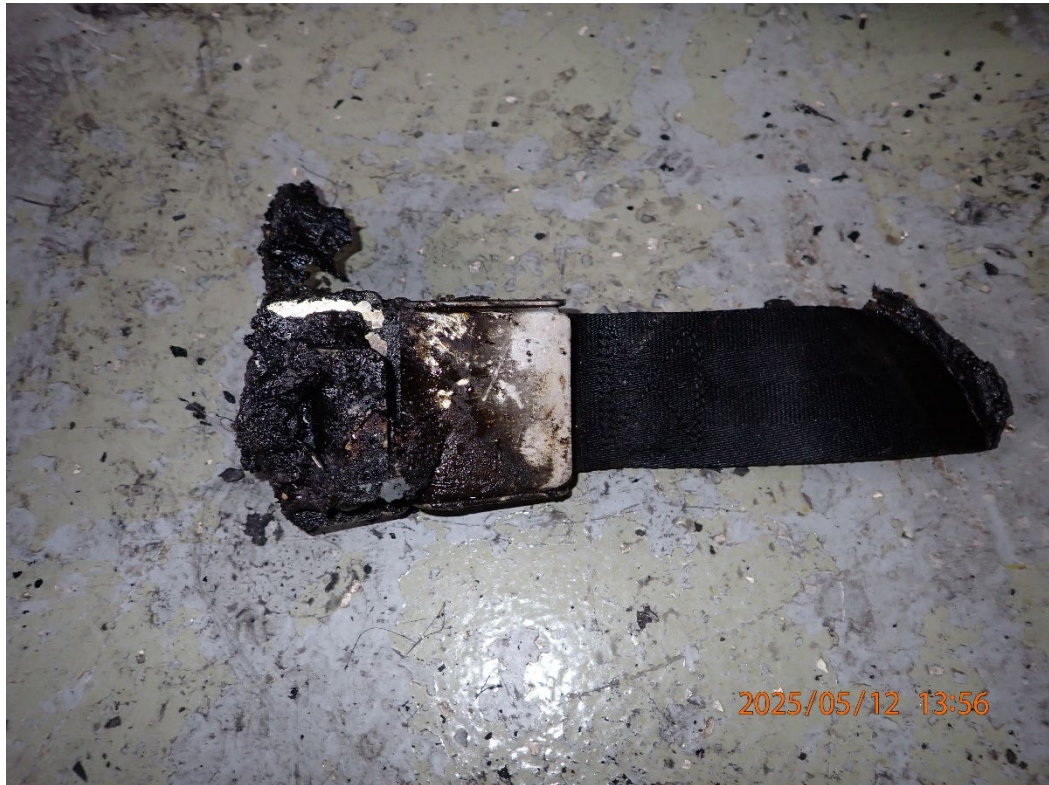
All five unoccupied seats remained attached to the fuselage floor. The left front pilot seat (utilized) remained partially attached to the floor. All seats were thermally reduced to their metal components. All lap belts and shoulder harnesses were consumed by fire. A lap belt buckle was located at the left pilot seat position and was latched.

**Photo 17: View of the pilot's seatbelt buckle.**

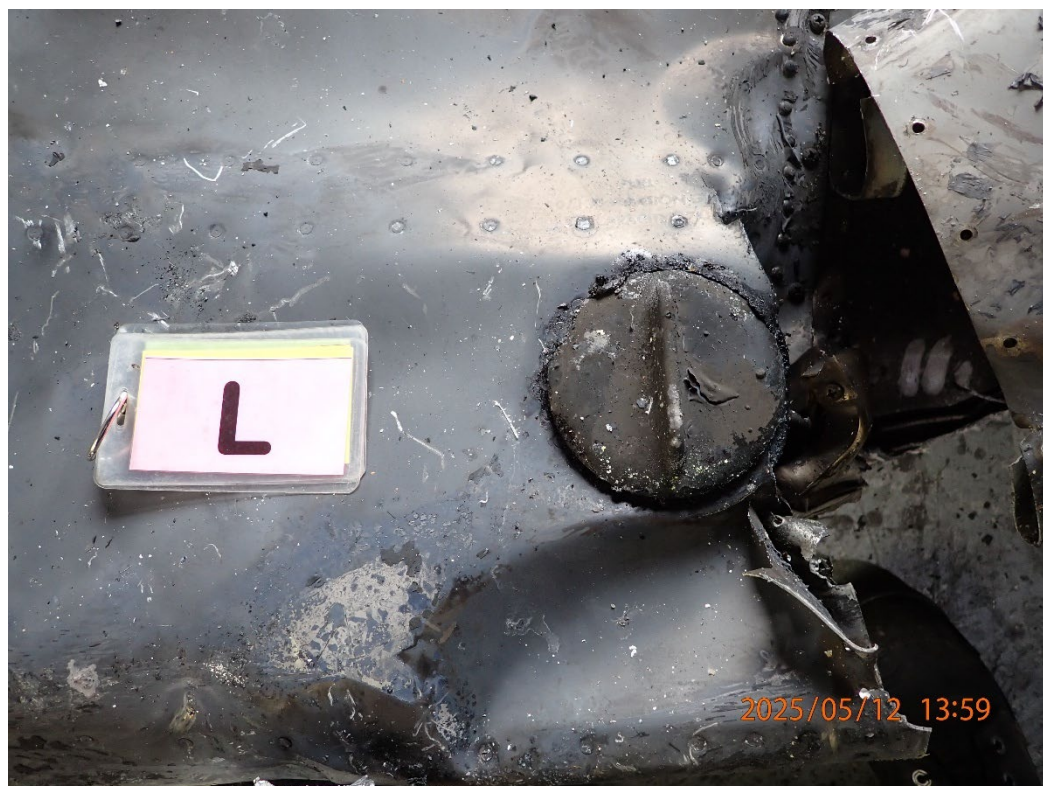
**Photo 18: View of the left fuel tank cap.**

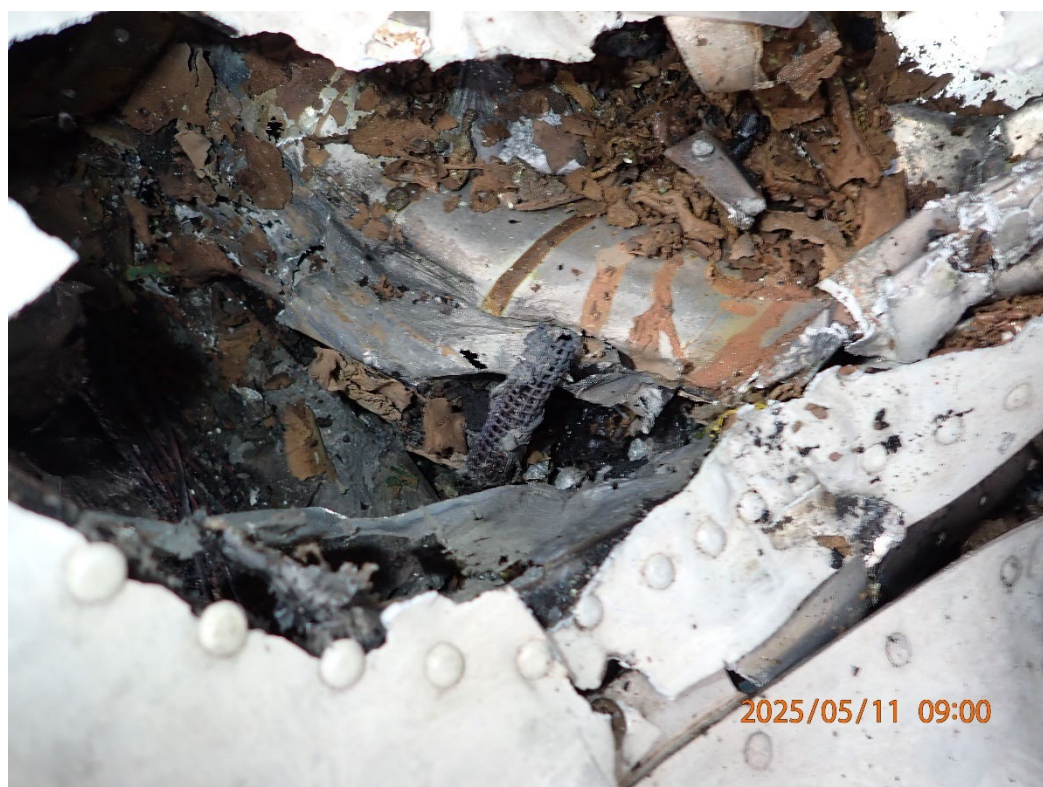
Both the left and right wing fuel caps remained installed in their respective wing attach points. The left main fuel tank finger screen was observed free of debris. The right main fuel tank finger screen was covered in molten metal due to postaccident fire.

**Photo 19: View of the left main fuel tank finger screen.**

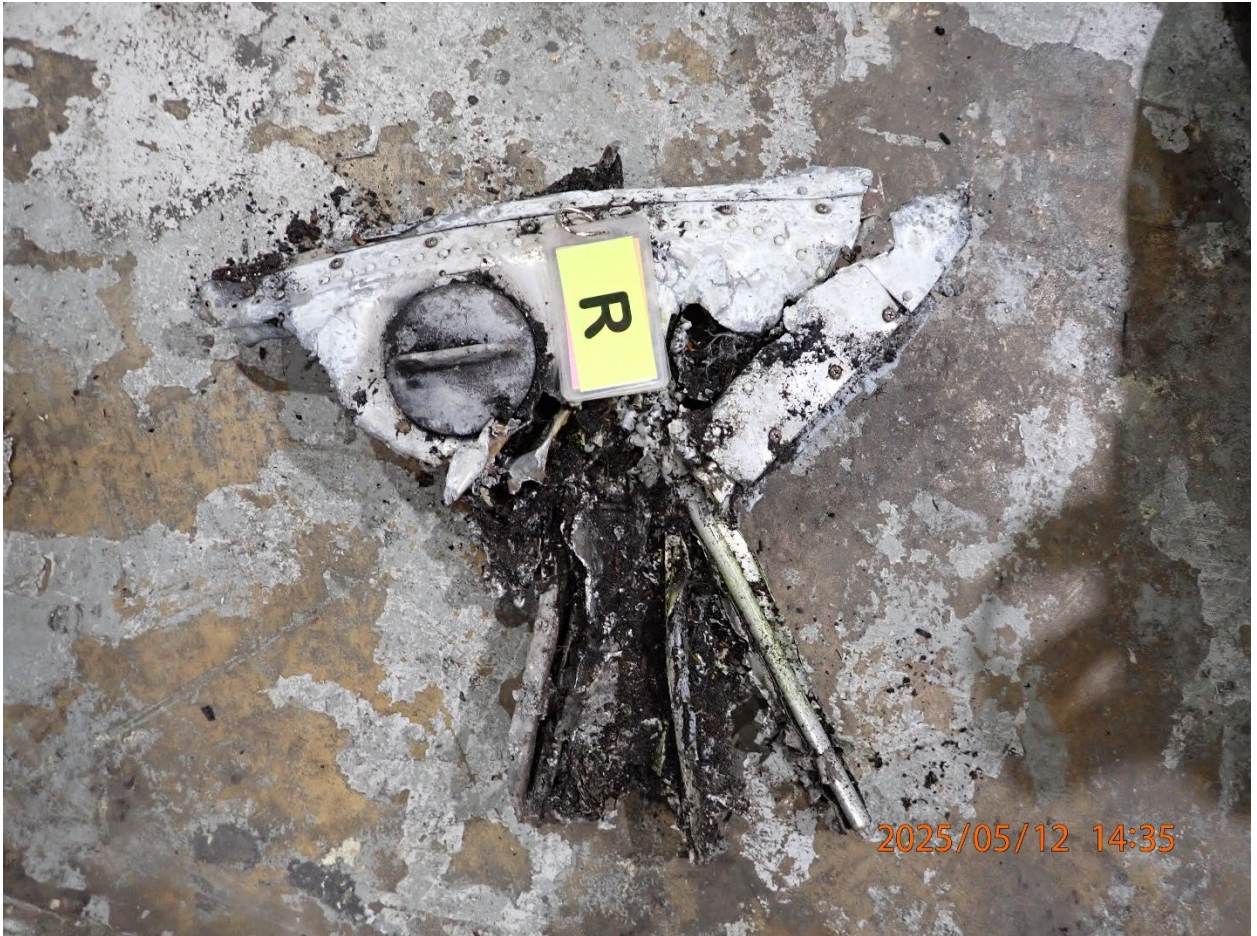
**Photo 20: View of the right fuel tank cap.**

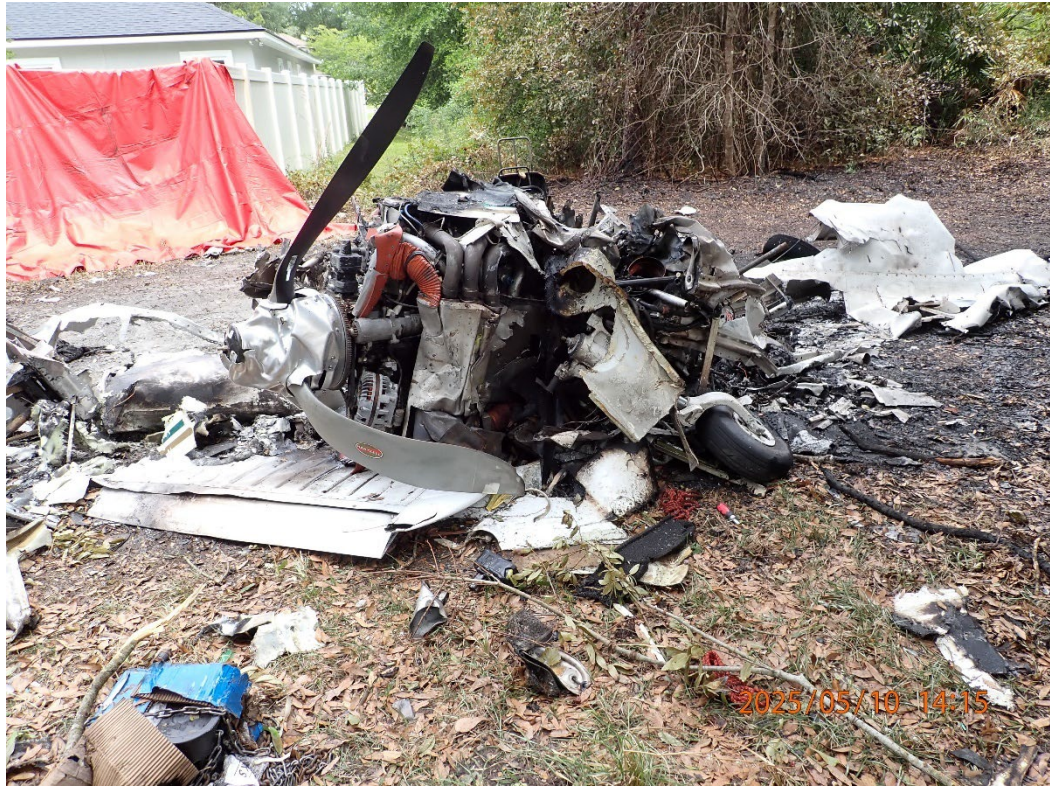
**Photo 21: View of the bottom of the engine at the accident site.**

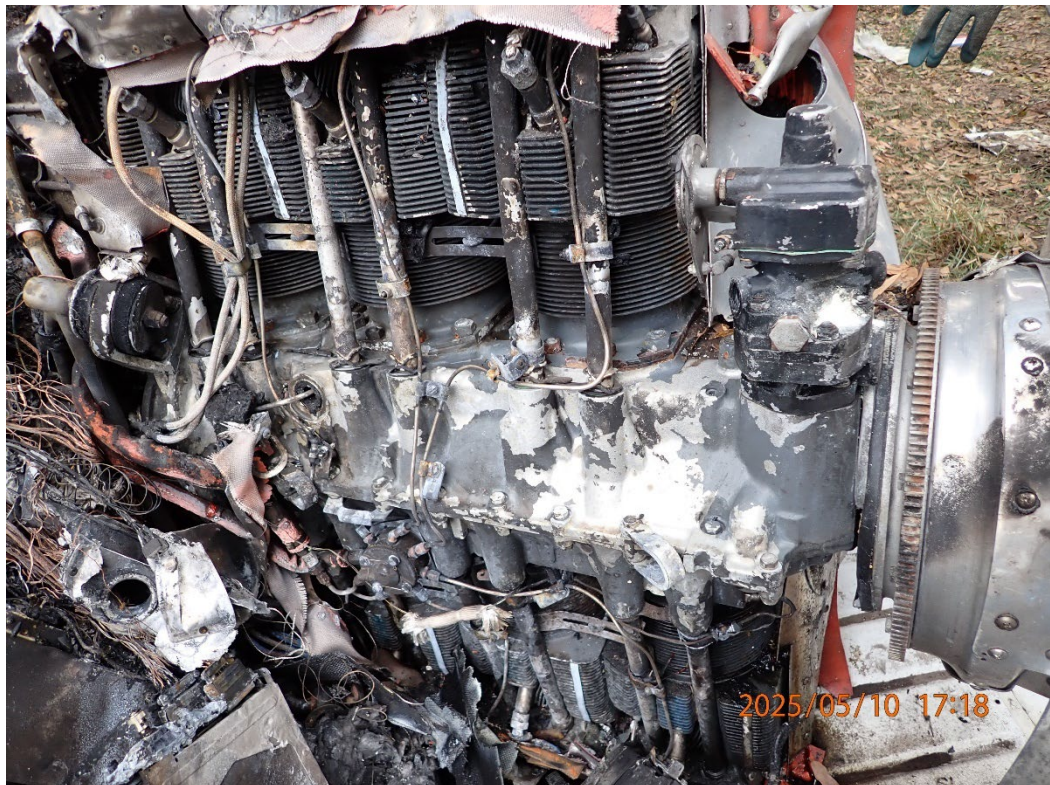
**Photo 22: View of the top of the engine at the accident site.**

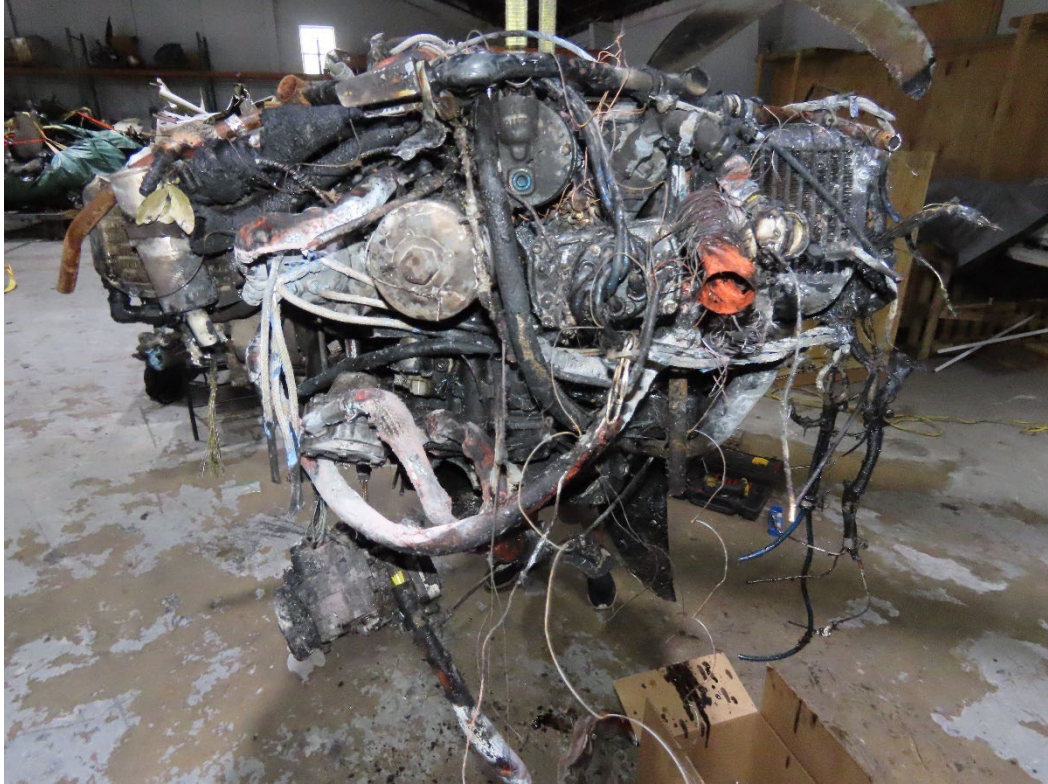
**Photo 23: View of the back of the engine. (Courtesy of Lycoming)**

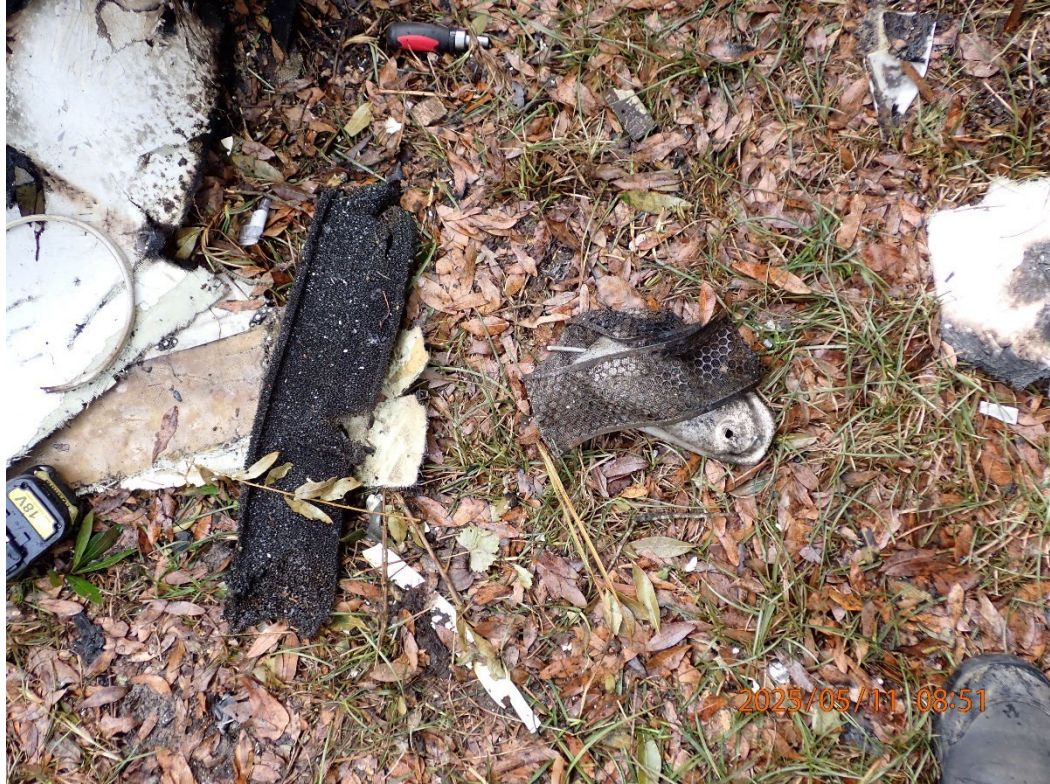
The induction and exhaust system exhibited impact and thermal damage. A portion of the air filter was observed at the accident site and was unobstructed.

**Photo 24: View of the remnants of the induction air filter.**

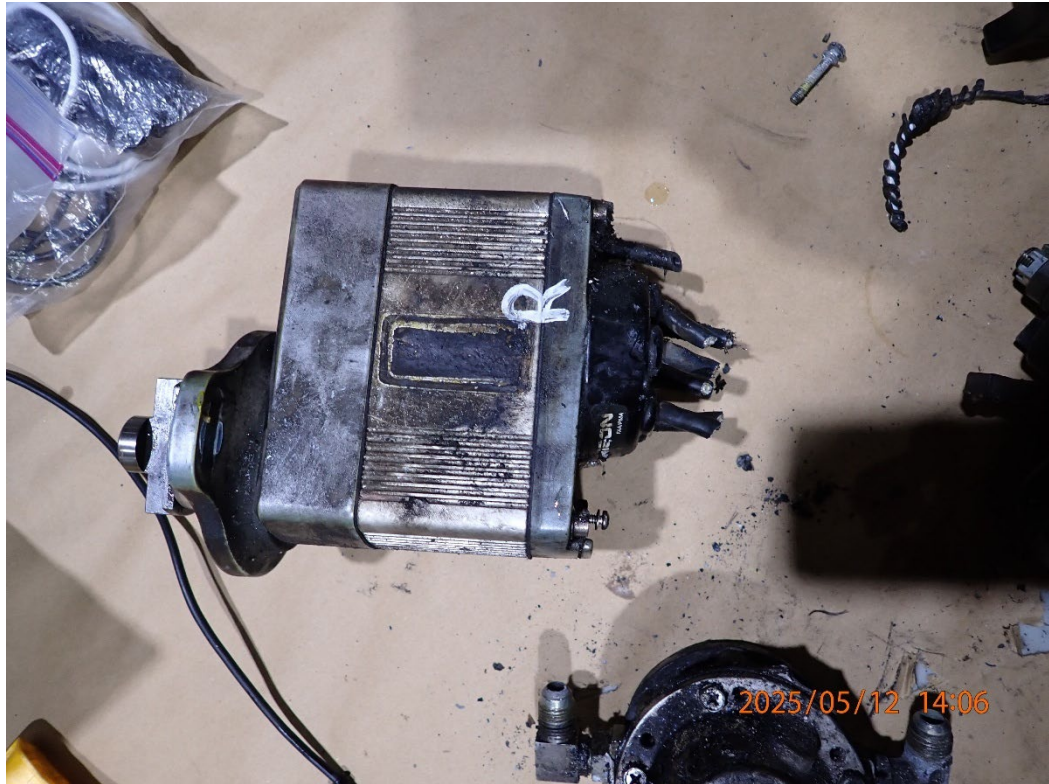
Both left and right hand magnetos were found tightly installed to the accessory section of the engine with signs of thermal damage. The left hand magneto was of the conventional type while the right hand was a electronic EIS type. The left hand magneto was rotated by hand and using an electric drill but would not produce spark consistent with the level of thermal damage observed. The right hand EIS magneto had 20-volt power source applied and the green led light illuminated briefly. The light quickly diminished and would not illuminate when with either the timing or power port had voltage applied.

**Photo 25: View of the right electronic magneto.**

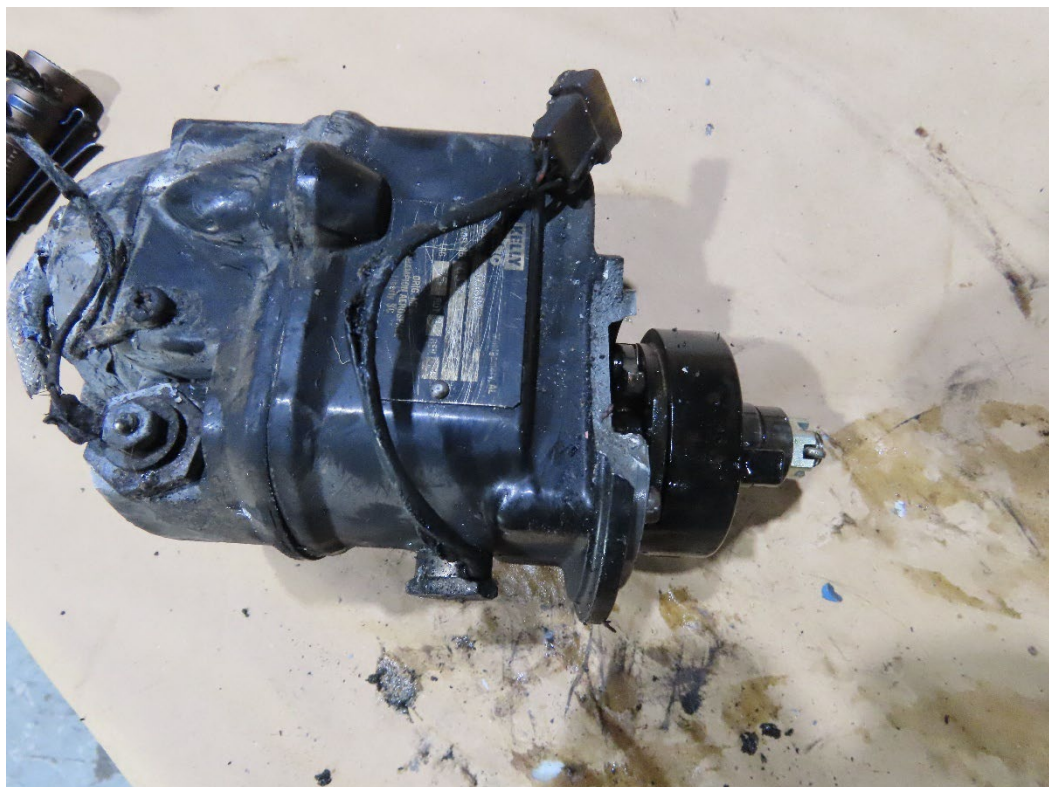
**Photo 26: View of the left magneto. (Courtesy of Lycoming)**
