# National Transportation Safety Board

ERA25FA201

## **WRECKAGE EXAMINATION**

Location: Yulee, FL  
Date: May 10, 2025  
Time: 0938 EDT  
1338 UTC  
Airplane: N30689; PA-32R-300

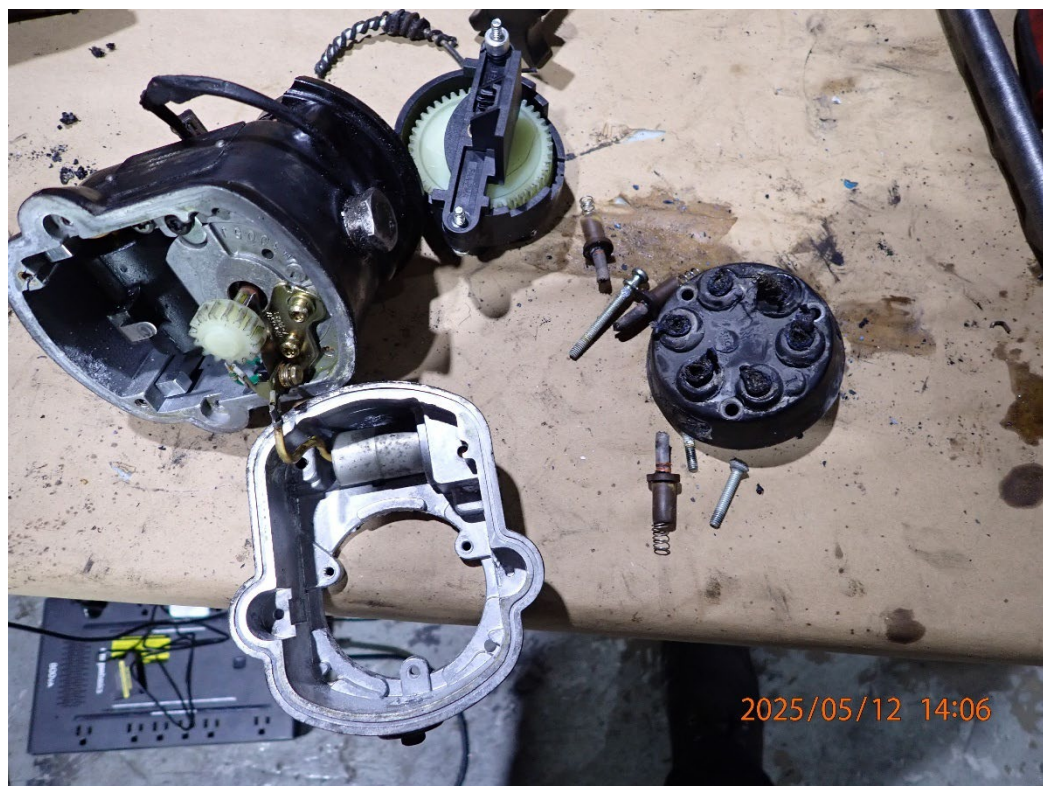
**Photo 27: View of the disassembled left magneto.**

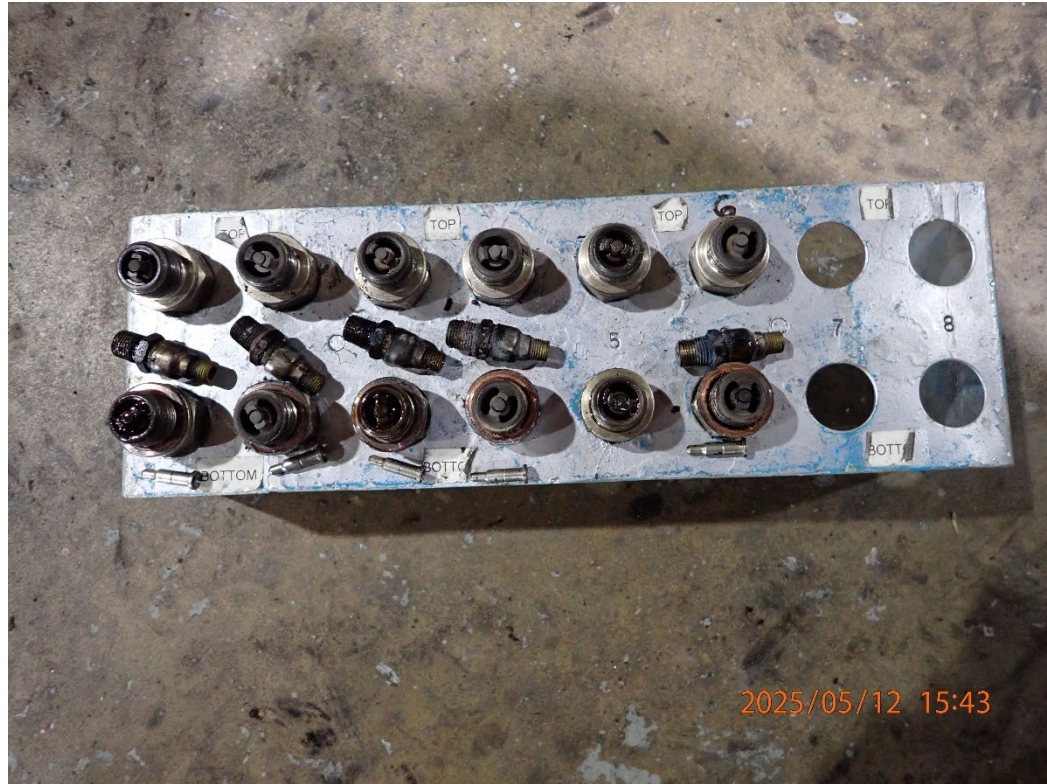
Both ignition harnesses sustained cuts, abrasions, and thermal damage. All sparkplugs were Tempest UREM38E massive electrode type and found to have normal coloration and wear patterns when compared to a champion Check-a-plug chart.

**Photo 28: View of the spark plugs and fuel injectors.**

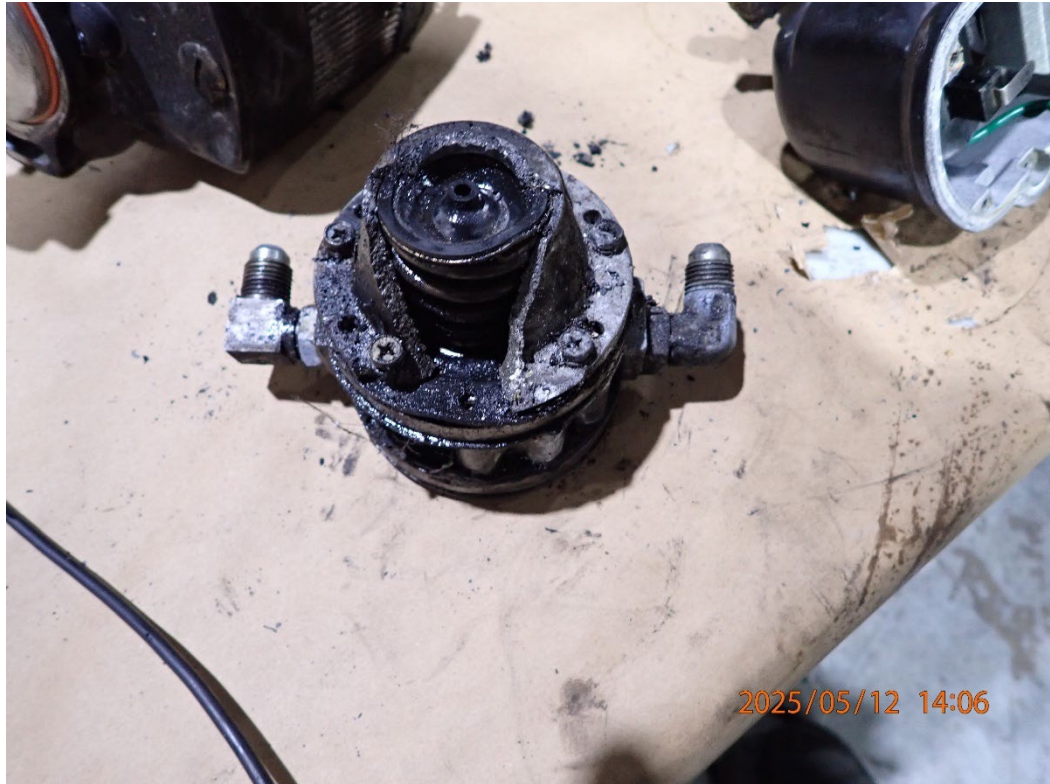
The engine driven fuel pump was found to be impact fractured from the accessory case. The fuel injector servo was found fractured from the lower side of the engine but attached to its throttle cable. The throttle plate was found in the closed idle position and moved freely when actuated by hand. The fuel inlet screen was found free and clear of any debris and unobstructed. The diaphragm was found intact and suffered thermal damage in the form of shrinkage. The brass plug was found to have the AD compliance "G" stamped. The bullet style impact tube screen was clear and unobstructed. The fuel manifold was found tightly installed to the top of the engine with all fuel injectors lines intact and tightly installed. The manifold was disassembled and found free and clear of any debris. The diaphragm was intact with no tears or debris observed. The odor of fuel was present upon disassembly of the unit. All fuel injectors were removed except number 5 due to impact damage and found to be free and clear of any blockages.

**Photo 29: View of the engine driven fuel pump.**

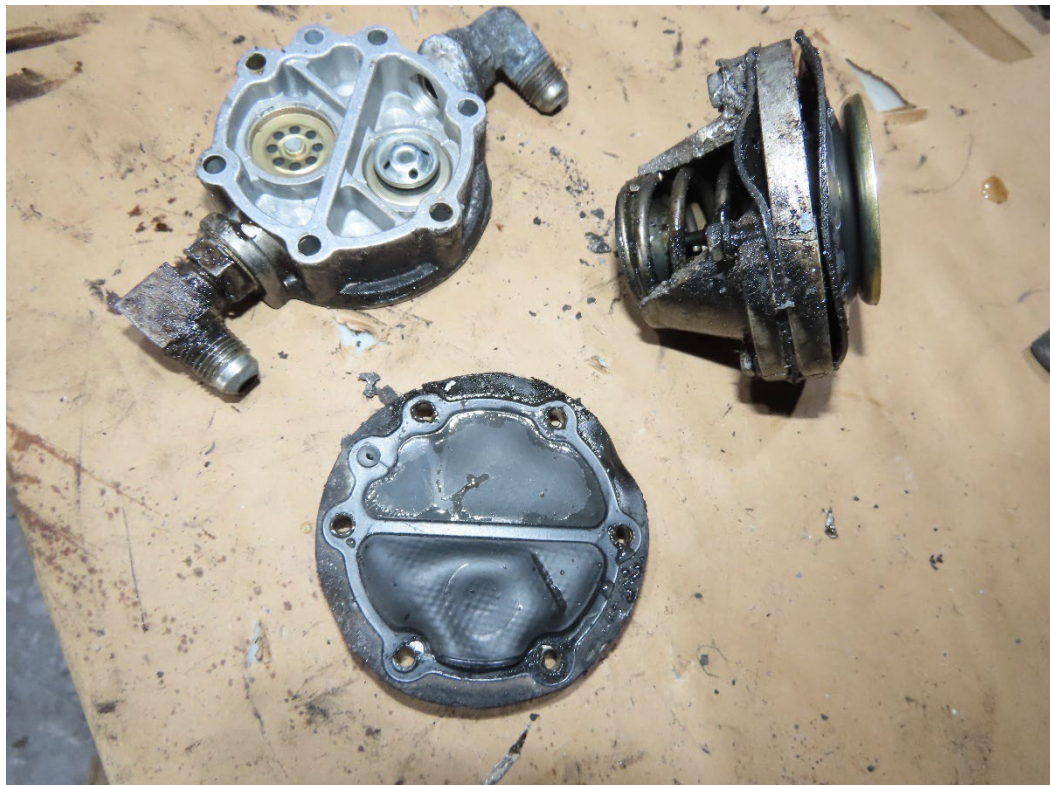
**Photo 30: View of the disassembled engine driven fuel pump. (Courtesy of Lycoming)**

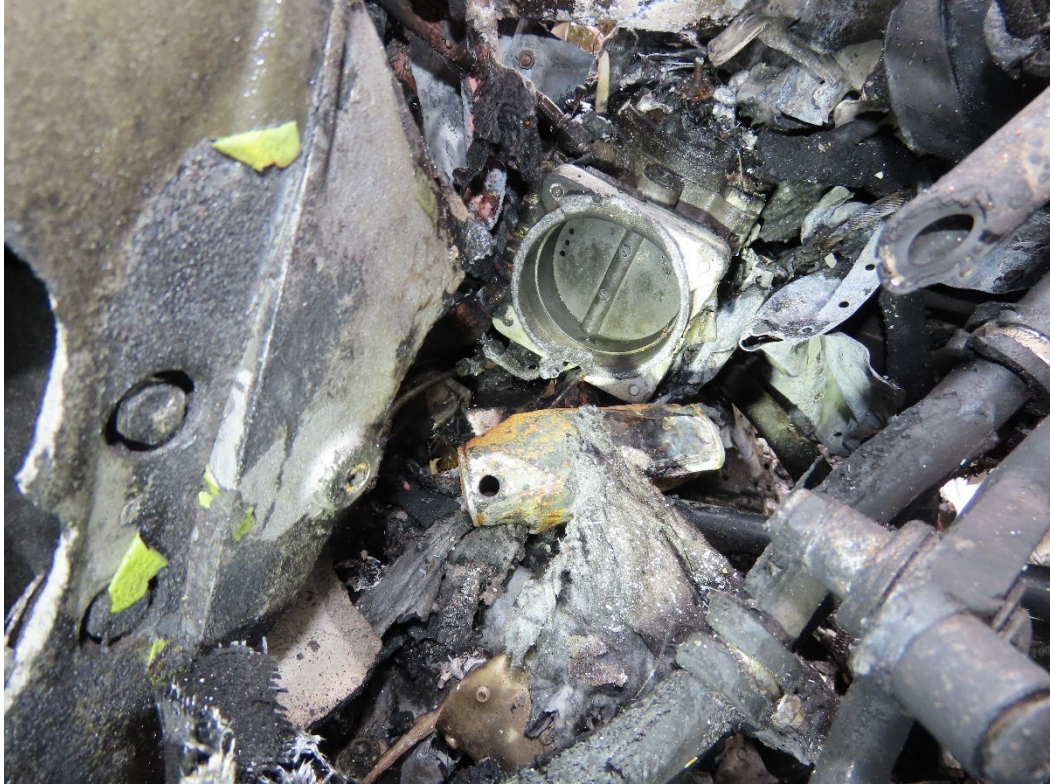
**Photo 31: View of the throttle plate as first seen at the accident site. (Courtesy of Lycoming)**

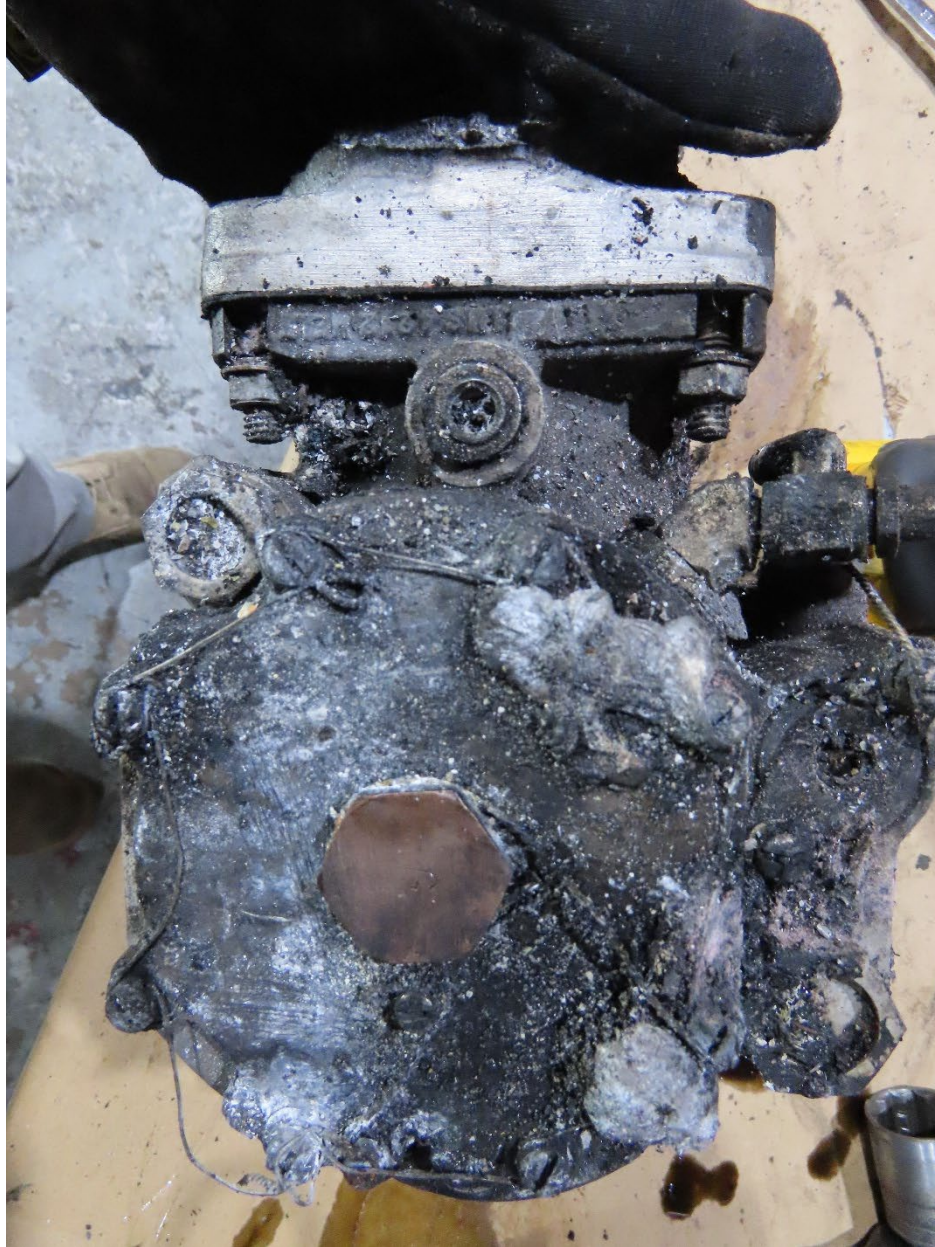
**Photo 32: View of the fuel injector servo. (Courtesy of Lycoming)**

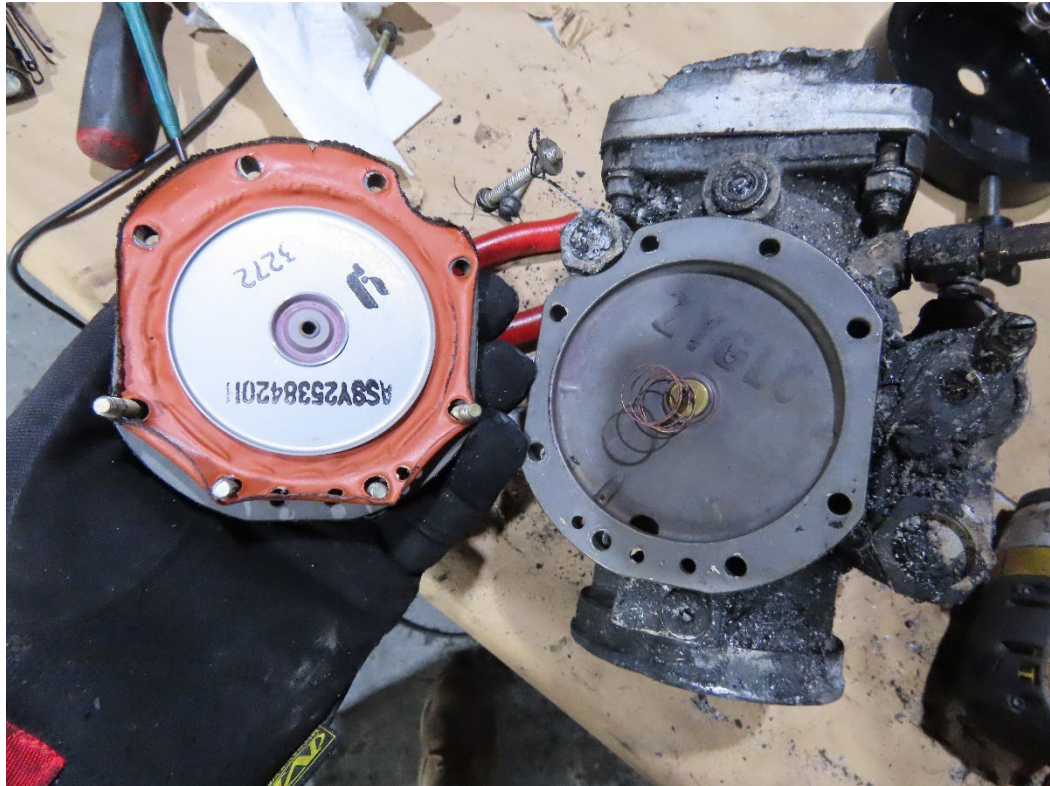
**Photo 33: View of the fuel injector servo diaphragm. (Courtesy of Lycoming)**

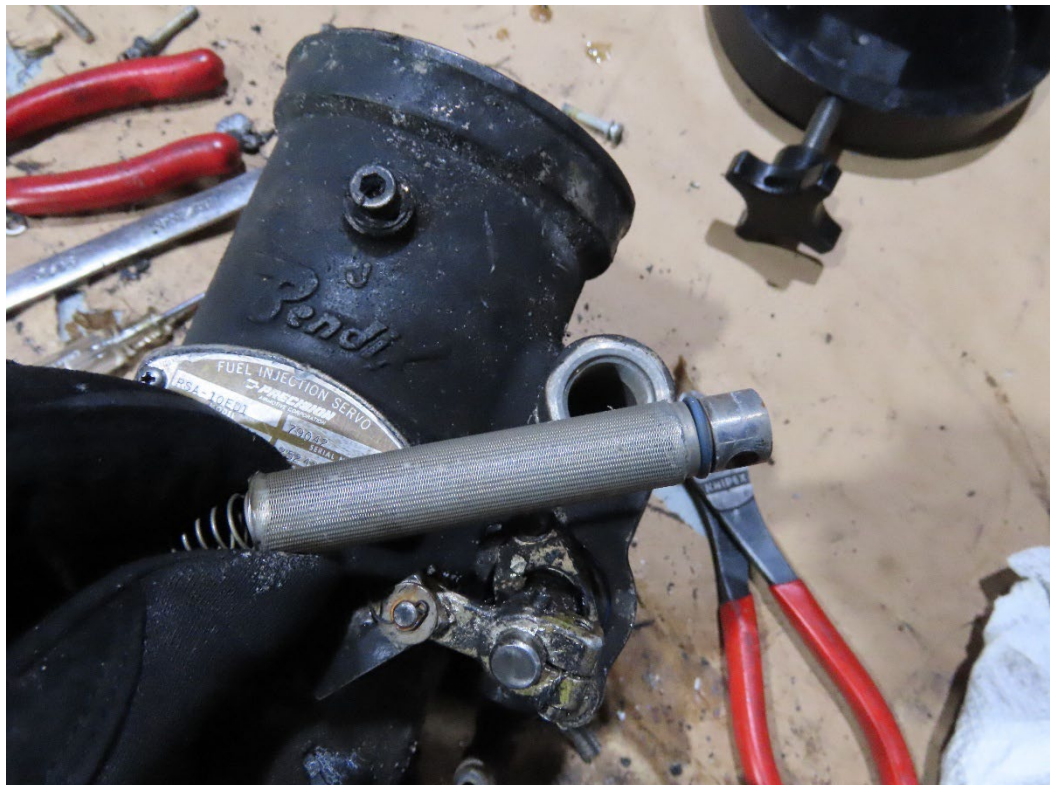
**Photo 34: View of the unobstructed fuel inlet screen. (Courtesy of Lycoming)**

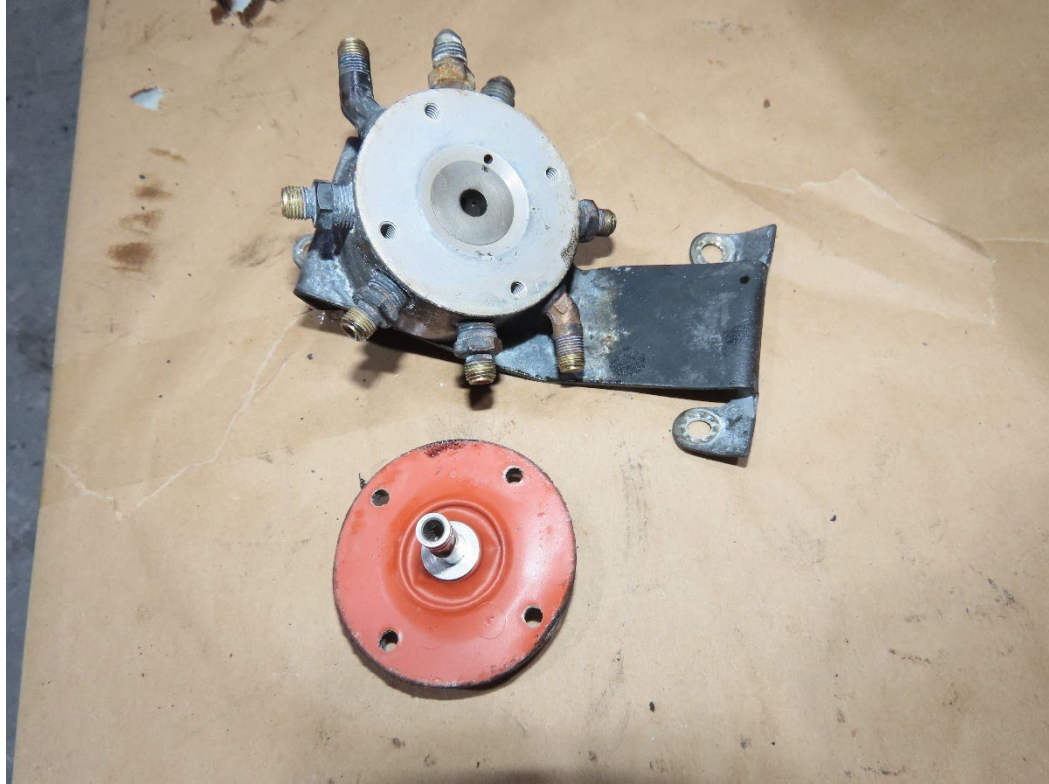
**Photo 35: View of the disassembled fuel manifold. (Courtesy of Lycoming)**

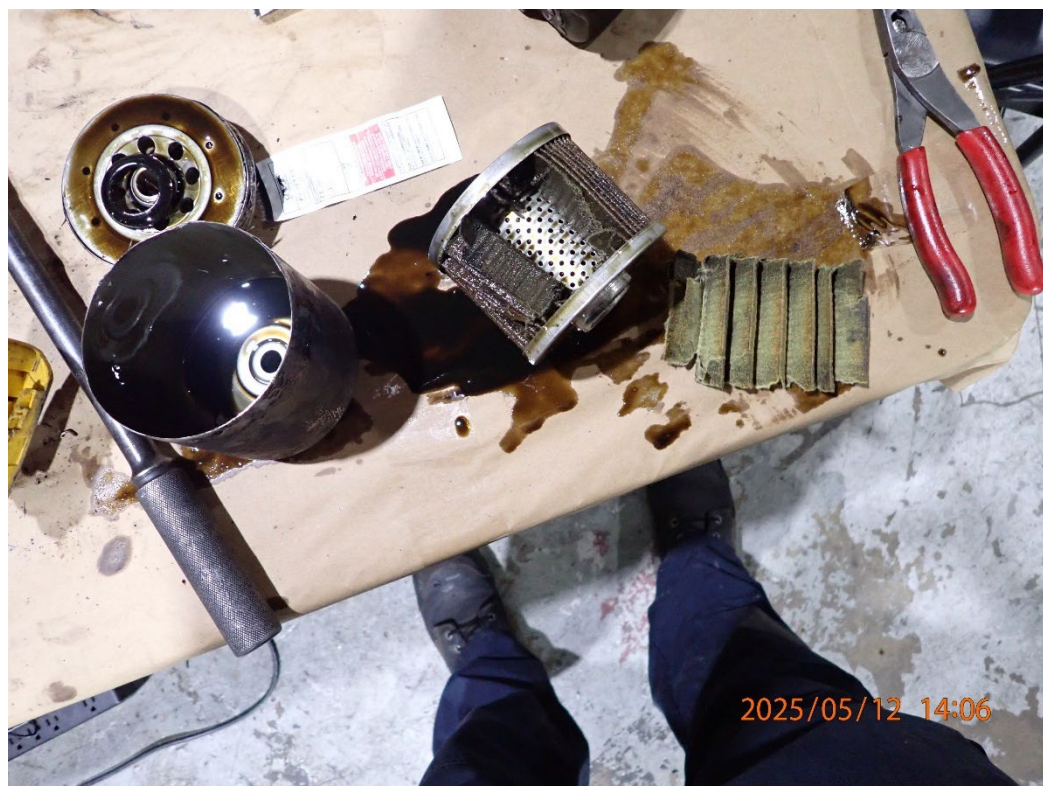
The oil filter remained attached to the engine accessory case and was removed and cut open for examination. The oil filter pleats were clean with no debris noted. The oil suction screen was removed and examined and was unobstructed.

**Photo 36: View of the cut open oil filter and unobstructed pleats.**

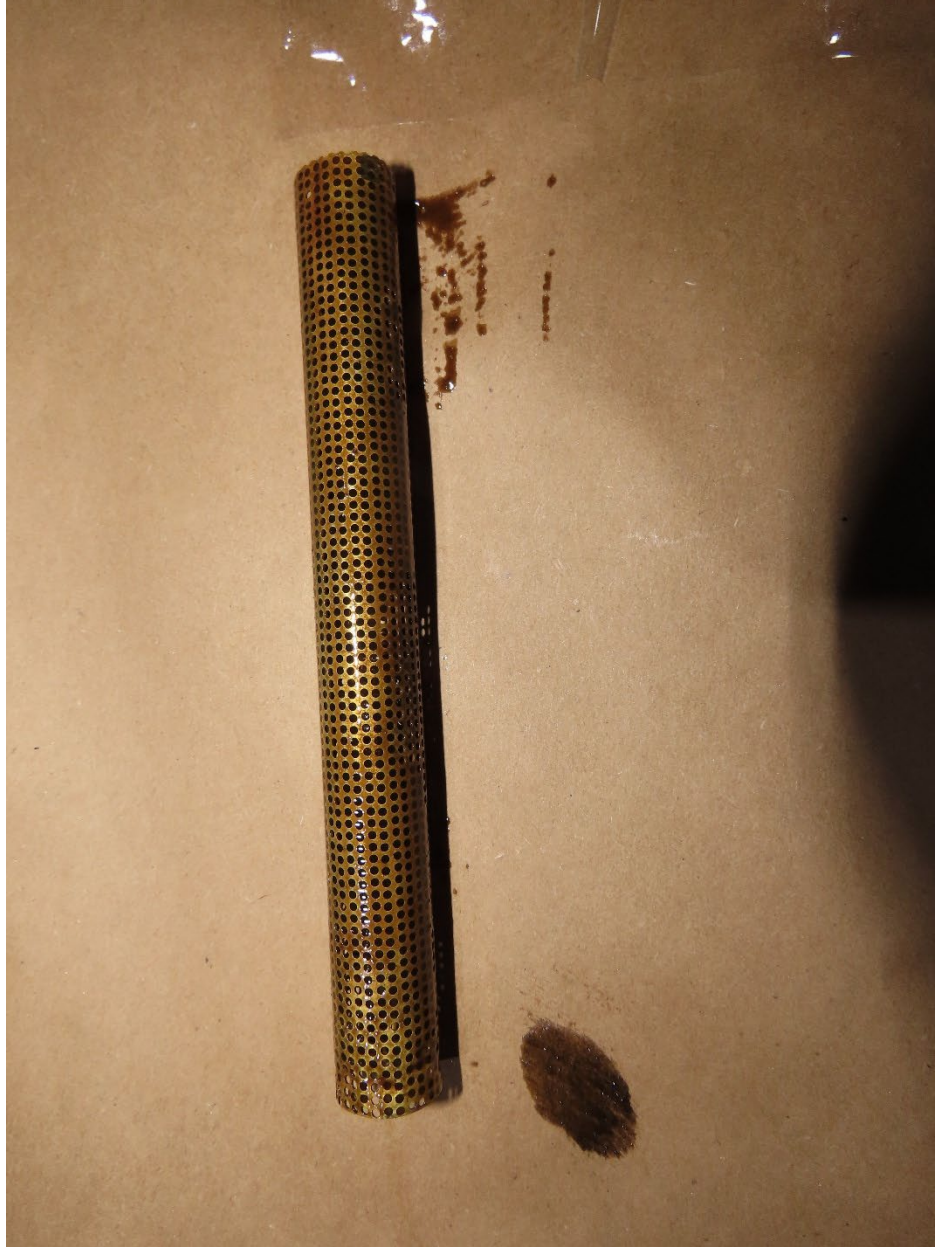
**Photo 37: View of the unobstructed oil suction screen. (Courtesy of Lycoming)**

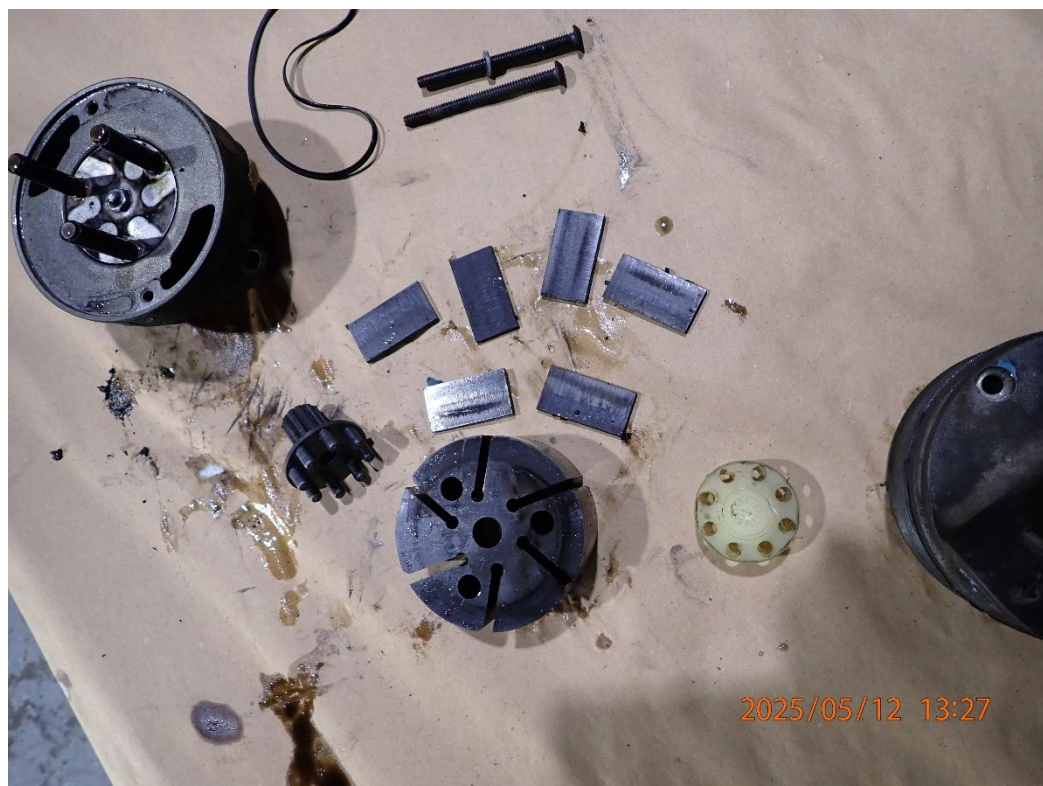
The vacuum pump remained installed in the accessory case of the engine and was removed for examination. The drive coupling remained intact and in place. The carbon rotor and veins were all found intact.

**Photo 38: View of the disassembled vacuum pump.**

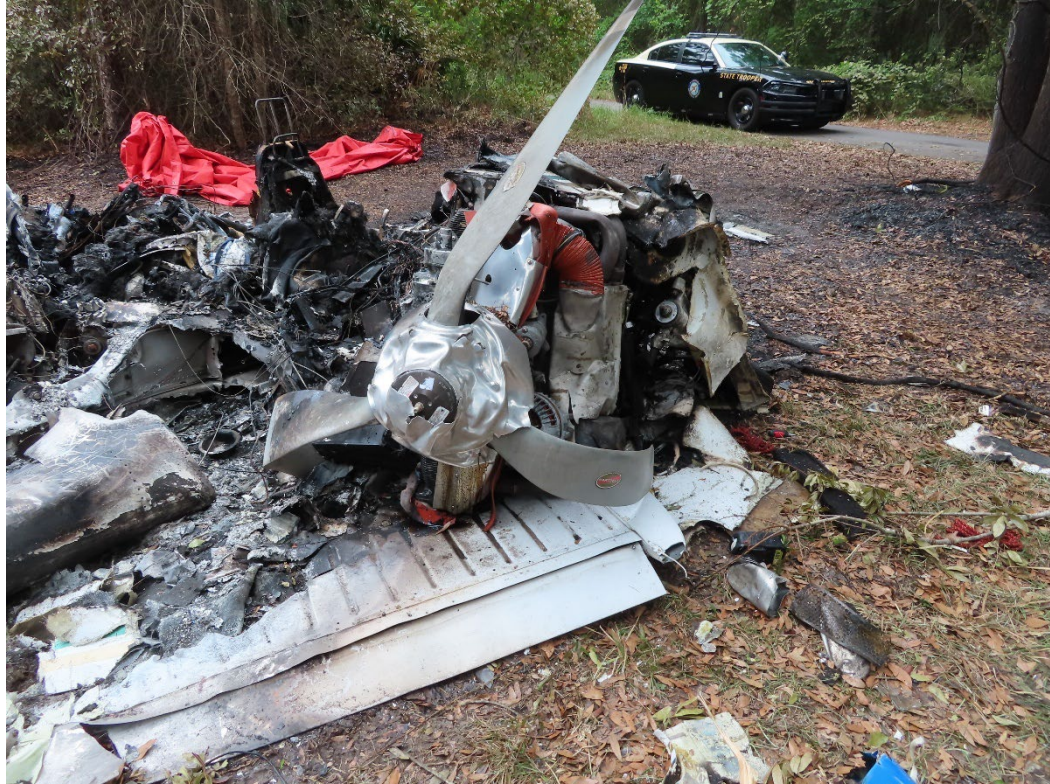
The three blade Hartzell propeller remained attached to the propeller mounting flange on the engine. The propeller blades exhibited aft bending, chordwise scratching, some leading-edge gouges, and leading-edge polishing. The propeller spinner revealed rotational deformation consistent with the propeller turning at the time of impact.

**Photo 39: View of the propeller at the accident site. (Courtesy of Piper)**

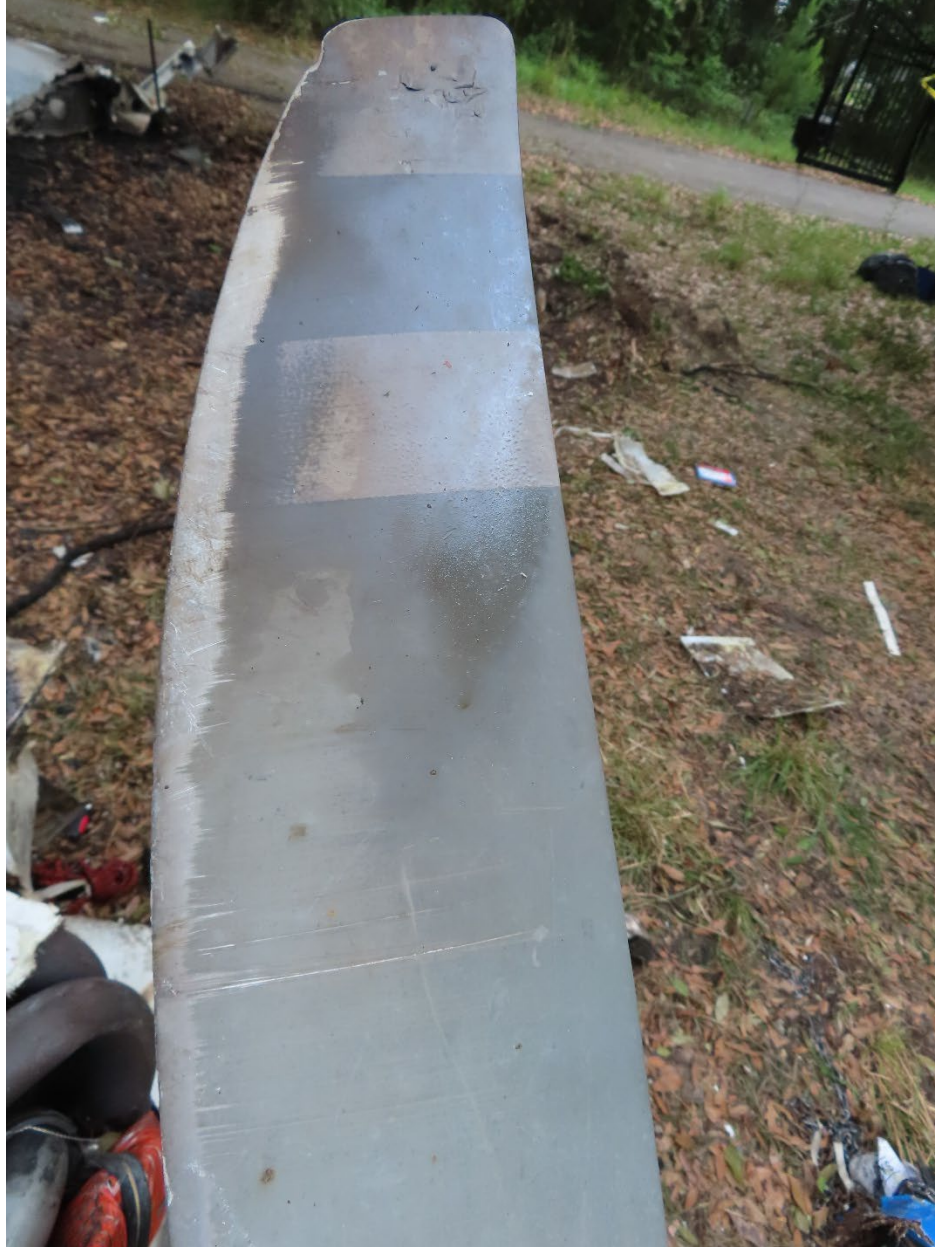
**Photo 40: Propeller leading-edge polishing and gouging, and chordwise scratching. (Courtesy of Piper)**

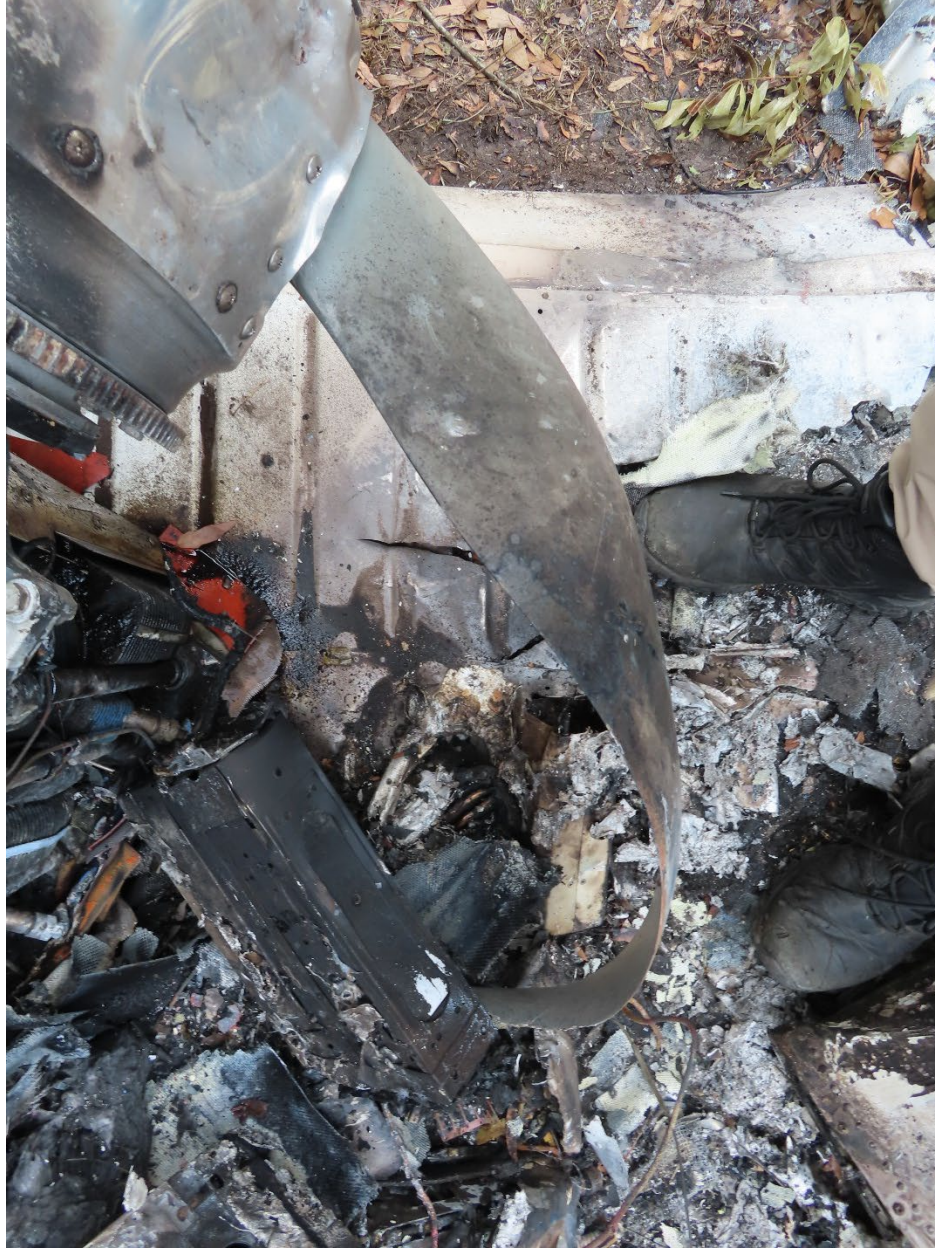
**Photo 41: View of propeller blade aft bending. (Courtesy of Piper)**

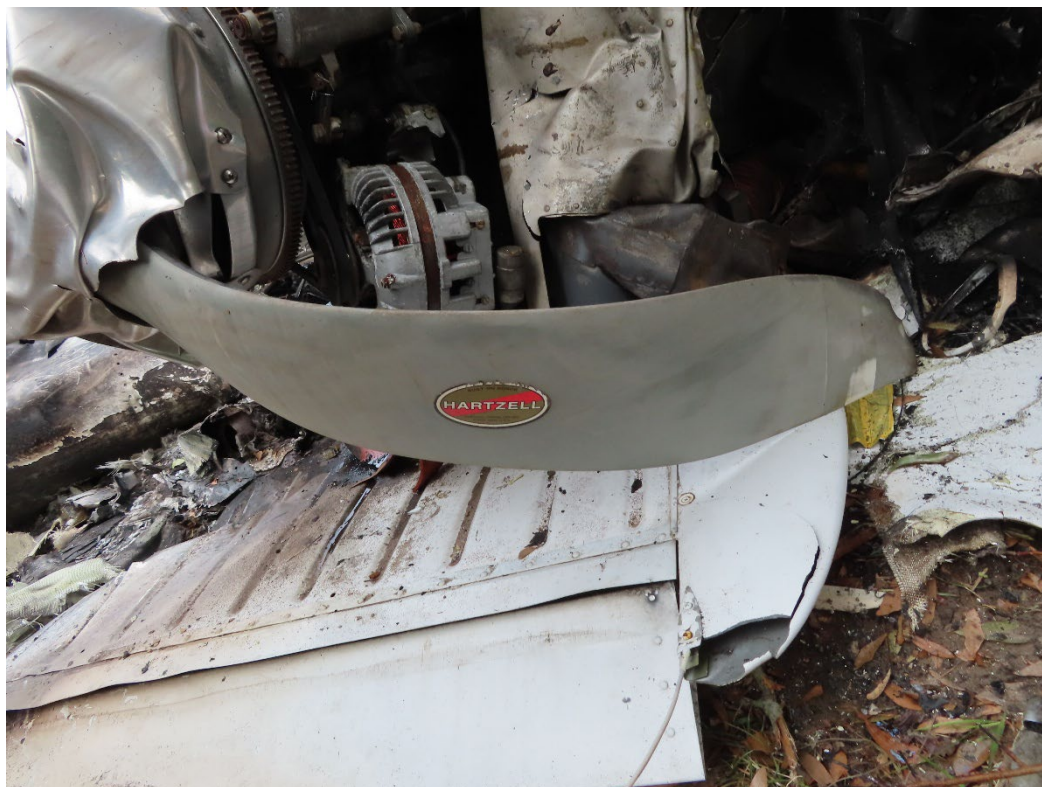
**Photo 42: View of propeller blade aft bending. (Courtesy of Piper)**

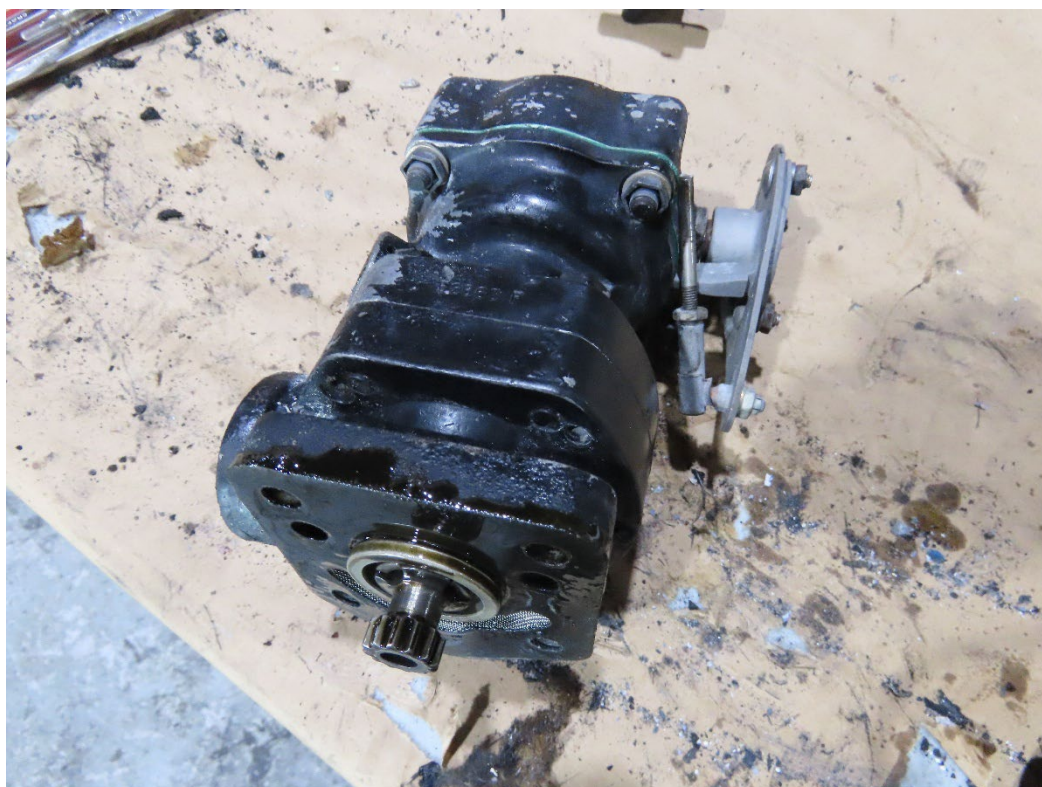
The prop governor was found tightly installed to the engine, removed, and rotated by hand with no issues. Oil pumped from the unit during manual rotation and the oil filter screen was found unobstructed. The propeller governor control arm was found in a full forward position at the accident site.

**Photo 43: View of the propeller governor. (Courtesy of Lycoming)**

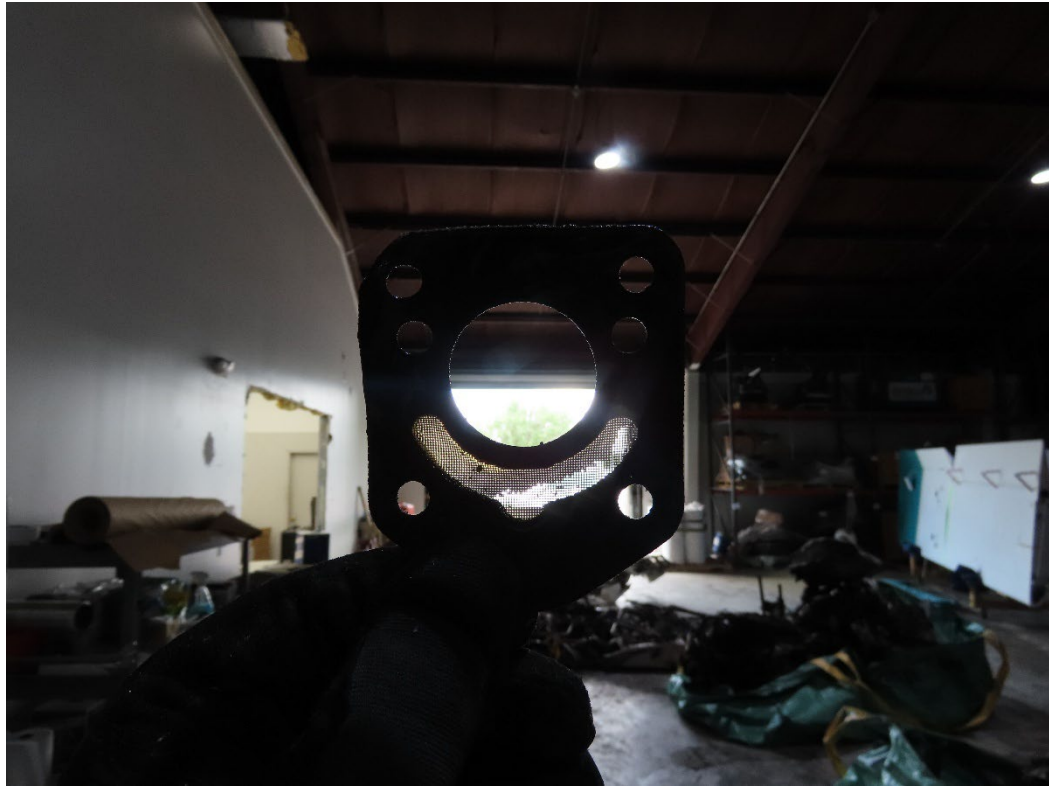
**Photo 44: View of the unobstructed governor oil screen. (Courtesy of Lycoming)**
