# National Transportation Safety Board

ERA25LA003

## **WRECKAGE EXAMINATION**

Location: Tampa Bay, FL  
Date: October 3, 2024  
Time: 1140 EDT  
1540 UTC  
Airplane: N8575F; Piper PA-28-181

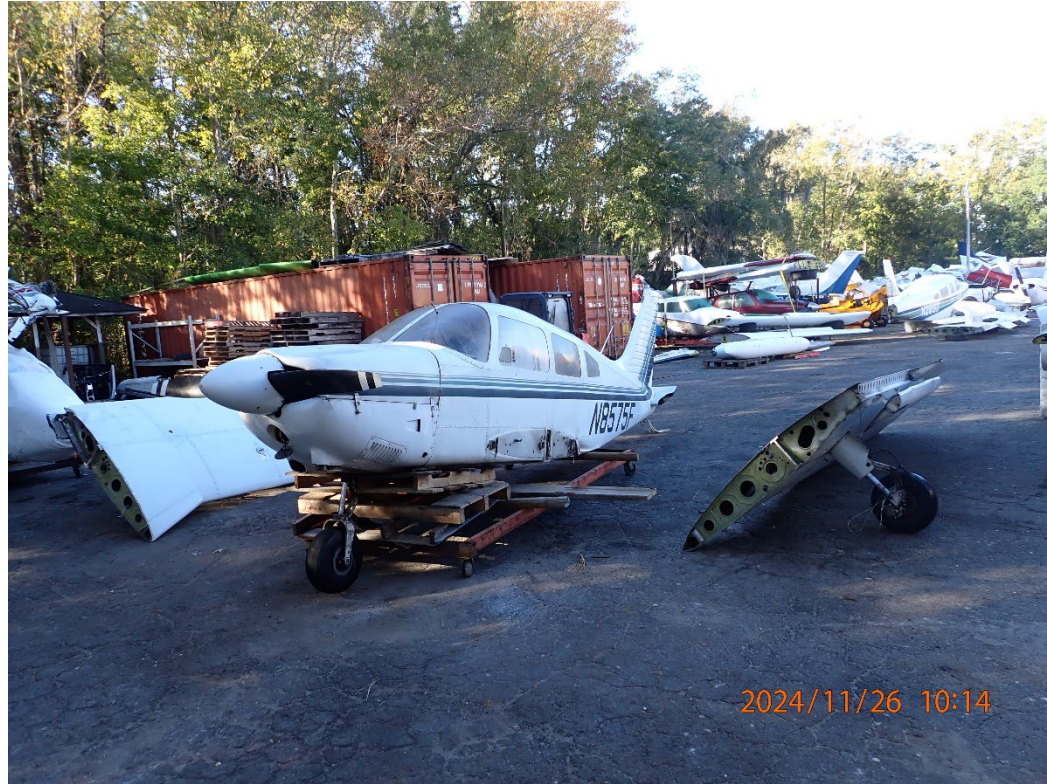
The fuselage remained intact. The left side of the fuselage exhibited impact damage 24 inches to 40 inches aft of the left wing main spar.

**Photo 1: View of the fuselage.**

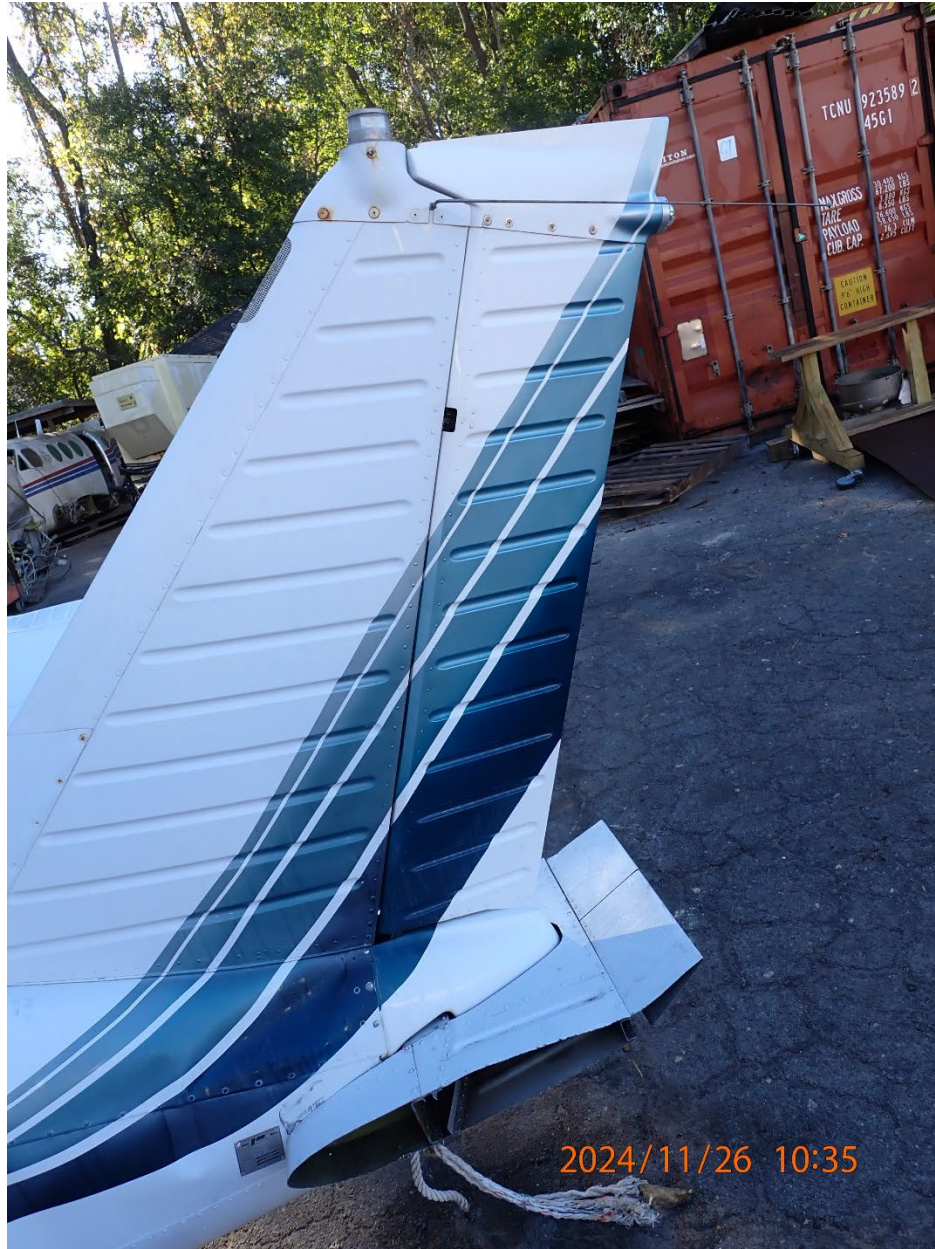
The stabilator had been cut to facilitate recovery, 21.5 inches remained attached to the empennage. Control continuity of the stabilator was confirmed from the flight controls in the cockpit to the flight control surface. Control continuity of the stabilator trim was confirmed from the flight control in the cockpit to the flight control surface. The vertical stabilizer was undamaged, and the rudder remained attached at all attachment points. Flight control continuity of the rudder was confirmed from the flight control in the cockpit to the flight control surface.

**Photo 2: View of the vertical stabilizer and rudder.**

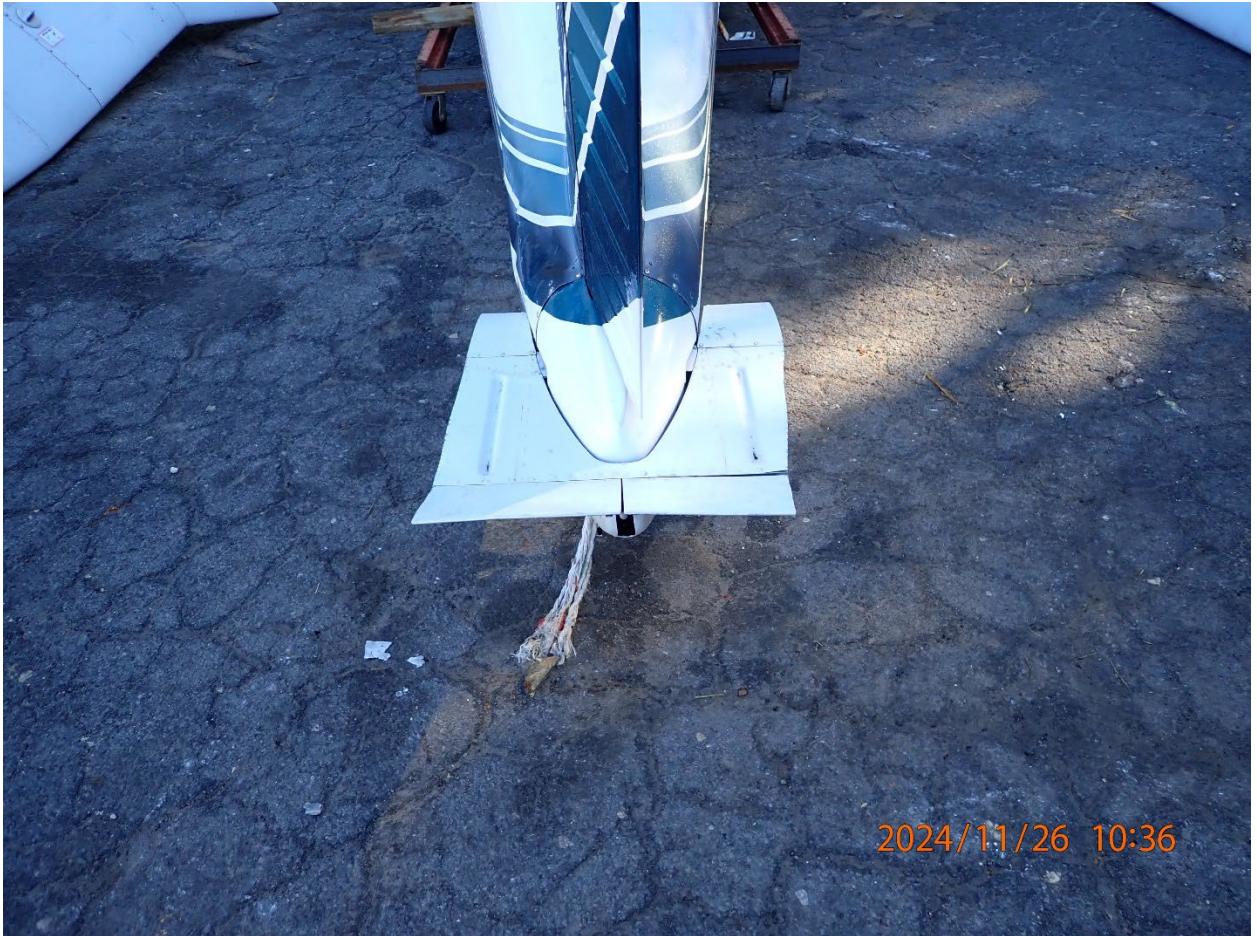
**Photo 3: View of the remaining portions of the stabilator and stabilator trim.**

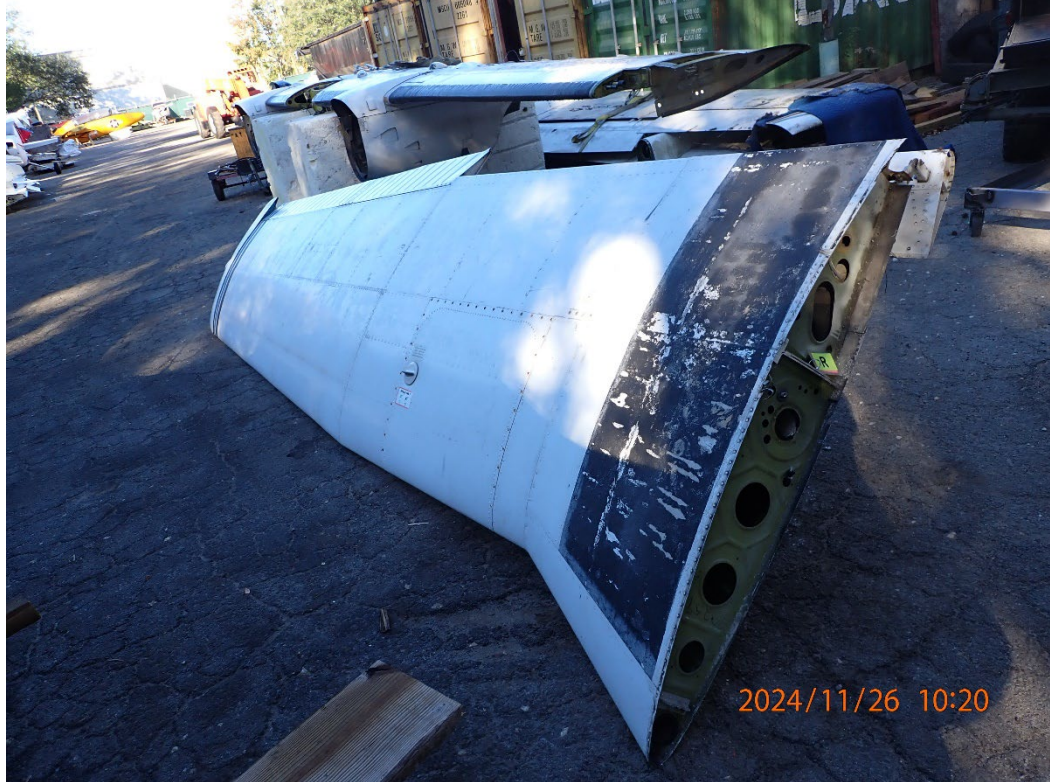
The right wing was undamaged and had been removed from the fuselage to facilitate recovery. The right aileron remained attached to the wing at all attachment points. Flight control continuity was confirmed from the flight control surface to the flight controls in the cockpit through cuts made to facilitate recovery. The right flap remained attached to the wing at all attachment points and control continuity was confirmed from the flight control surface to the flight control in the cockpit.

**Photo 4: View of the right wing.**

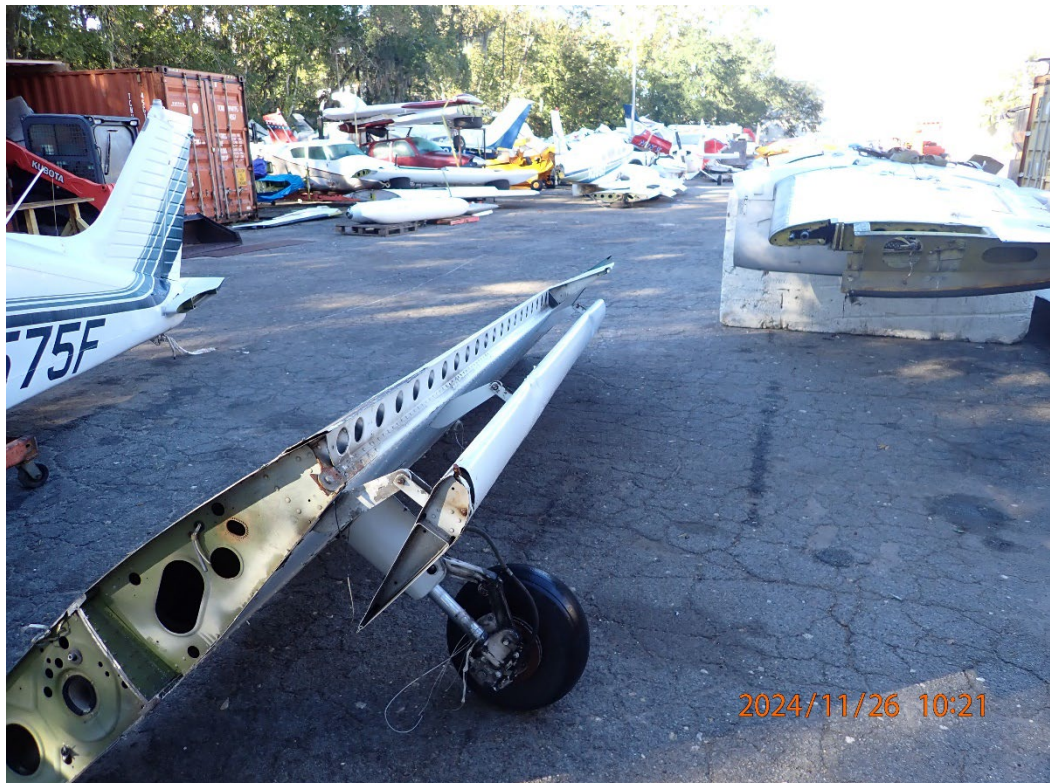
**Photo 5: View of the trailing edge of the right wing.**

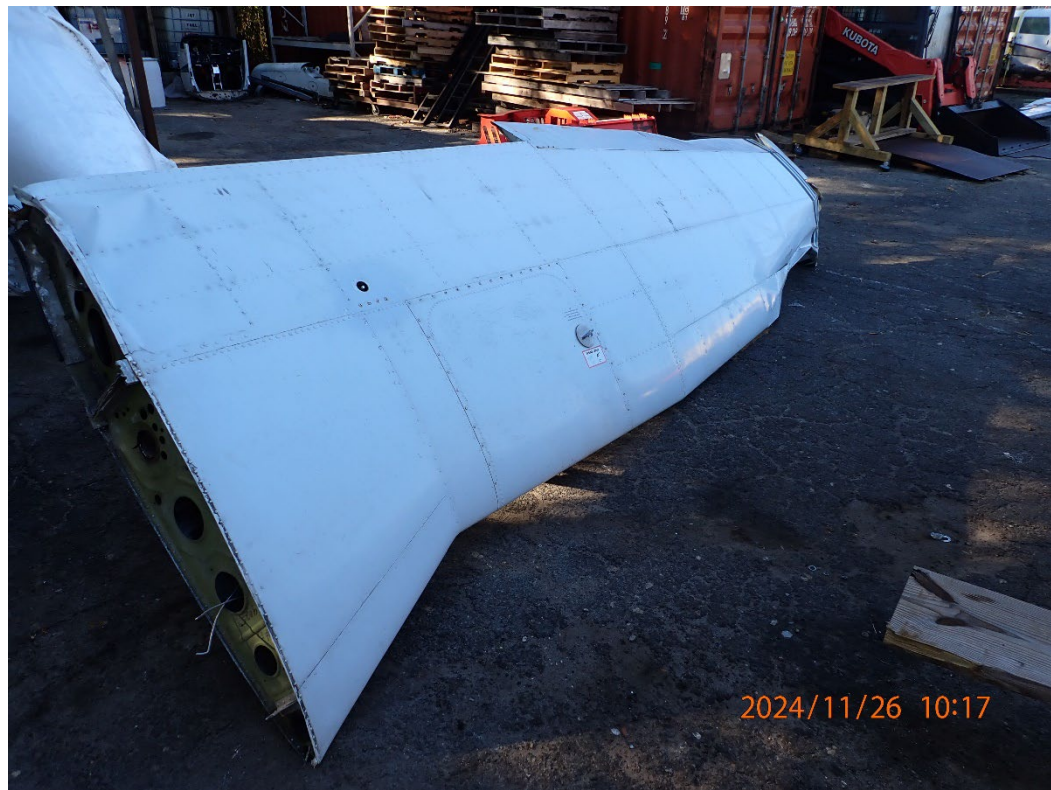
The left wing had been removed to facilitate recovery. The left wing leading edge was impact crushed aft from the wing tip to about 65 inches inboard of the wingtip. The left wing root exhibited buckling aft of the main wing spar. The left aileron remained attached to the wing at all attachment points. Control continuity was confirmed from the flight control surface to the flight controls in the cockpit through impact separation of the control cable. The control cable fracture was consistent with overload and exhibited a broomstraw appearance. The left flap remained attached to the wing at all attachment points. Control continuity was confirmed from the flight control in the cockpit to the flight control surface through an overload fracture of the flap actuation pushrod.

**Photo 6: View of the left wing.**

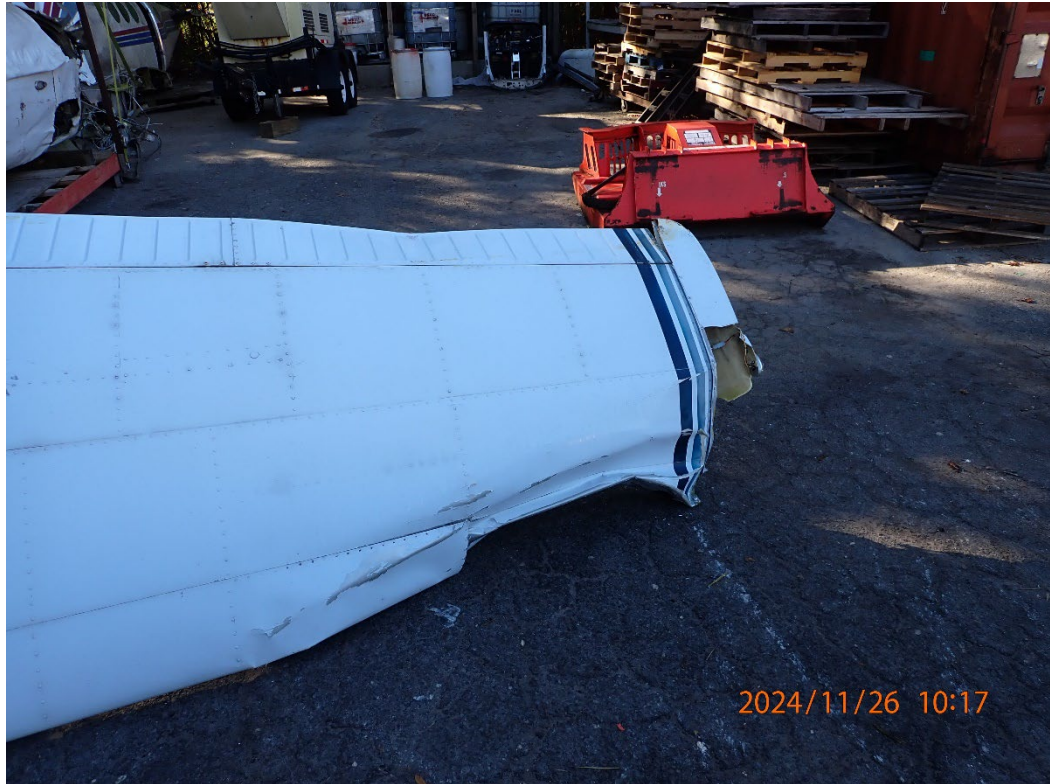
**Photo 7: View of damage to the left wing.**

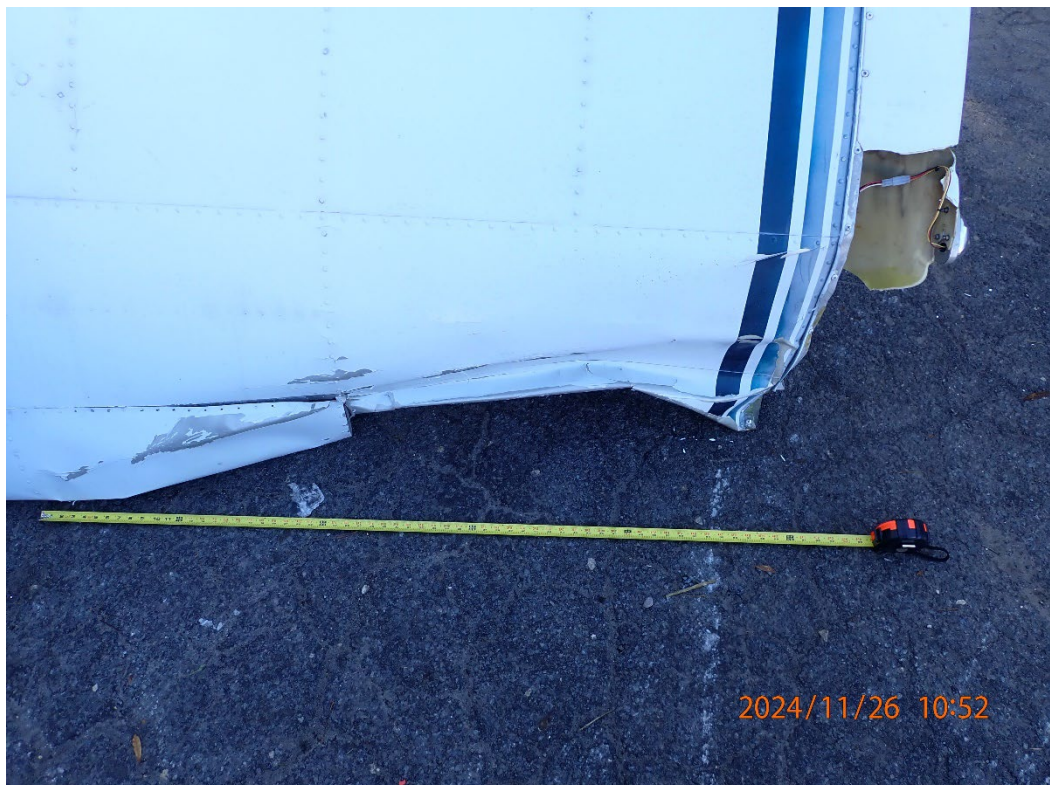
**Photo 8: View of damage to the leading edge of the left wing.**

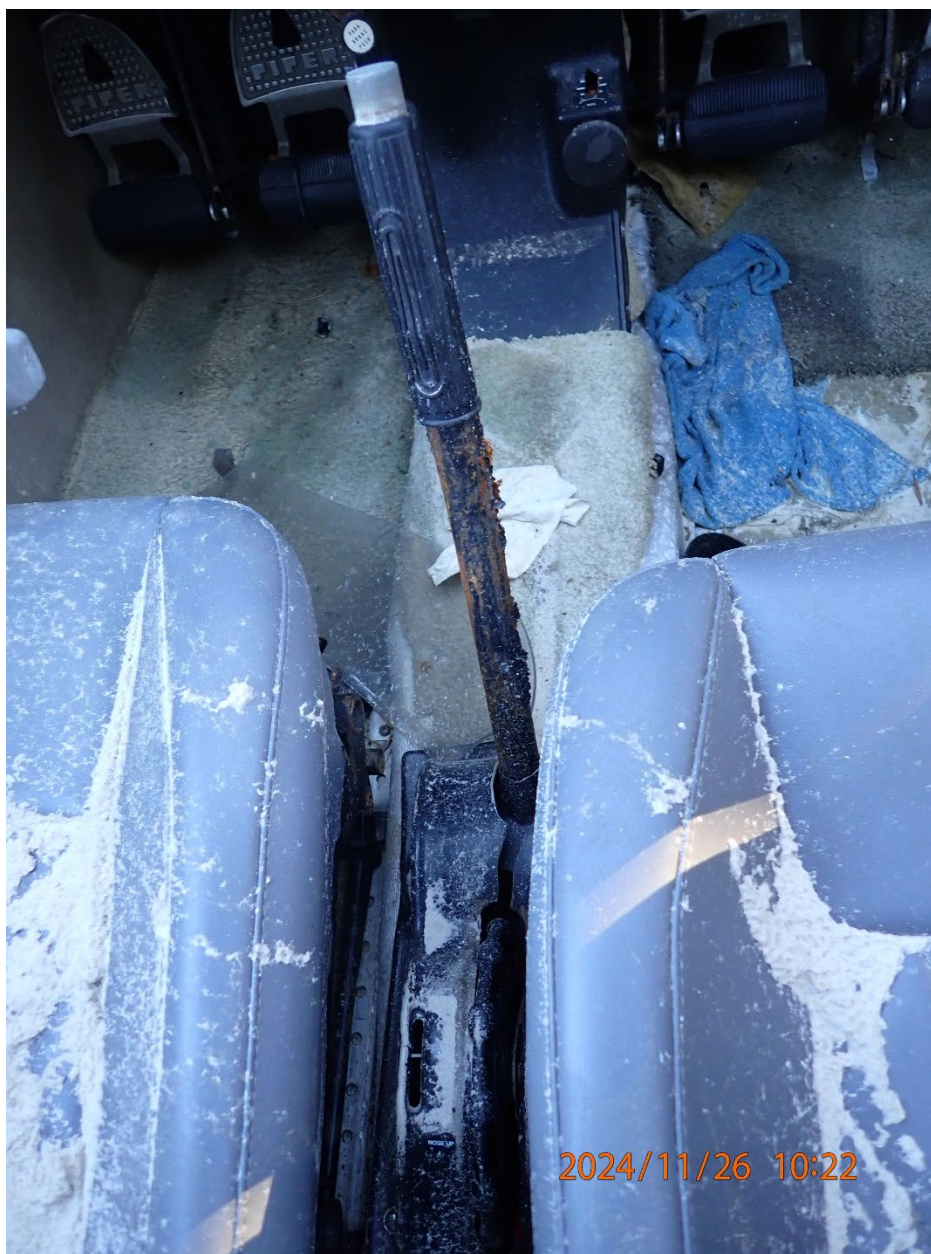
The cockpit had been submerged in salt water and exhibited corrosion consistent with the saltwater immersion. The XPDR circuit breaker was the only one popped out. The keys were not installed, and the ignition was turned to OFF. The flap handle was in the fully extended position. The stabilator trim was slightly nose down. The fuel selector was selected to the left tank. The throttle and carburetor heat controls were continuous from the cockpit to the controls on the carburetor and moved from stop to stop. The mixture lever was found in the full rich position and could not be moved by hand. The following switch positions were observed:

**Photo 9: View of the stabilator trim control and flap control handle.**

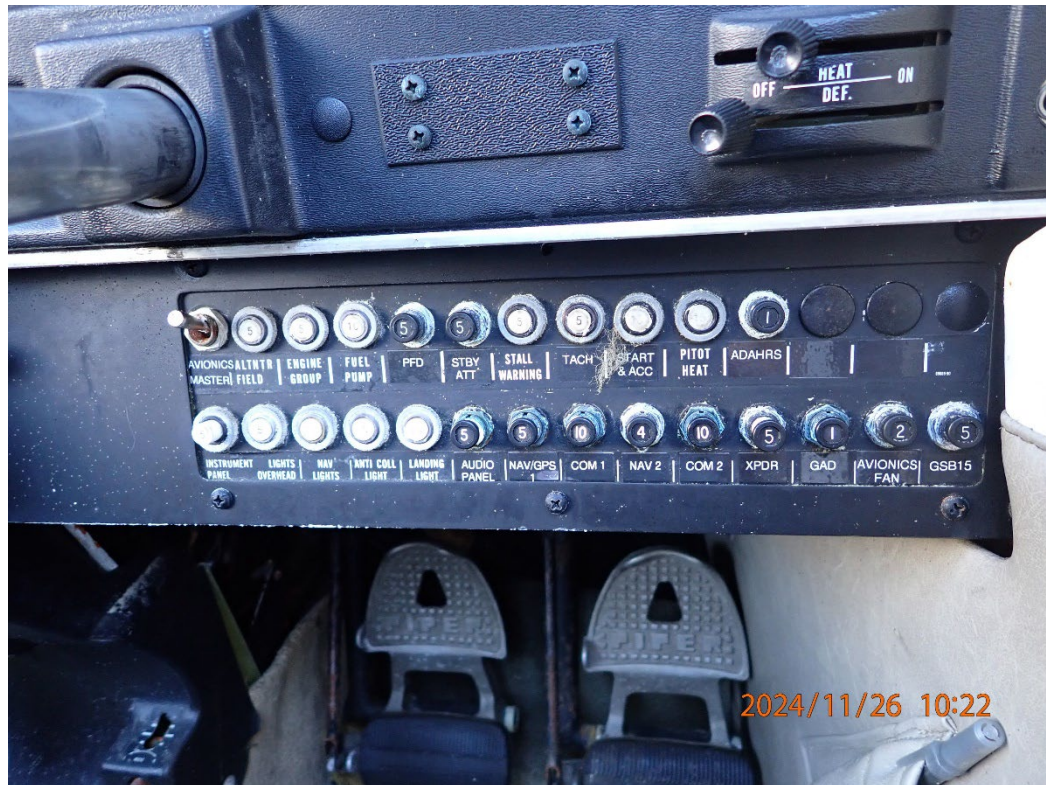
Photo 10: View of the circuit breaker panel.

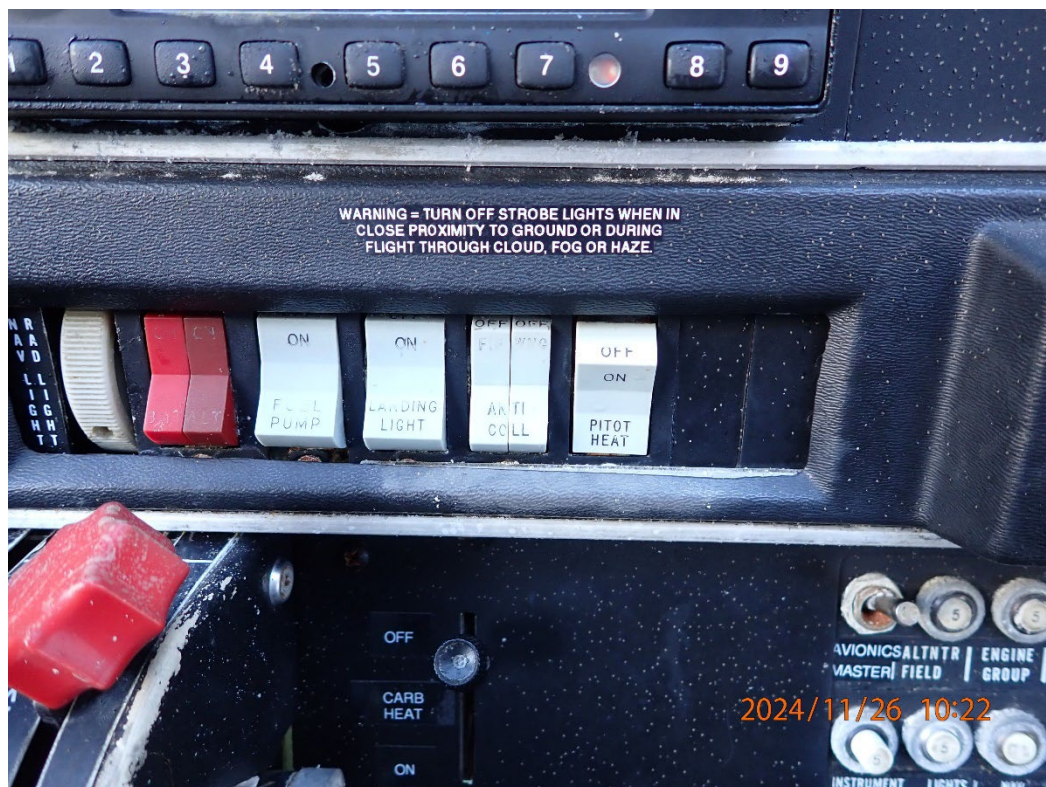
- Avionics master - ON
- Master BAT ALT - ON
- Fuel Pump - ON
- Landing Light - ON
- Anti Coll - ON
- Pitot heat - OFF

Photo 11: View of cockpit switches.

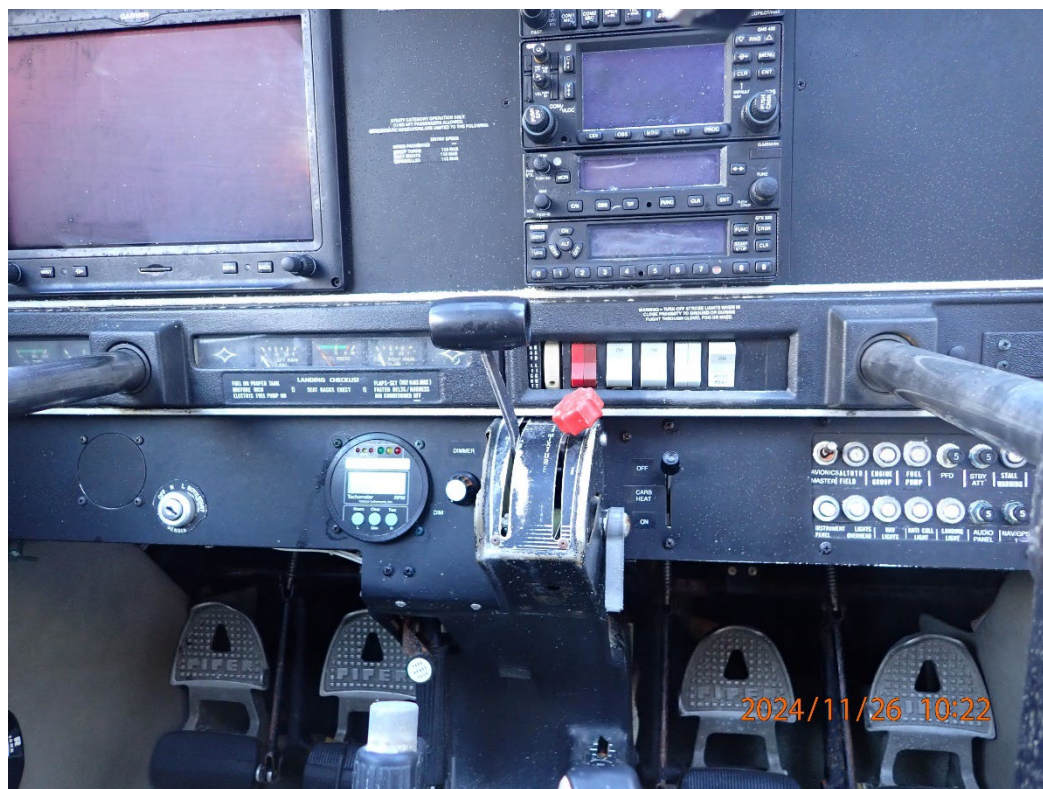
**Photo 12: View of throttle quadrant.**

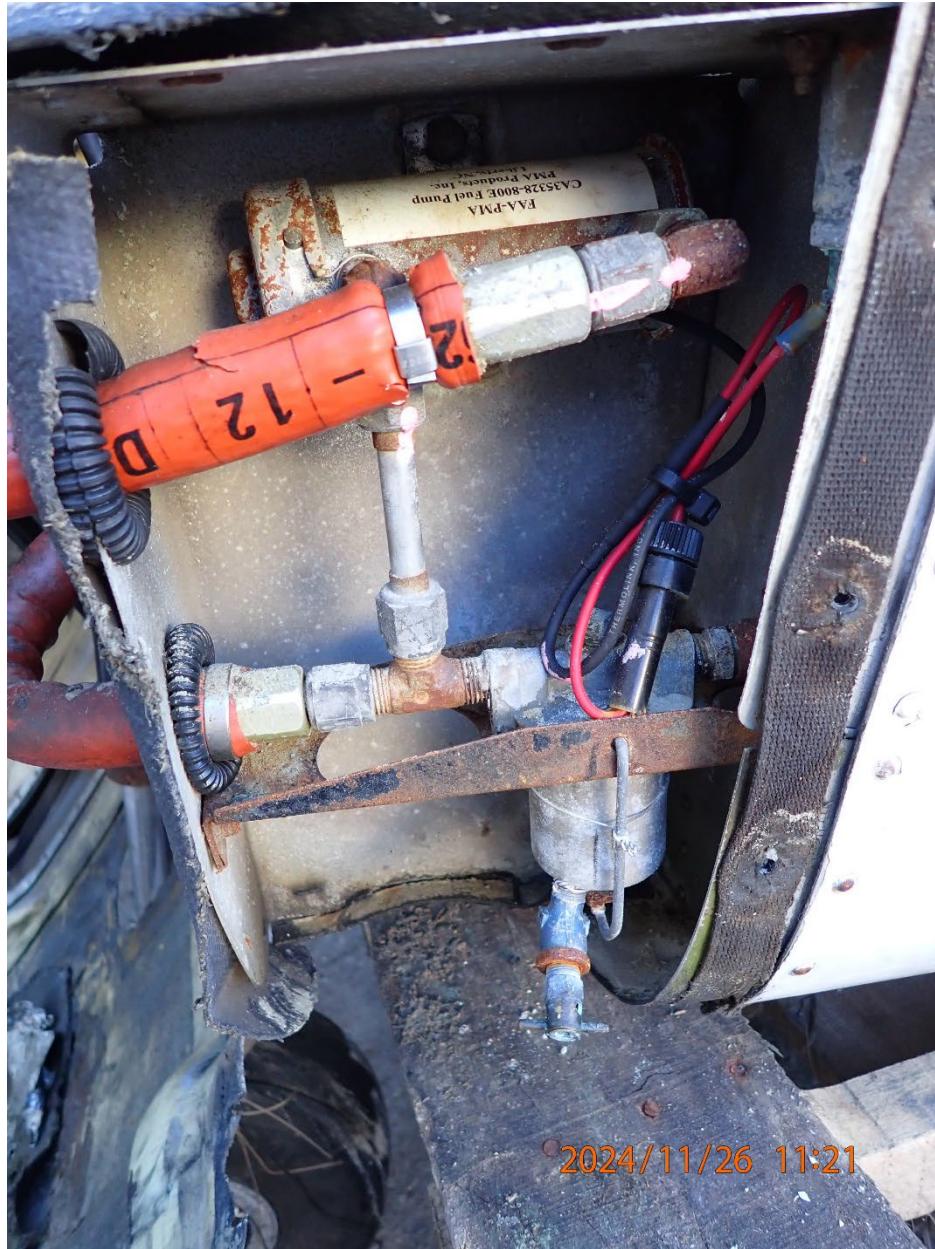
Both wing fuel tank caps remained installed on the respective wings. The aircraft fuel selector was selected to the left main fuel tank. The fuel strainer was removed and examined. The strainer bowl contained debris consistent with saltwater immersion. The fuel strainer screen was removed, examined, and exhibited minimal obstruction consistent with saltwater immersion.

**Photo 13: View of fuel strainer.**

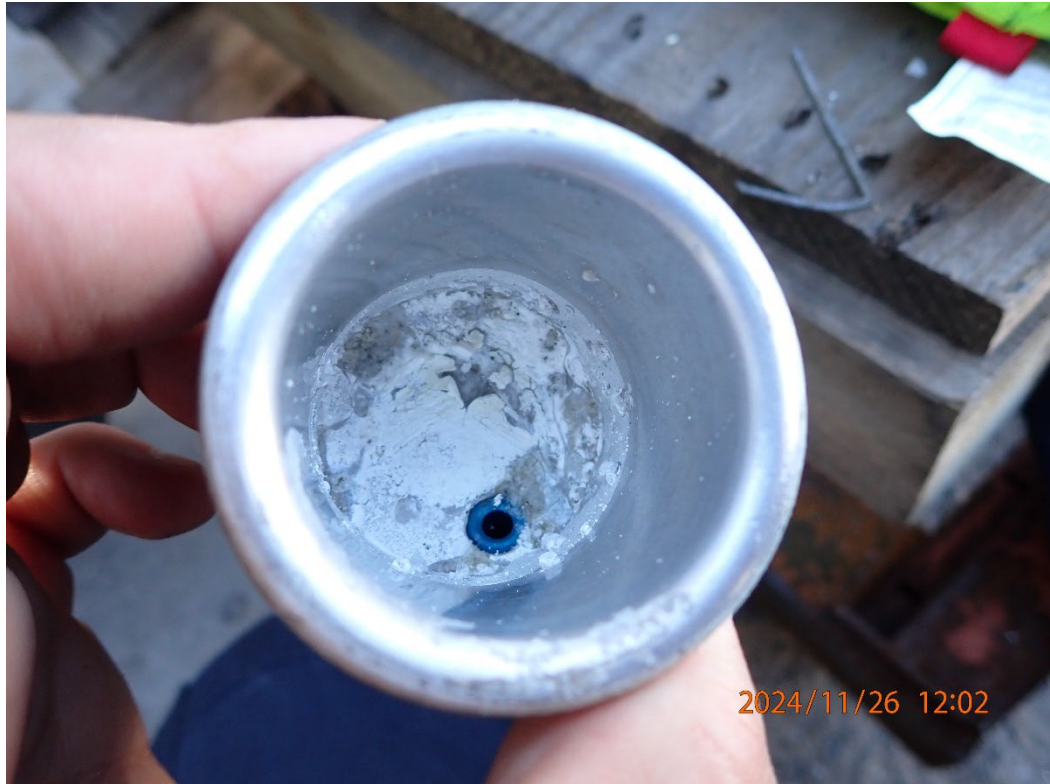
**Photo 14: View of fuel strainer bowl.**

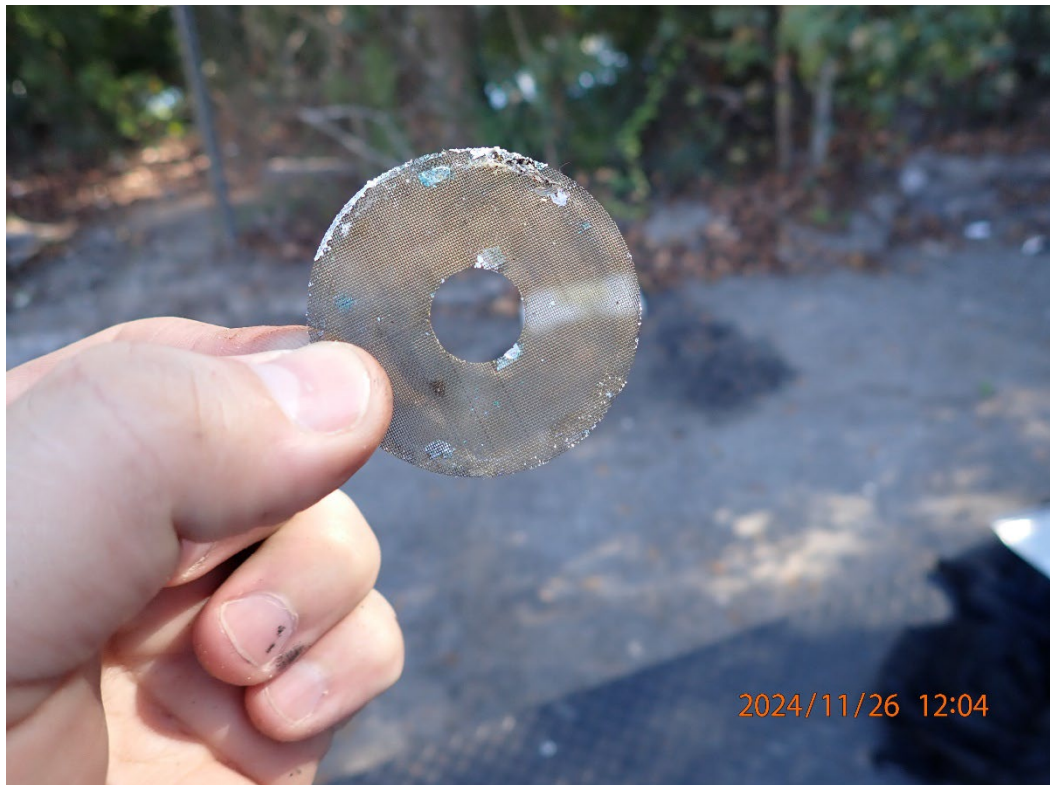
**Photo 15: View of fuel strainer screen.**

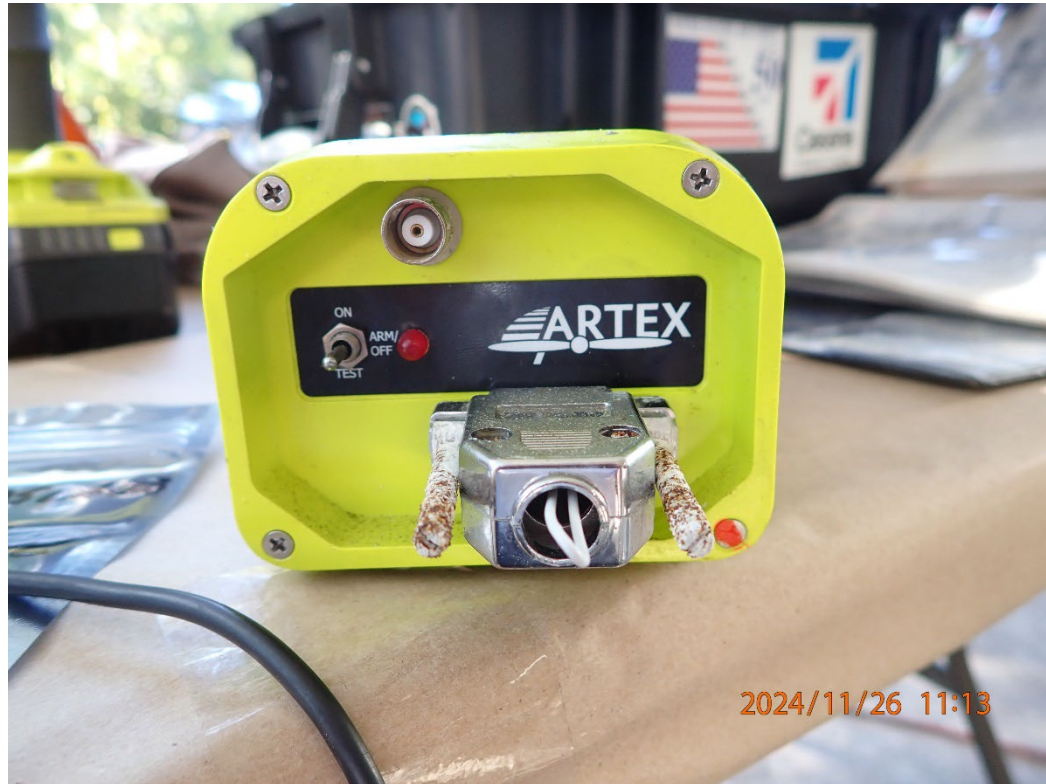
The ELT remained installed on the airplane in its mounting bracket and was connected to the antenna.

**Photo 16: View of the front of the ELT.**

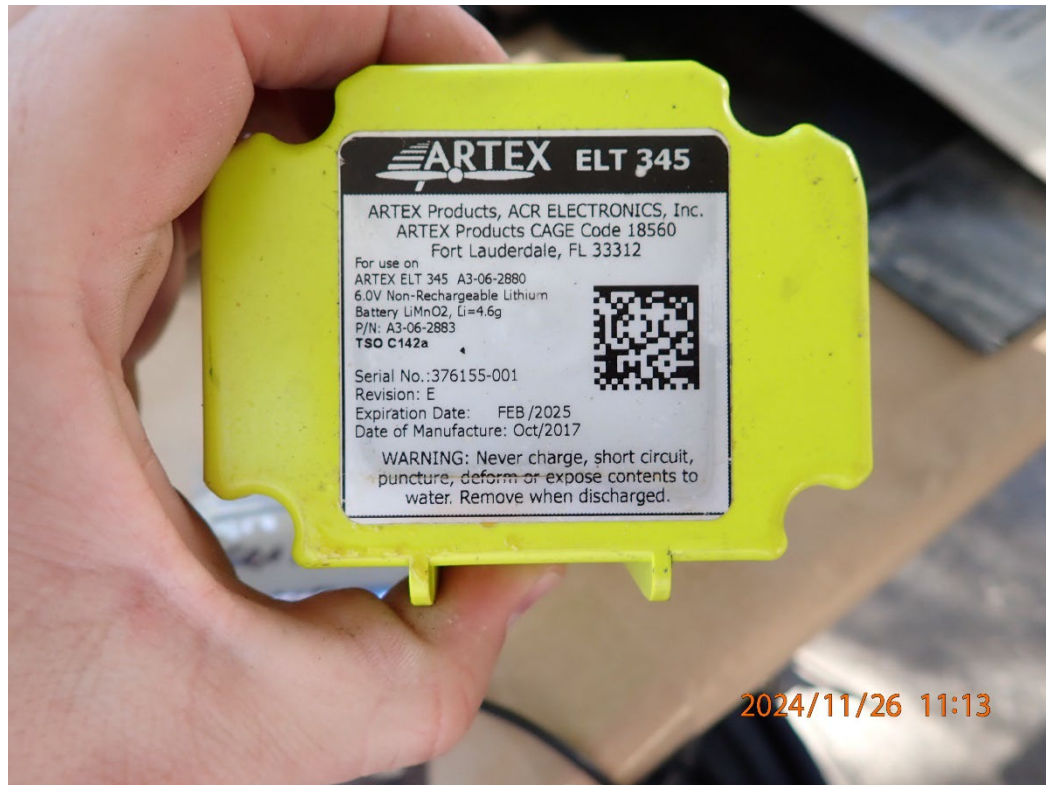
**Photo 17: View of the ELT.**

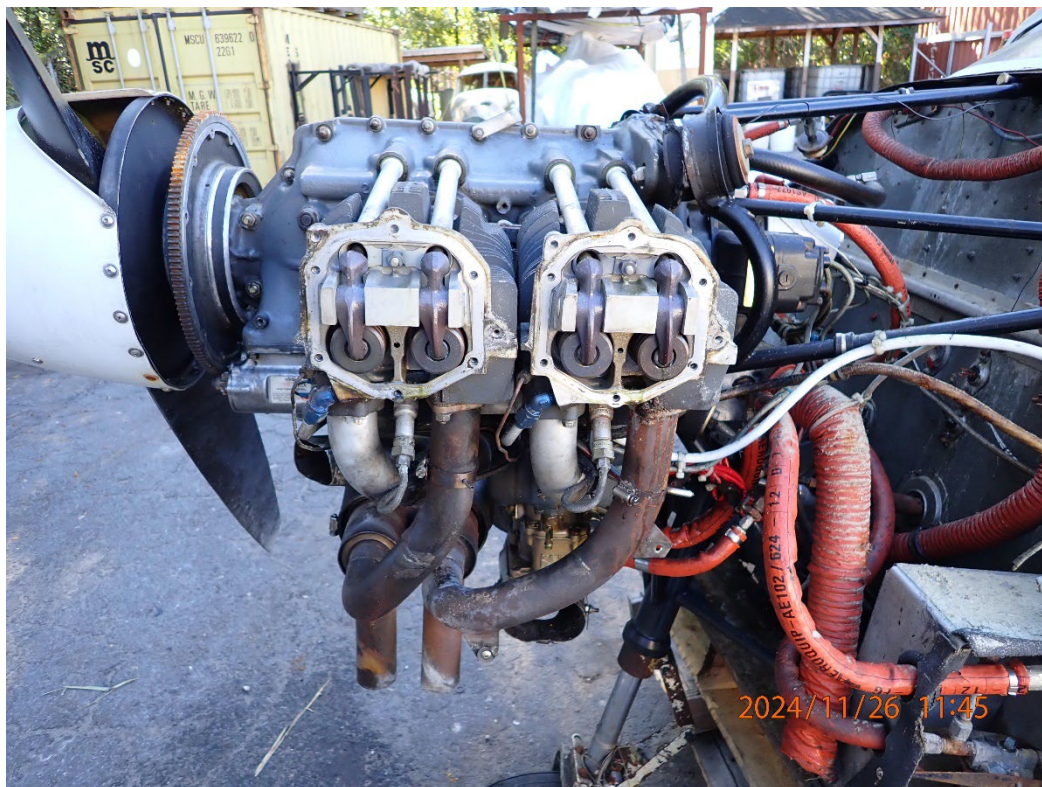
The engine was a Lycoming O-360-A4A rated to 180 horsepower at 2700 RPM. The engine remained attached to the fuselage via the undamaged engine mount. The cowling and baffling were removed to facilitate an examination of the engine. The engine exhibited compression and suction on all cylinders using the thumb method when the propeller was rotated by hand through 720° of rotation. Continuity of the valve train was confirmed through multiple rotations of the propeller by hand.

**Photo 18: View of the Nos. 2 & 4 cylinders with rocker box covers removed.**

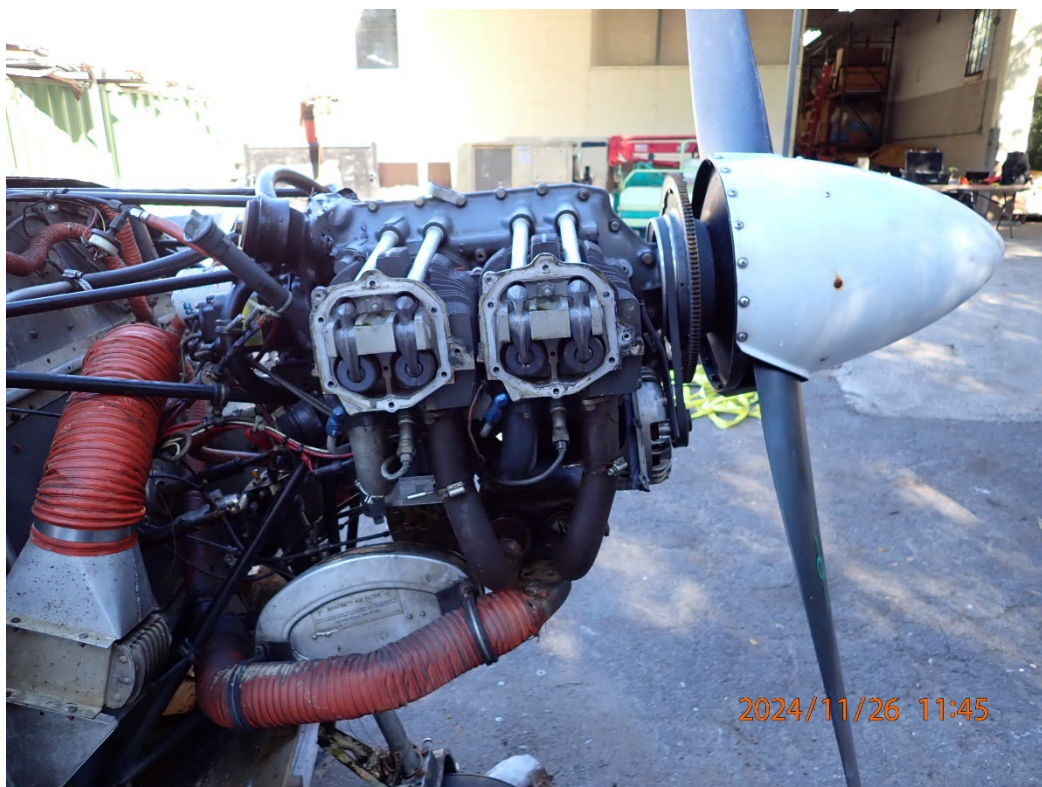
**Photo 19: View of the Nos. 1 & 3 cylinders with rocker box covers removed.**

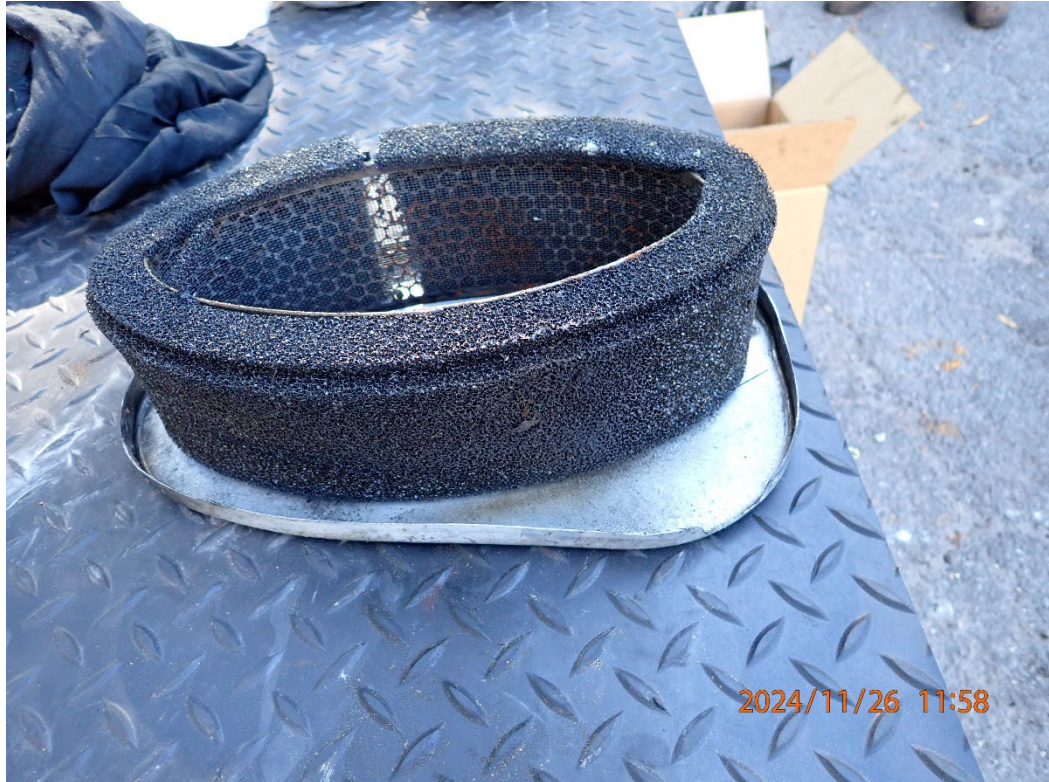
The induction system was undamaged and unobstructed. The engine air filter was removed and examined and was unobstructed.

**Photo 20: View of the unobstructed engine air filter.**

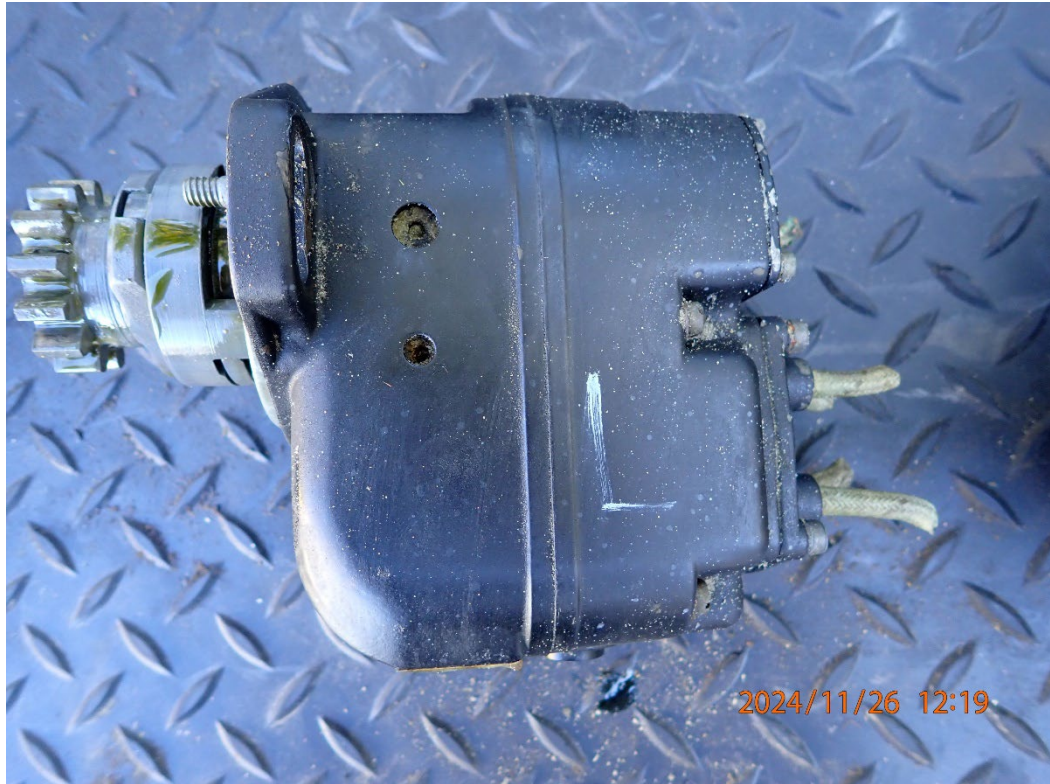
The left and right magnetos remained installed on the engine accessory case and were tight. Both magnetos were removed for examination. Both magnetos were rotated using an electric drill and no spark was observed. Both magnetos were disassembled and exhibited extreme corrosion throughout.

**Photo 21: View of the left magneto.**

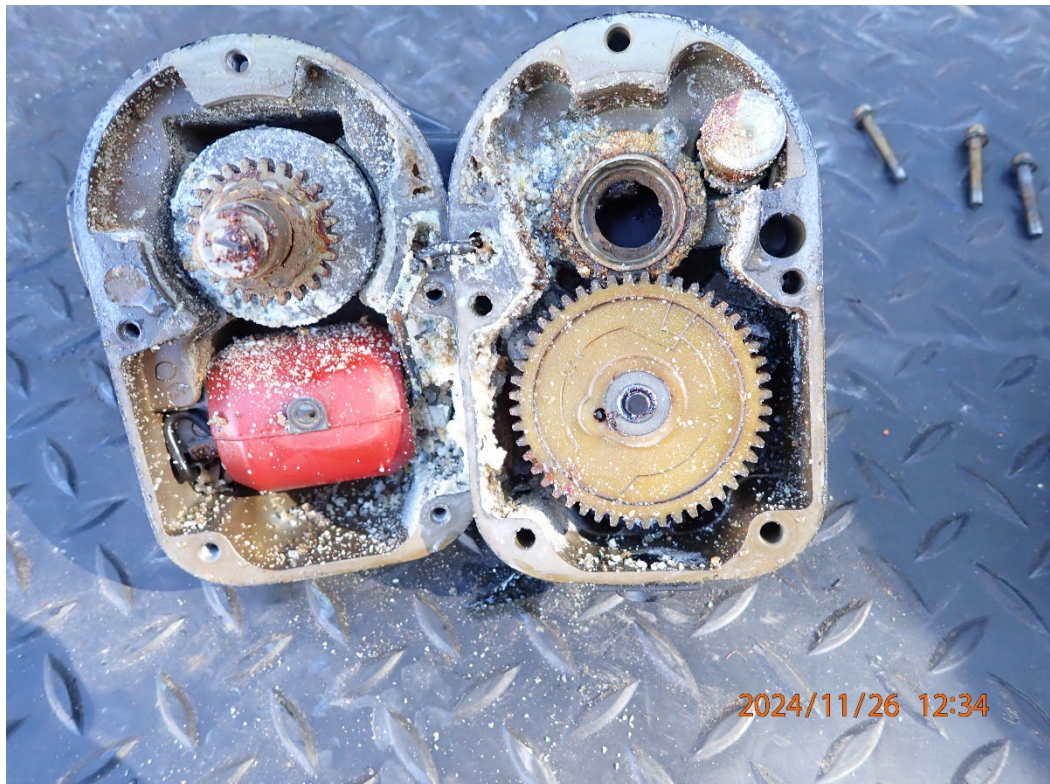
**Photo 22: View of the inside of the left magneto.**

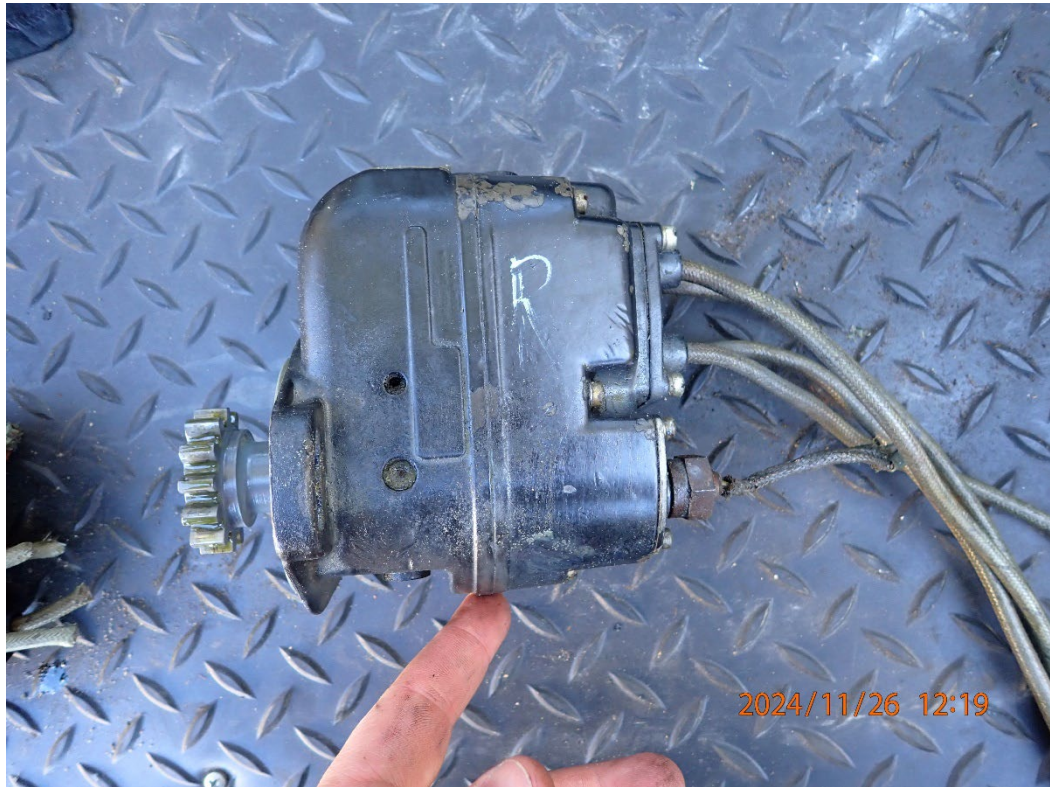
**Photo 23: View of the right magneto.**

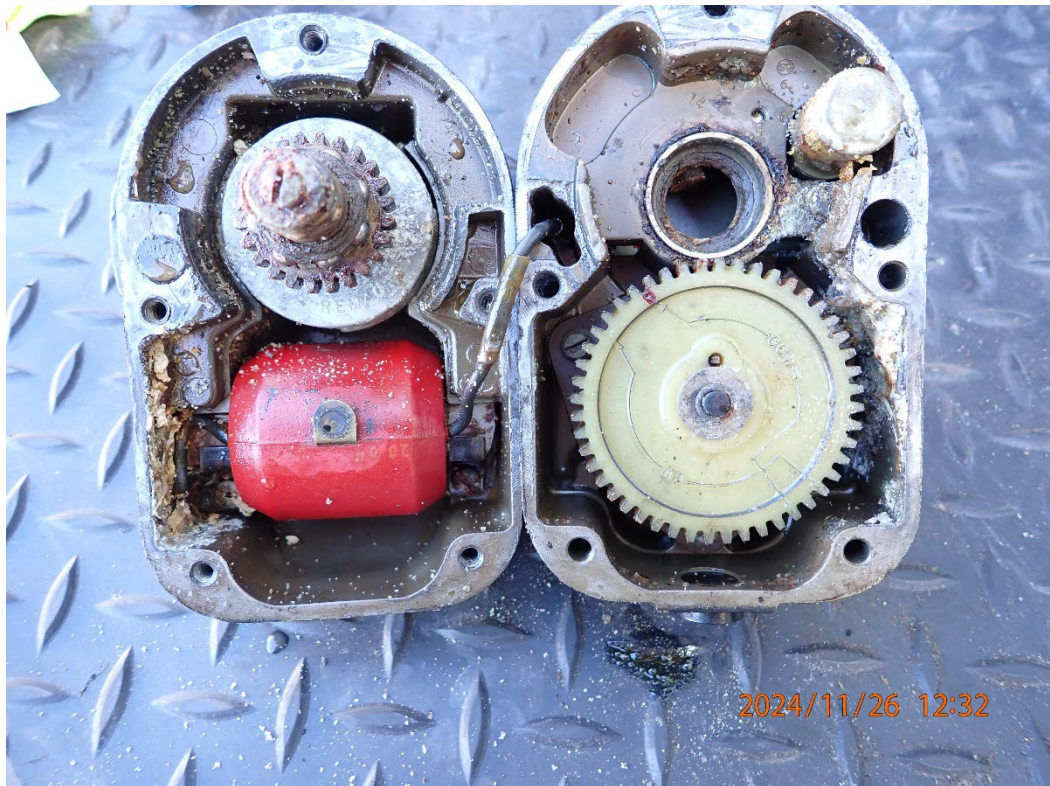
**Photo 24: View of the inside of the right magneto.**
