# National Transportation Safety Board

ERA25LA003

## **WRECKAGE EXAMINATION**

Location: Tampa Bay, FL  
Date: October 3, 2024  
Time: 1140 EDT  
1540 UTC  
Airplane: N8575F; Piper PA-28-181

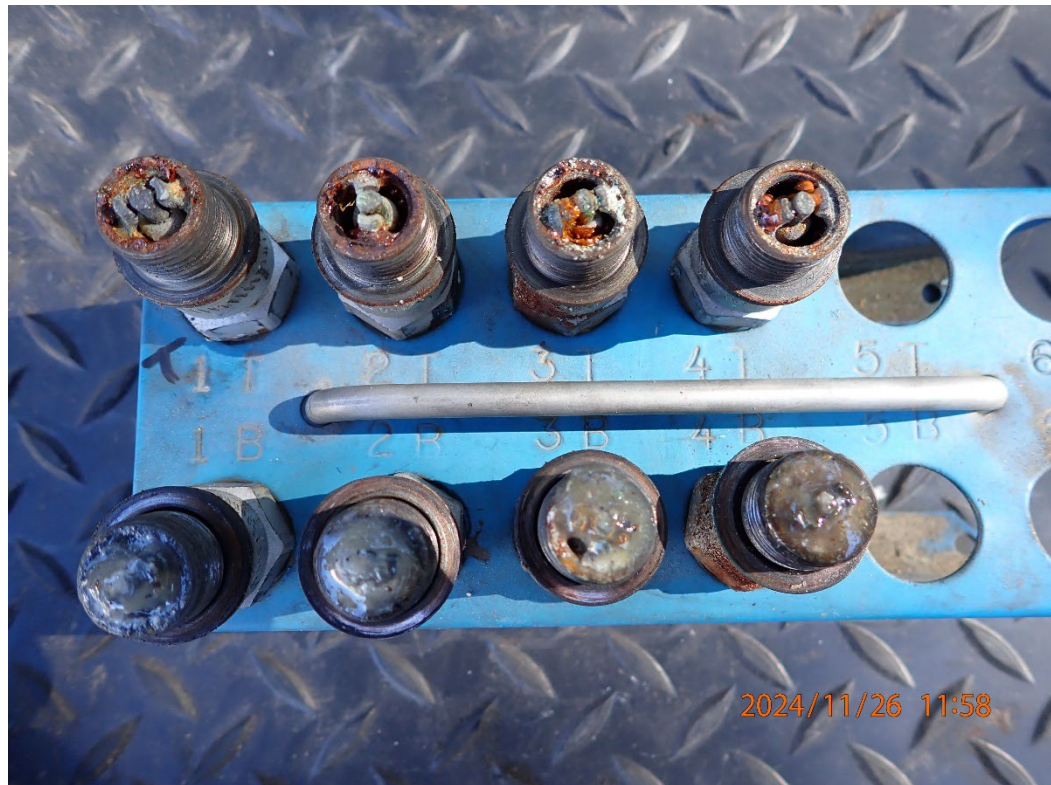
The ignition harness from the magnetos to the sparkplugs was undamaged. The spark plugs remained installed in all cylinders. All sparkplugs exhibited corrosion consistent with submersion in salt water.

**Photo 25: View of the sparkplugs.**

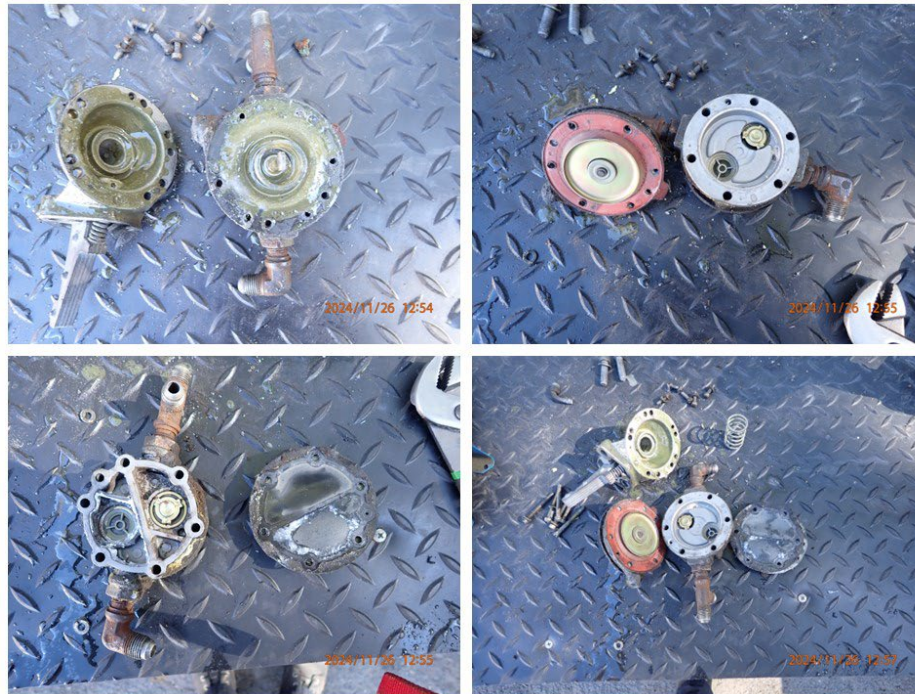
The engine driven fuel pump was removed and examined. The pump did not pump air when operated by hand. The pump was then disassembled and exhibited extreme amounts of corrosion throughout consistent with the saltwater immersion the engine sustained.

**Photo 26: View of the disassembled engine driven fuel pump.**

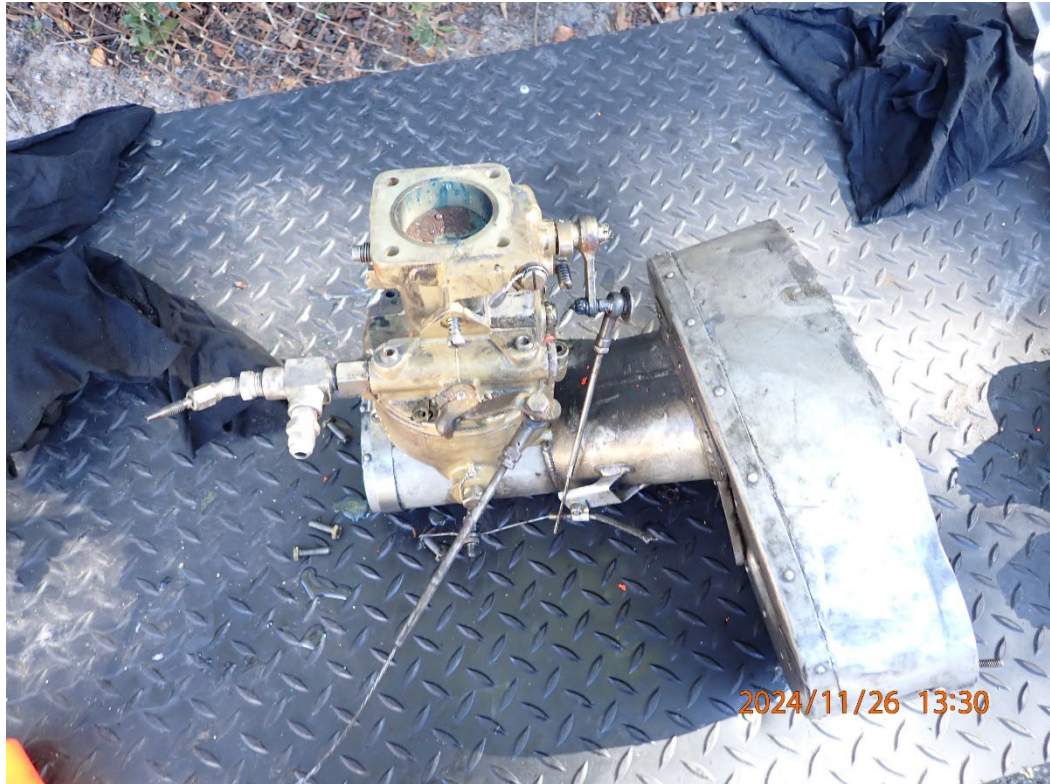
The carburetor was removed and examined. The throttle control arm remained installed on the carburetor and moved from stop to stop when actuated by hand. The carburetor heat control arm remained installed and operated normally from stop to stop when actuated by hand. The mixture control arm remained installed on the carburetor and moved from stop to stop when actuated by hand. The accelerator pump operated normally when the throttle was manipulated by hand. The carburetor was partially disassembled to facilitate examination. The bowl was filled with a brown

**Photo 27: View of the carburetor removed from the engine.**

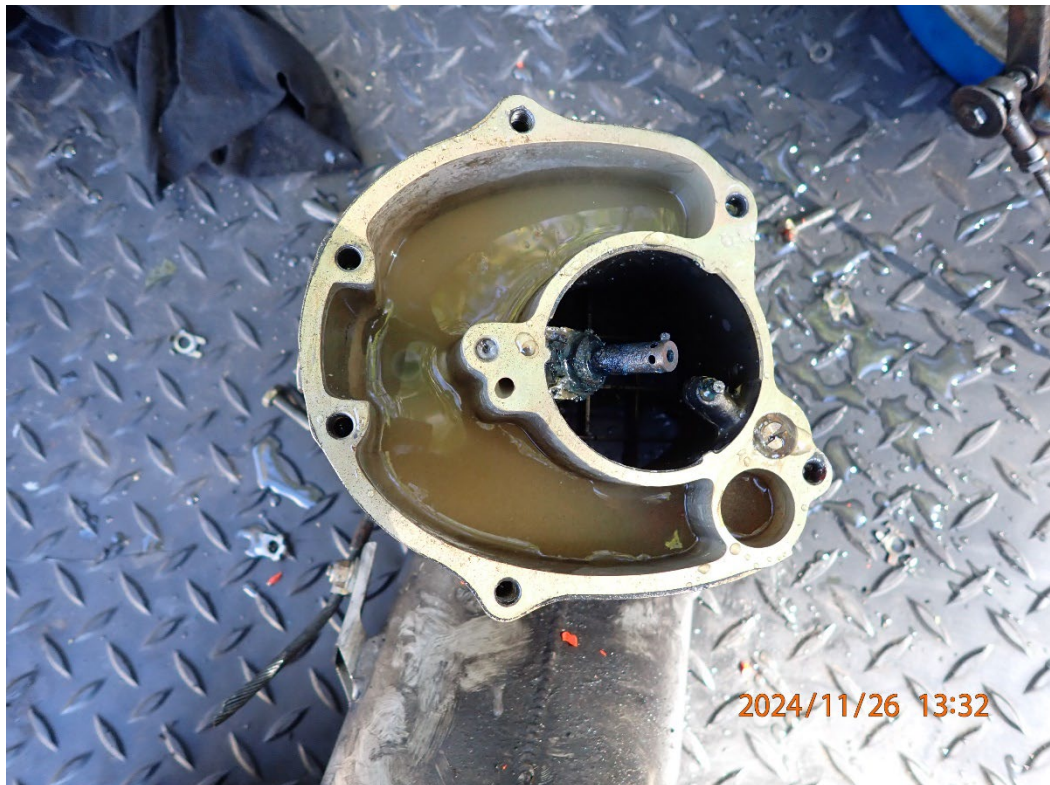
liquid consistent in color and odor with saltwater. There was a small amount of debris in the bowl consistent with saltwater corrosion. The bowl floats were undamaged. Internal components throughout exhibited corrosion consistent with saltwater immersion. The carburetor fuel inlet screen was removed, examined, and contained a small amount of debris.

**Photo 28: View of the carburetor bowl.**

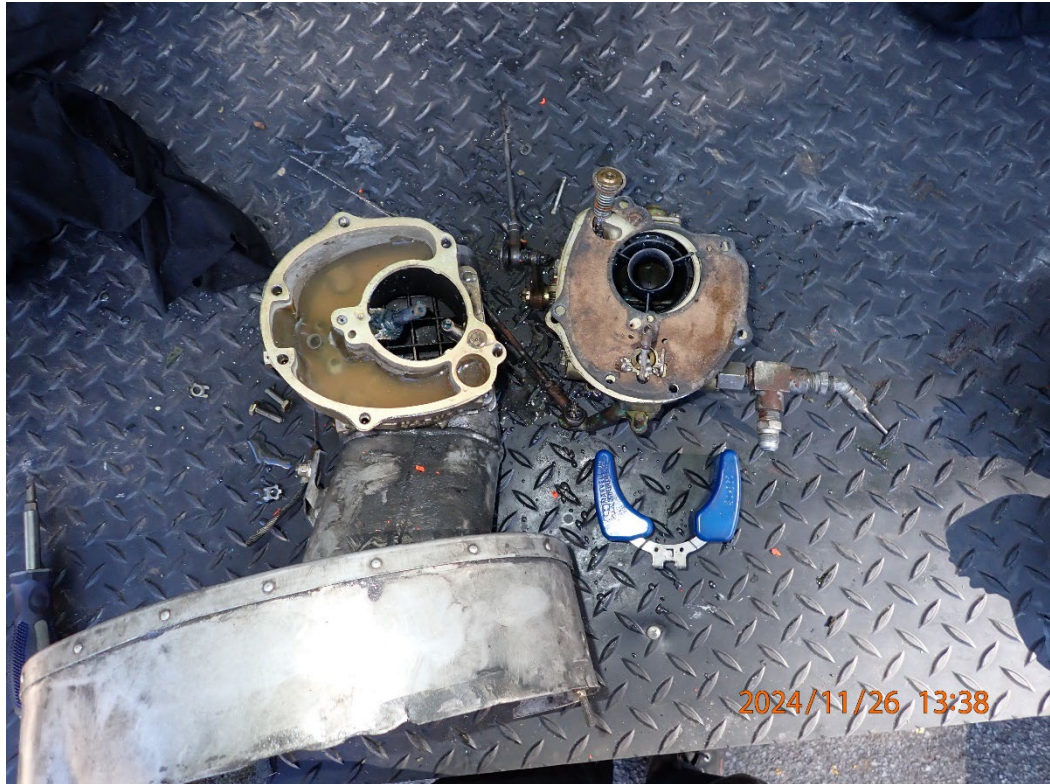
**Photo 29: View of the disassembled carburetor.**

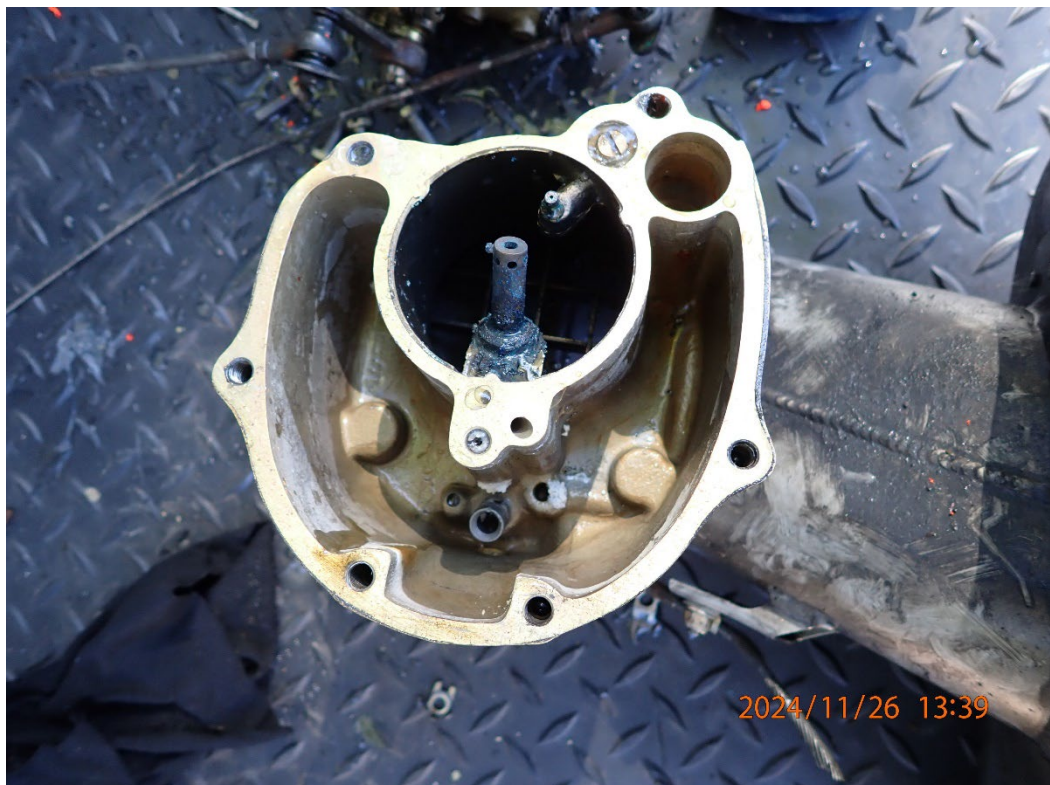
**Photo 30: View of the carburetor bowl after the removal of the liquid.**

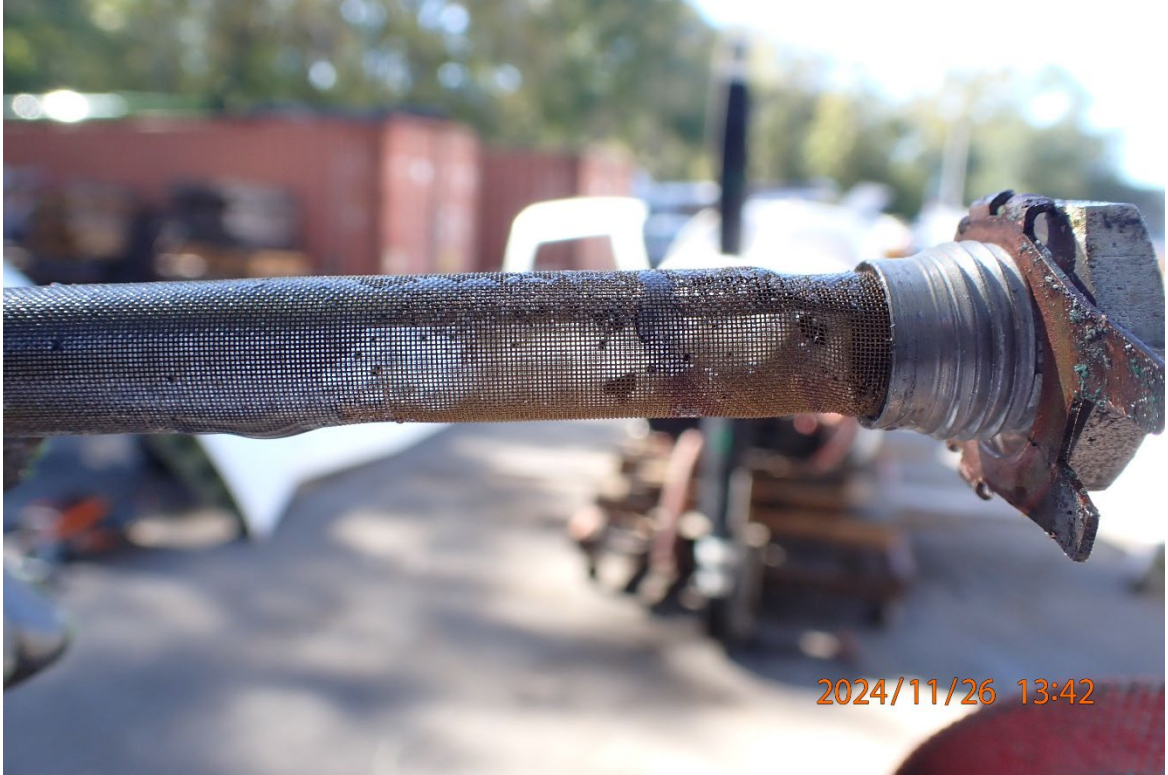
**Photo 31: View of the carburetor fuel inlet screen.**

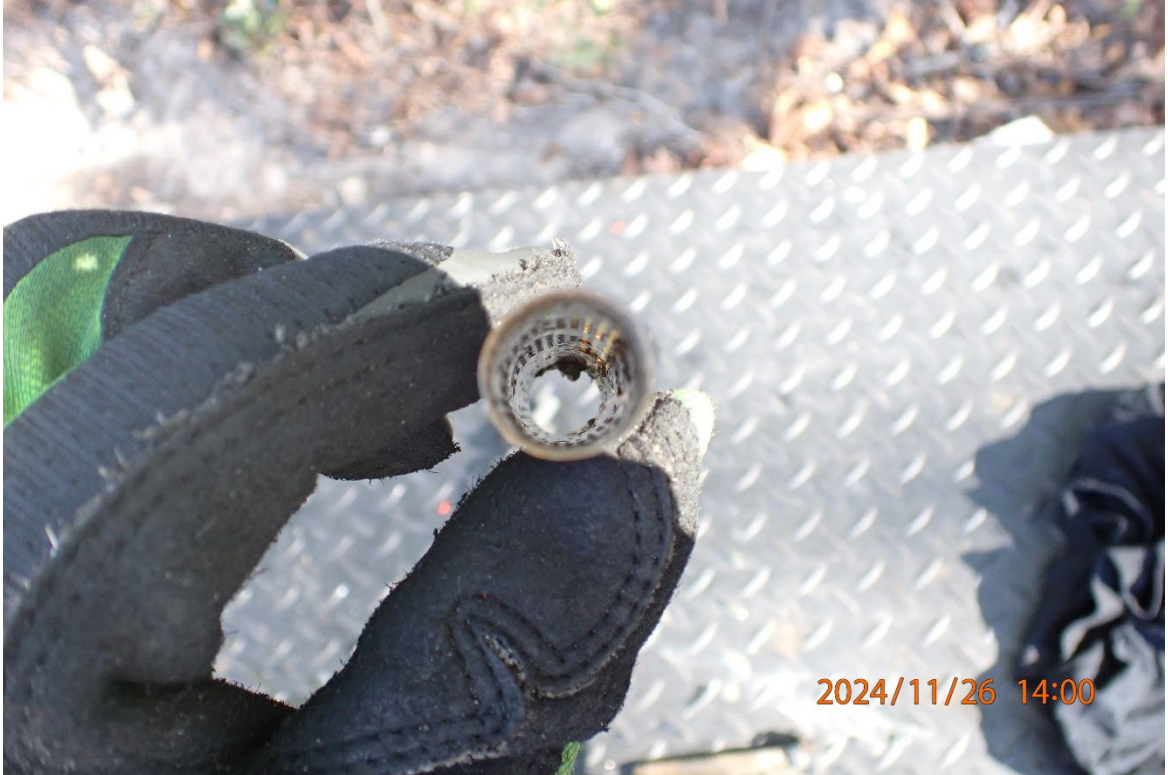
The dipstick was removed, and the amount of oil present was not able to be determined. The oil suction screen was removed and a small amount of debris was observed in the screen. The oil filter dated 8/20/20 was removed and cut open. The filter pleats were removed and examined and were unobstructed.

Photo 32: View of the oil suction screen.

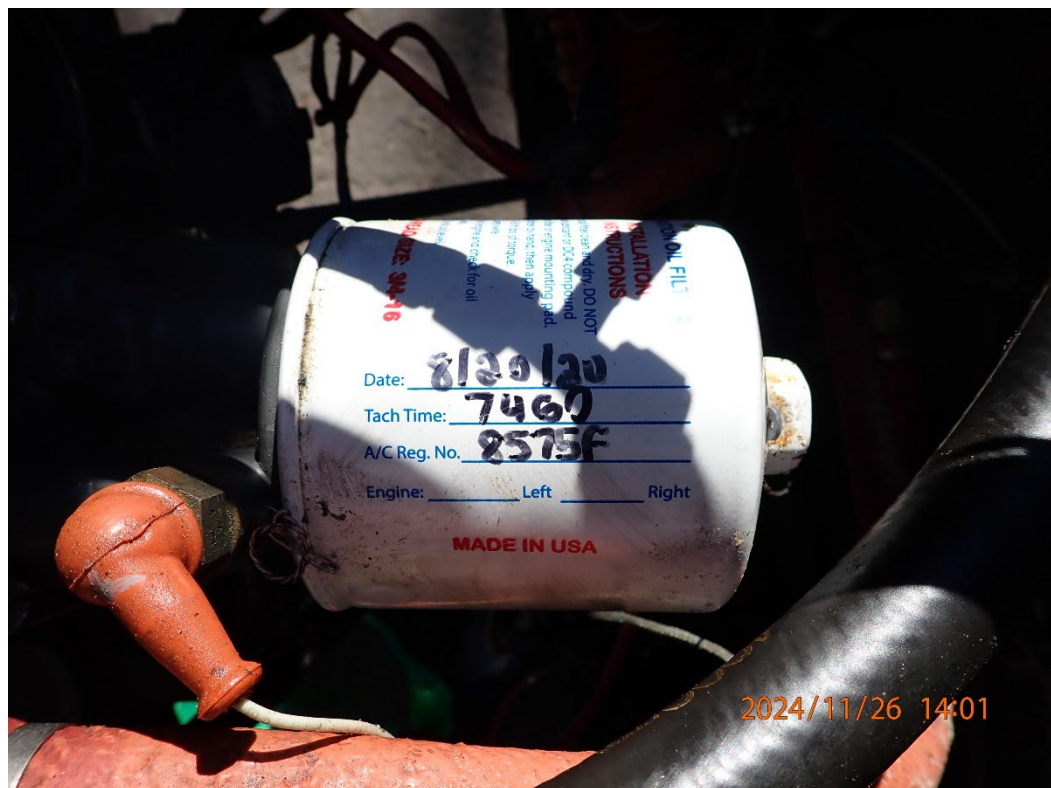
Photo 33: View of the oil filter.

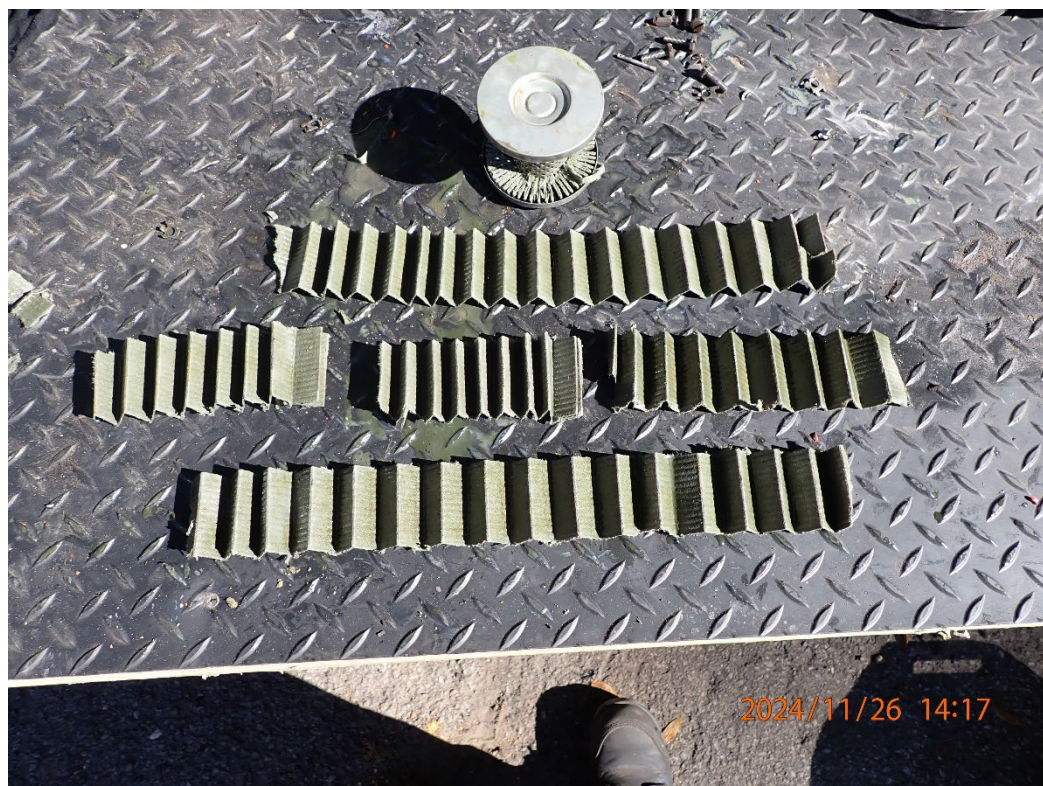
**Photo 34: View of the oil filter media.**

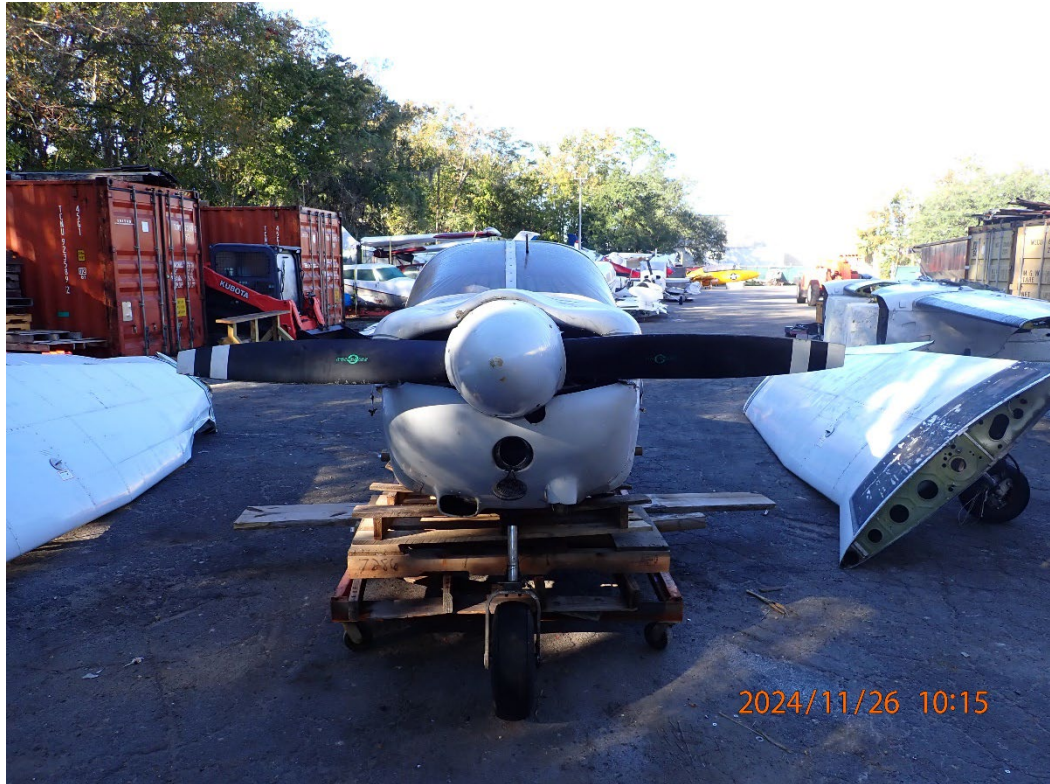
The propeller remained attached to the crankshaft flange and was undamaged.

**Photo 35: View of the undamaged propeller attached to the airplane.**

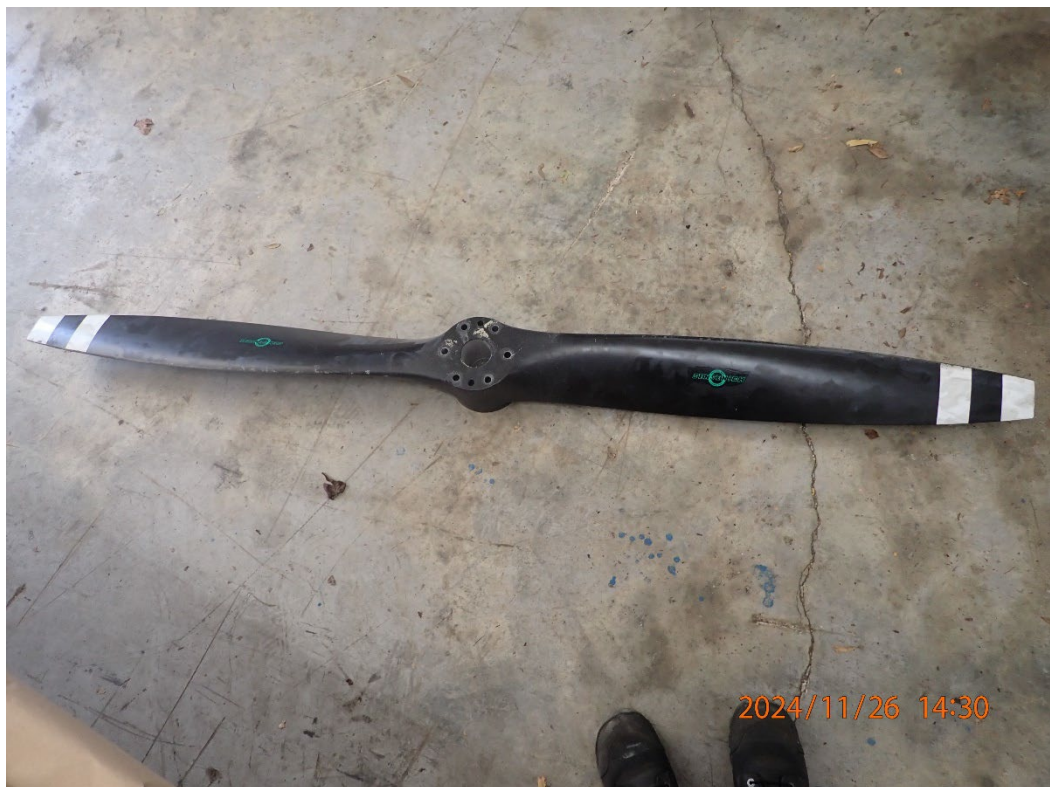
**Photo 36: View of the undamaged propeller removed from the airplane.**
