# National Transportation Safety Board

ERA25LA006

## **ENGINE TEST RUN**

Location: Moore Haven, FL  
Date: October 3, 2024  
Time: 1314 EDT  
1714 UTC  
Airplane: N12RD; Piper PA-24-250

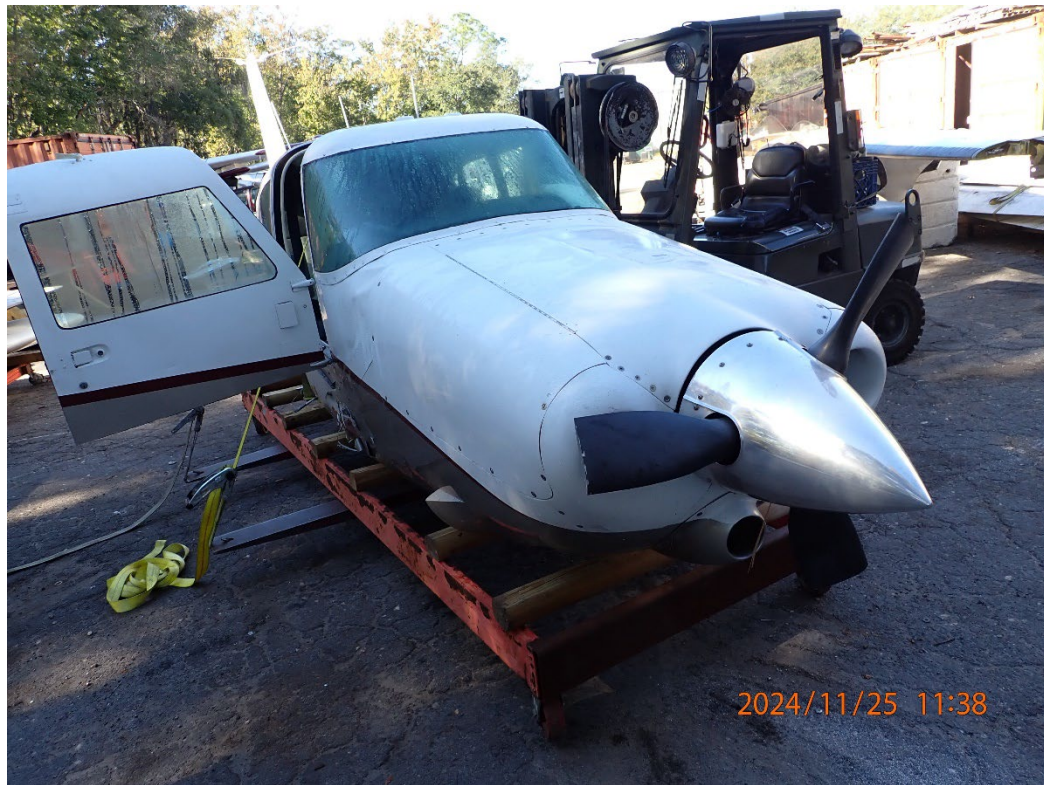
The engine was first observed installed on the airframe with the cowling installed. The top and front portions of the cowling were removed to facilitate an engine test run. The throttle and mixture controls in the cockpit were operated and it was observed that the controls on the carburetor moved from stop to stop. The carburetor heat control in the cockpit had minimal movement and the actuator arm had minimal movement.

**Photo 1: View of the engine as first observed.**

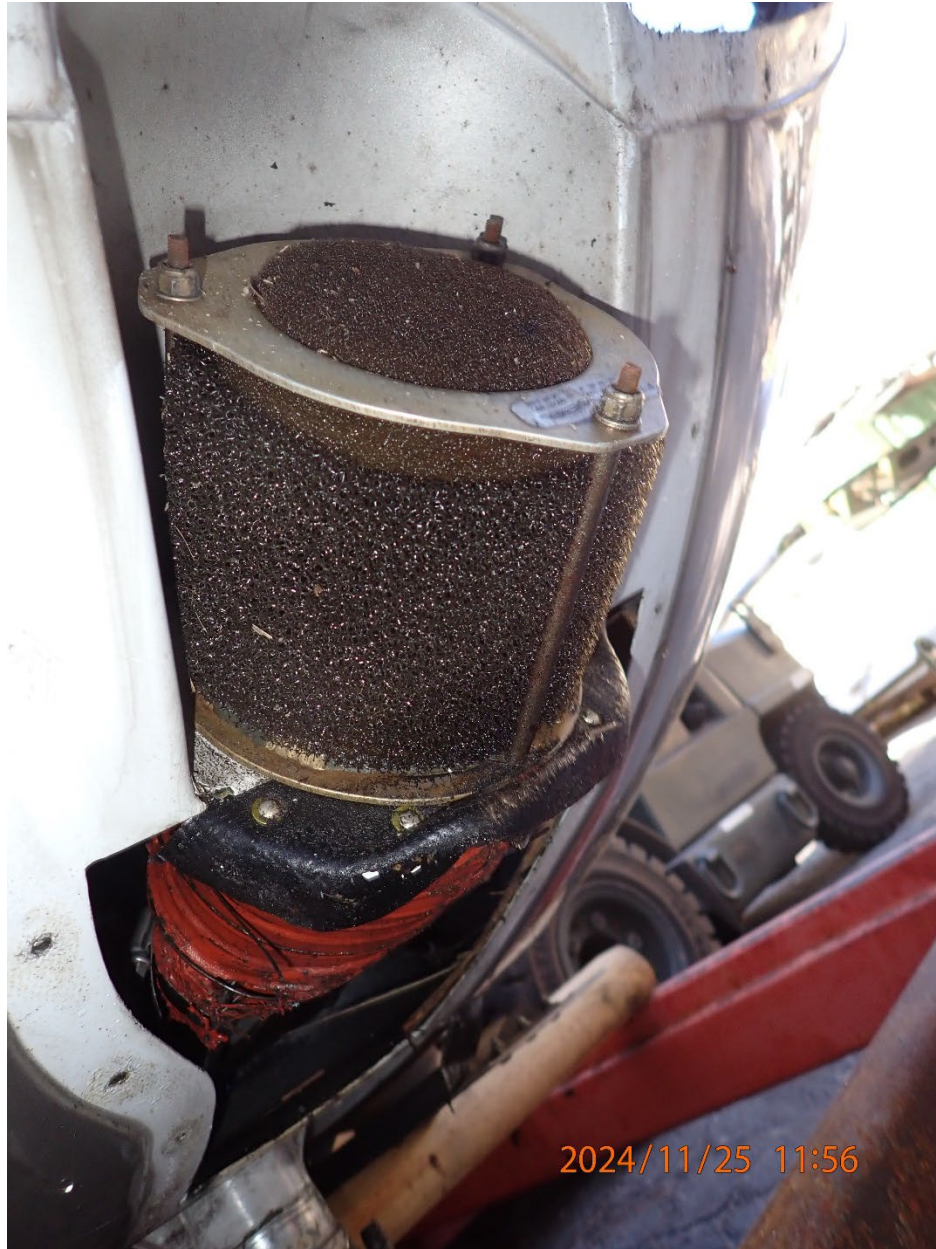
The induction air filter remained installed on the engine and was unobstructed. The induction system was operationally checked, and no discrepancies were noted.

**Photo 2: View of the unobstructed engine air intake filter.**

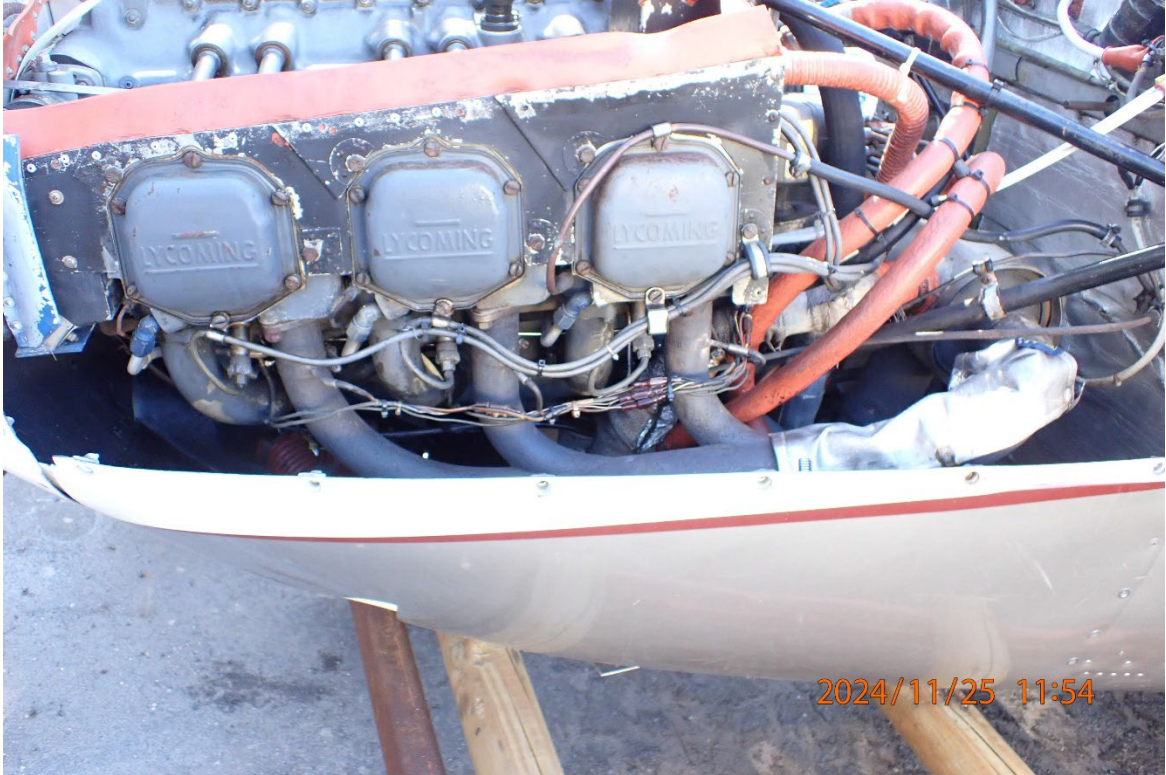
The exhaust system was undamaged and was operationally checked with no discrepancies noted.

**Photo 3: View of the undamaged exhaust.**

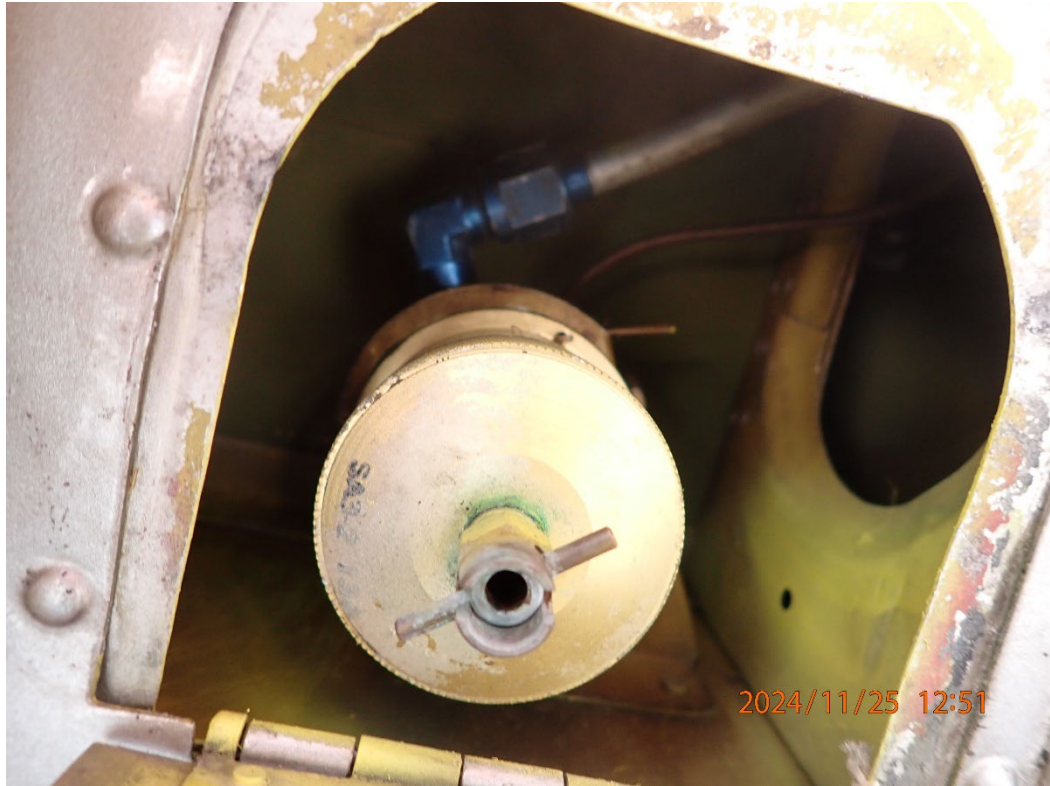
The wings had been removed from the fuselage and subsequently the main left and right wing fuel tanks were checked for breaches by filling them with water. No breaches were noted when the wings were full of water. The fuel selectors in the cockpit were selected to L. Main and R. Main. The airframe fuel strainer was opened and there was no liquid present. The fuel strainer bowl contained a small amount of debris and the fuel strainer screen was unobstructed. For the engine test run a fuel tank was plumbed into the airplane's boost pump which was checked and operated when power was applied using the airplane's battery. All other fuel components were operationally checked and operated normally.

**Photo 4: View of the fuel strainer.**

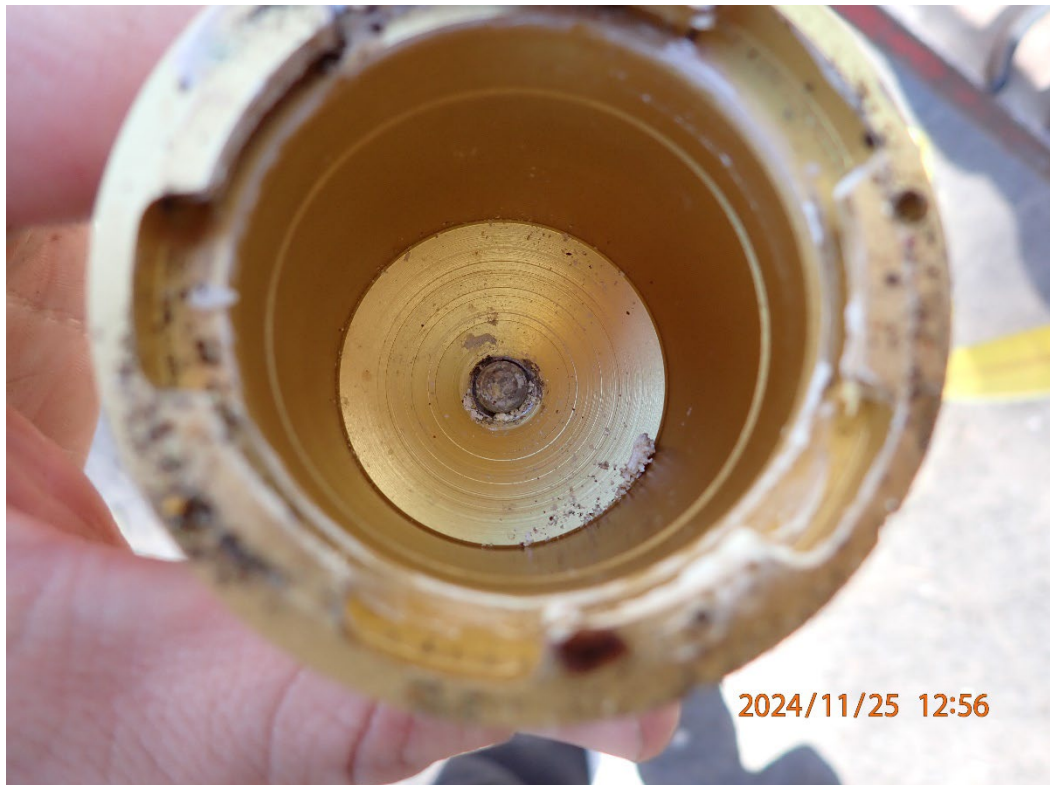
**Photo 5: View of the fuel strainer bowl.**

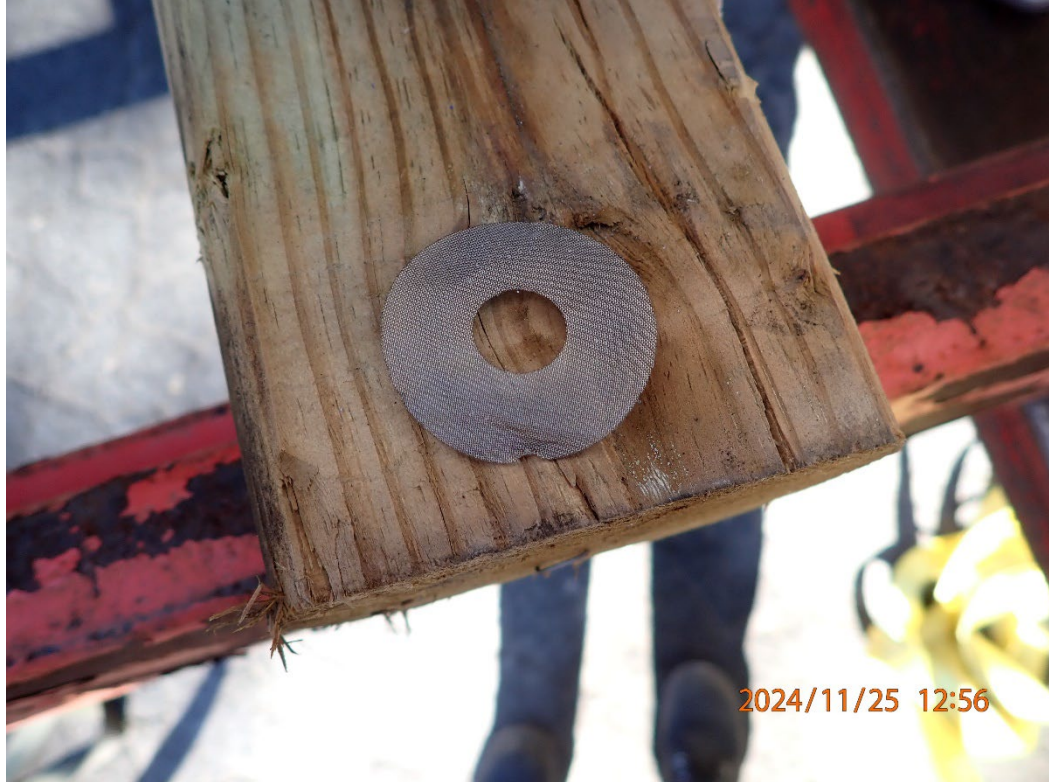
**Photo 6: View of the unobstructed fuel strainer screen.**
