# National Transportation Safety Board

ERA25LA007

## **EXAMINATION SUMMARY**

Location: Rutherford, North Carolina  
Date: October 03, 2024  
Time: 1730 EDT  
2130 UTC  
Airplane: North American, Navion A, NAV-4-960, N9117R

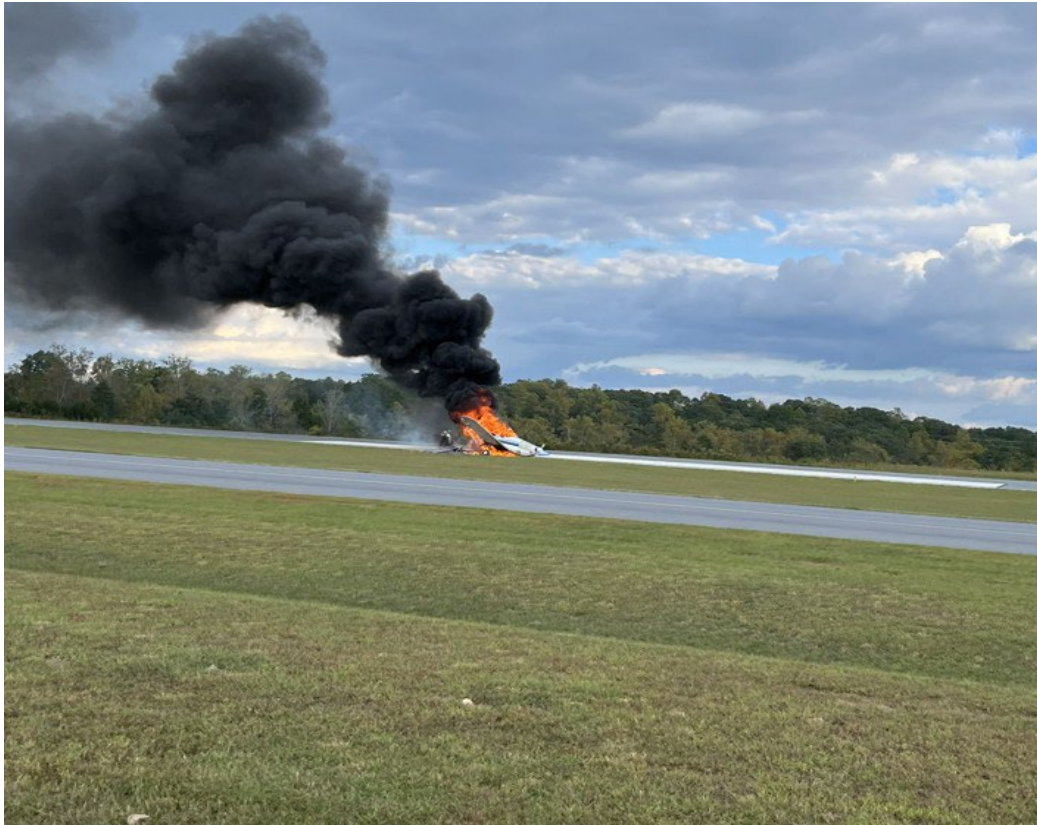
The airplane came to rest in a nose down attitude on runway 19 at FQD. The inflight and postaccident fire consumed majority of the airplane.

*Figure 1- Accident site (photo provided by FAA)*

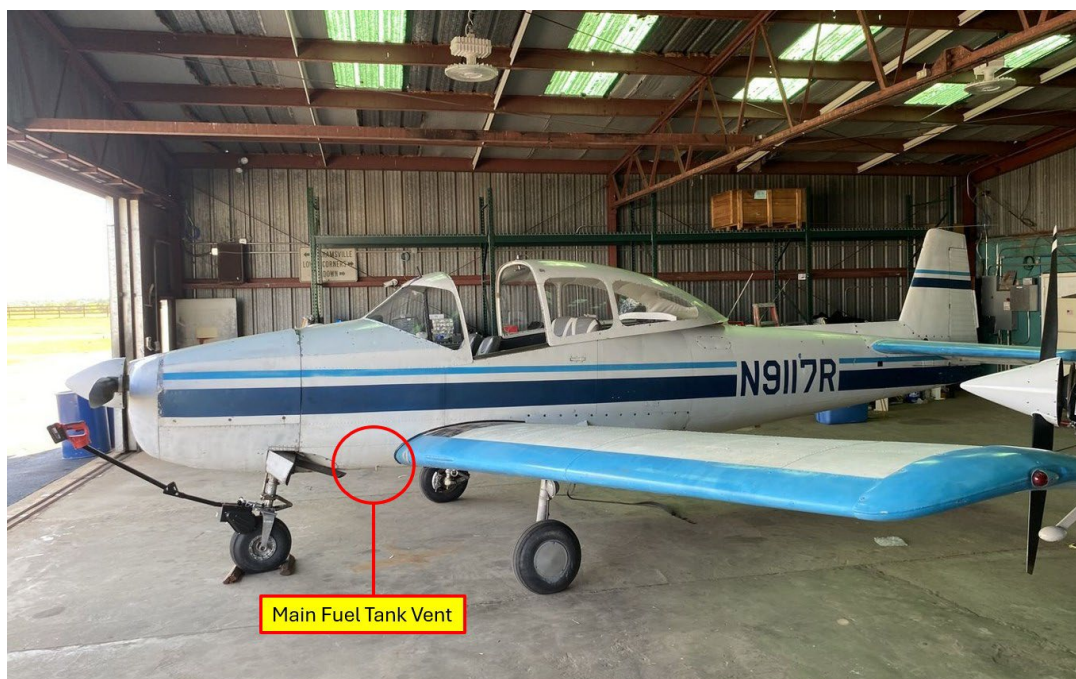
No anomalies were noted to the engine. Thermal damage was noted to the hydraulic components in the engine area. A loose high-pressure hydraulic line B-nut was observed at the controllable relief valve which was mounted to the firewall above the left exhaust extension pipe. There was no hydraulic fluid observed in the reservoir. Majority of the hydraulic lines were destroyed aft of the firewall.

Review of the airplane's maintenance manual indicated that the main fuel tank vent line extended into the atmosphere beneath the left side of the fuselage near the wing's leading edge. A preaccident photograph of the airplane showed that the vent line was positioned approximately 10 inches aft and generally aligned with the left exhaust extension pipe (see figure 2).

Figure 2- Annotated photograph of the vent location.
