ERA25LA011

## INVESTIGATION PHOTOGRAPHS

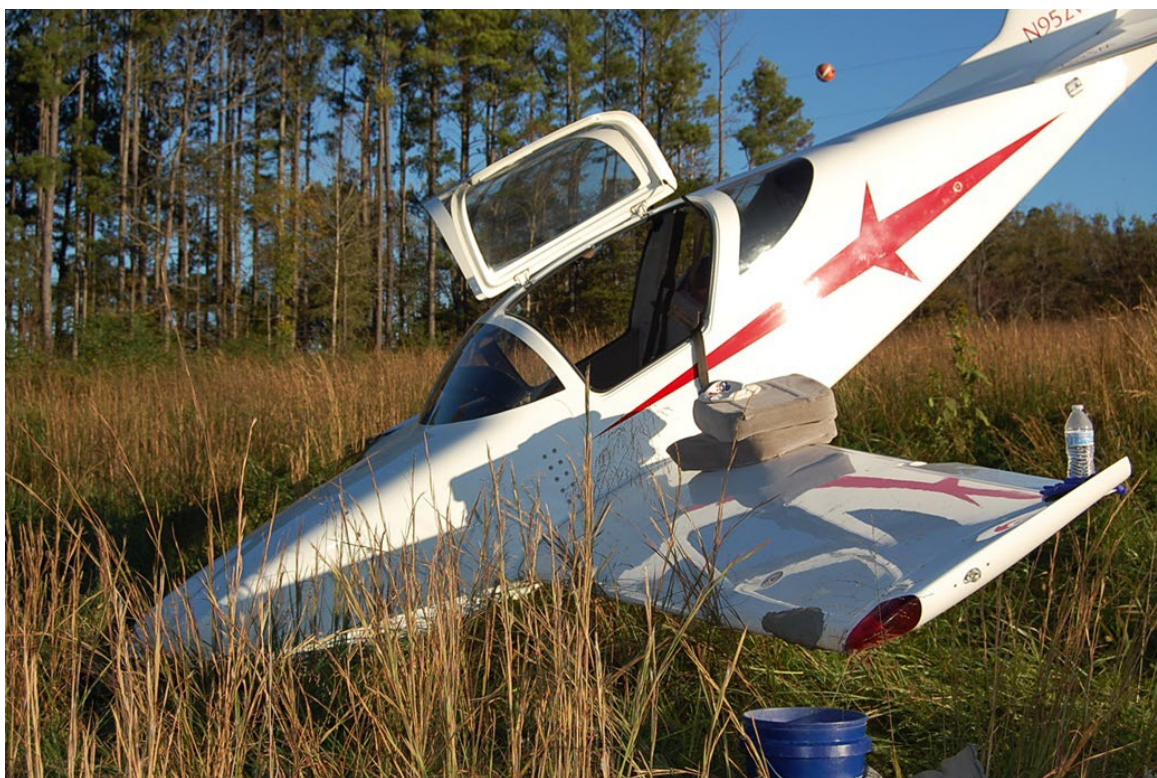
**Photograph 1 - Main Wreckage (Courtesy of VASP)**

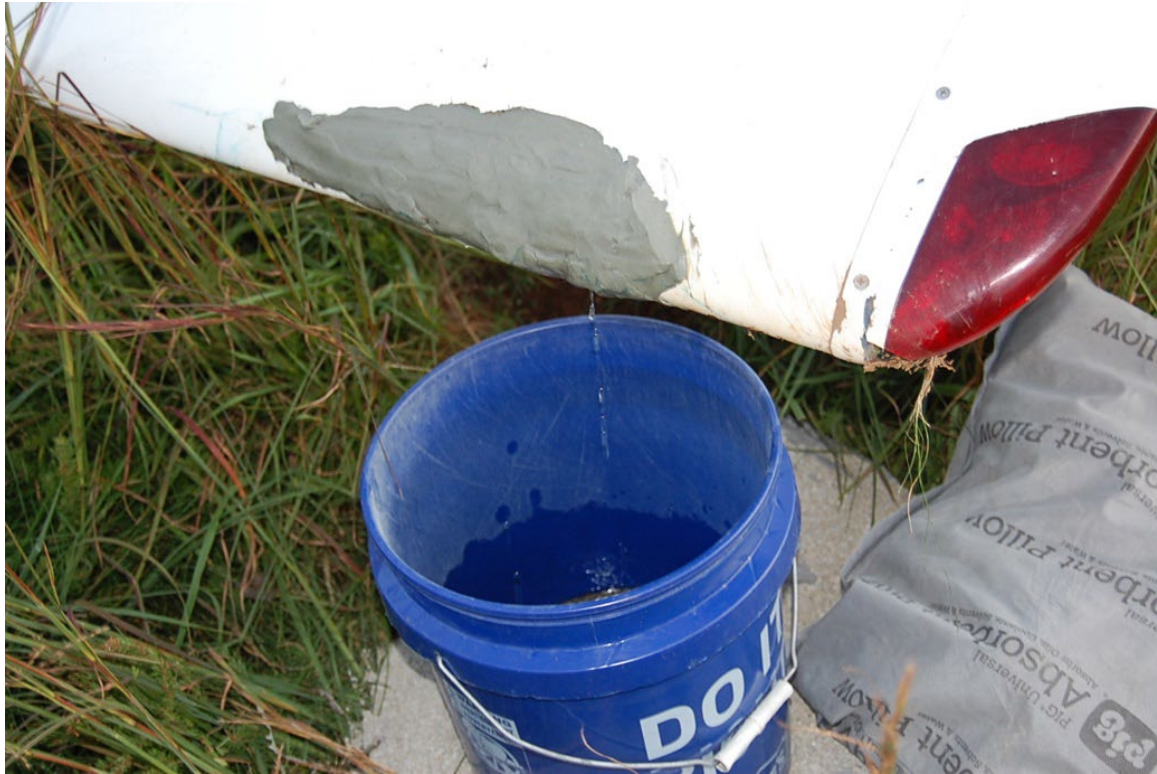
**Photograph 2 - Left Wing Damage (Courtesy of VASP)**

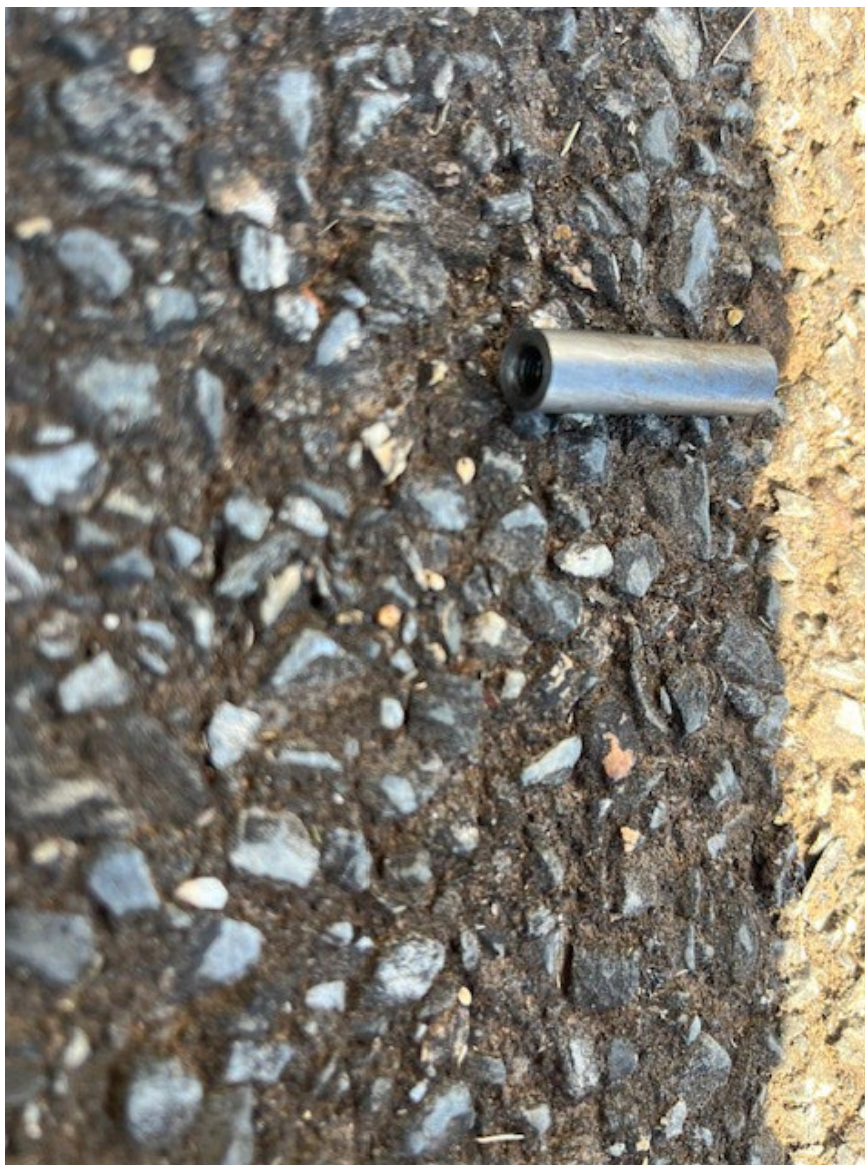
**Photograph 3 - Throttle Cable Coupler (Courtesy of FAA)**

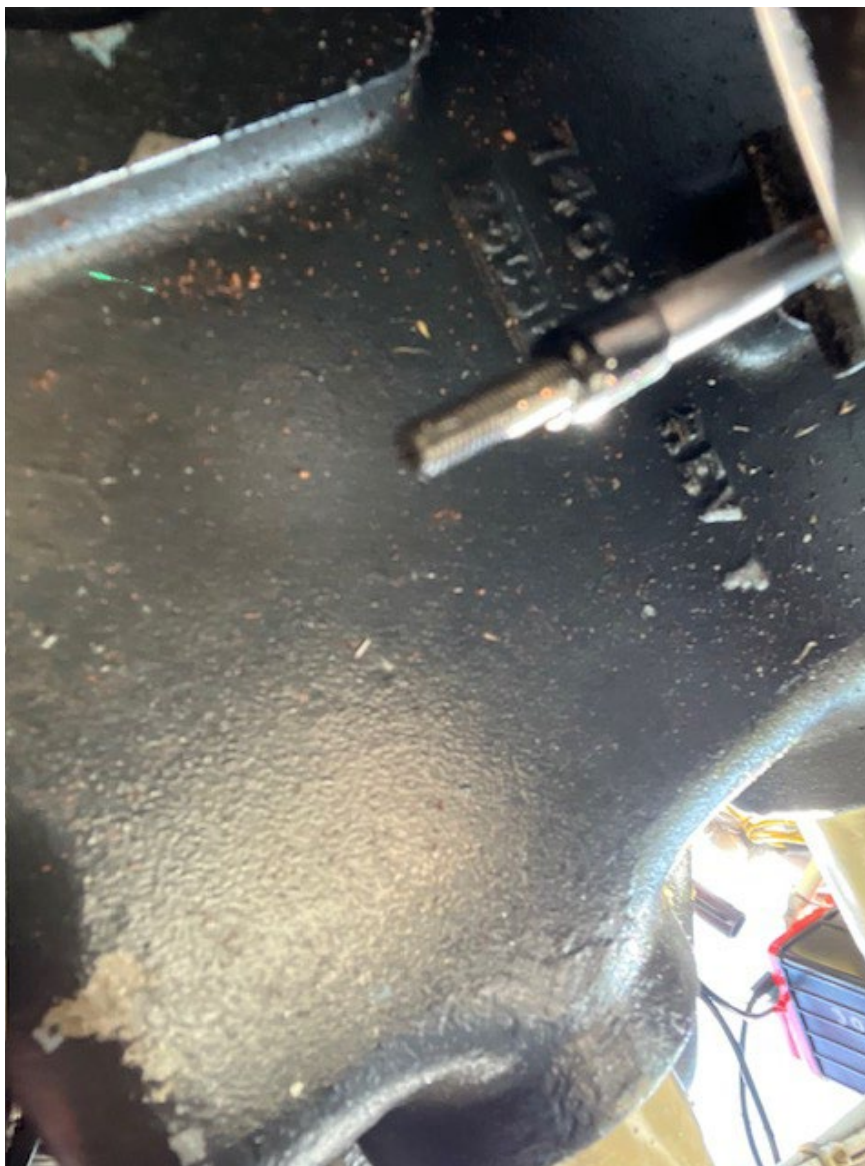
**Photograph 4 - Throttle Cable (Courtesy of FAA)**

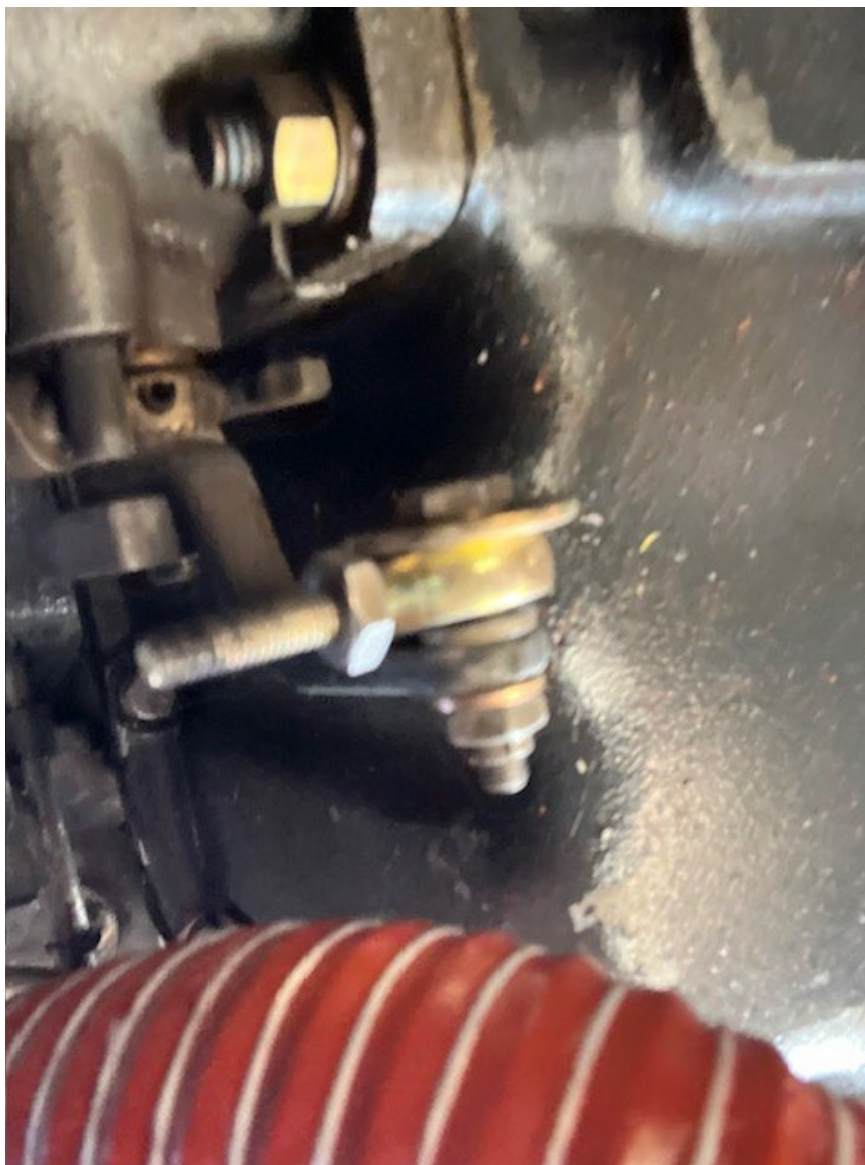
**Photograph 5 - Throttle Arm (Courtesy of FAA)**
