# National Transportation Safety Board

ERA25LA012

## **CARBURETOR TESTING AND EXAMINATION**

Location: Louisville, KY  
Date: October 11, 2024  
Time: 18:20 EDT  
22:20 UTC  
Airplane: Piper PA28-160  
Component: Marvel Schebler Carburetor: P/N: 10-5135 S/N: MSB17910

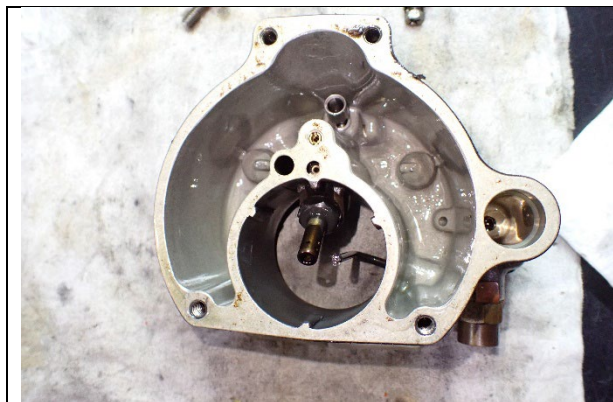
The carburetor was disassembled, and the internal components were examined. The disassembly revealed that the carburetor bowl and fuel inlet screen were clear of any contamination, and there was no corrosion observed within the bowl. The accelerator pump displayed normal operating and wear signatures. The accelerator pump check valve was installed correctly. The float height setting was checked and was found to be within specifications. The floats and the float valve were removed, and the float valve and seat displayed normal operating and seating signatures. The float, float valve retaining pin, and bracket displayed normal wear signatures. The mixture control assembly and mixture control sleeve displayed normal operating and wear signatures. The main fuel nozzle remained secure, and there were no obstructions or debris within the main fuel nozzle or the mixture control sleeve. The throttle valve operated normally during actuation; however, the throttle valve shaft and bushings displayed significant wear, allowing side motion of the throttle shaft. A dial indicator was placed against the shaft, and the linear movement averaged to be 0.019 inches. According to the AvStar technician, this could allow a small amount of bypass air to enter the throttle body, which could slightly lean the fuel/air mixture. However, the amount of wear would not have precluded normal operation of the throttle valve.

Photograph 1: Carburetor bowl

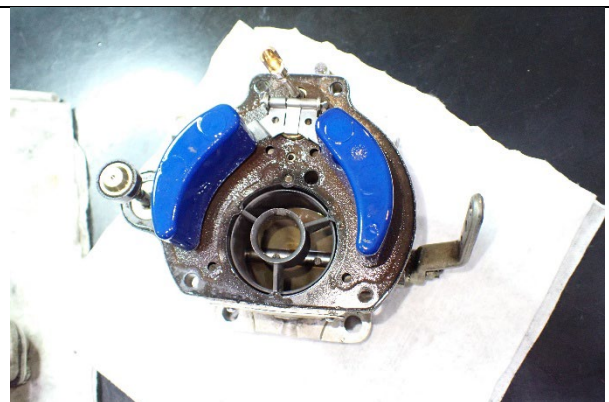
Photograph 2: Carburetor top assembly

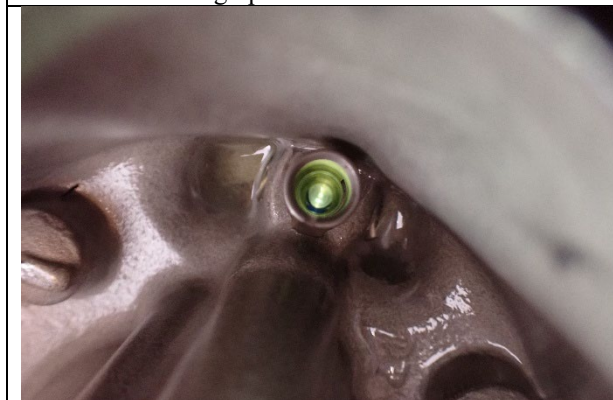
Photograph 3: Mixture sleeve with light passing through the passage

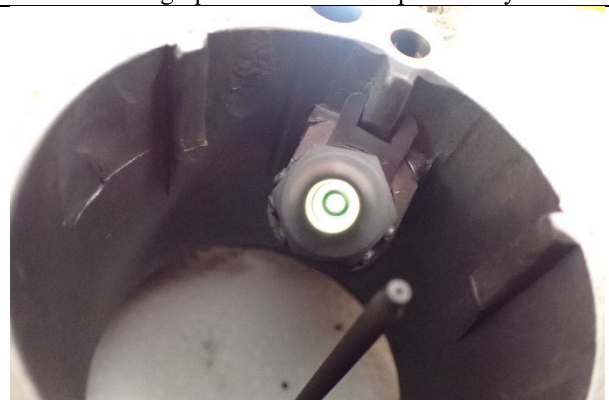
Photograph 4: Main nozzle with light passing through the passage

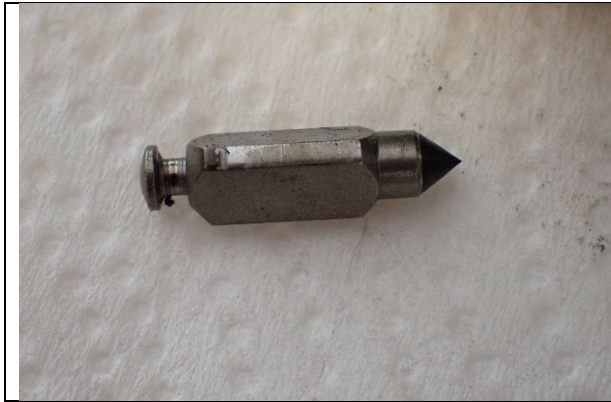
Photograph 5: Float valve

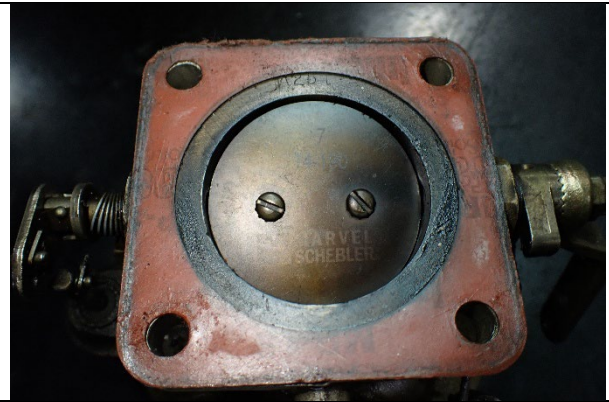
Photograph 6: Throttle valve

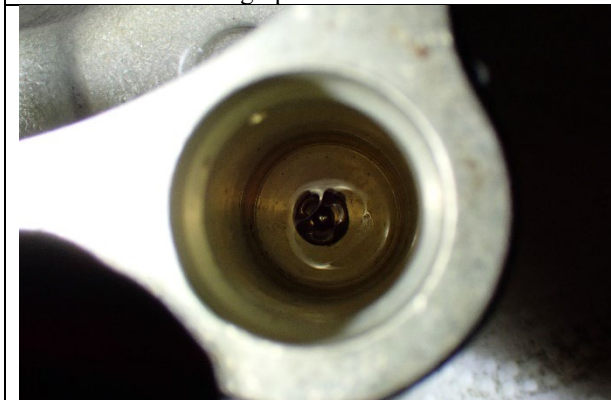
Photograph 7: Accelerator pump boss and check valve

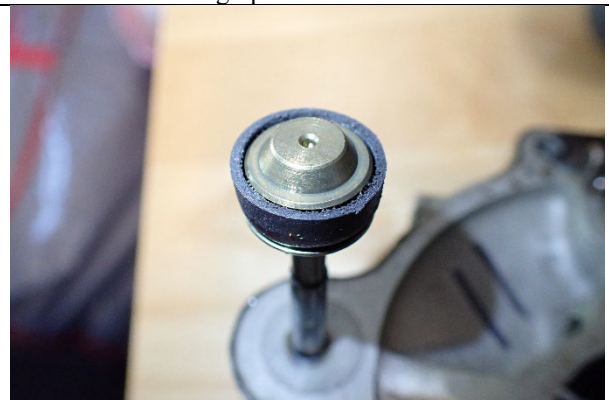
Photograph 8: Accelerator pump

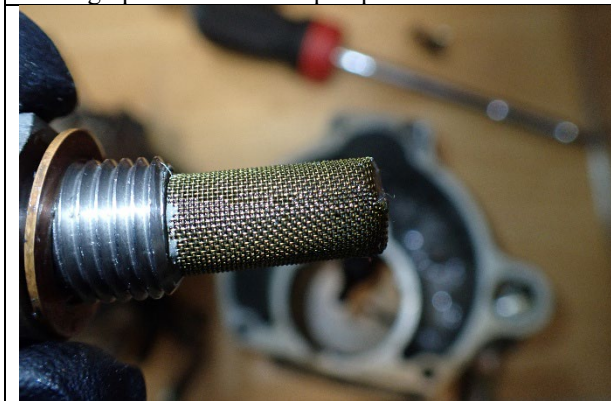
Photograph 9: Fuel inlet screen

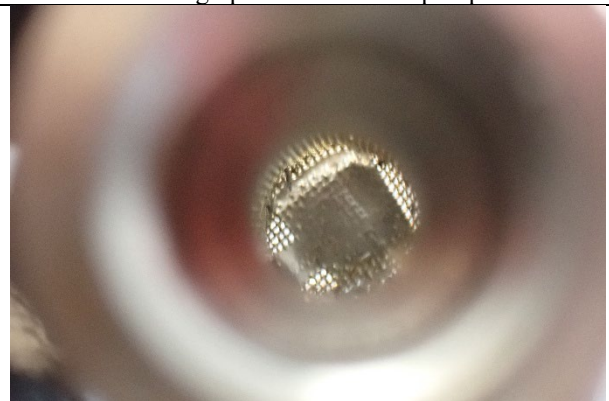
Photograph 10: Fuel inlet screen (interior view)
