ERA25LA012

## INVESTIGATION PHOTOGRAPHS

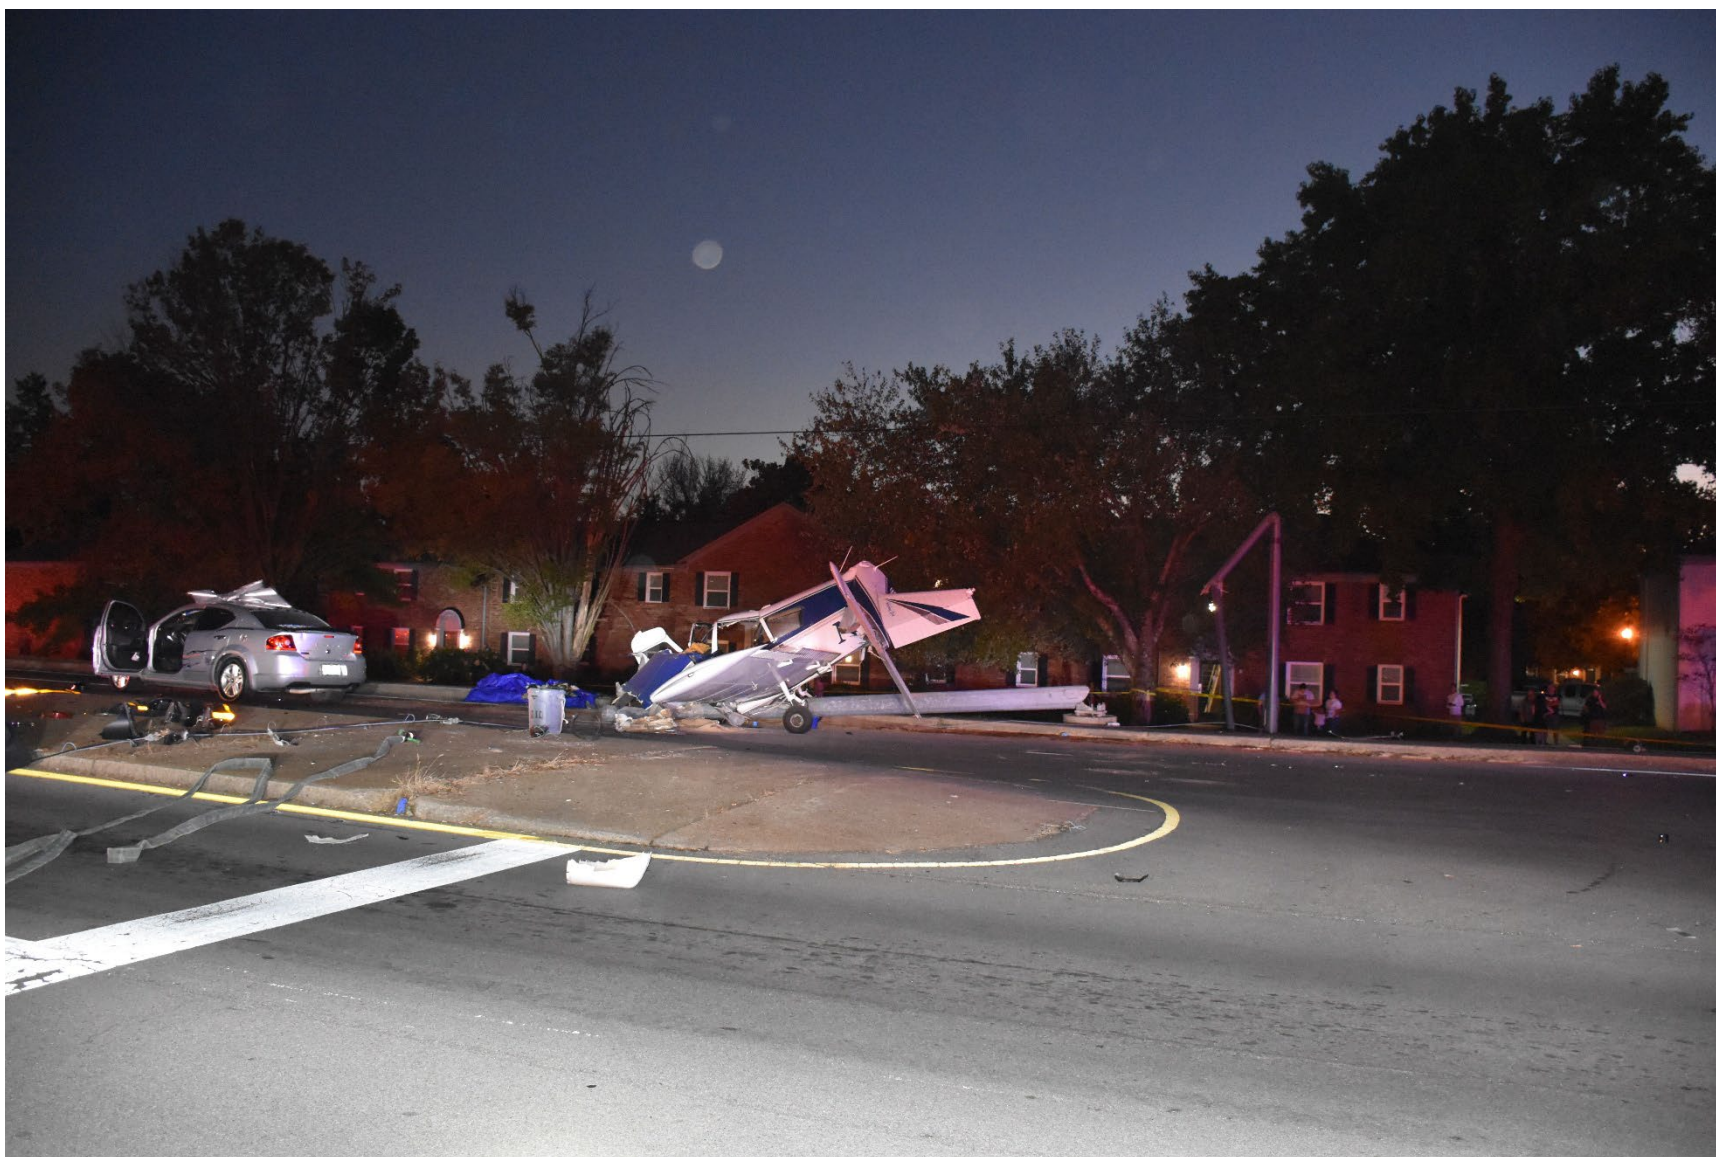
**Photograph 1 - Airplane at accident site (Courtesy of LMPD)**

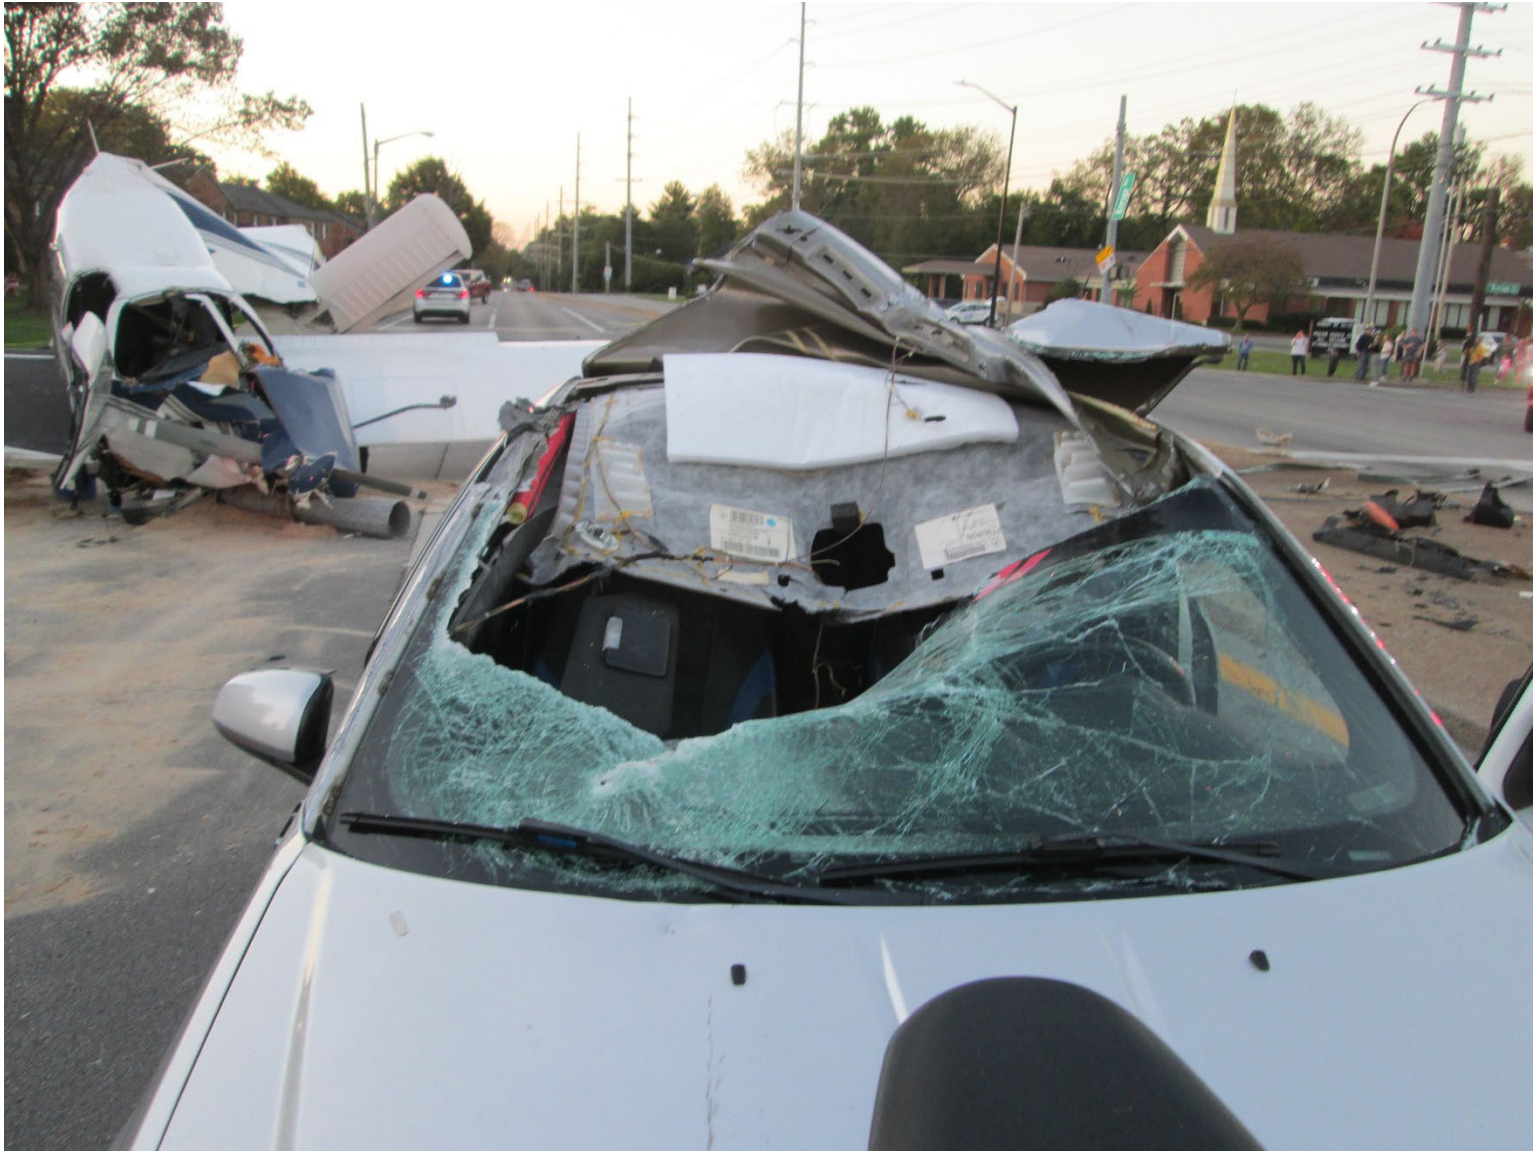
**Photograph 2 - Damaged car and airplane at accident site (Courtesy of LMPD)**

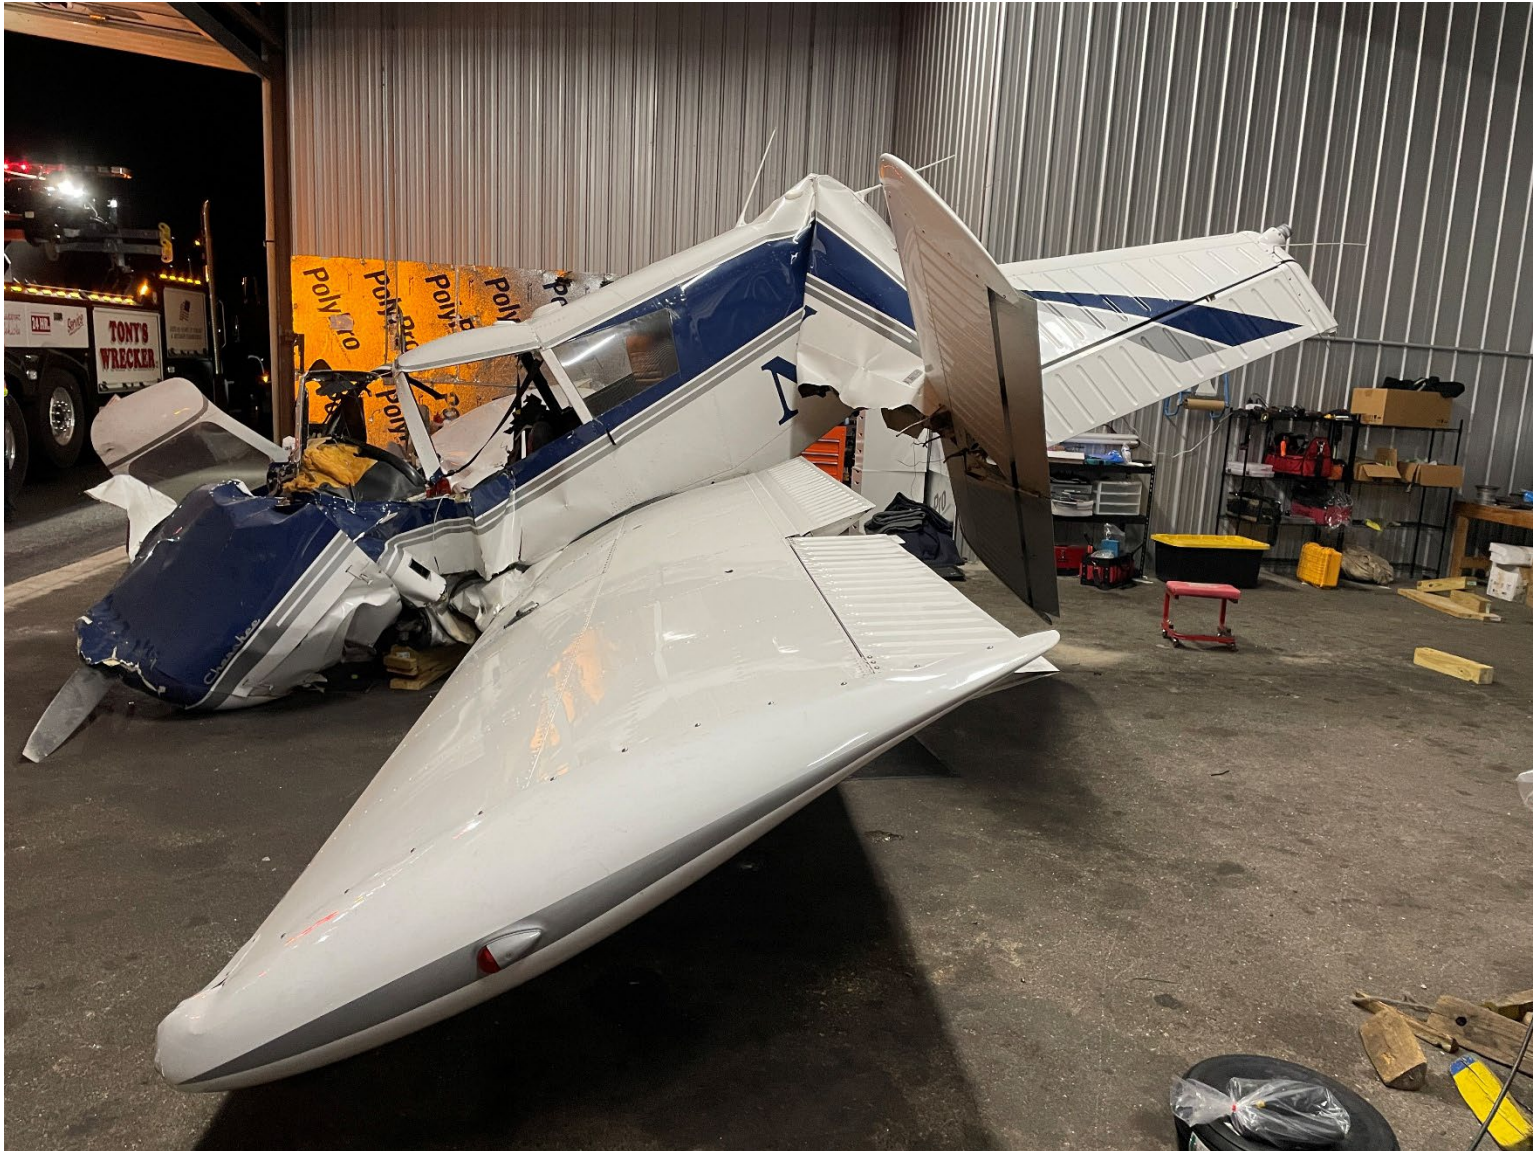
**Photograph 3 - Airplane after initial recovery (Courtesy of FAA)**

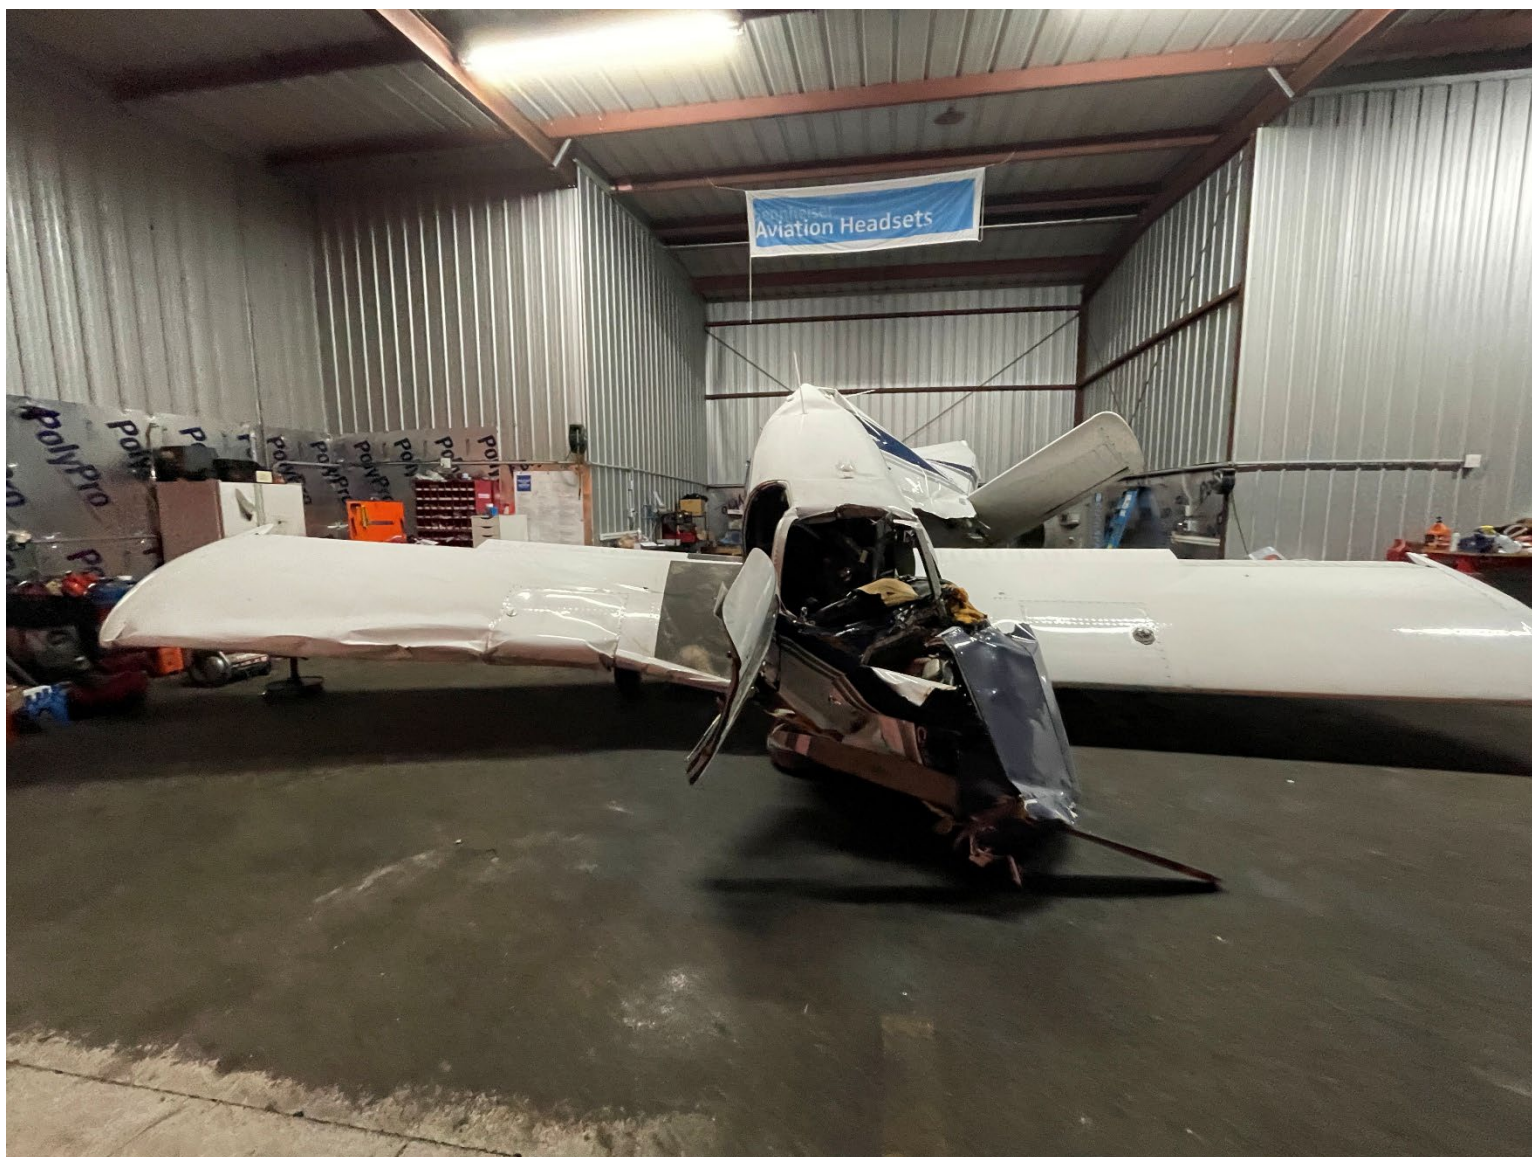
**Photograph 4 - Airplane after initial recovery (Courtesy of FAA)**

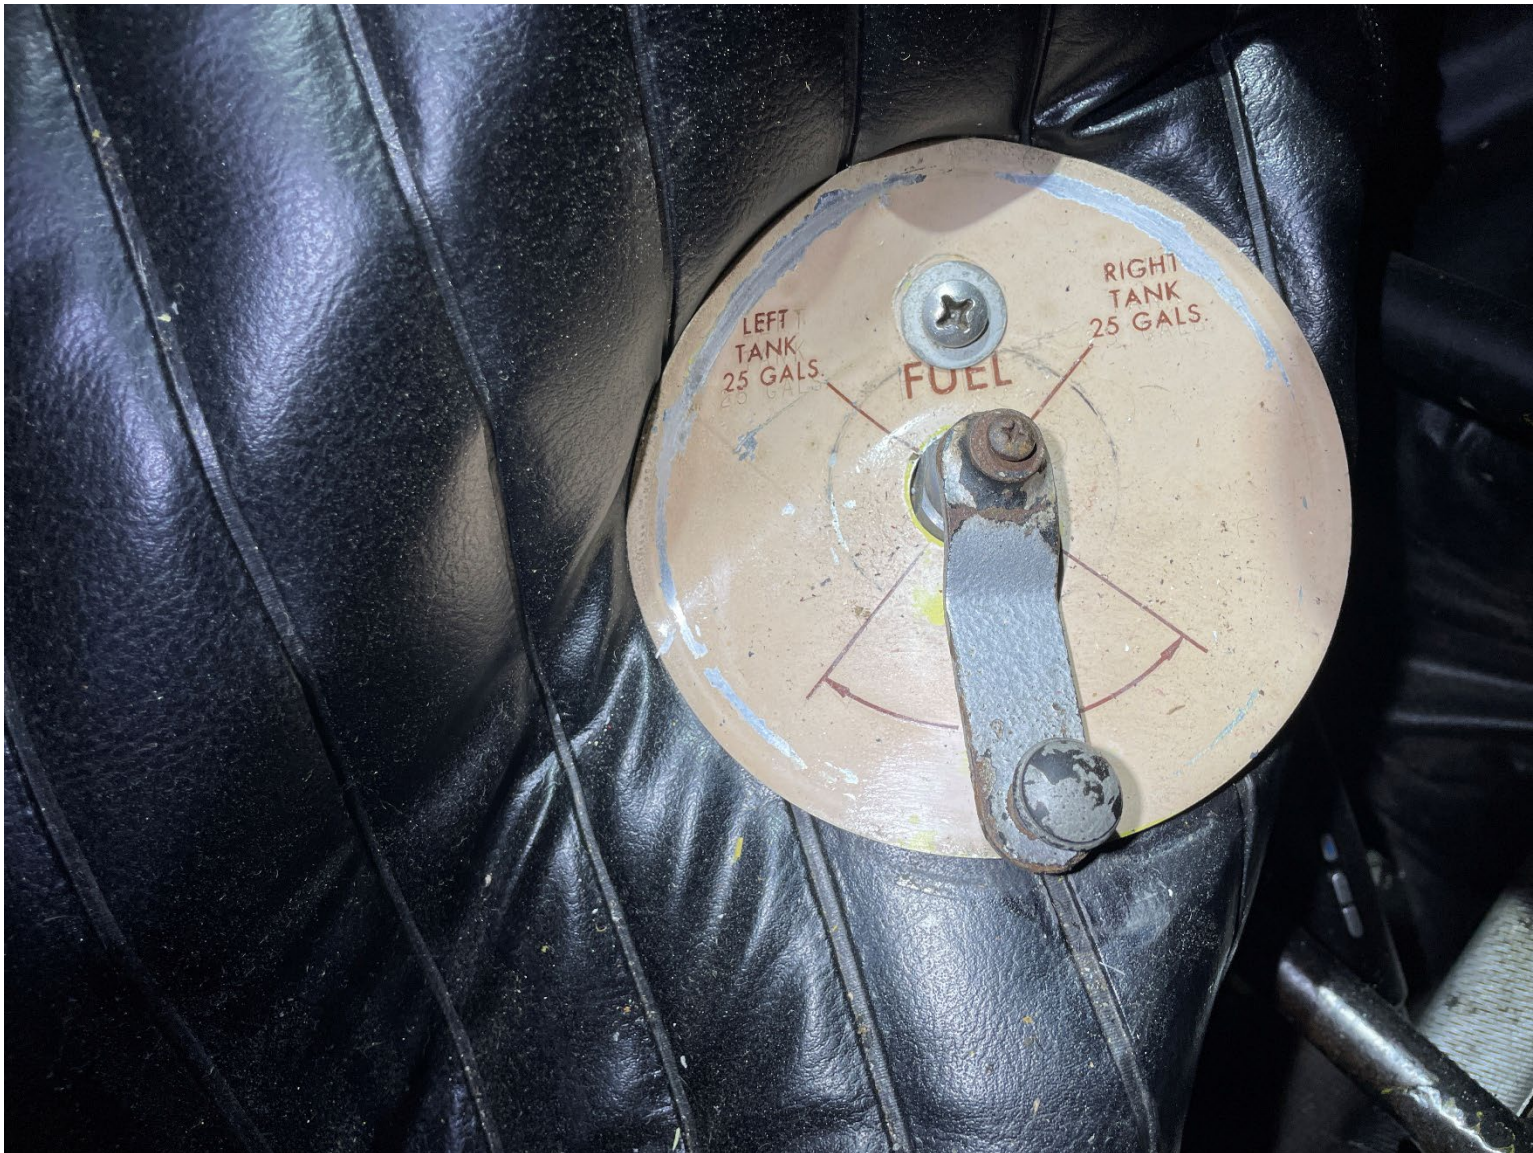
**Photograph 5 - Fuel selector handle as found after initial recovery (Courtesy of FAA)**

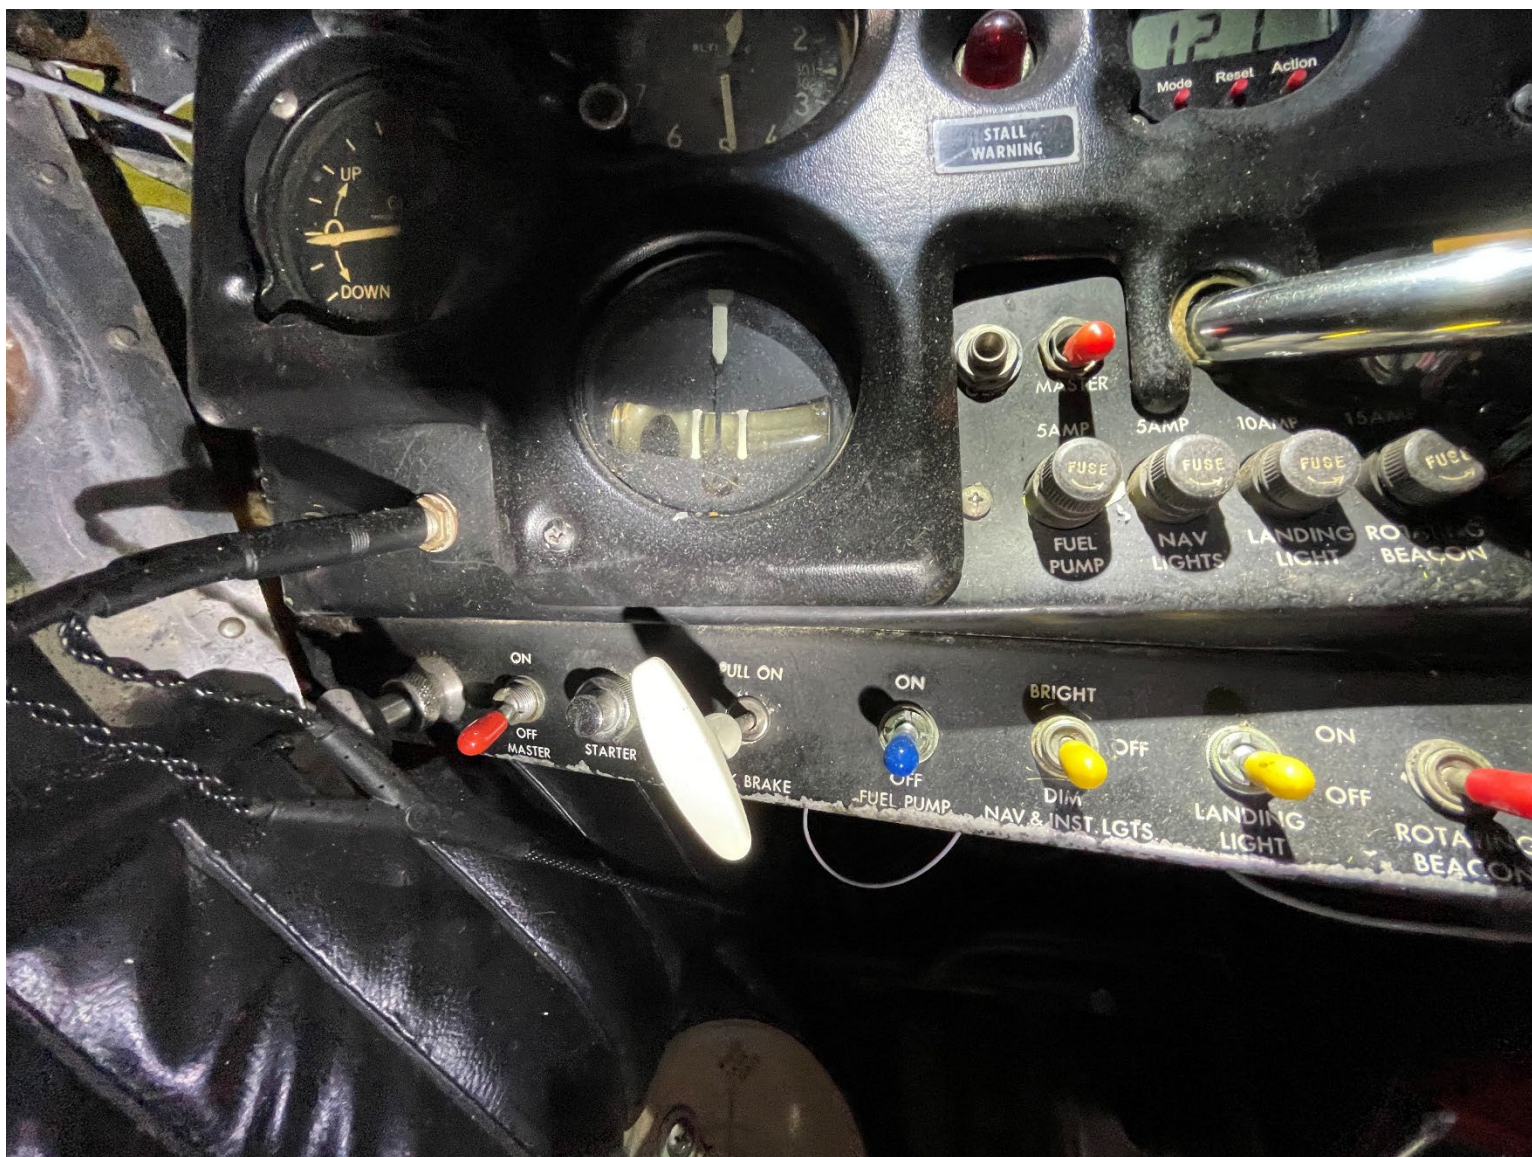
**Photograph 6 - Instrument panel as found after initial recovery (Courtesy of FAA)**

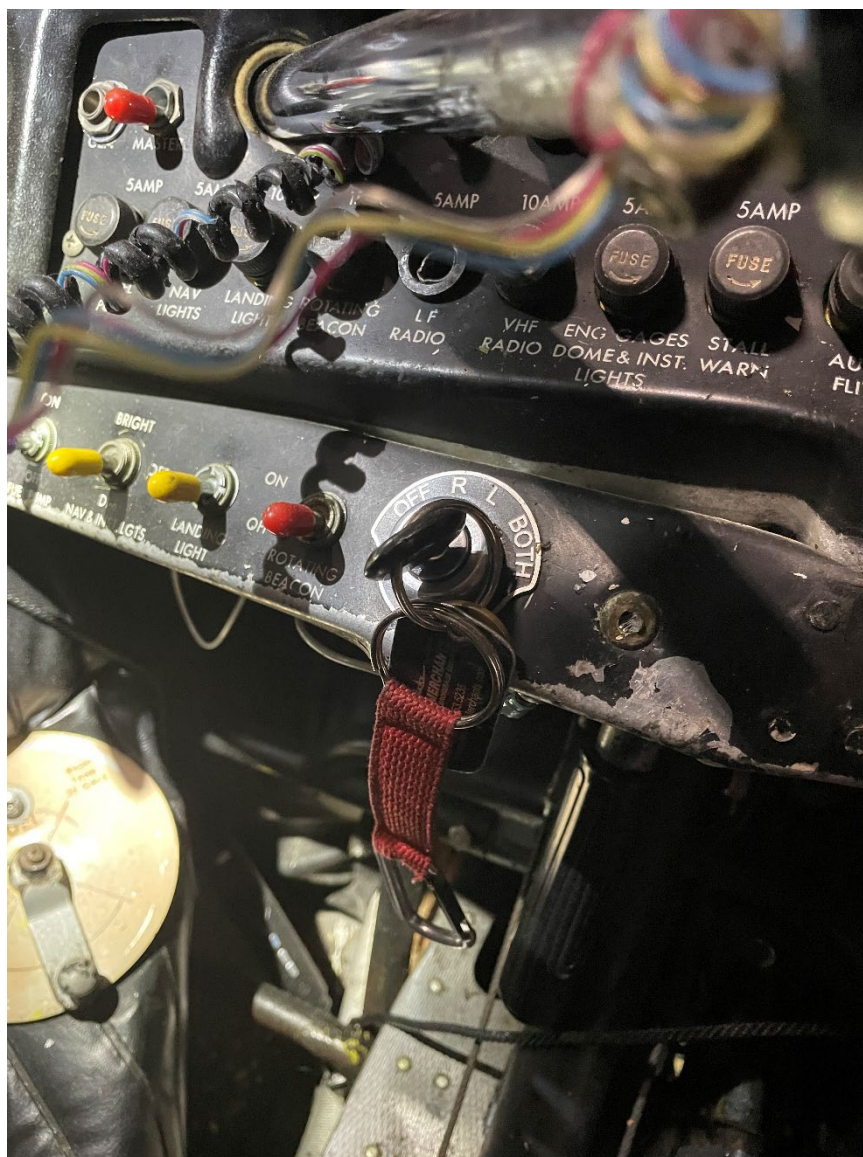
**Photograph 7 - Instrument panel as found after initial recovery (Courtesy of FAA)**

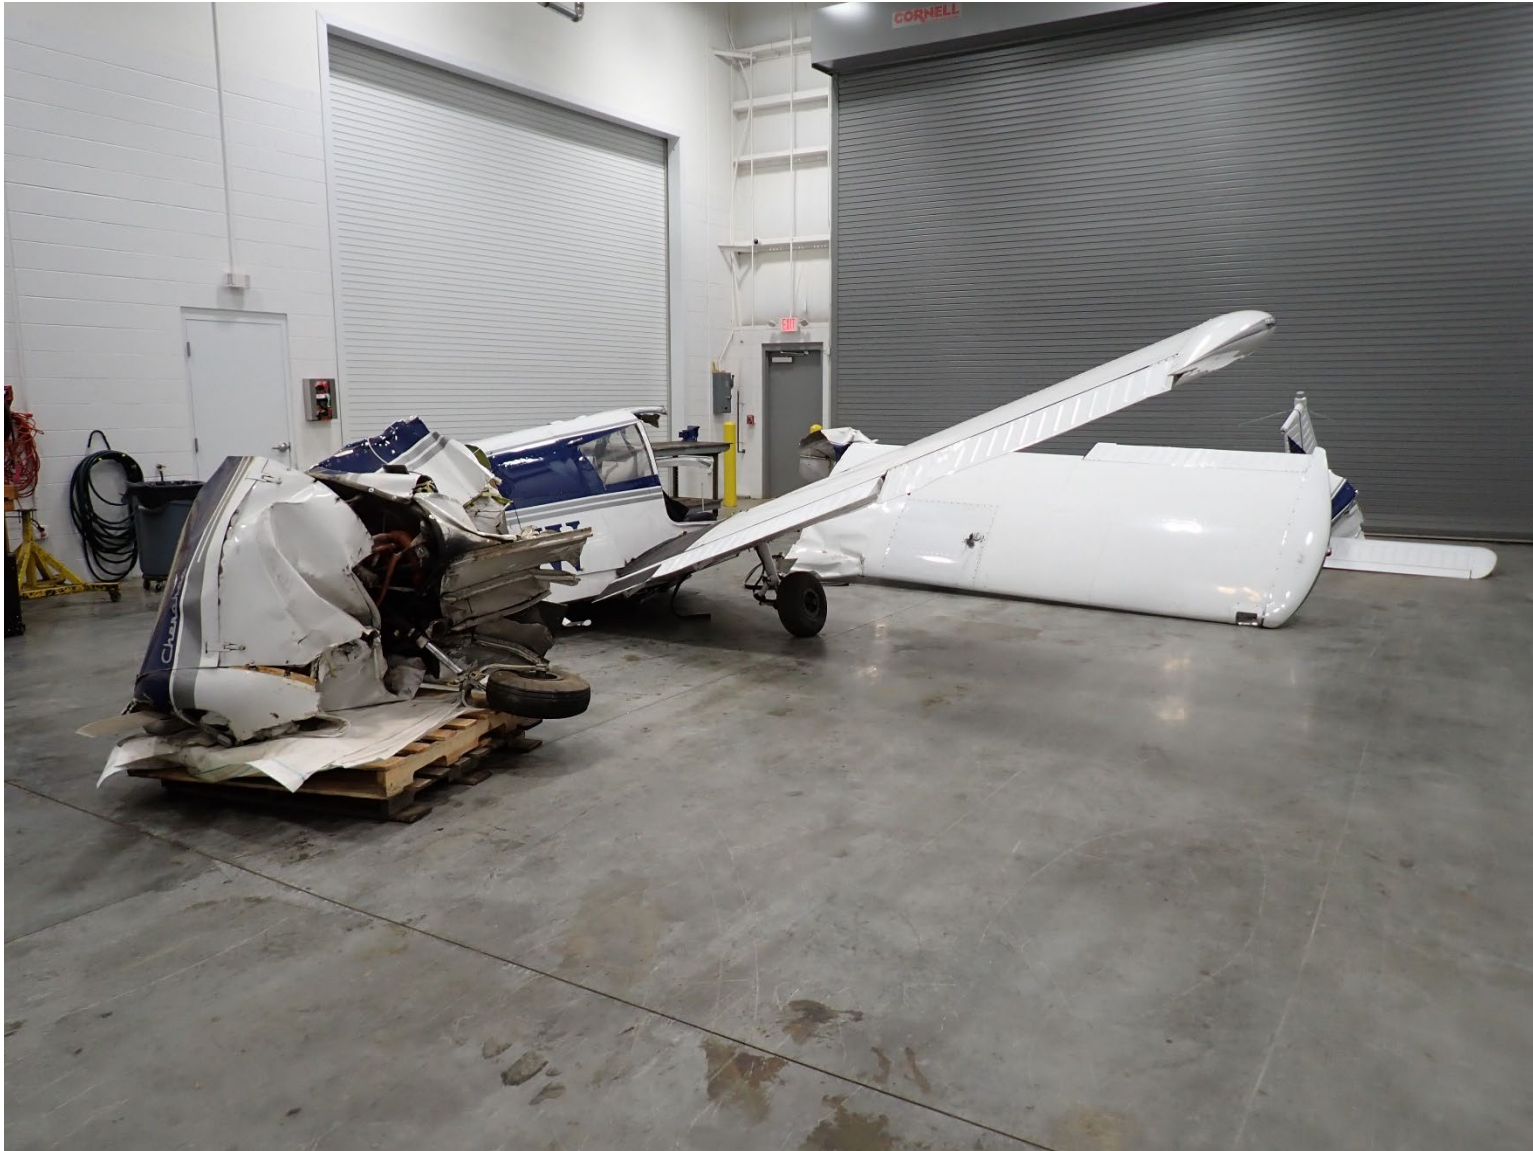
**Photograph 8 - Airplane overview after recovery to AMF**
