# National Transportation Safety Board

ERA25LA012

## **WRECKAGE EXAMINATION REPORT**

Airplane: Piper PA-28 (Registration: N5006W)

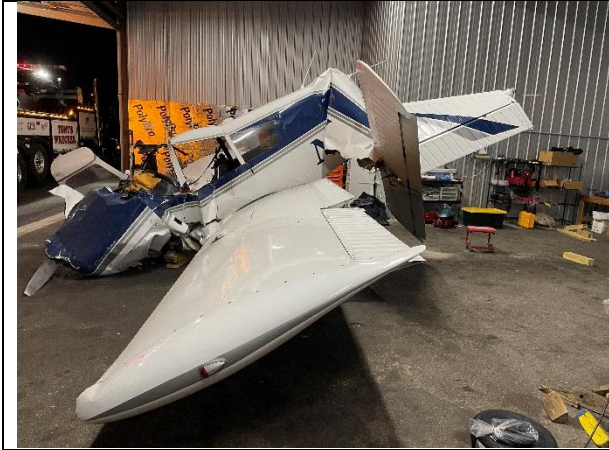
Photograph 1: Airplane after initial recovery (Source: FAA)

The airframe had sustained substantial damage to both wings, fuselage, and empennage. The left wing, empennage, and the fuselage just aft of the instrument panel were cut by recovery personnel to facilitate transport.

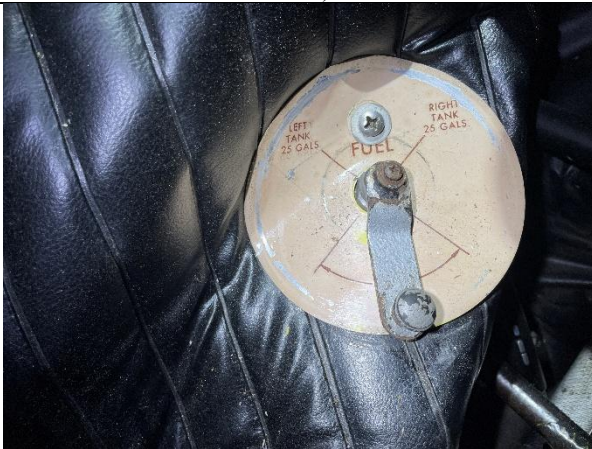
Photograph 3: Fuel selector handle as found after initial recovery (Source: FAA)

The fuel selector valve was found in between the two "OFF" detents and no air was observed when blowing low-pressure air through the valve. The fuel selector valve was tested in the "LEFT" and "RIGHT" positions utilizing low-pressure air, and the selector valve operated normally. Tactile detents were present in each position of the selector valve handle. The fuel line going from the airplane's firewall to the fuel strainer was noted to be kinked and displayed dry rot; however, it was not obstructed. The fuel strainer bowl had partially separated, which was consistent with the observed impact damage. The strainer screen was removed, was found to be unobstructed, and the strainer bowl was clean. Fuel line continuity was established from the fuel selector valve to the left and right fuel tanks; they were found to be unobstructed, and all separations were consistent with impact damage and recovery cuts. Both fuel tank inlet screens were observed and were found to be unobstructed. The right fuel tank vent line was found to be unobstructed from the fuel tank to the outboard vent. The left fuel tank vent line was found to be obstructed and was cleared using low-pressure air; the obstruction could not be located after clearing the vent line. The left fuel tank cap was a vented cap, and the vent galleys were clear of obstructions. The left fuel tank gasket was found to be dry-rotted; however, it remained pliable. The right fuel tank vented cap gasket and vent gasket were found to be pliable; however, the gasket was dry-rotted. The airframe electrically driven fuel pump was removed and tested by connecting to a 12V battery; the fuel pump was audibly observed to operate.

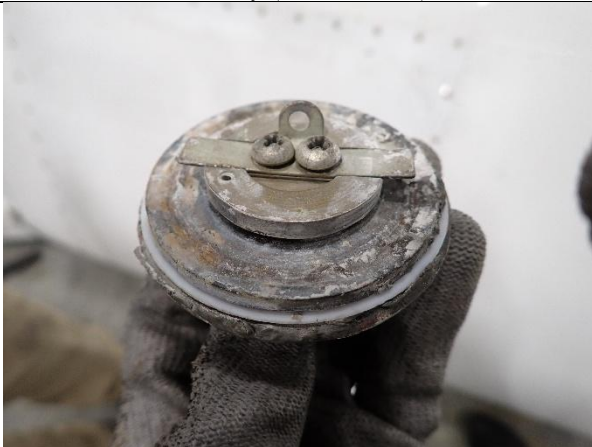
Photograph 5: Left fuel cap (Source: NTSB)

The wreckage was examined at AMF Aviation in Springfield, TN, after the airplane had been recovered. The only mechanical anomaly found during the examination was that the left fuel tank vent line was obstructed; however, the left fuel tank vented fuel cap was clear of obstructions. No further mechanical failures or malfunctions were observed that would have prevented normal operation. The carburetor was retained for further testing and examination.

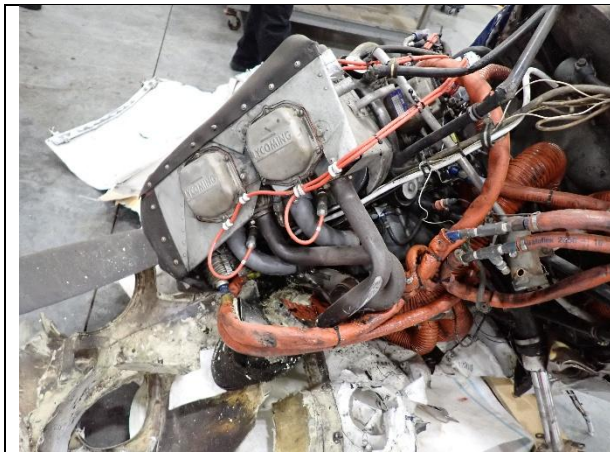
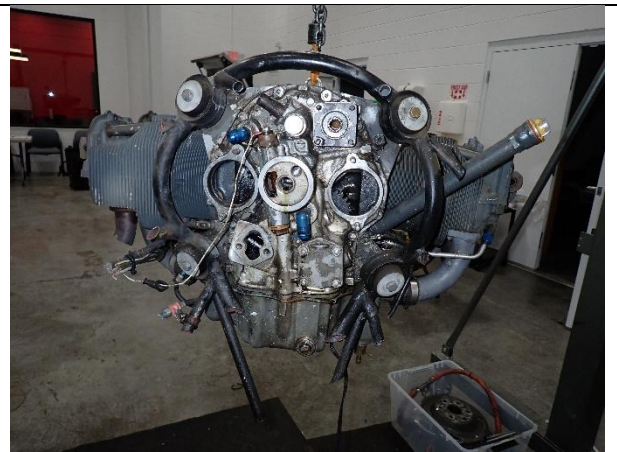
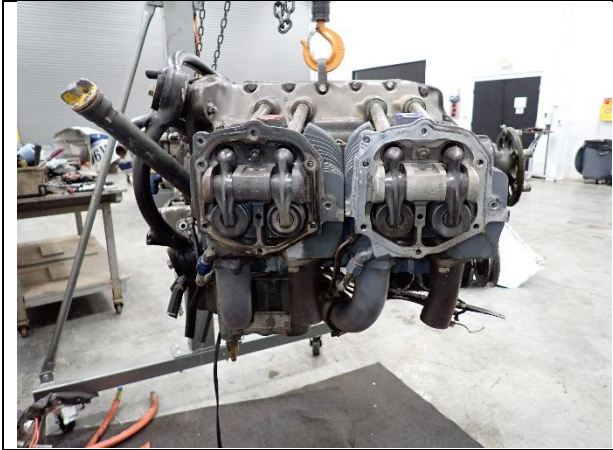
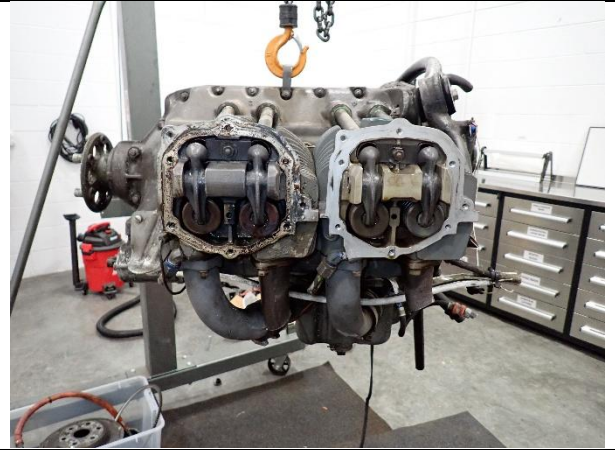
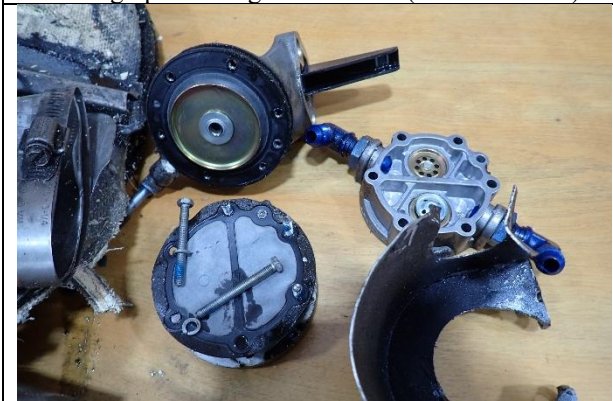
The engine remained attached to the airframe through the engine mounts, hoses, wires, and cables. The engine was removed from the airframe to facilitate examination. Continuity was established between the crankshaft, camshaft, connecting rods, and associated components by rotating the propeller by hand 720°. All four cylinders displayed good thumb compression and suction. The overhead components (valves, springs, and rocker arms) displayed normal operating and lubrication signatures and operated normally during crankshaft rotation. The cylinders were inspected using a lighted borescope; the piston faces, cylinder walls, and valve heads displayed normal operating and combustion signatures.

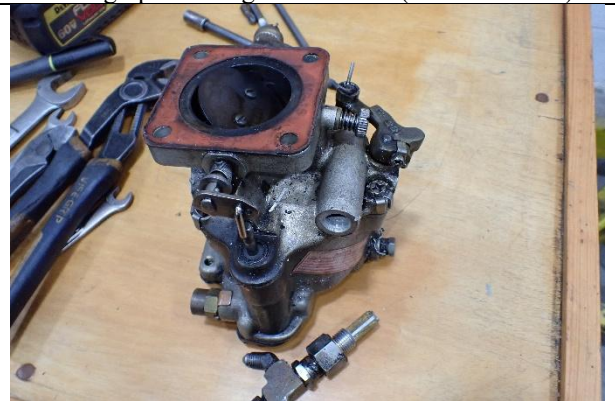
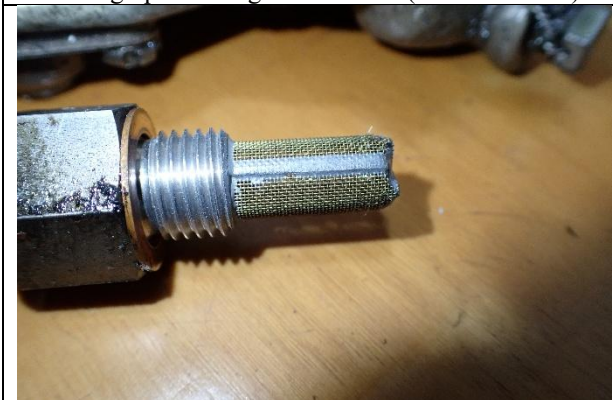
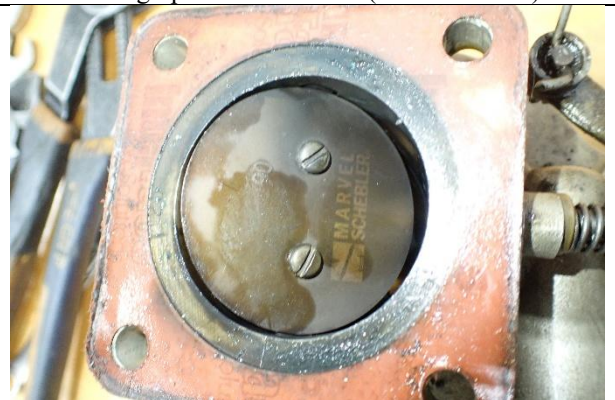
capable of pumping air. The fuel pump was disassembled, and the internal components displayed normal operating signatures. The fuel line going to the carburetor remained secure, and there were no signs of fuel leaks. Engine control continuity was established by moving the cockpit controls and observing throttle and mixture control movement at the carburetor. The carburetor mixture and throttle control arms were capable of normal movement, and the throttle valve operated normally. The fuel inlet screen was removed and was found to be clear of obstructions. The carburetor was retained for further testing.

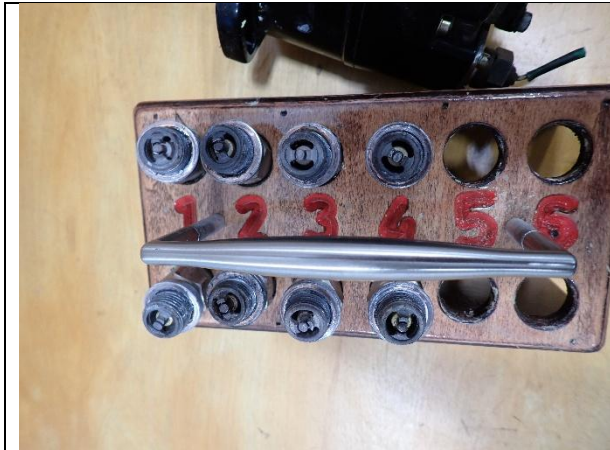
Photograph 19: Spark plugs (Source: NTSB)

Both magnetos remained attached to their installation points and were undamaged. The magnetos were removed, and both were capable of creating a spark on all four of their respective posts. The ignition harness displayed impact damage concentrated near the magnetos. The ignition harness caps remained secured to each magneto, and each ignition lead remained securely attached to each spark plug; no signs of chafing or arcing were observed. The spark plugs were removed and displayed normal wear and operating signatures.

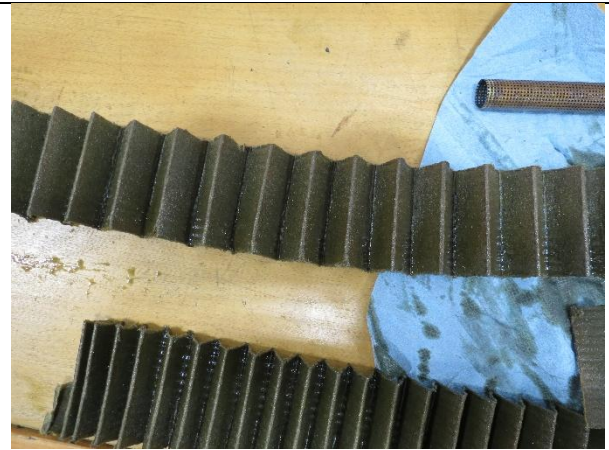
Photograph 20: Oil filter pleats(Source: Lycoming)

The oil filter was removed, and the housing was cut open. The filter pleats were inspected, and no anomalies were observed. During crankshaft rotation, it was observed that the oil pump was capable of pumping residual oil.

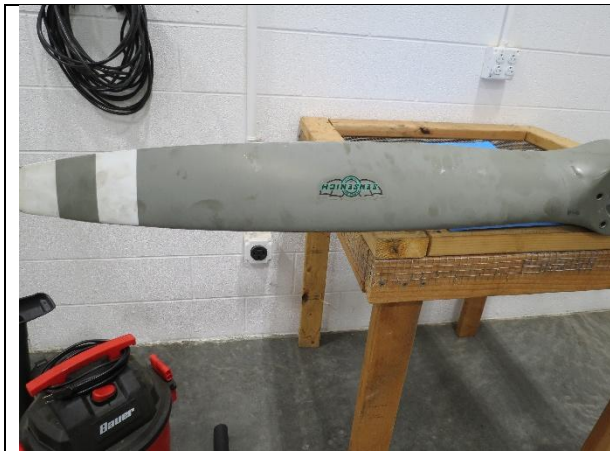
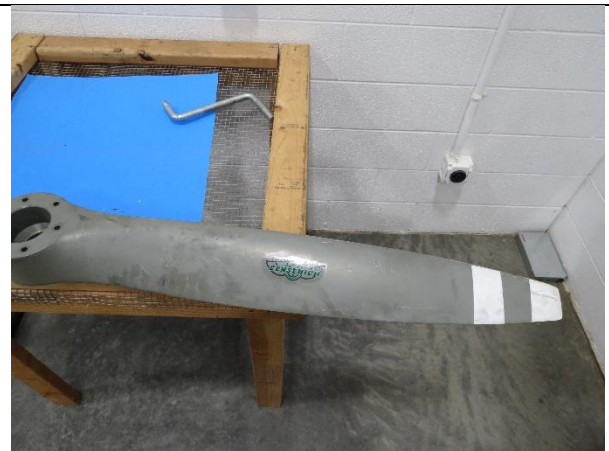
The propeller remained attached to the engine and displayed only a small dent on one of the propeller blades' leading edges. There was no further damage observed.
