ERA25FA014

## INVESTIGATION PHOTOGRAPHS

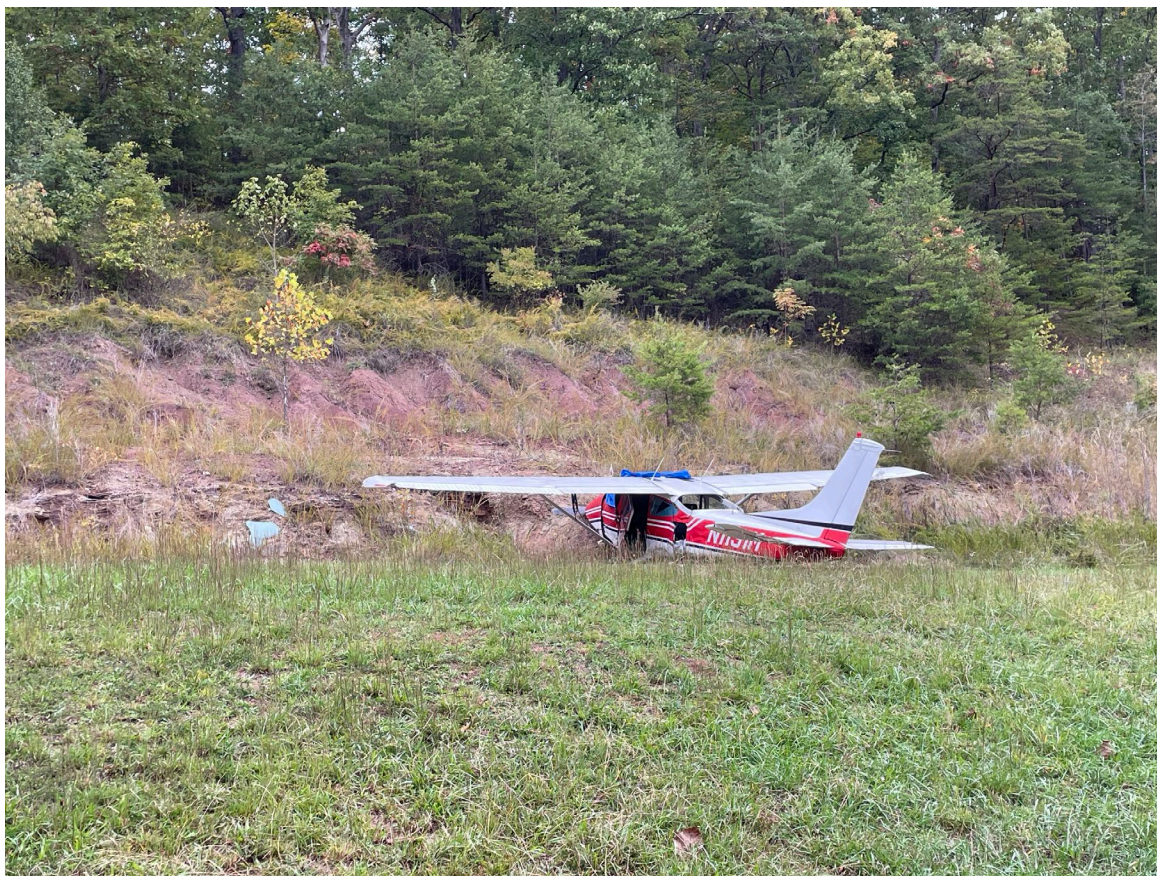
**Photograph 1 - Accident Site Overview (Courtesy of FAA)**

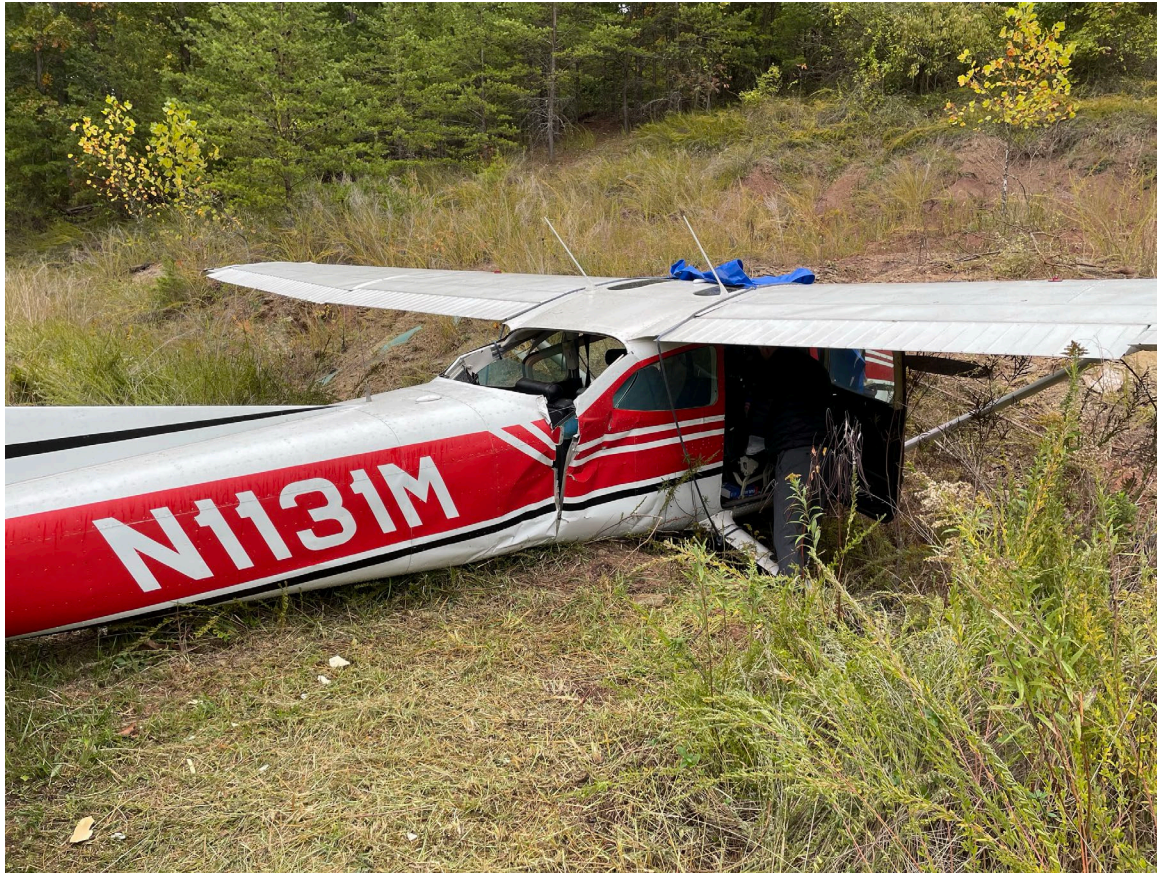
**Photograph 2 - Damage to the Fuselage from Right Side (Courtesy of FAA)**

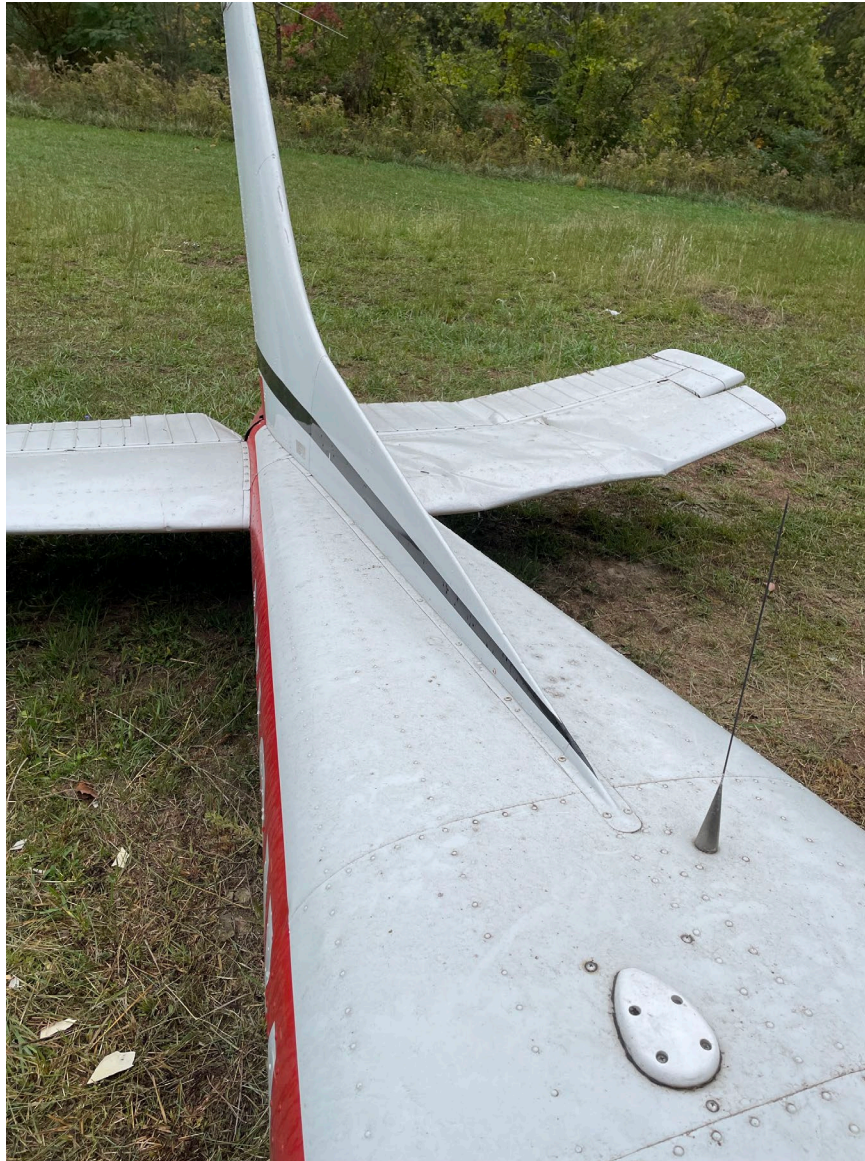
**Photograph 3 - Damage to the Left Elevator (Courtesy of FAA)**

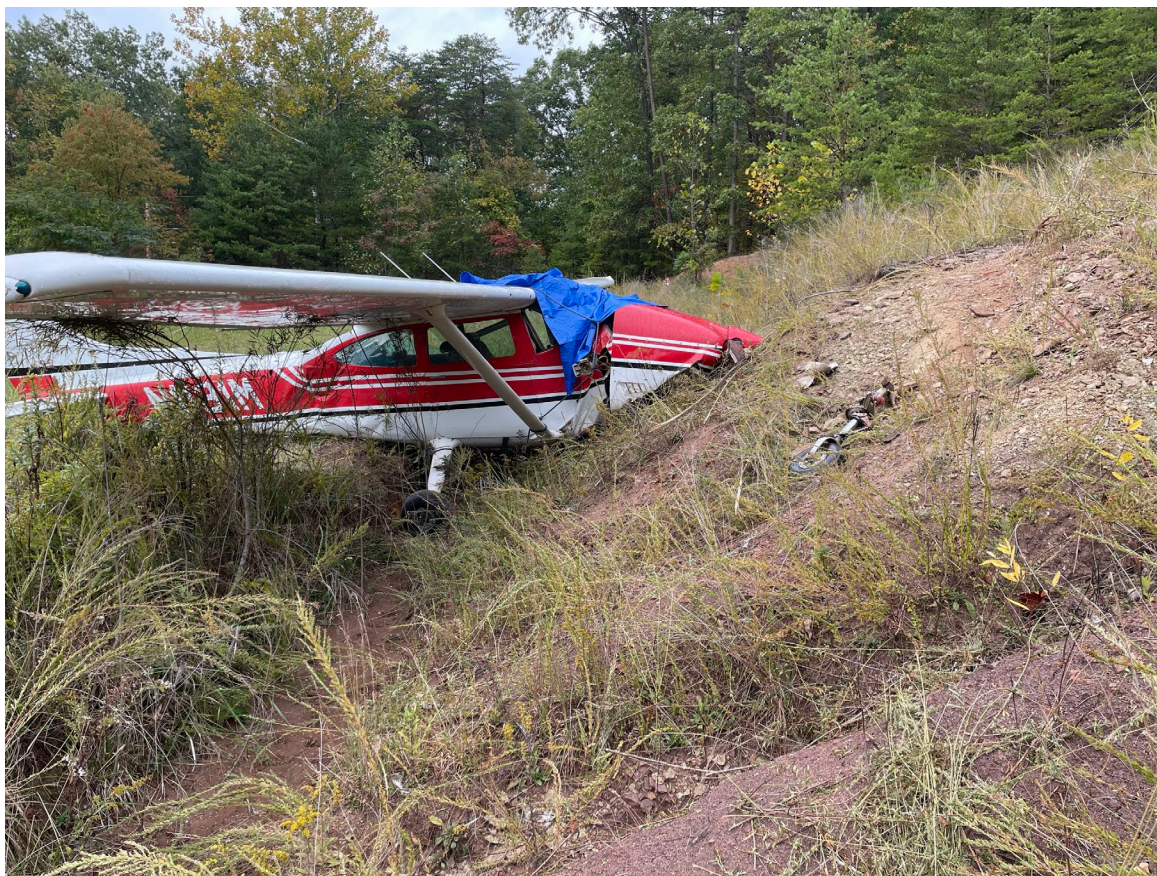
**Photograph 4 - Angle of Embankment Compared to the Airplane (Courtesy of FAA)**
