**Date:** October 22, 2024  
**Subject:** ERA25LA015, Record of Conversation/Interview  
**Contact:** Michael "Mike" Leonzo

**Date:** October 23, 2024  
**Subject:** ERA25LA015, Record of Conversation/Interview  
**Contact:** Travis D. Burchfield

**Date:** October 23 2024  
**Subject:** ERA25LA015, Record of Conversation/Interview  
**Contact:** John A. Davis, Owner of N127BD

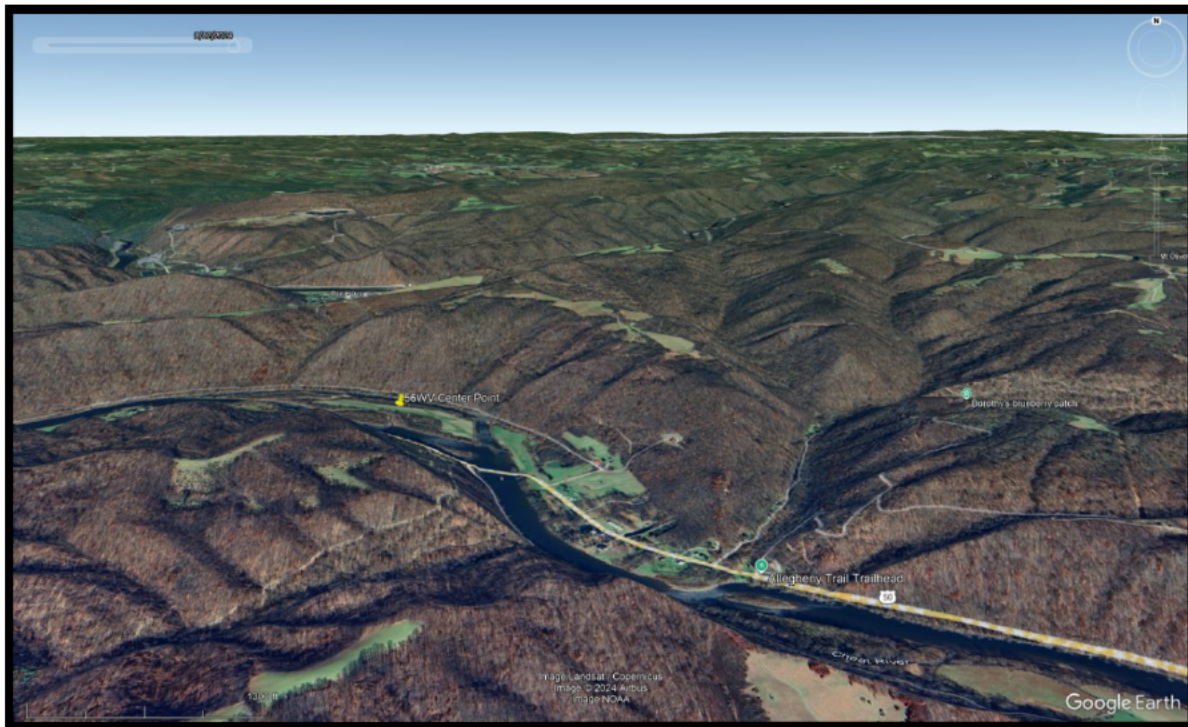
It is a relatively smooth runway with no bumps or dips. On approach, because of a mountain pilots will make a 45° dog leg before landing. Because of the mountain (Figure 1) straight-in approaches

can't be performed. The last portion of final approach is flown over a river. The runway begins at the shore of the Cheat River.

**Figure 1: Google Earth Image of Airport Location Among Mountains**
