ERA25LA016

## INVESTIGATION PHOTOGRAPHS

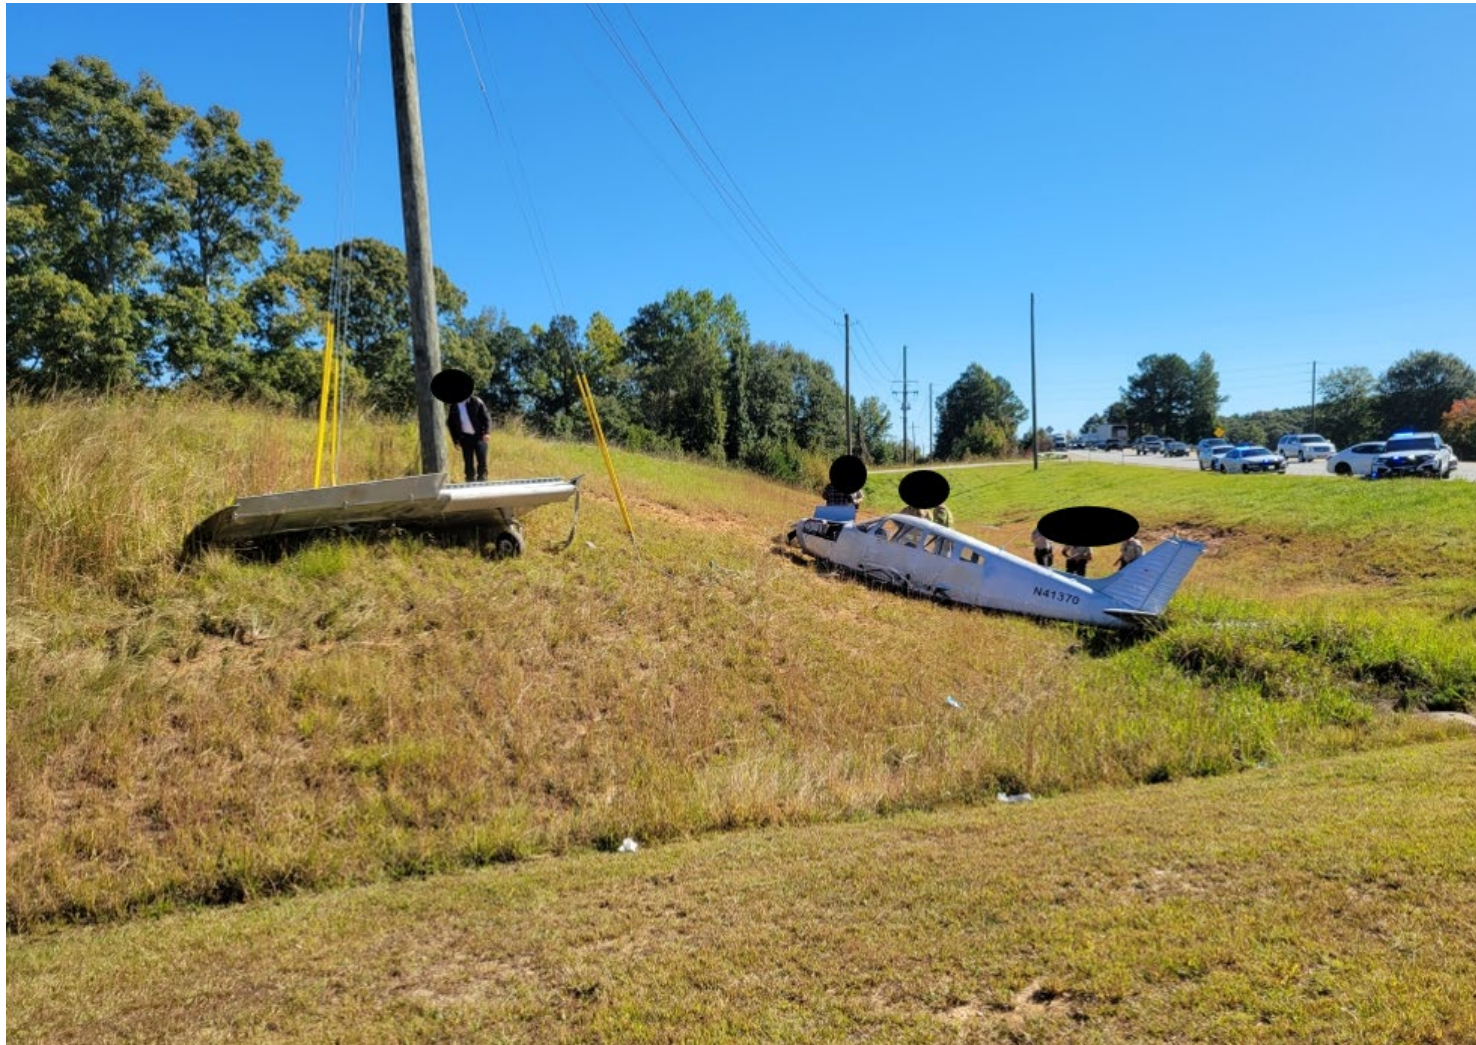
**Photograph 1 - View of left profile side of airplane at accident site.  
(Courtesy of Leading Edge Investigations)**

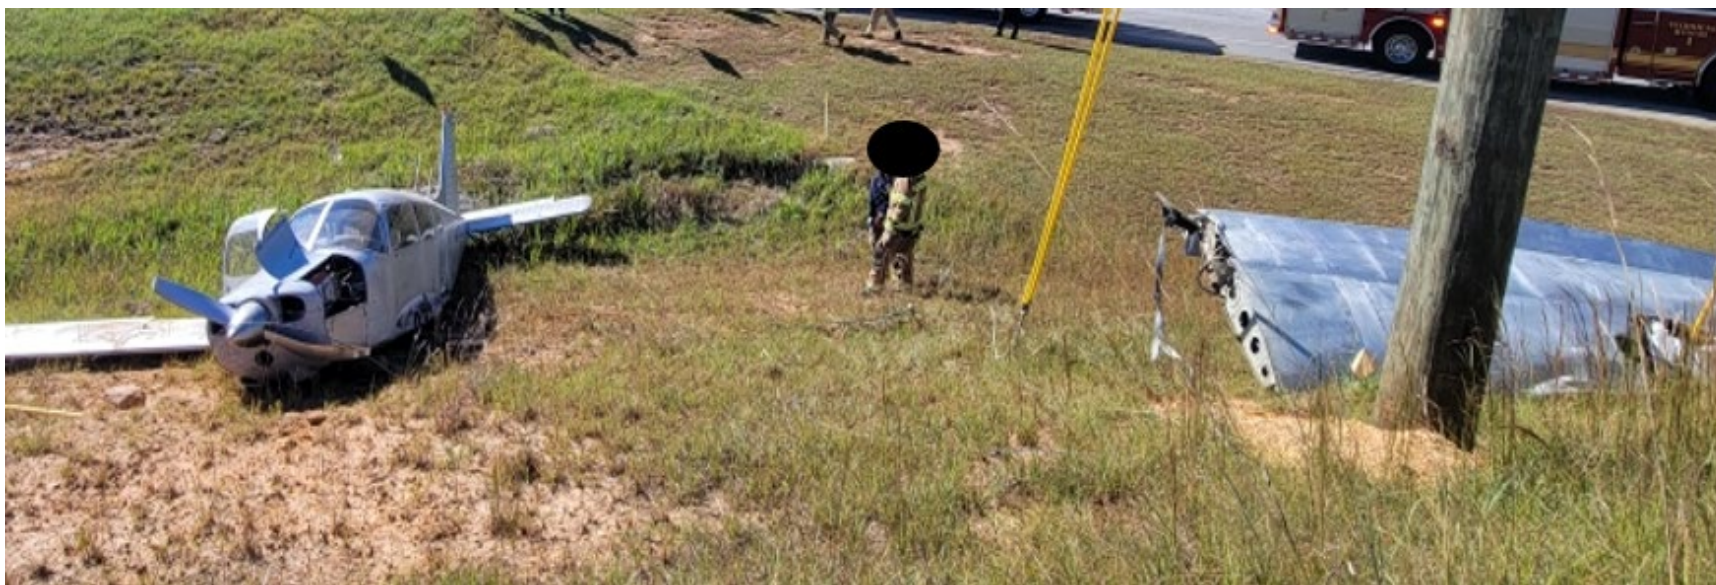
**Photograph 2 - View of airplane at accident site. (Courtesy of Leading Edge Investigations)**

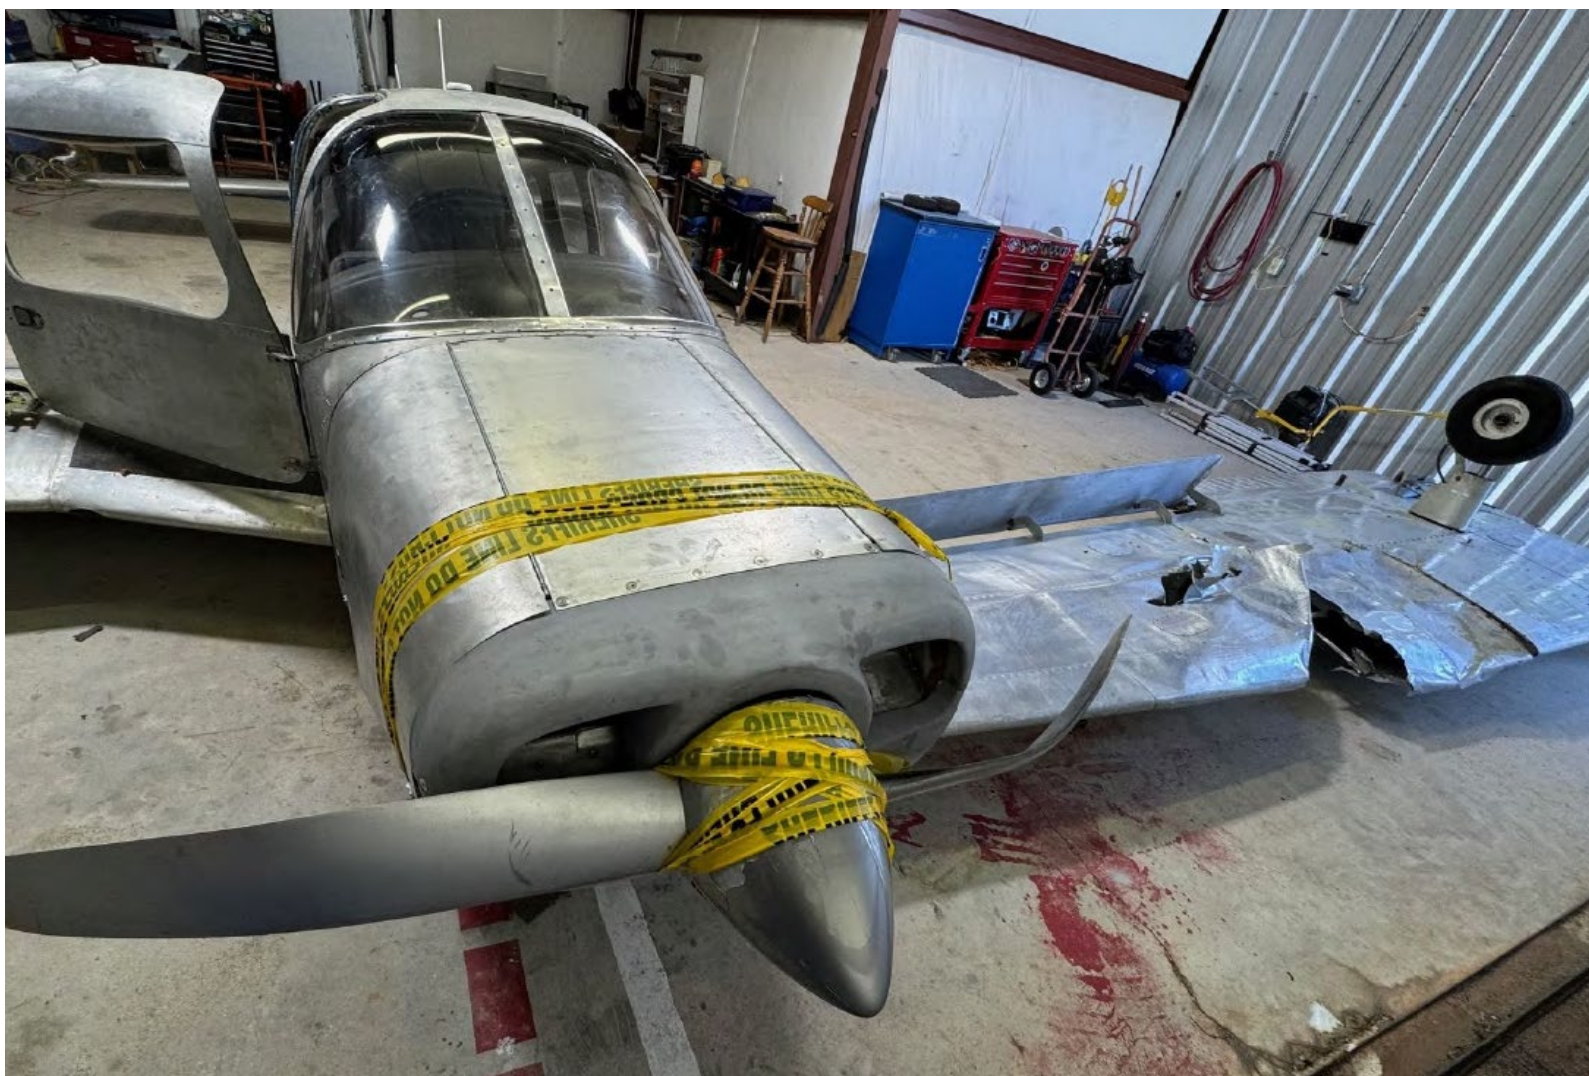
**Photograph 3 - View of airplane in hangar. (Courtesy of Leading Edge Investigations)**

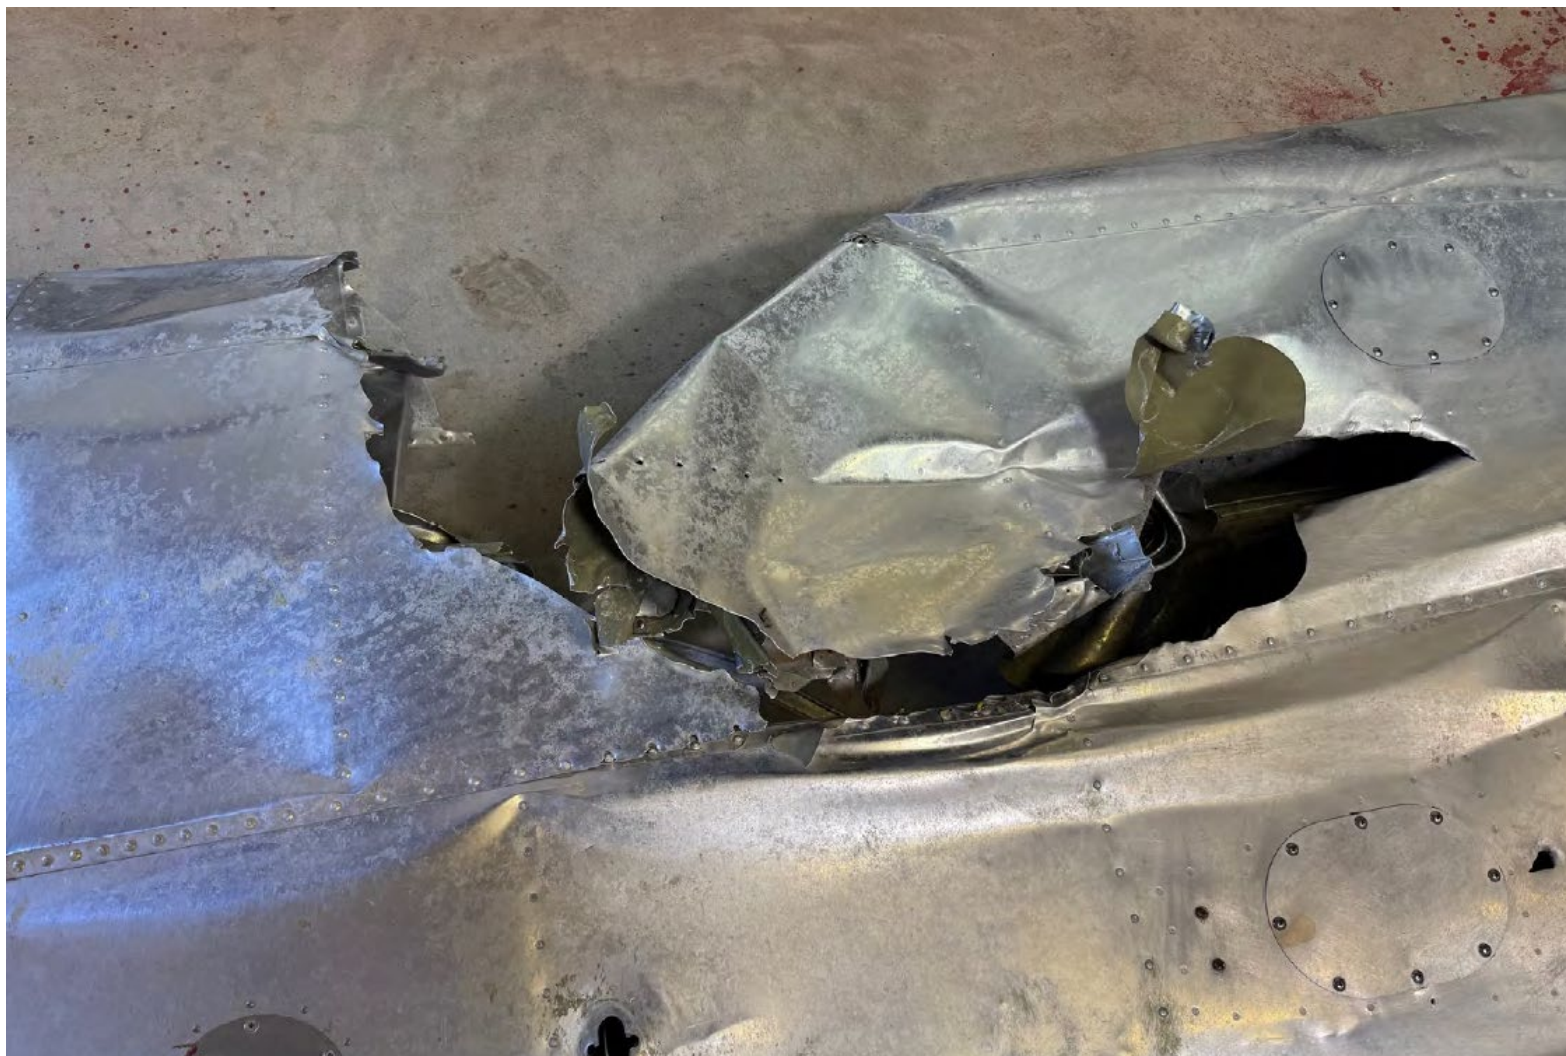
**Photograph 4 - Left wing damage from pole. (Courtesy of Leading Edge Investigations)**
