ERA25LA021

## INVESTIGATION PHOTOGRAPHS

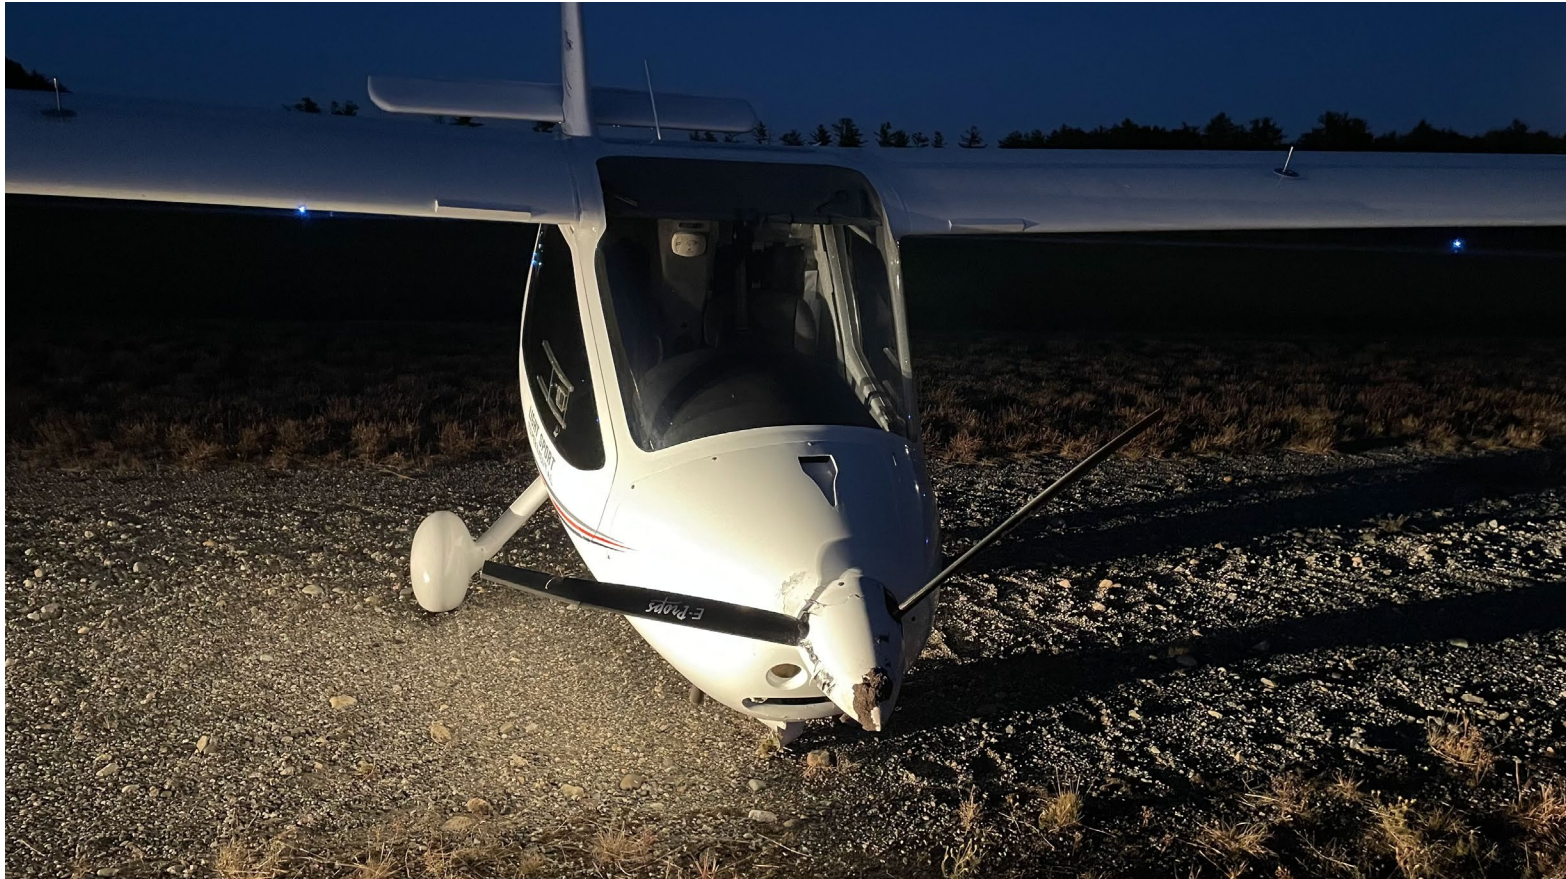
**Photograph 1 - Main Wreckage (Courtesy of FAA)**

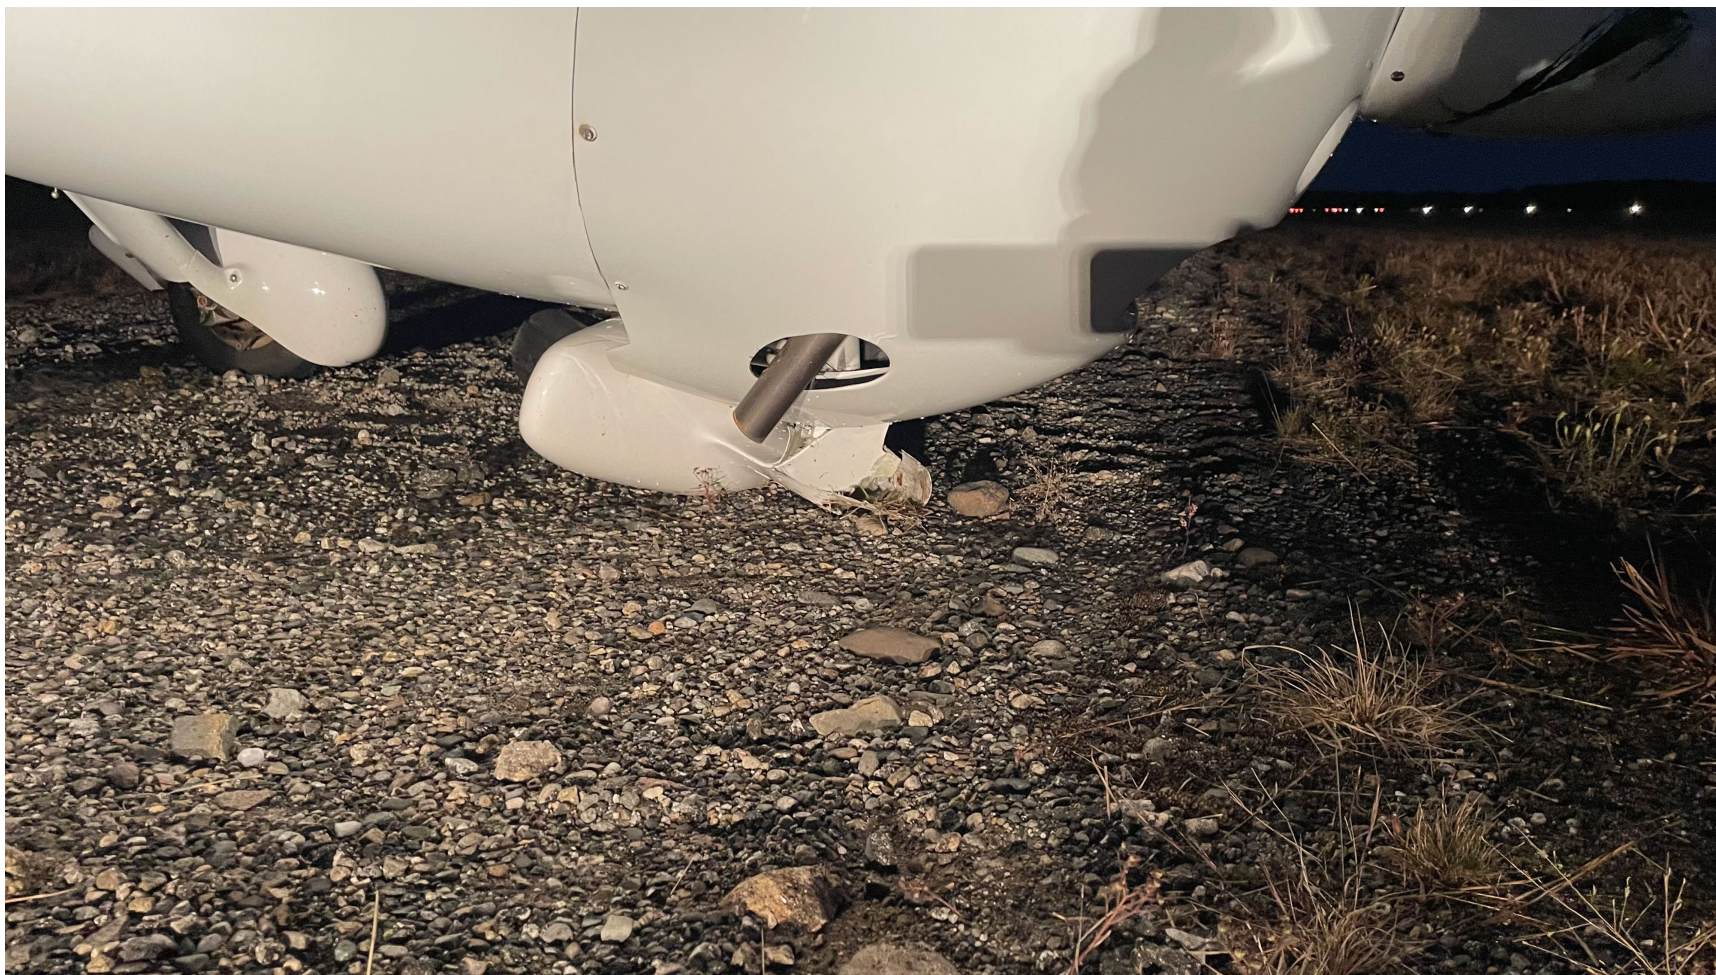
**Photograph 2 - Buckled Nose Landing Gear (Courtesy of FAA)**

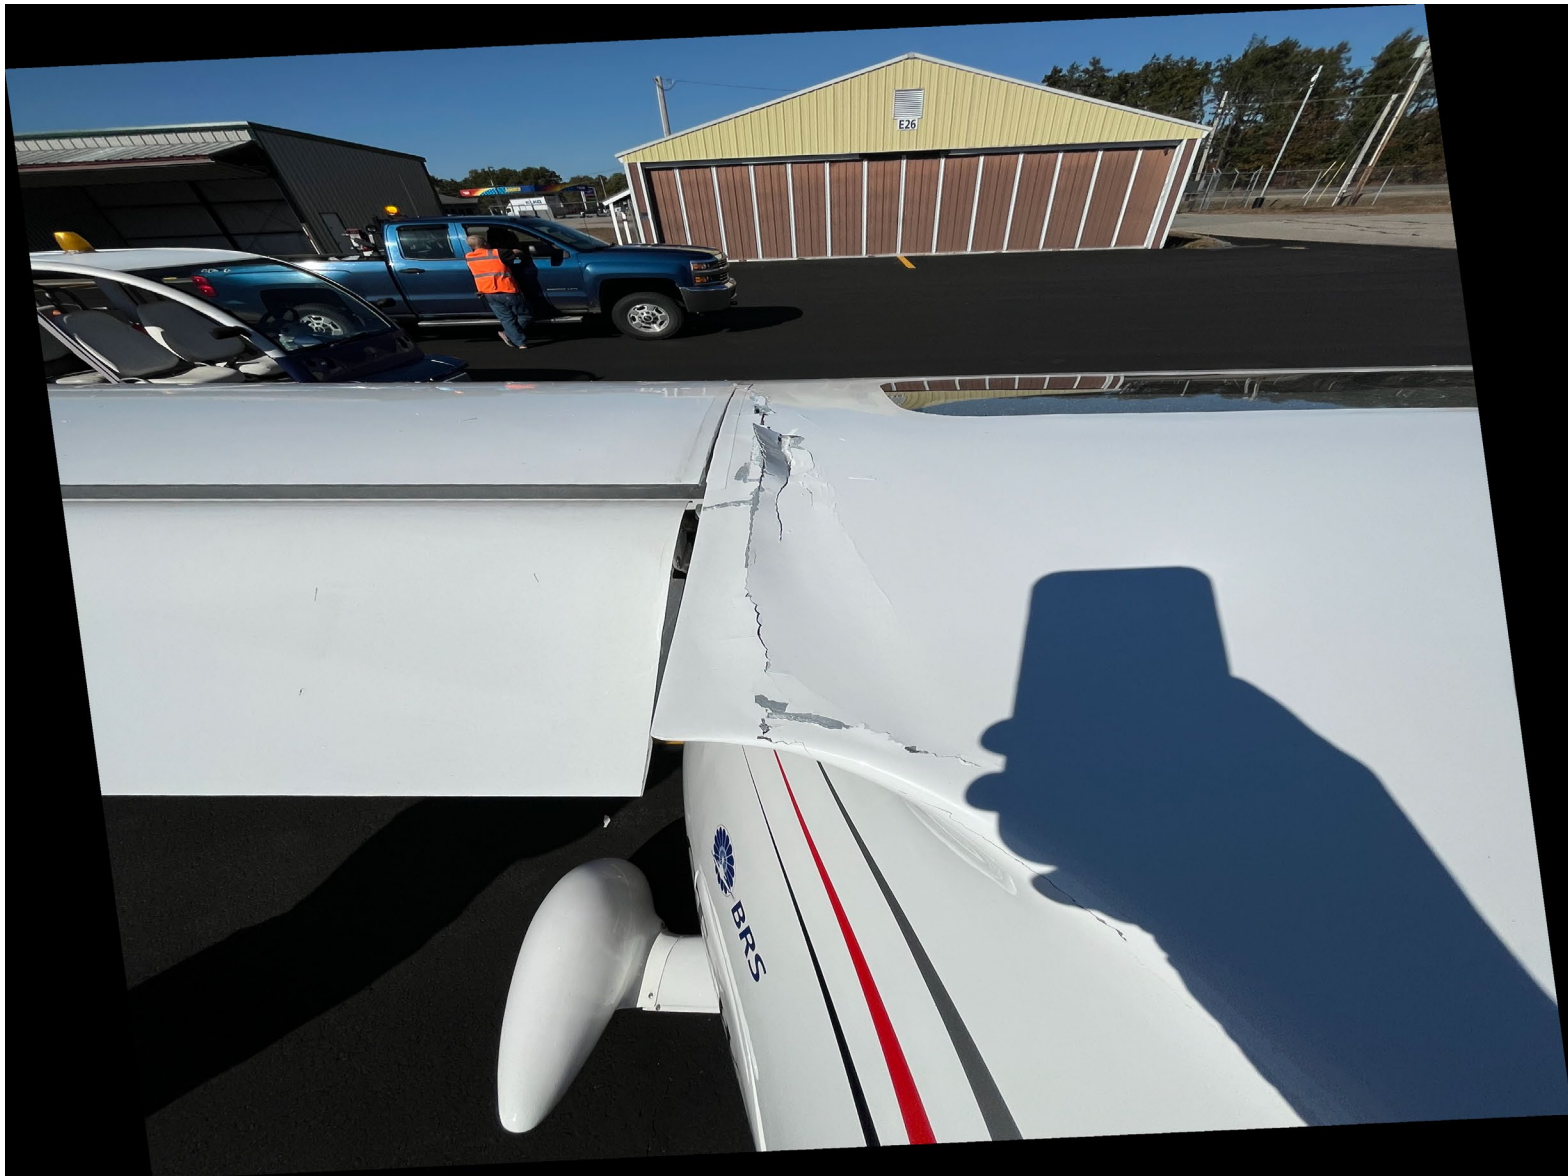
**Photograph 3 - Upper Fuselage Damage (Courtesy of FAA)**

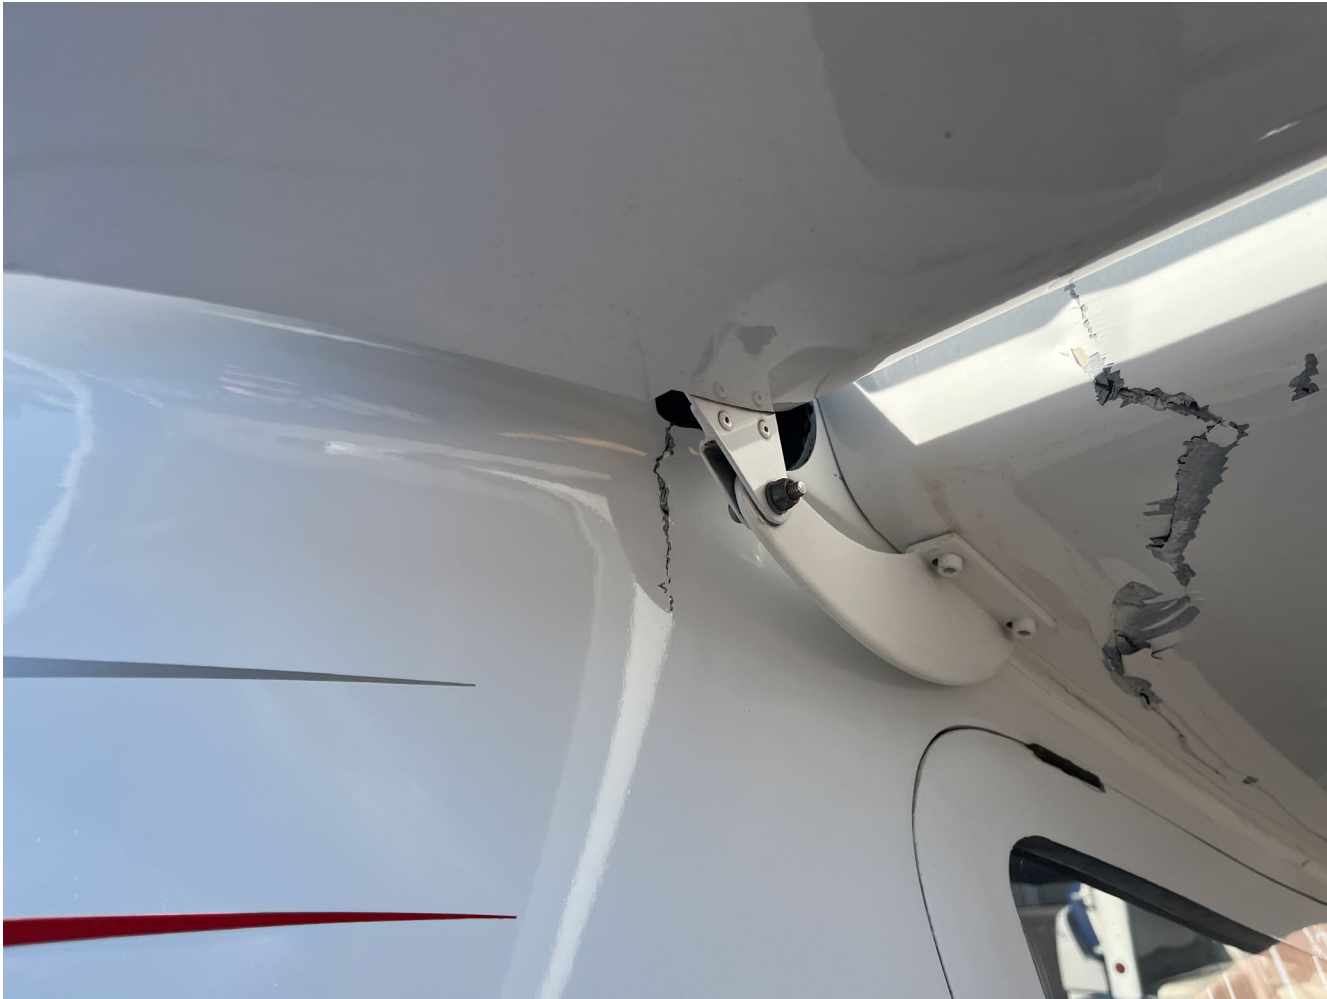
**Photograph 4 - Wing Root Damage (Courtesy of FAA)**

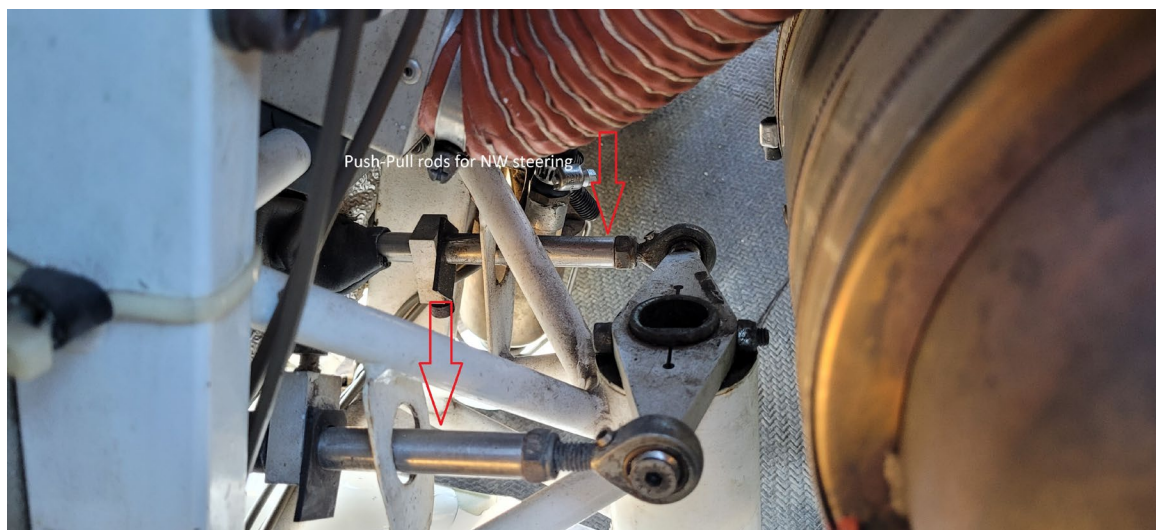
**Photograph 5 - Nosewheel Steering Linkage (Courtesy of FAA)**
